**MINERALS PROGRAM INSPECTION REPORT**  
**PHONE: (303) 866-3567**

<b>MINE NAME:</b> Kauffman Pit	<b>MINE/PROSPECTING ID#:</b> M-1978-327	<b>MINERAL:</b> Sand and gravel	<b>COUNTY:</b> Larimer
<b>INSPECTION TYPE:</b> Monitoring	<b>INSPECTOR(S):</b> Amy Eschberger	<b>INSP. DATE:</b> April 14, 2017	<b>INSP. TIME:</b> 10:45
<b>OPERATOR:</b> Jake Kauffman & Son, Inc.	<b>OPERATOR REPRESENTATIVE:</b> Mary Kauffman, Troy Kauffman, Shane Kauffman, Dan Giroux	<b>TYPE OF OPERATION:</b> 112c - Construction Regular Operation	
<b>REASON FOR INSPECTION:</b> Normal I&E Program	<b>BOND CALCULATION TYPE:</b> Complete Bond	<b>BOND AMOUNT:</b> \$84,440.00	
<b>DATE OF COMPLAINT:</b> NA	<b>POST INSP. CONTACTS:</b> None	<b>JOINT INSP. AGENCY:</b> None	
<b>WEATHER:</b> Clear	<b>INSPECTOR'S SIGNATURE:</b>

**JAKE KAUFFMAN and SON, INC.**  
**LARIMER COUNTY, COLORADO**  
**M-78-327**  
**TR-06**  
**EXHIBIT F - FINAL RECLAMATION PLAN**  
**WITH FINAL POST-MINING AFTER-USES**

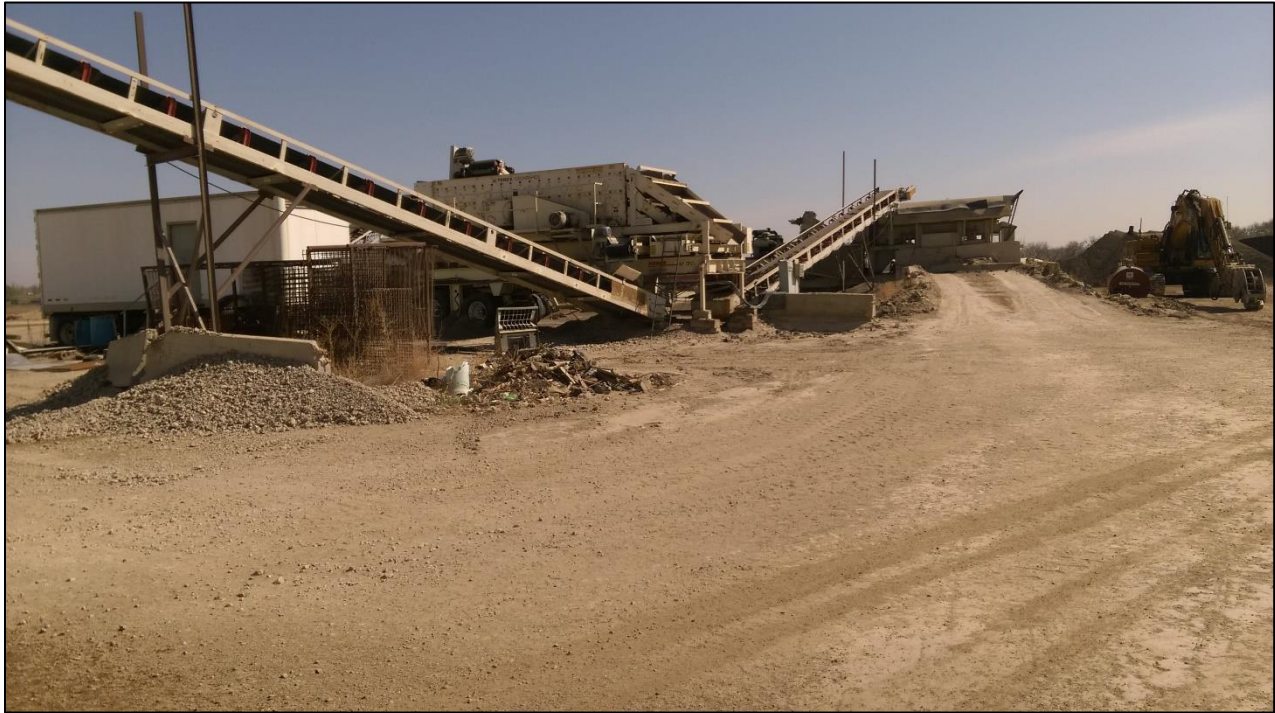
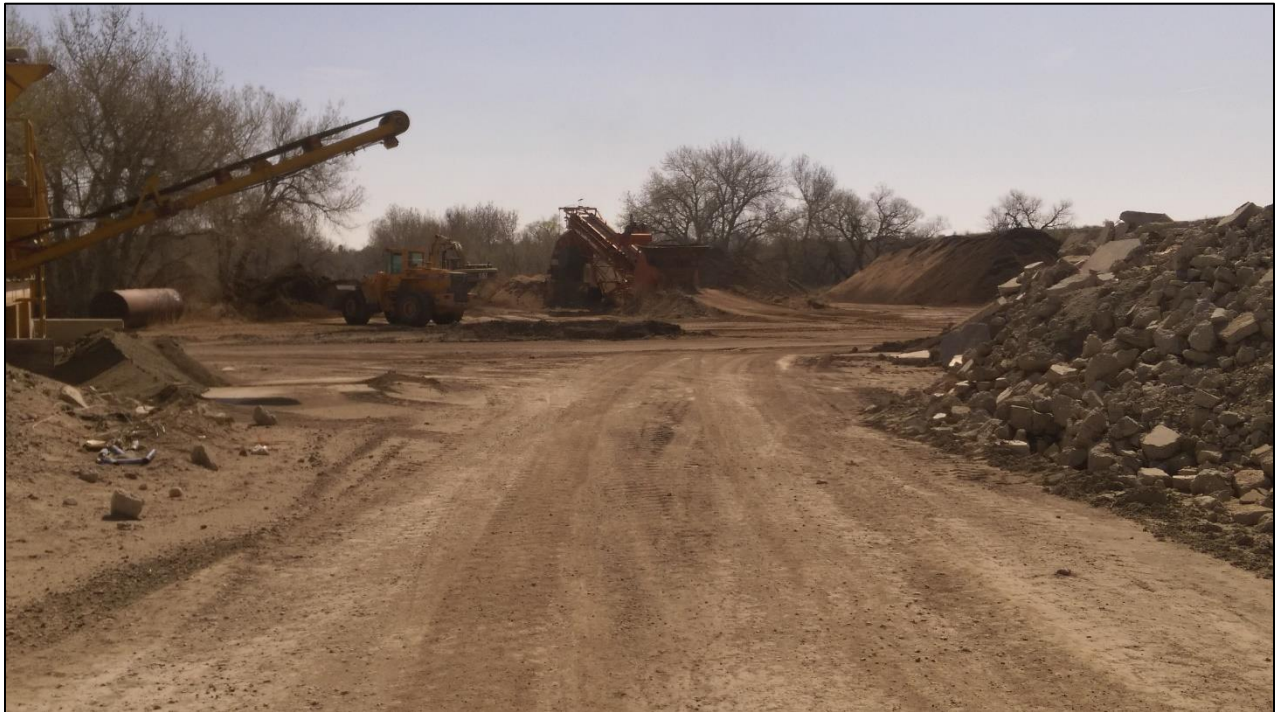
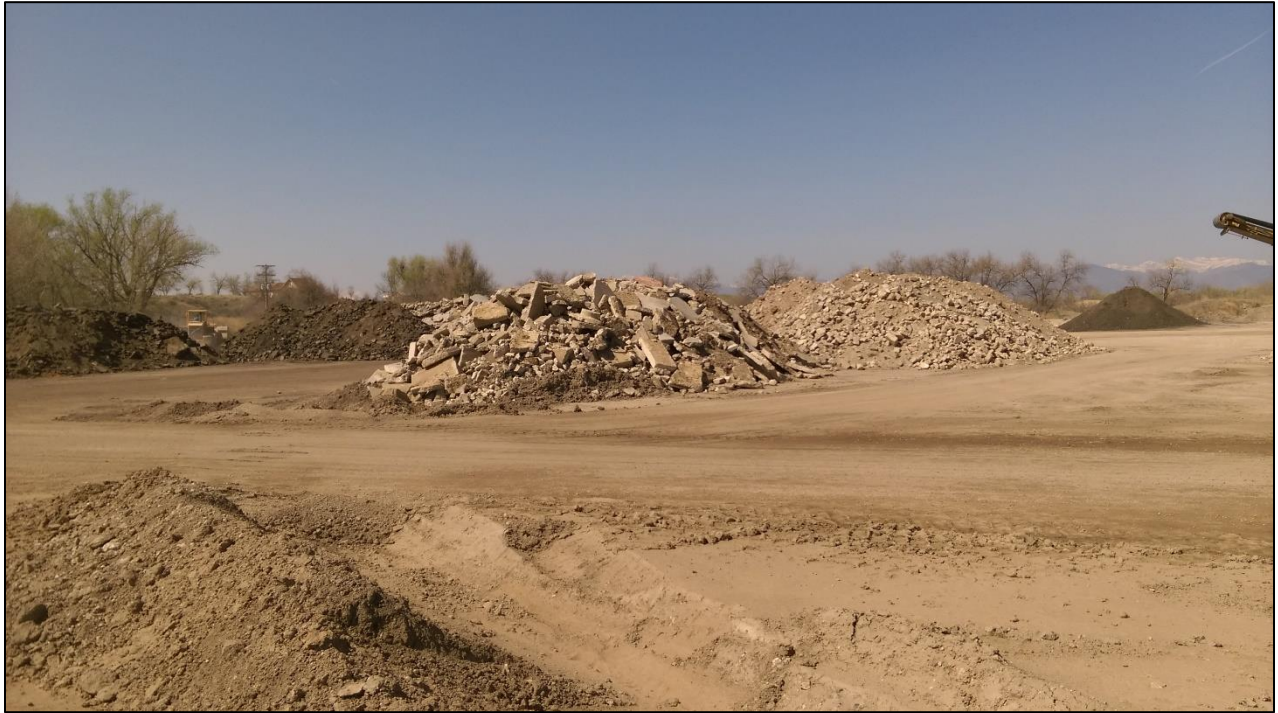
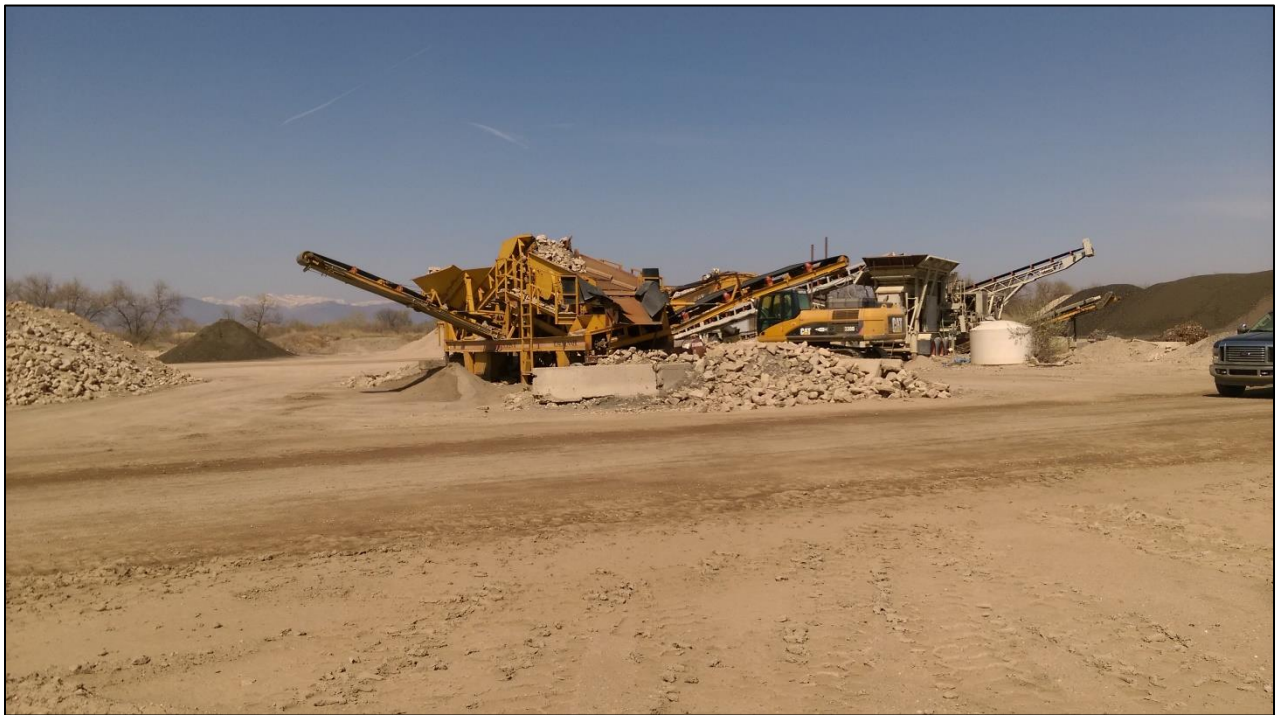
**Photo 1.** View of recycled materials operation located in southern portion of permit area. This area was active during the inspection.

**Photo 2.** View of recycled materials operation located in southern portion of permit area. This area was active during the inspection.

**Photo 3.** View of recycled materials operation located in southern portion of permit area. This area was active during the inspection.

**Photo 4.** View of recycled materials operation located in southern portion of permit area. This area was active during the inspection.

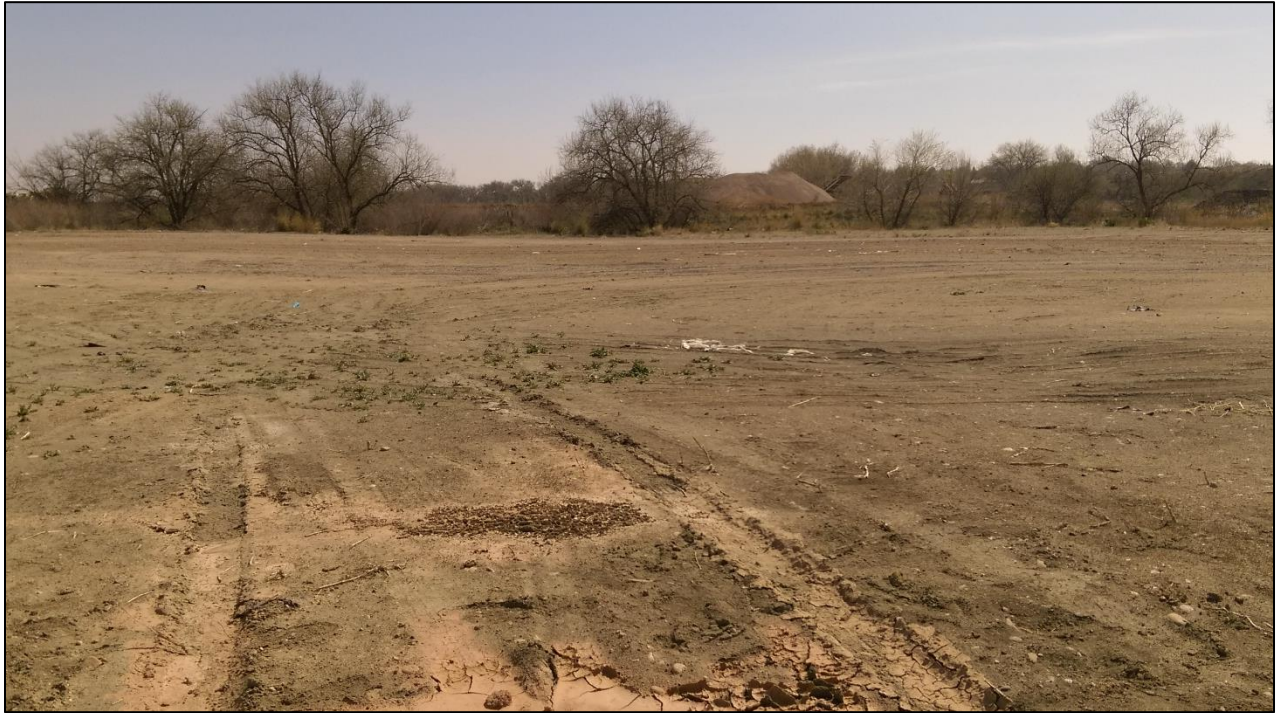
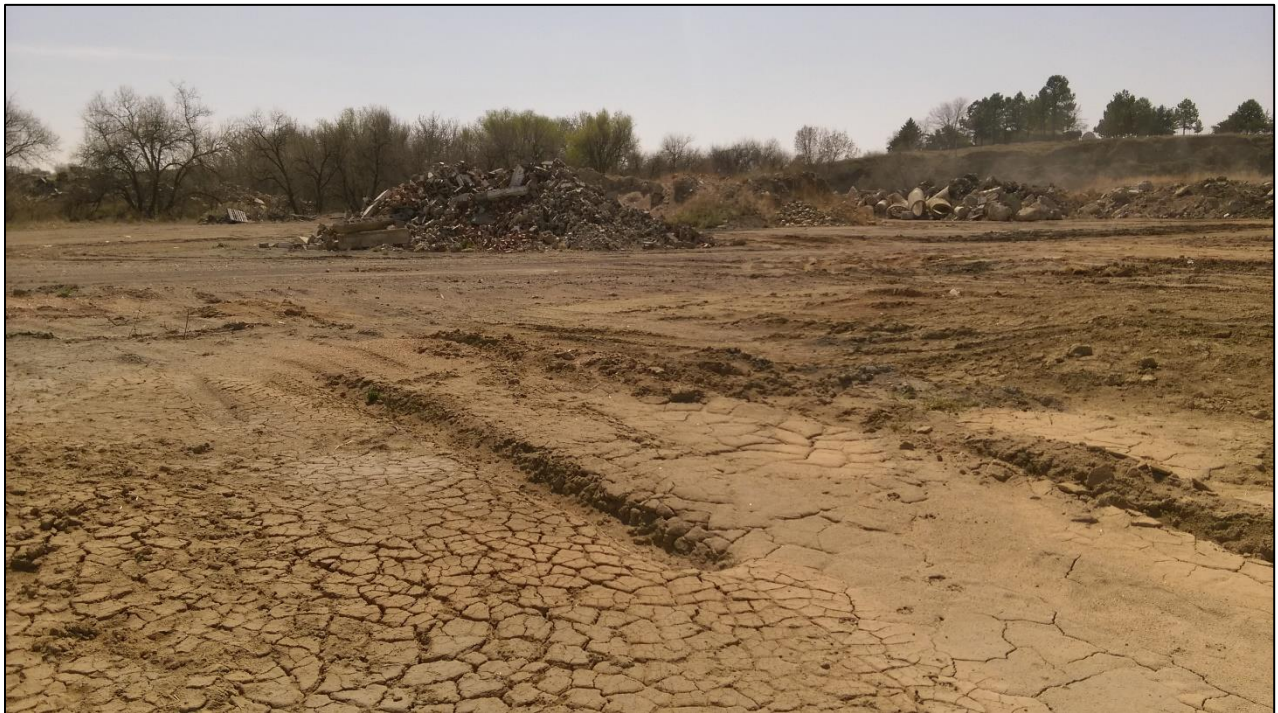
**Photo 5.** View of storage area located east of the south pond. This area will remain after reclamation for use by the operator's adjacent commercial business.

**Photo 6.** View of storage area located east of the south pond. This area will remain after reclamation for use by the operator's adjacent commercial business.

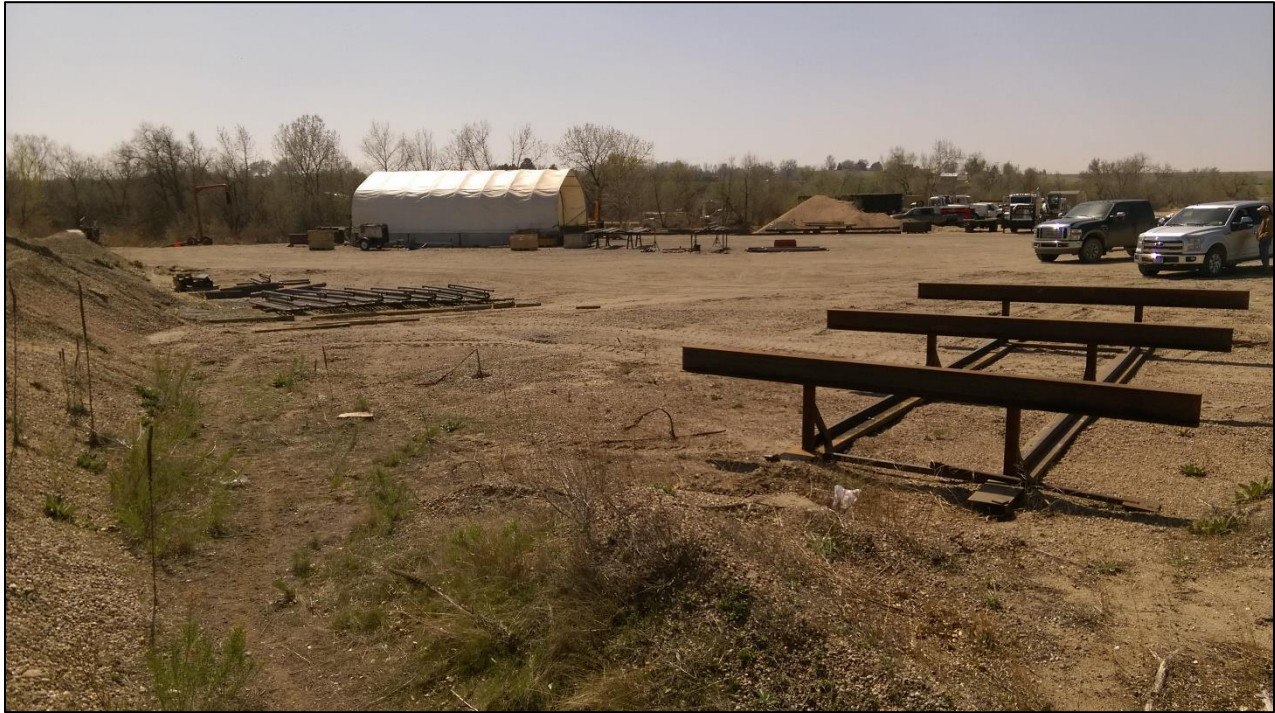
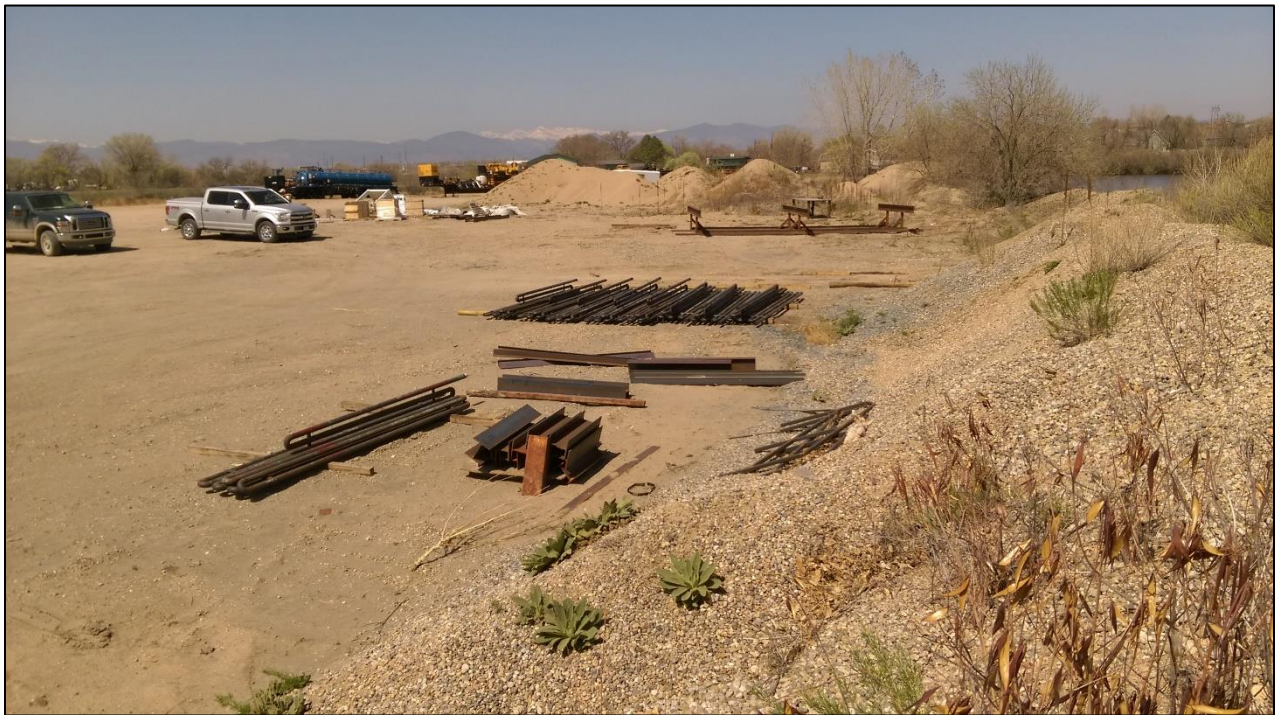
**Photo 7.** View of storage area located south of the north pond. This area will remain after reclamation for use by the operator's adjacent commercial business.

**Photo 8.** View of storage area located south of the north pond. This area will remain after reclamation for use by the operator's adjacent commercial business.

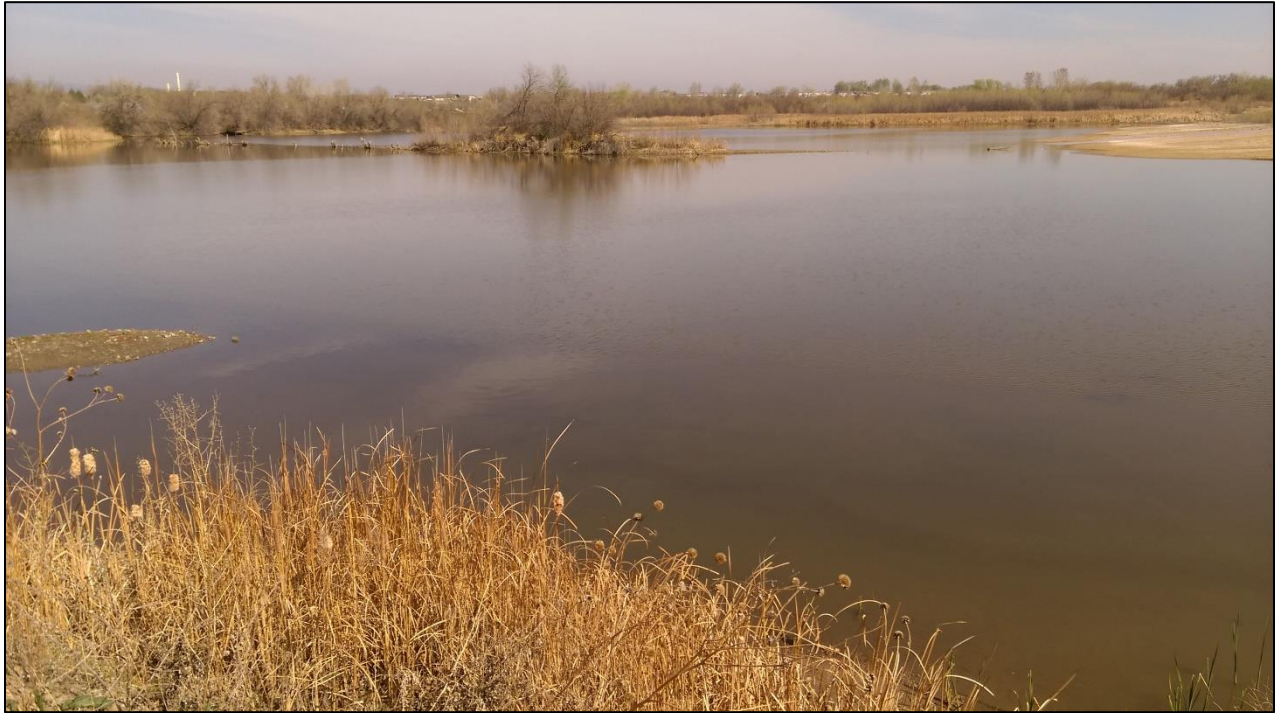
**Photo 9.** View looking north across south pond. All shorelines have been reclaimed except for the eastern portion which is part of the storage area to remain for industrial/commercial use.

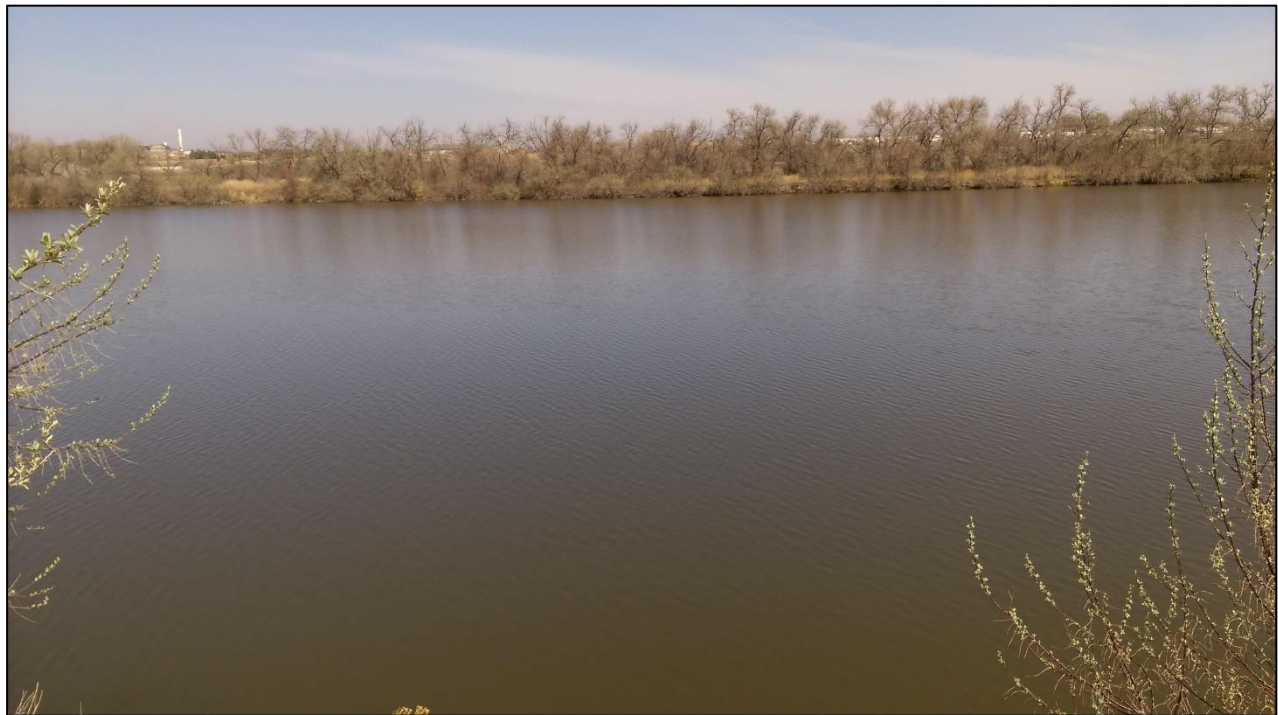
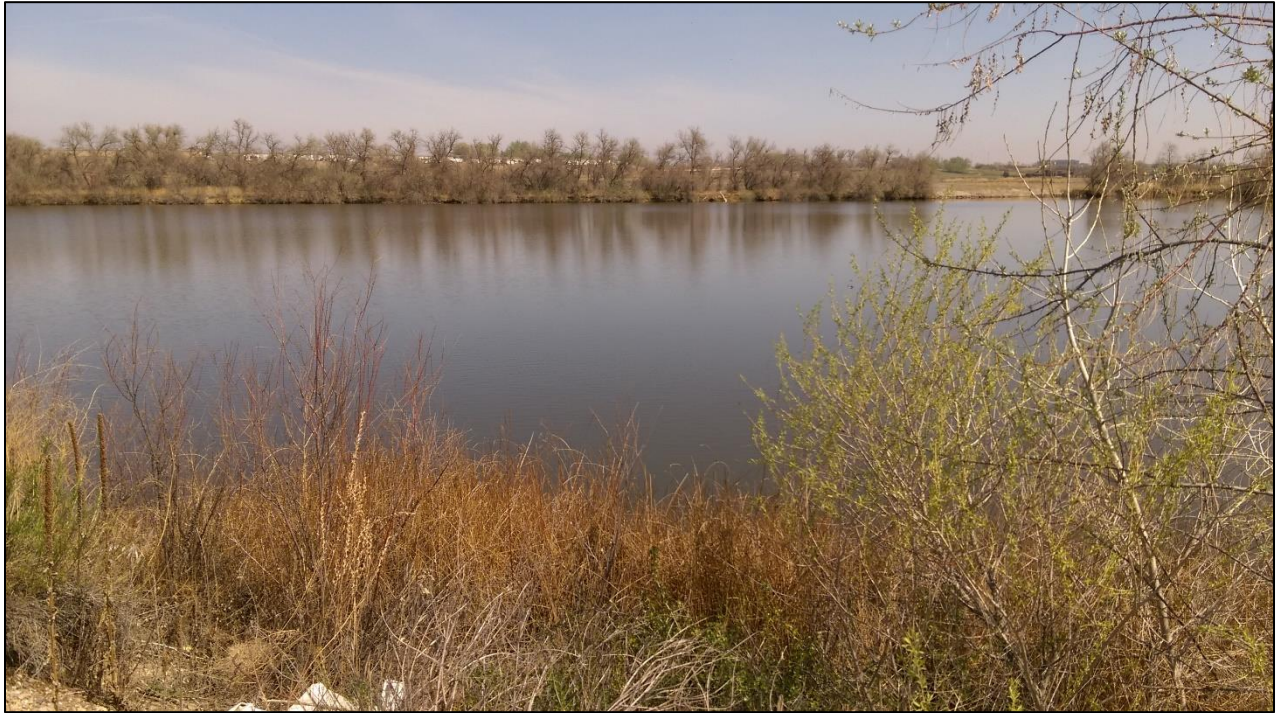
**Photo 10.** View looking north across north pond. All shorelines have been reclaimed except for a portion of the southern shoreline which is part of the storage area to remain for industrial/commercial use.

**Photo 11.** View looking northeast across north pond. All shorelines have been reclaimed except for a portion of the southern shoreline which is part of the storage area to remain for industrial/commercial use.

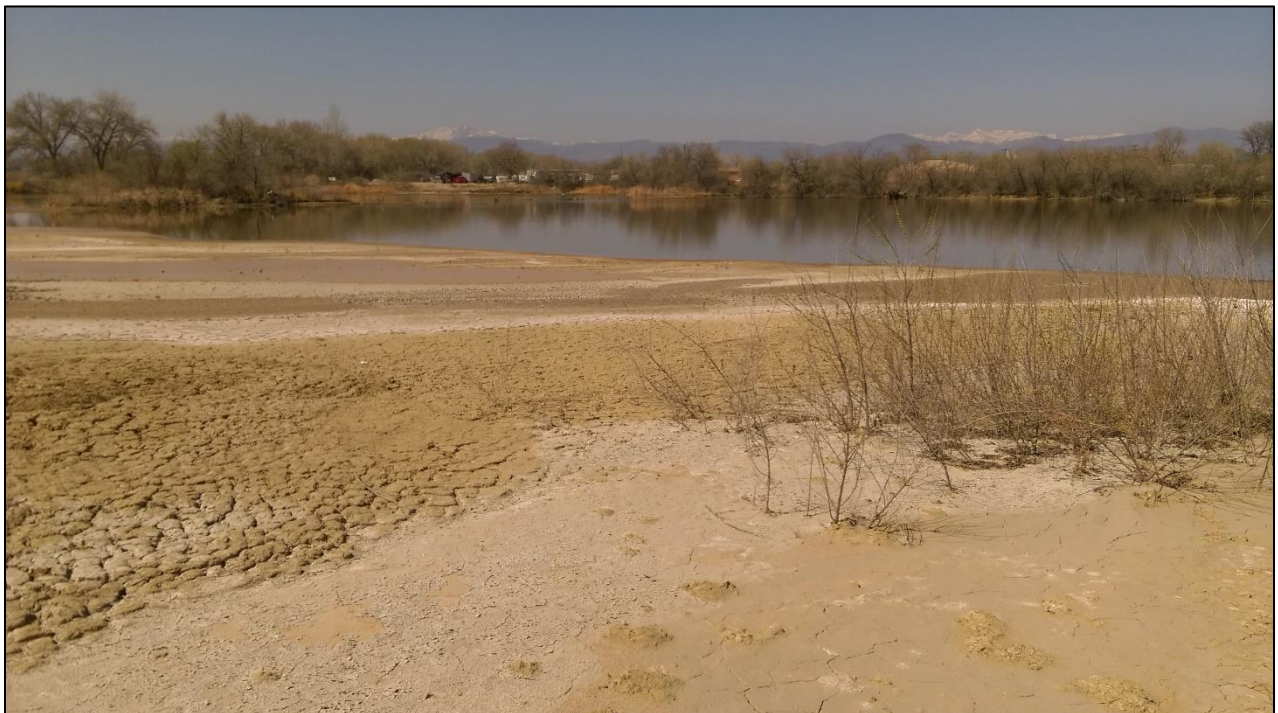
except for the eastern portion where the storage area is expanding as the operation continues to backfill this portion of the pond. Shorelines in this area are 4H:1V or flatter (**Photo 12**). Because the operator has designated this area for industrial/commercial use, it will not require revegetation for final release.

**Photo 12.** View looking southwest across eastern shoreline of south pond with slope gradients of 4H:1V or flatter. This portion of the south pond shoreline is part of the storage area that will remain for industrial/commercial use.

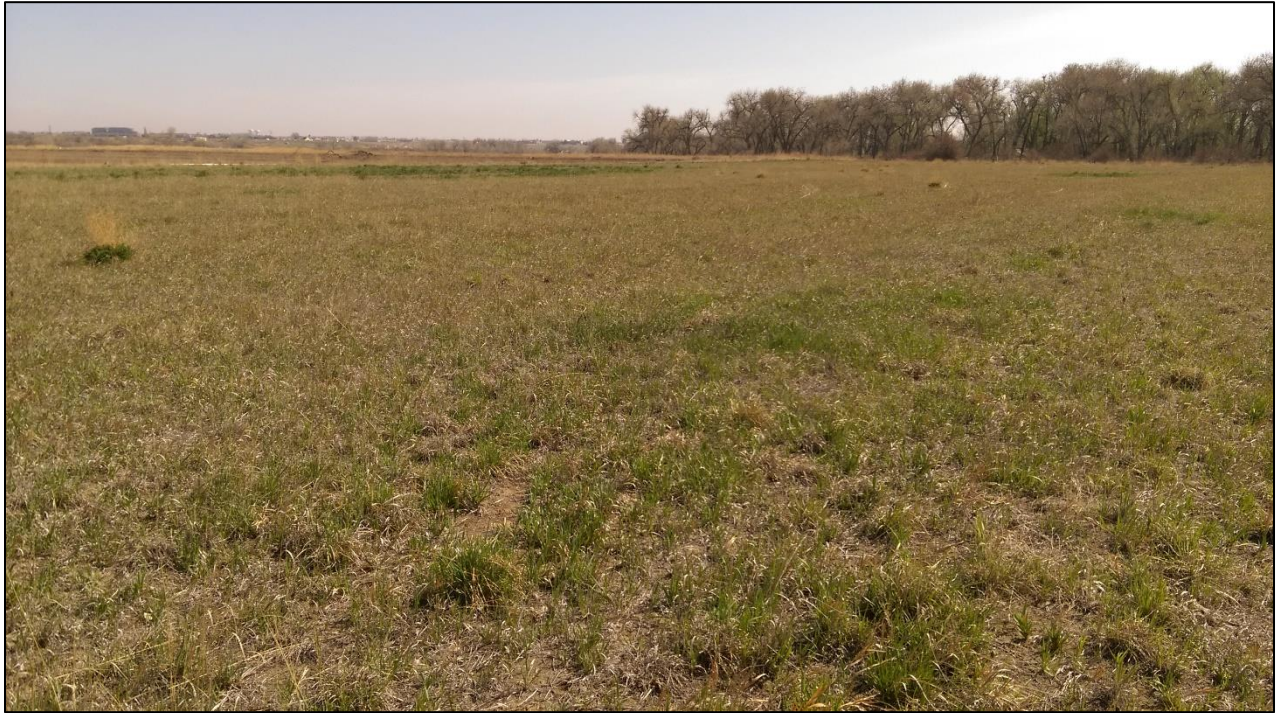
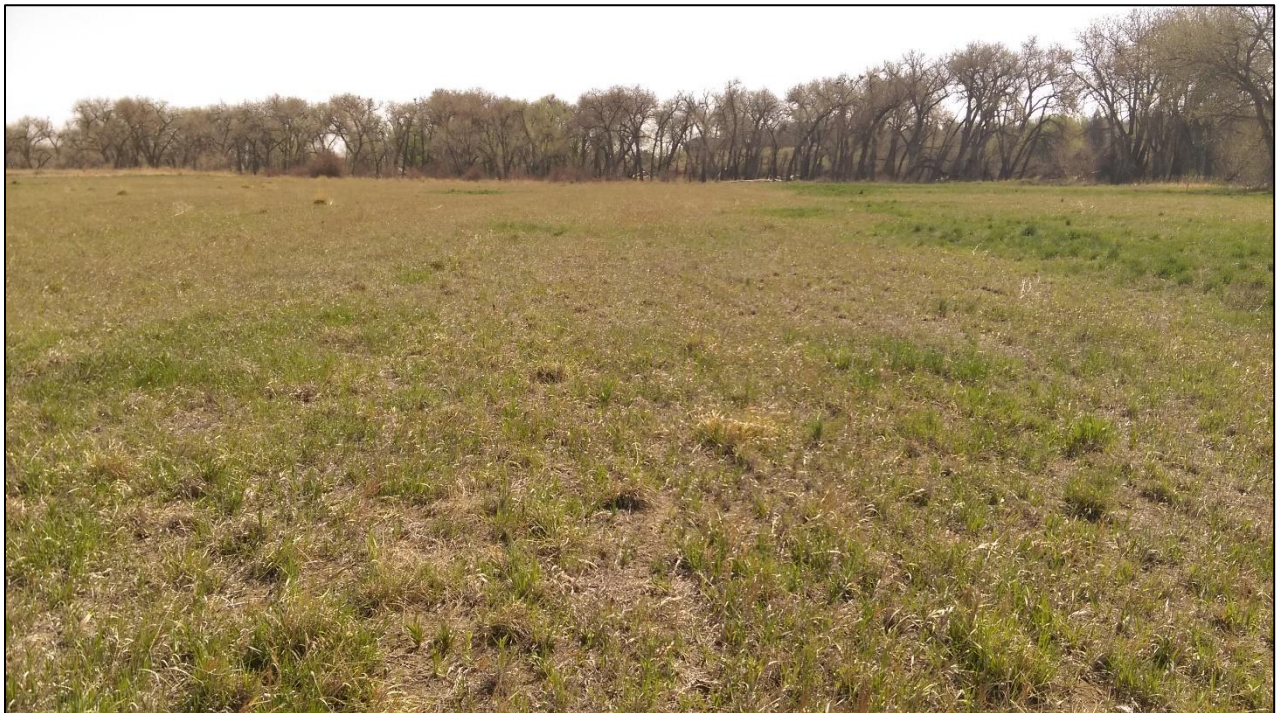
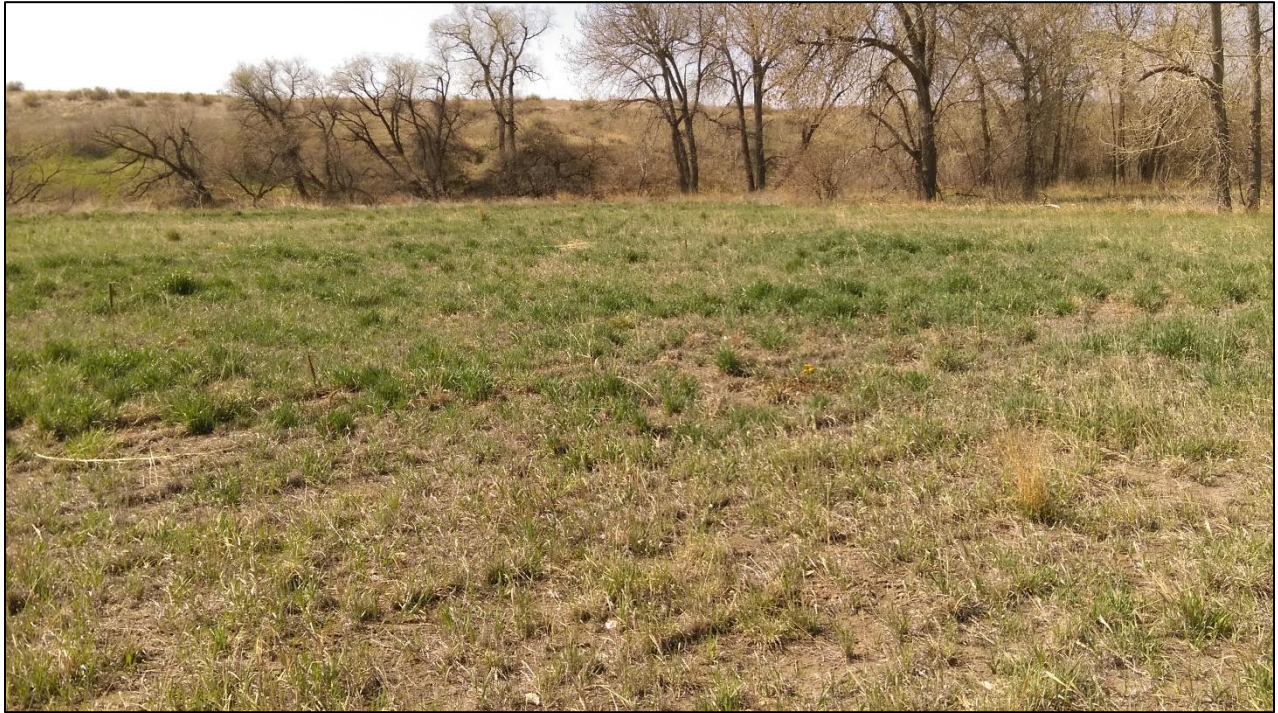
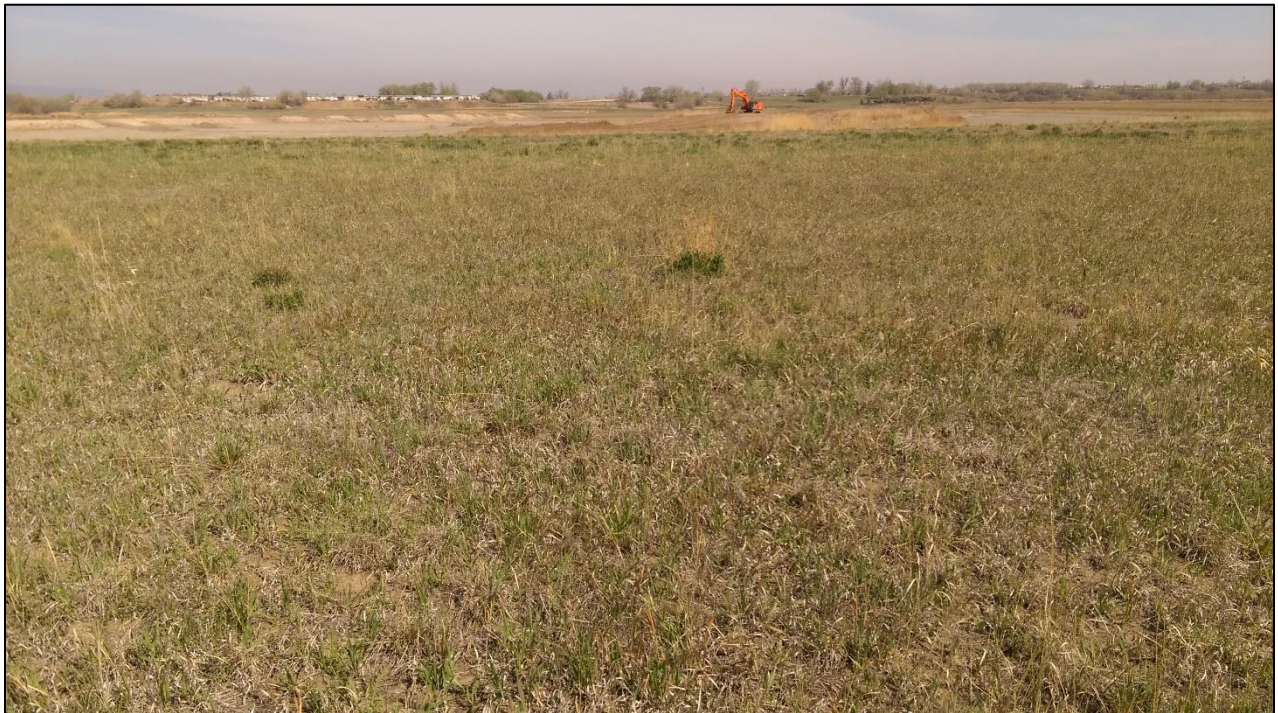
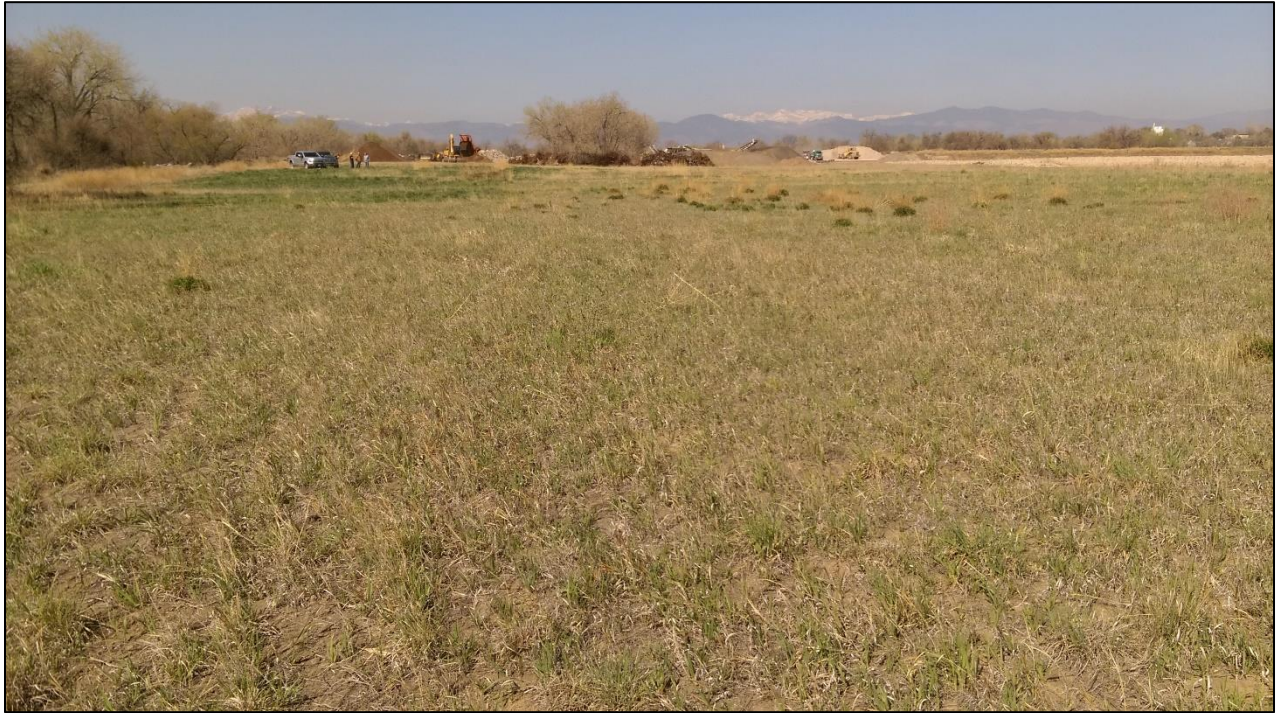
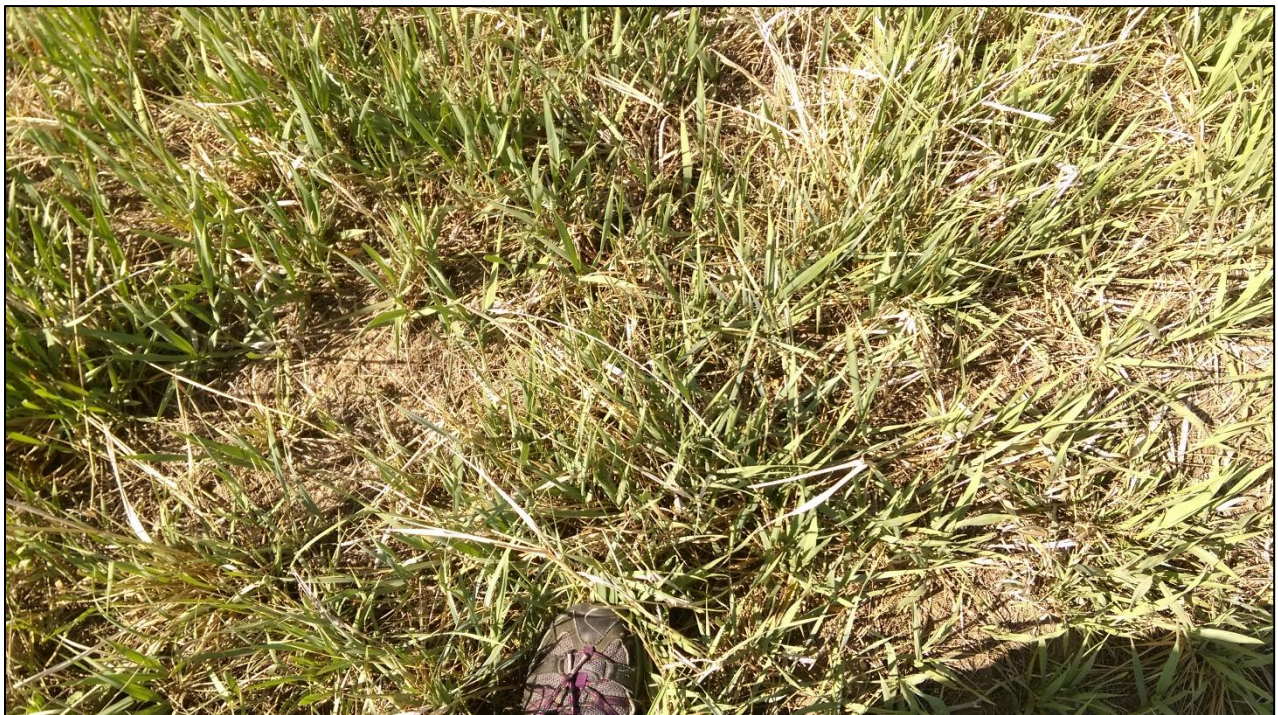
The Division inspected the 9.1 acre area located in the far eastern portion of the permit area designated to be reclaimed as dryland grass pasture. This area was graded to nearly flat and had a good mixture of native grasses and forbs established across the entire area (**Photos 13-18**). The operator has placed metal posts at the western edge of this area to separate it from the rest of the permit area. The Division considers the eastern portion of the permit area to be reclaimed in accordance with the approved reclamation plan. After the inspection, on May 23, 2017, the Division received an Acreage Reduction request (Revision No. AR-2) from the operator to release this portion of the permit area. At the same time, the operator also submitted a Surety Reduction request (Revision No. SR-2) to remove costs for reclaiming this portion of the permit area from the required financial warranty. On June 1, 2017, the Division sent notice of these requests to the landowner, Larimer County, the local Soil Conservation District, and the Division of Water Resources. The public comment period for these requests will end on June 16, 2017. So far, the Division has only received a comment from DWR (see enclosed comment received on June 8, 2017). If no objections are received within the public comment period, the Division will approve Revision No. AR-2 to release the 9.1 acre area, reducing the permit area to 75.1 acres.

**Photo 13.** View looking northeast across 9.1 acre area in eastern portion of permit area reclaimed to dryland grass pasture.

**Photo 14.** View looking east across 9.1 acre area in eastern portion of permit area reclaimed to dryland grass pasture.

**Photo 15.** View looking south across 9.1 acre area in eastern portion of permit area reclaimed to dryland grass pasture.

**Photo 16.** View looking north across 9.1 acre area in eastern portion of permit area reclaimed to dryland grass pasture.

**Photo 17.** View looking west across 9.1 acre area in eastern portion of permit area reclaimed to dryland grass pasture.

**Photo 18.** Close-up view of grasses established in 9.1 acre area in eastern portion of permit area reclaimed to dryland grass pasture.

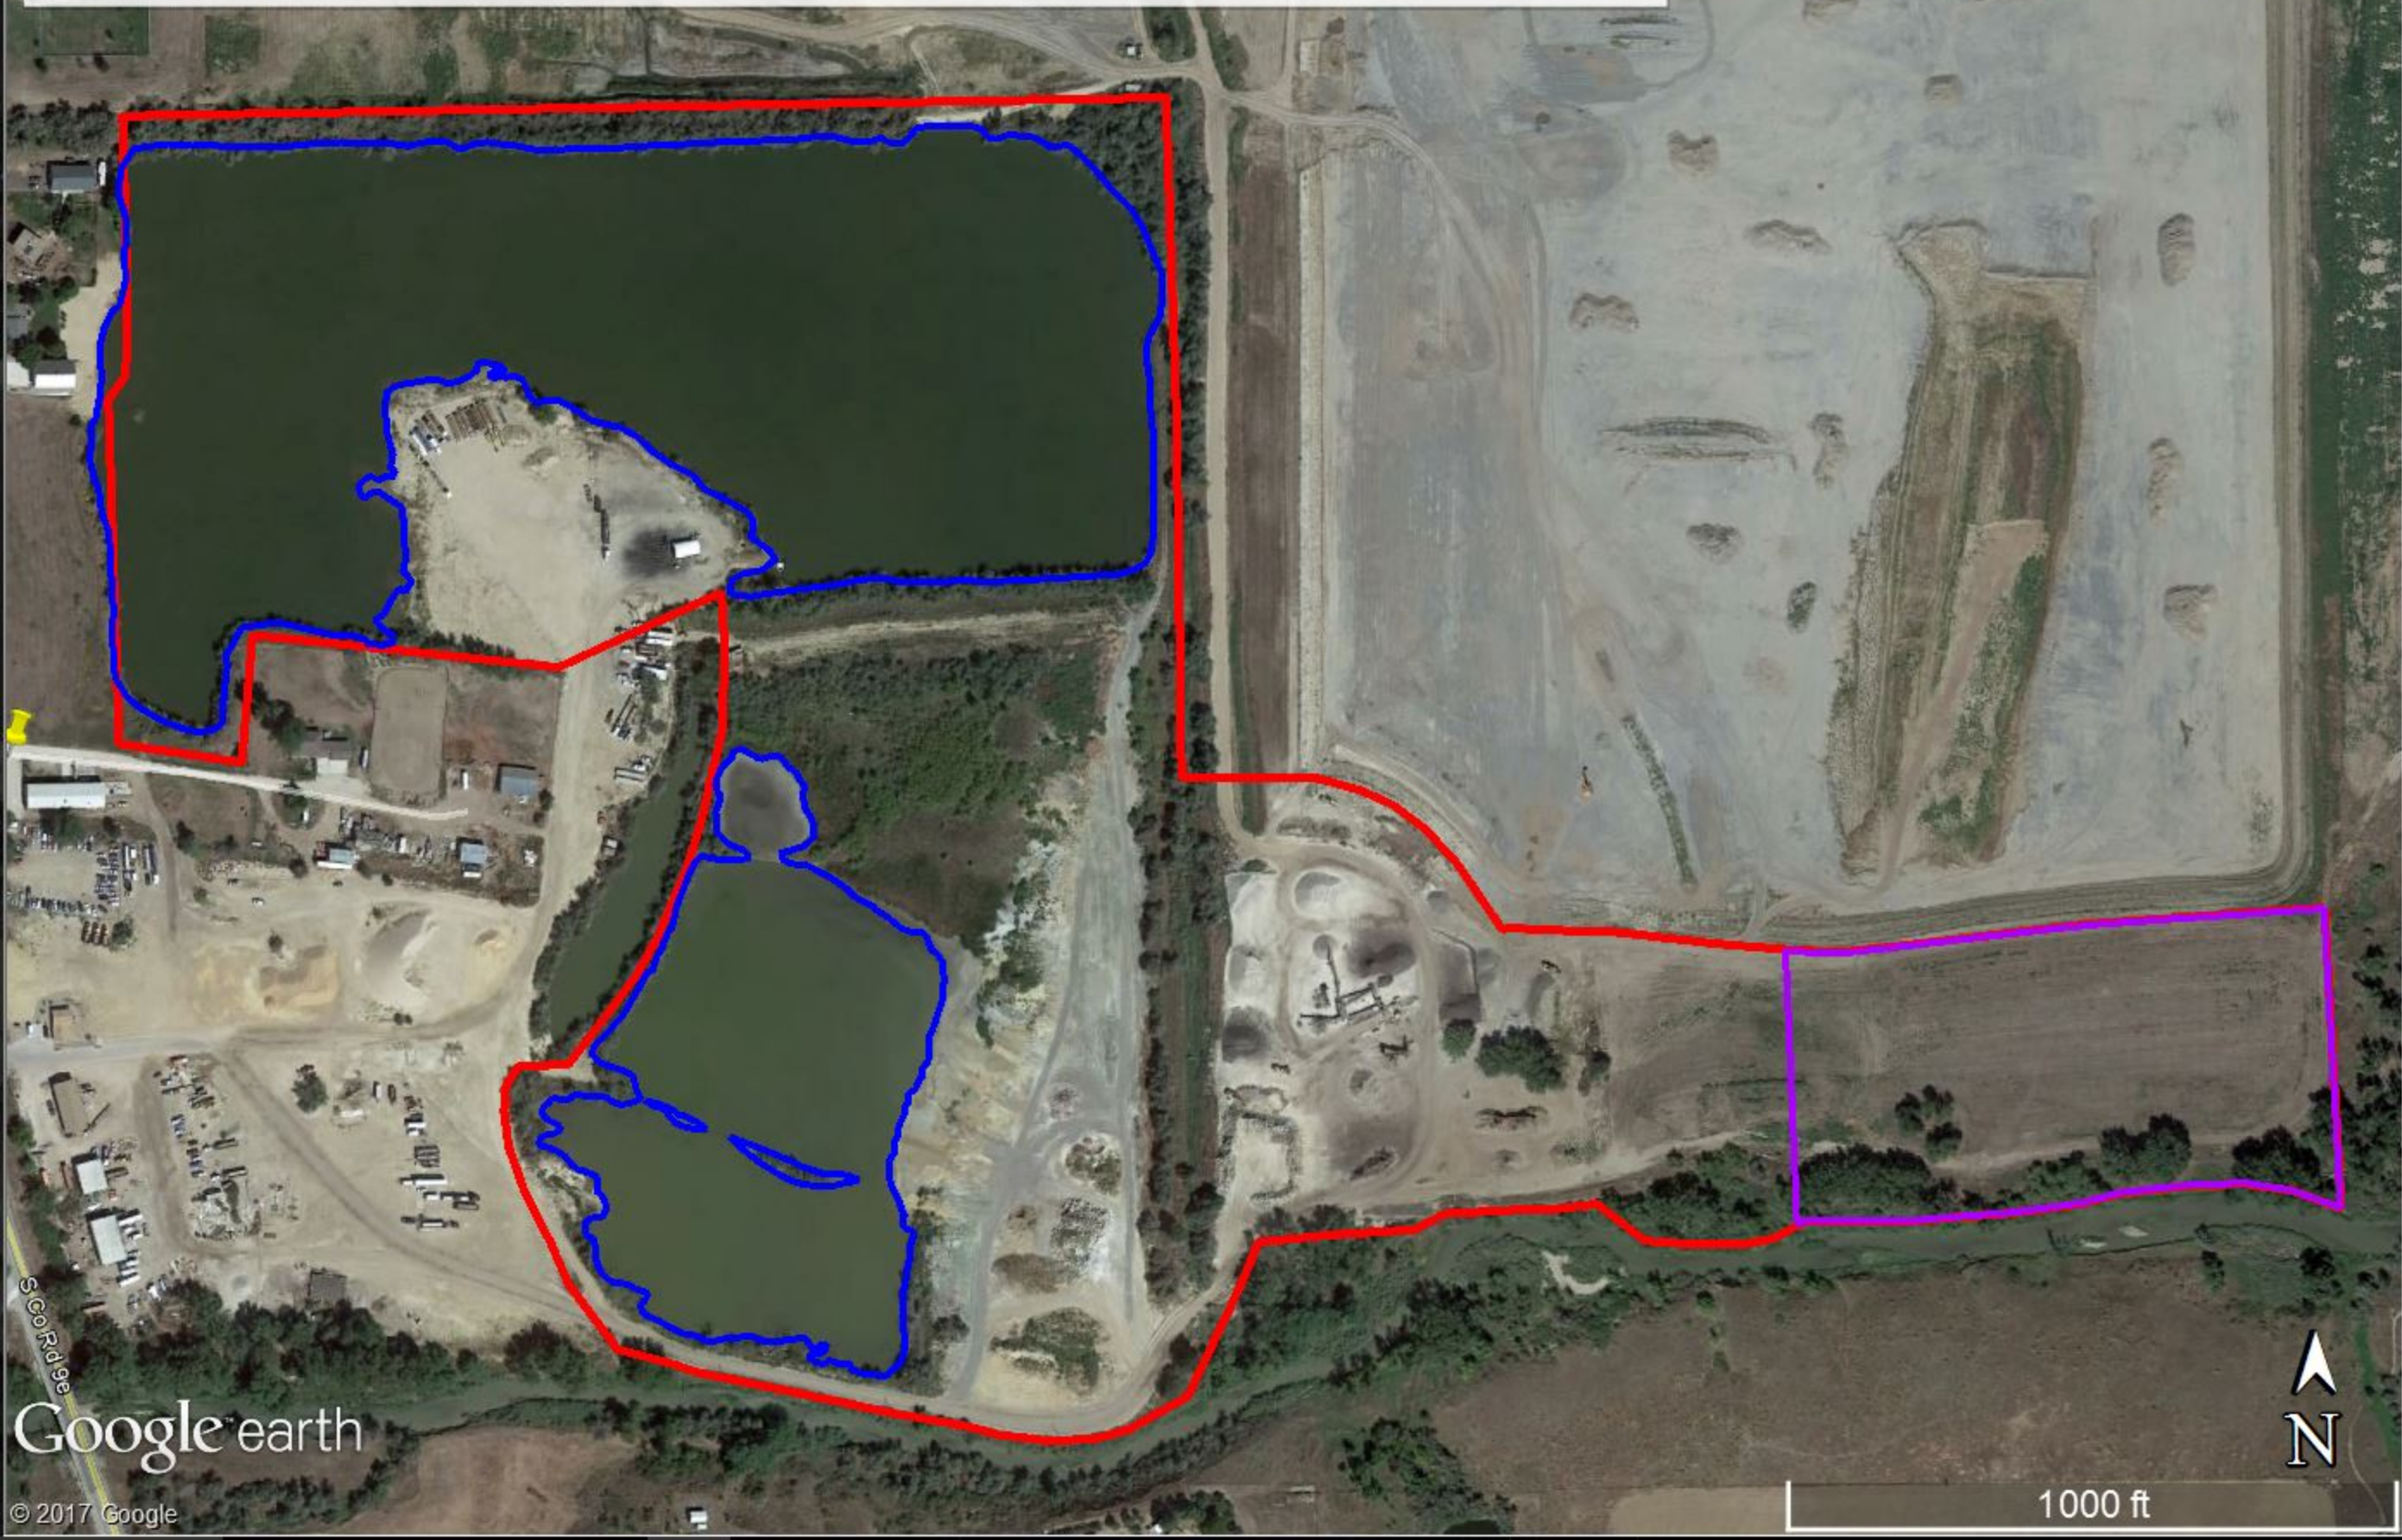
# M1978-327 / Kauffman Pit / Jake Kauffman & Son, Inc.

Red Outline = 84.2 acres = Approved Permit Area

Blue Outline = 34.7 acres = Total Exposed Groundwater (25.8 acres north pond + 8.89 acres south pond)

Purple Outline = 9.1 acres = AR-2 Partial Release Request
