**MINERALS PROGRAM INSPECTION REPORT**  
**PHONE: (303) 866-3567**

<b>MINE NAME:</b> Kauffman Pit	<b>MINE/PROSPECTING ID#:</b> M-1978-327	<b>MINERAL:</b> Sand and gravel	<b>COUNTY:</b> Larimer
<b>INSPECTION TYPE:</b> Monitoring	<b>INSPECTOR(S):</b> Amy Eschberger	<b>INSP. DATE:</b> April 14, 2017	<b>INSP. TIME:</b> 10:45
<b>OPERATOR:</b> Jake Kauffman & Son, Inc.	<b>OPERATOR REPRESENTATIVE:</b> Mary Kauffman, Troy Kauffman, Shane Kauffman, Dan Giroux	<b>TYPE OF OPERATION:</b> 112c - Construction Regular Operation	
<b>REASON FOR INSPECTION:</b> Normal I&E Program	<b>BOND CALCULATION TYPE:</b> Complete Bond	<b>BOND AMOUNT:</b> \$84,440.00	
<b>DATE OF COMPLAINT:</b> NA	<b>POST INSP. CONTACTS:</b> None	<b>JOINT INSP. AGENCY:</b> None	
<b>WEATHER:</b> Clear	<b>INSPECTOR'S SIGNATURE:</b>

**JAKE KAUFFMAN and SON, INC.**  
**LARIMER COUNTY, COLORADO**  
**M-78-327**  
**TR-06**  
**EXHIBIT F - FINAL RECLAMATION PLAN**  
**WITH FINAL POST-MINING AFTER-USES**

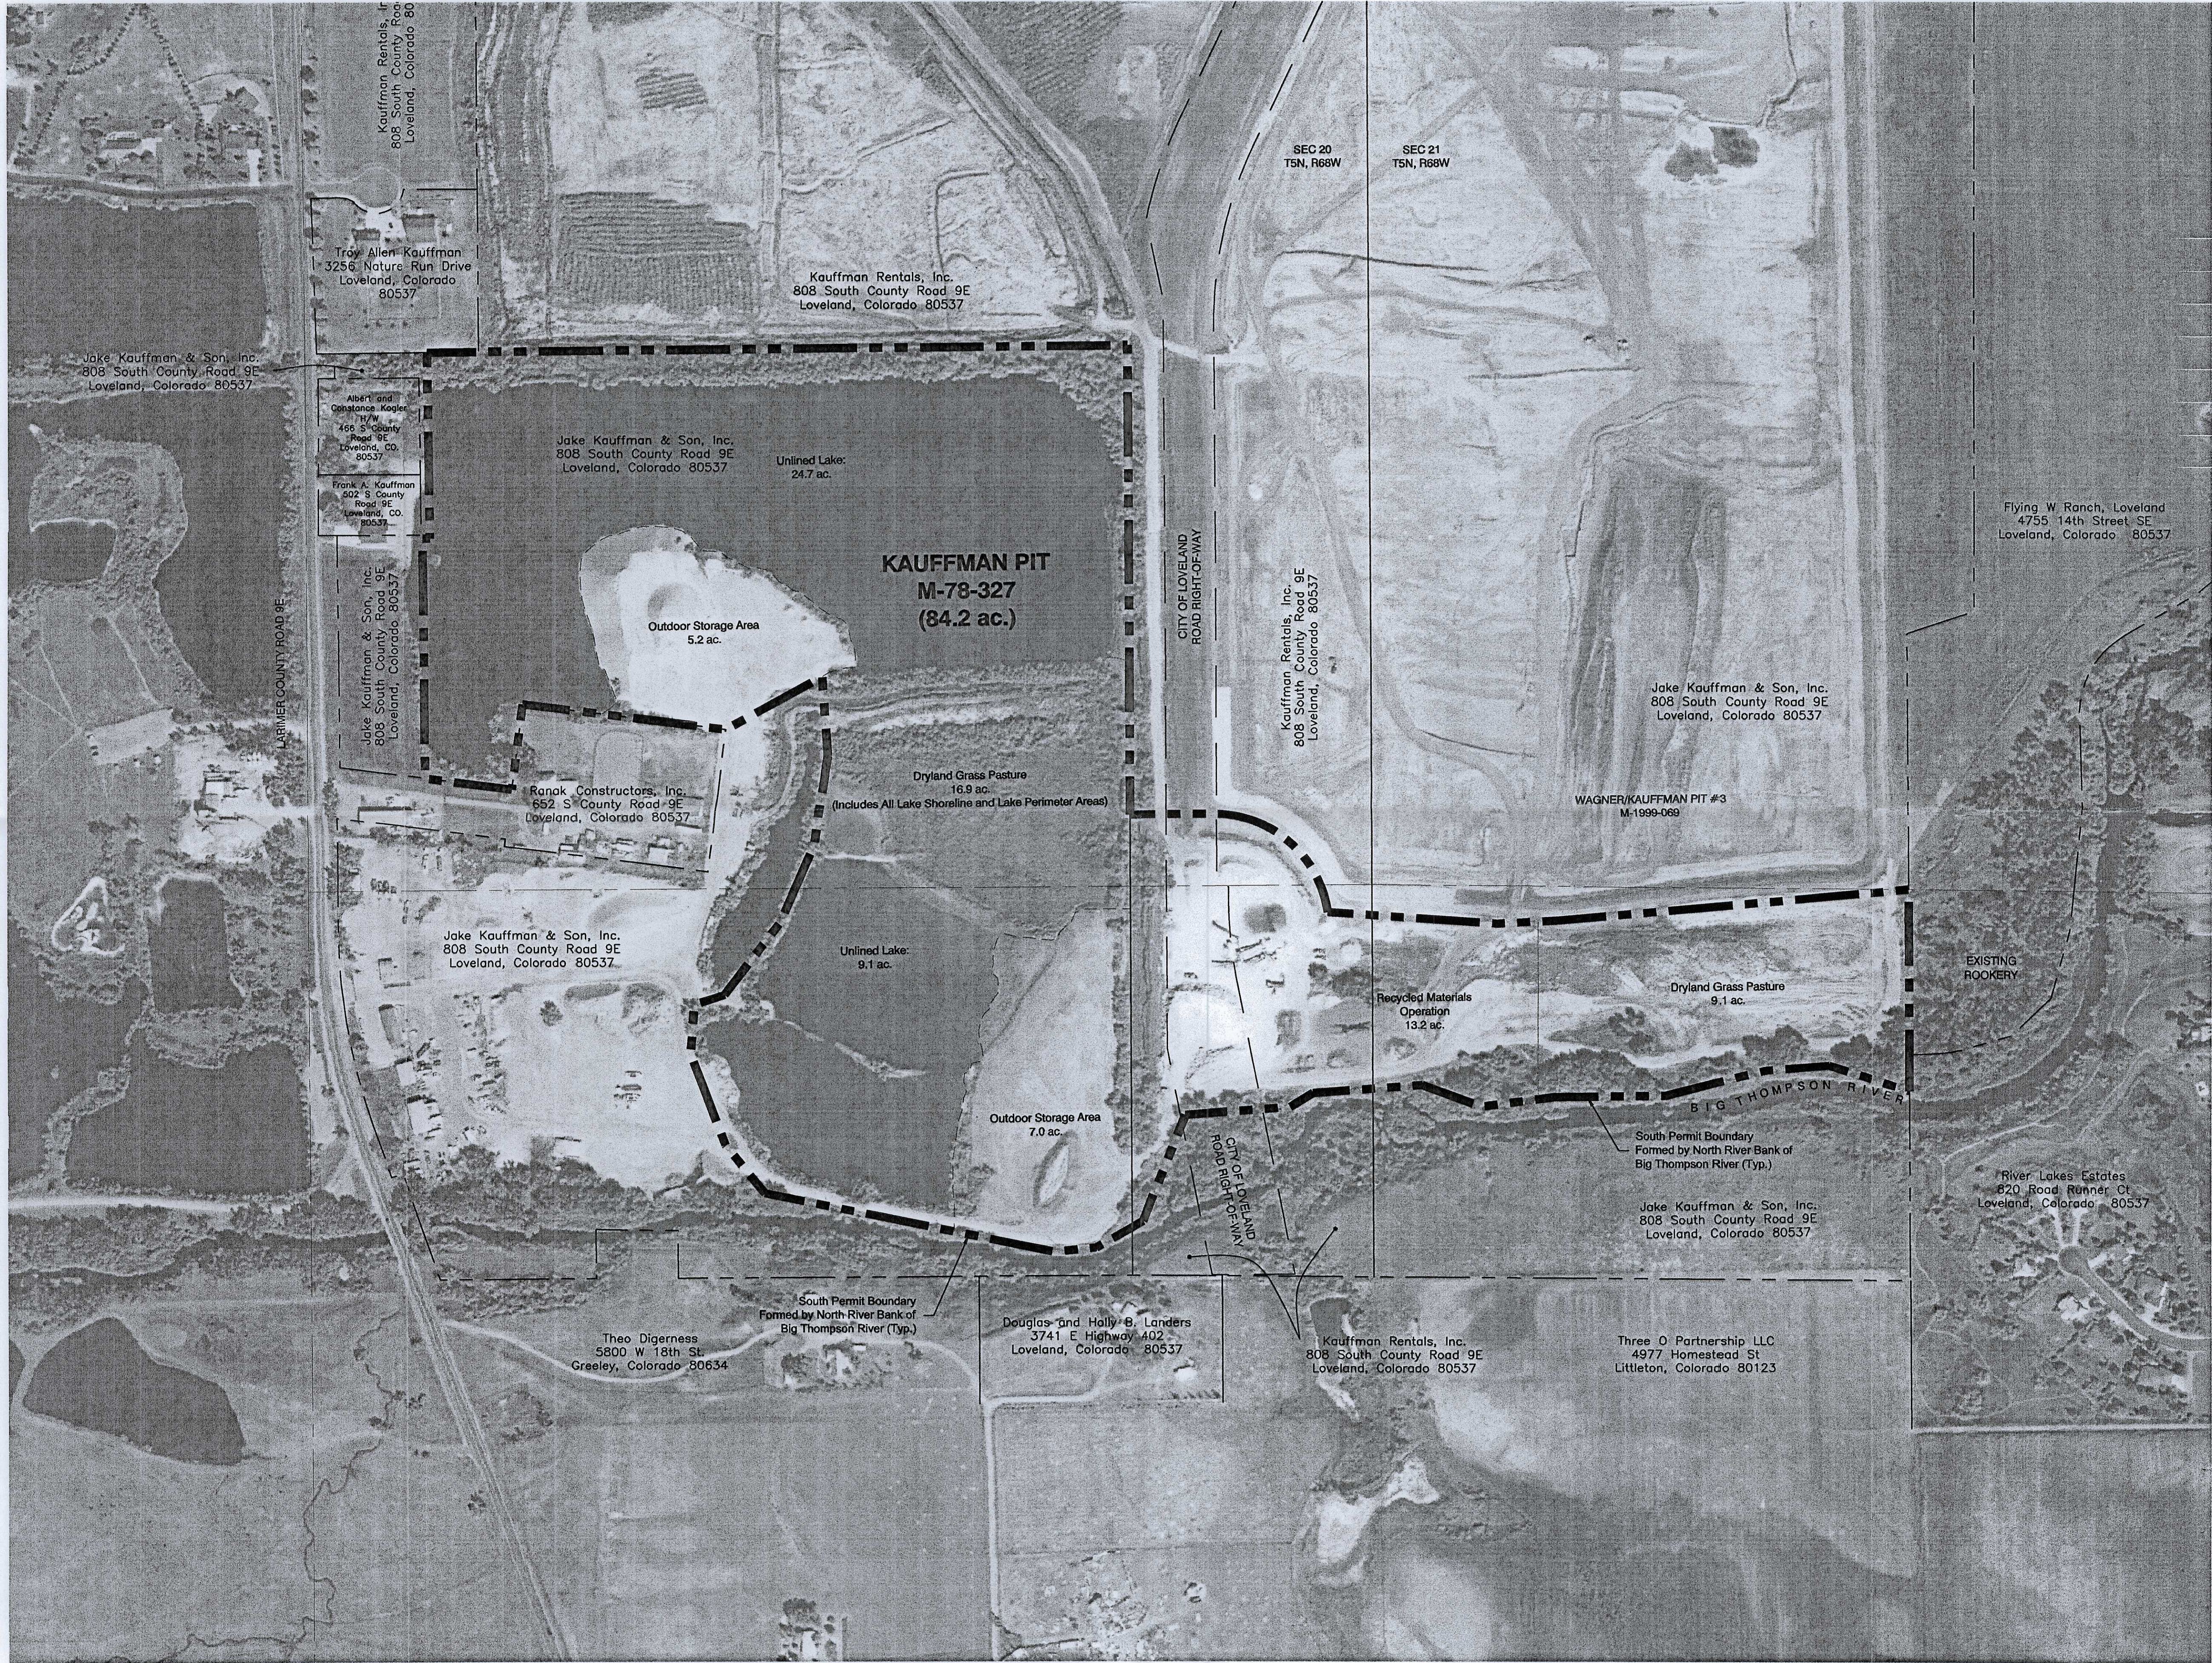
The approved reclamation plan for the site includes leaving unlined ponds with shoreline slope gradients ranging from 2.5H:1V to 5H:1V. Portions of disturbed land will be revegetated with a native grass mixture. The approved reclamation plan map (revised with TR-6 approval in 2012; see enclosed map) designates two material storage areas to remain for use by the adjacent commercial yard, including one at the south end of the north pond, and one at the east edge of the south pond. The two storage areas currently consist of approximately 12.5 acres, but may increase in area as the operation continues to backfill these portions of the ponds to gain additional storage area for the commercial operation. The reclamation plan map also designates a recycled materials operation to exist in the south-central portion of the permit area, estimated to be approximately 13.2 acres in size. The permit record indicates this area was mined and then backfilled prior to 2000. Finally, there are two dryland grass pasture areas that will remain for reclamation, one located in the far eastern portion of the permit area (9.1 acres) and the other in the area separating the two ponds (16.9 acres). The approved post-mining land use for the site was changed from pastureland to industrial/commercial with the Division's approval of Revision No. TR-2 in 1998. The operator requested this change in order to create more consistency with county zoning and permitted end use for the site.
