RE: Silent Hill; DRMS File No. P-2015-007; Notice of Financial Warranty Release Request

Re: Request for reclamation responsibility release, Silent Hill operation, P-2015-007

Reclamation Report

Name of Operation: Silent Hill

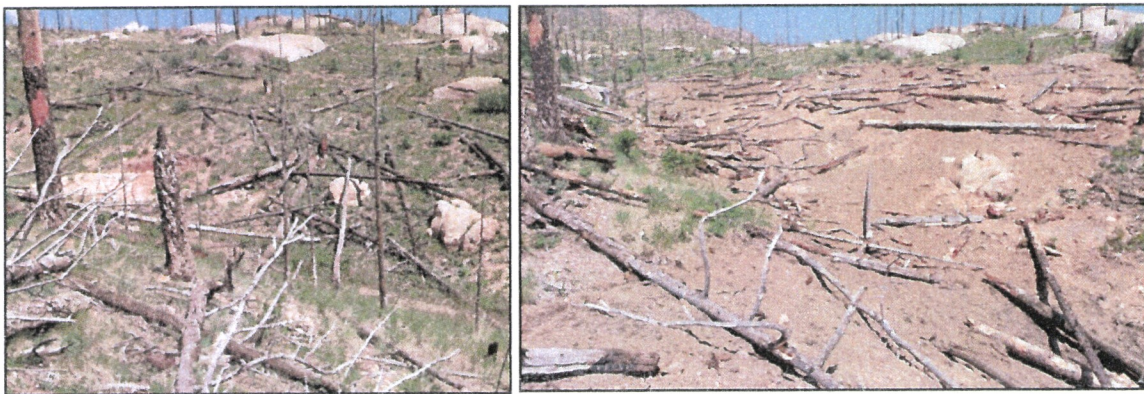
Site reclamation: Reclaiming proceeded by first complete backfilling the pit with excavated saprolite/gruss. Several small boulders and rochs were redistributed for natural appearance. Surface was leveled to follow original natural contours. Topsoil was subsequently redistributed over the disturbed area.

The reclaimed topographic conditions are similar to the pre-disturbed conditions. The reclaimed landscape blends with the surrounding contours.

The timber and braches were redistributed onto the topsoil, with a preferred orientation perpendicular to the slope direction to aid in erosion control.

Figure 1: Site conditions before (left, June 13) and after reclamation (right, June 25).

Fig. 1 shows site before operation and after reclamation.

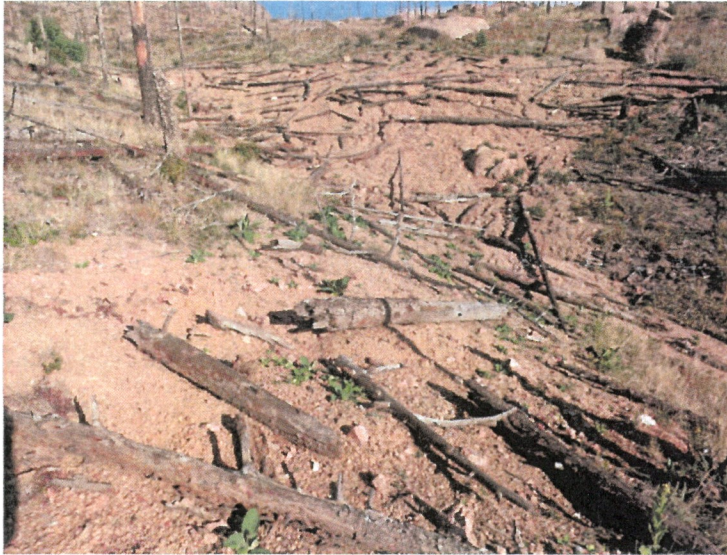
First seeds germinated in August 2015 and vegetation started to establish throughout the fall of 2015 aided by regular and above average precipitation. Fig. 4 shows site condition in September 2015.

Figure 4: Site conditions as of September 2015, looking north across the project site. First vegetation established. Logs and branches distributed for erosion control and density similar to surrounding area.

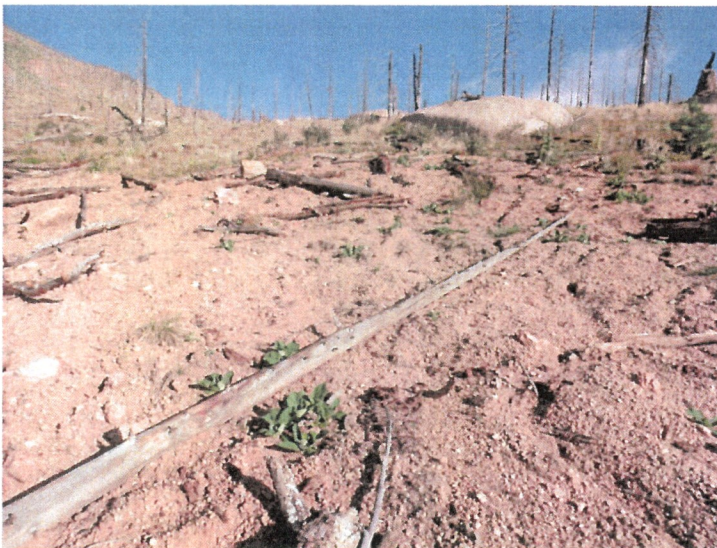
Fig. 5 shows a close up view of the upper area with leveled and recontoured terrain, logs for erosion control, and first signs of vegetation.

Figure 5: Site conditions as of September 2015, looking north across the project site, upper area, with first vegetation established.

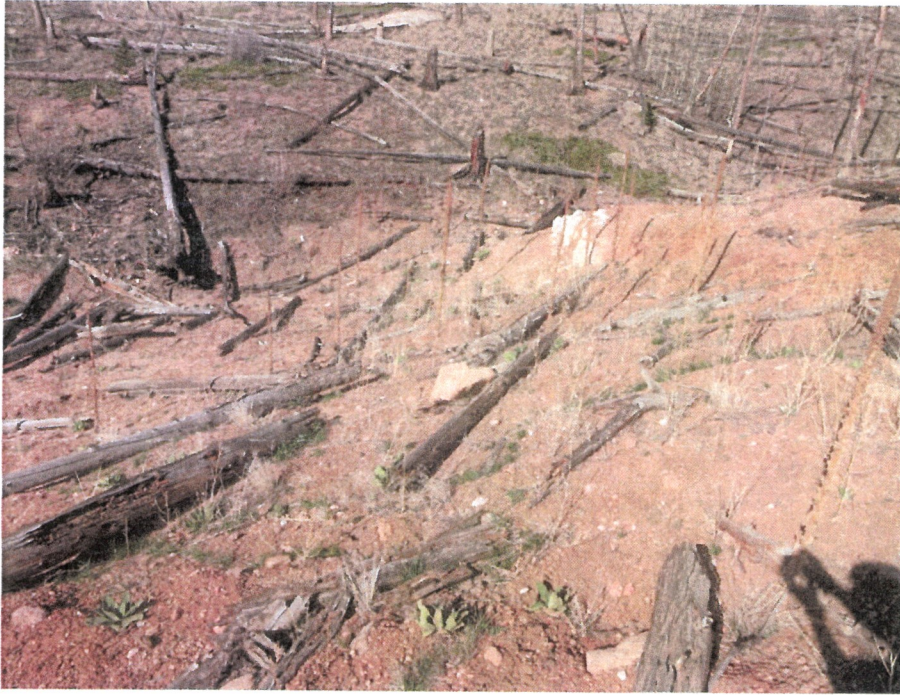
Site monitoring continued through fall 2016 and into spring 2017. Vegetation cover further expanded as seen in Fig. 7. No signs of erosion is seen across the project area.

Figure 7: Site conditions as of May 2017 looking west across the project area. Vegetation expanded throughout the project area.

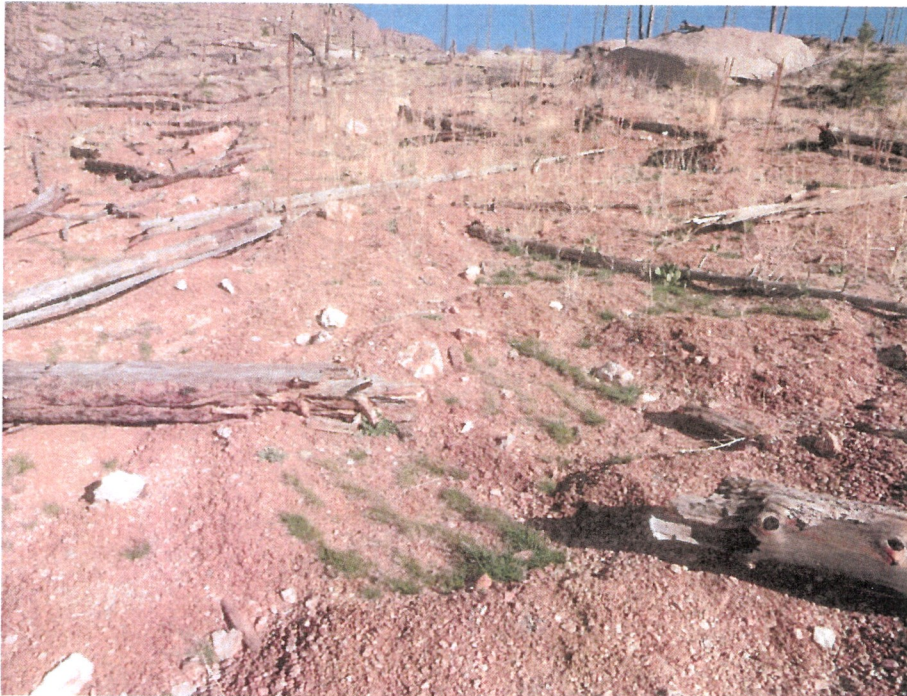
Fig. 8. shows corresponding view to the north. Only minimal number of non-native plants occurred, primarily mulleins, which were removed regularly.

Figure 8: Site conditions as of May 2017 looking north across the project area. Vegetation expanded throughout the project area, with weed control applied.
