Permit Number: C-2010-089

Mine Name: New Horizon North Mine

Operator: Elk Ridge Mining and Reclamation,

August 2, 2017

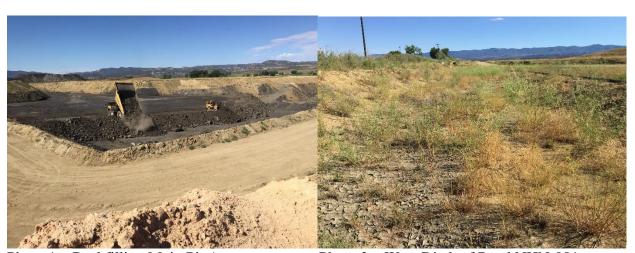
The center of the main pit continued to be backfilled. The fill is being hauled from the overburden stockpile (photo 1).

Pond NHN-001 contained water but was not discharging. Overflow flow water from the water tank was being directed to the pond. The east and west ditches were in good condition with vegetation growing in the bottom. The vegetation was grasses and forbs which provided stabilization to the ditch (photo 2). No species with woody stems were noted. The primary and emergency spillways were free and clear of obstructions.

Photo 1 – Backfilling Main Pit Area

Photo 2 – West Ditch of Pond NHN-001

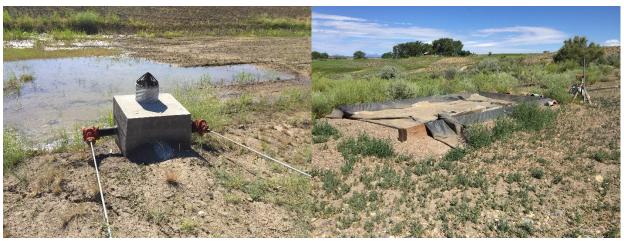
Pond NHN-002 contained water but was not discharging. The primary and emergency spillways were free and clear of obstructions (photo 3). The south ditch was in good condition.

The portable water pump was not in place at Pond NH1-001. The spill containment device and supporting equipment remained in place (photo 4).

Photo 3 – Pond NHN-002 Primary Spillway

Photo 4 – Spill Containment at Pond NH1-001

Tamarisks plants were noted on the banks of pond NHN-002 and need to be treated.
