Gold Hill Mill

Permit No. M-1994-117

Colorado Milling Company, LLC

**Possible violation of C.R.S. 34-32-116(7)(h) for failure to
protect areas outside of the affected land from damage
during the mining operation**

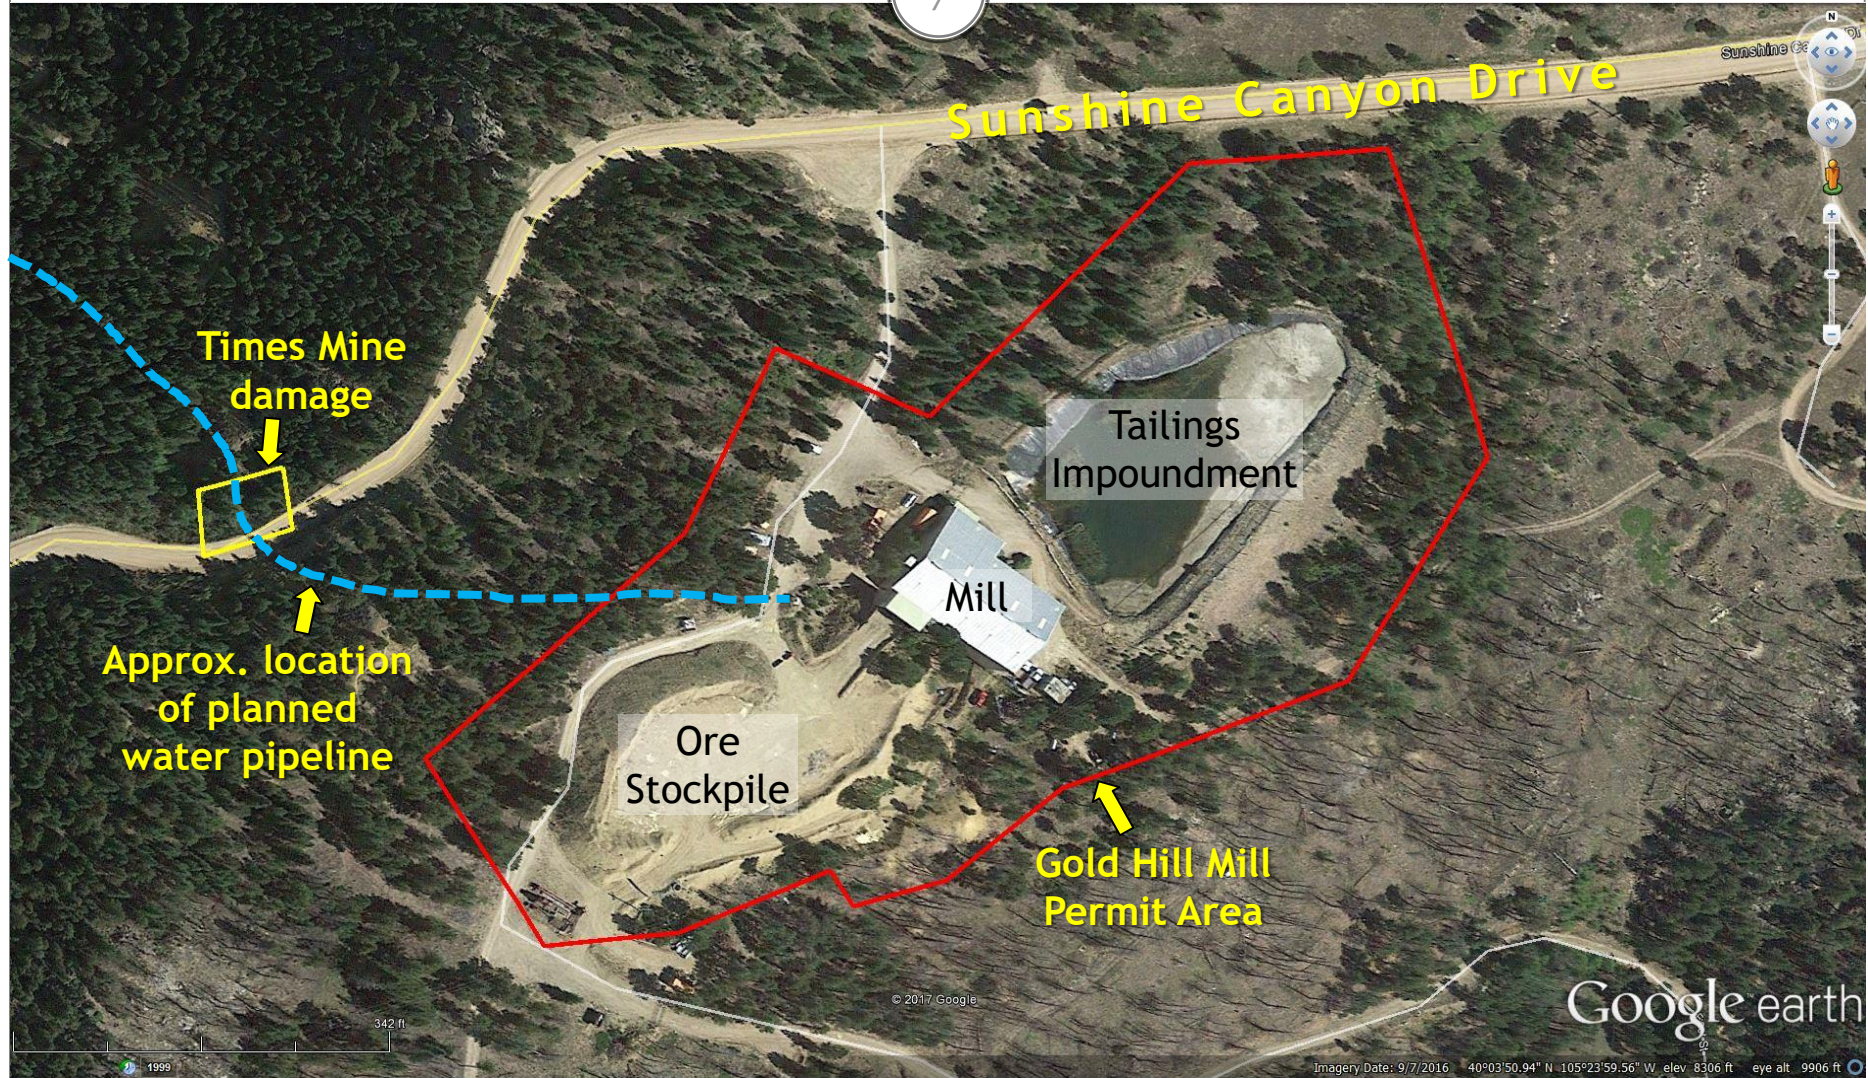
7

Gold Hill Mill Permit Area Showing Operator's Mill Water Conveyance Plan

- Mr. Steen's proposed pump station would be located on federal land
- Pump station may require installation of power line
- Pump station is part of proposed 2" diameter pipeline extending from Left Hand Creek to Gold Hill Mill (approximately 3,900' in length with 1,000' gain in elevation)
- Proposed pipeline to be located within an existing easement on Boulder County lands
- Proposed pipeline would pass under Sunshine Canyon Drive via the historic Times Mine adit

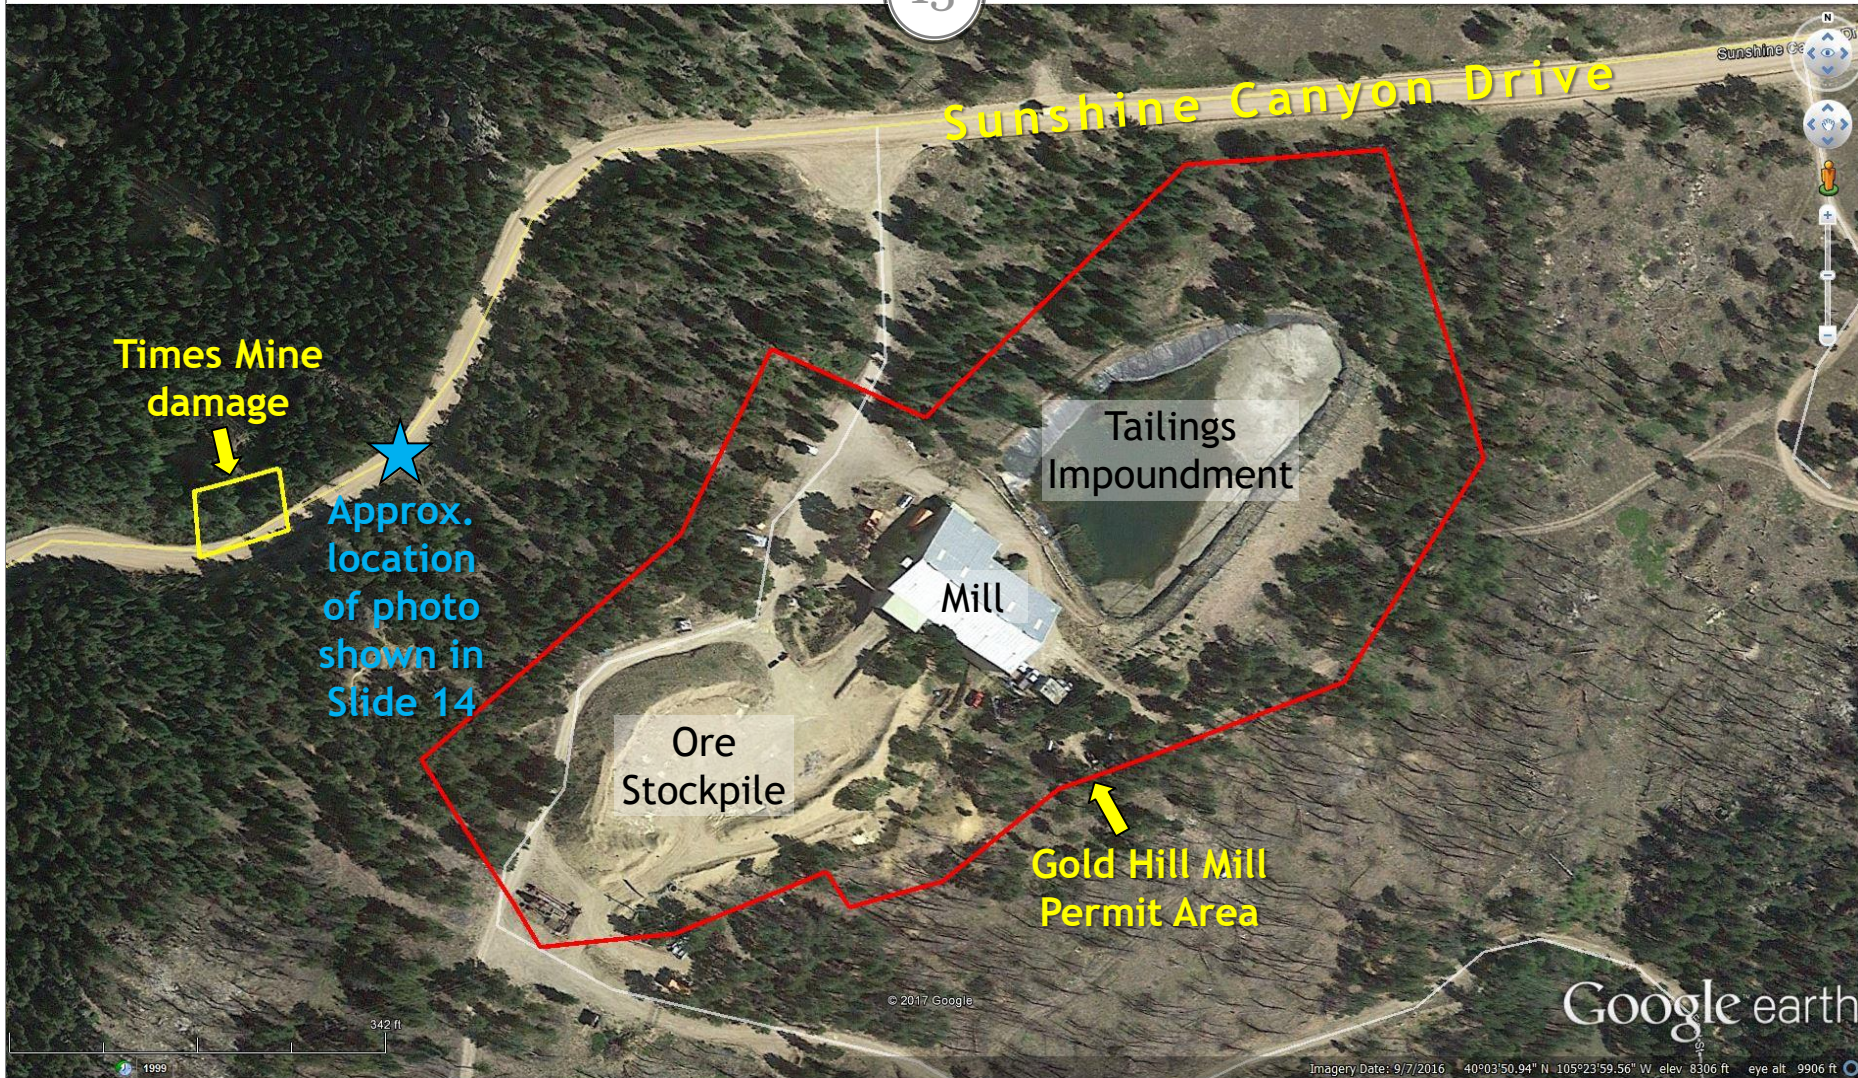
13

DRMS observed damage to Sunshine Canyon Drive resulting from collapse of the Times Mine adit, caused by operator's actions (Mark Steen).

- Times Mine adit is located immediately beneath Sunshine Canyon Drive
- Mr. Steen removed historic timber sets from the Times Mine adit
- Mr. Steen installed a 16'long x 5'diameter culvert in the Times Mine adit
- Times Mine adit collapsed after or during installation of the culvert
- Mr. Steen was attempting to rehabilitate the Times Mine adit to provide passage for a water pipeline extending from Left Hand Creek to the mill
- Times Mine adit is located outside of the current permit boundary
- Damage to the county road has created a public safety hazard

- 1) Within 15 days of the effective date of the Board Order, the Permittee shall demonstrate to the Division's satisfaction that the appropriate Boulder County permit, addressing repair and stabilization of the damaged portion of Sunshine Canyon Drive, has been attained. An appropriate demonstration shall include a copy of the approved County permit.
- 2) Within 15 days of issuance of the County permit, the Permittee shall complete the plan(s) as approved in the County permit.

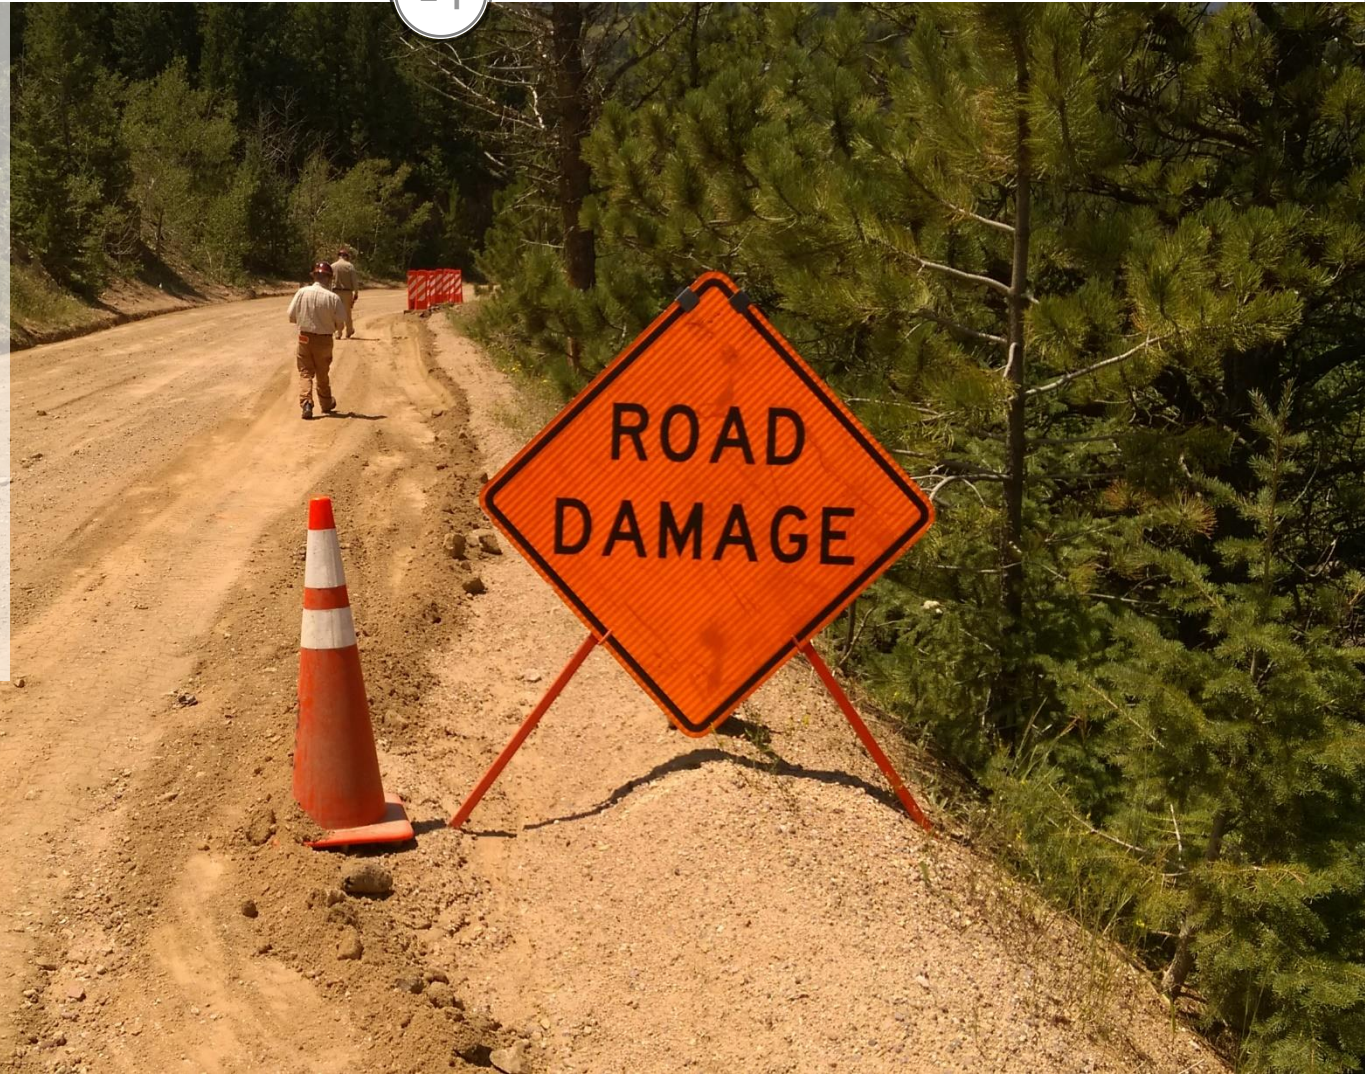
14

Looking west down Sunshine Canyon Drive toward Times Mine damage. Note safety sign and cones placed by Boulder County Transportation Dept. to warn the public of hazardous conditions.

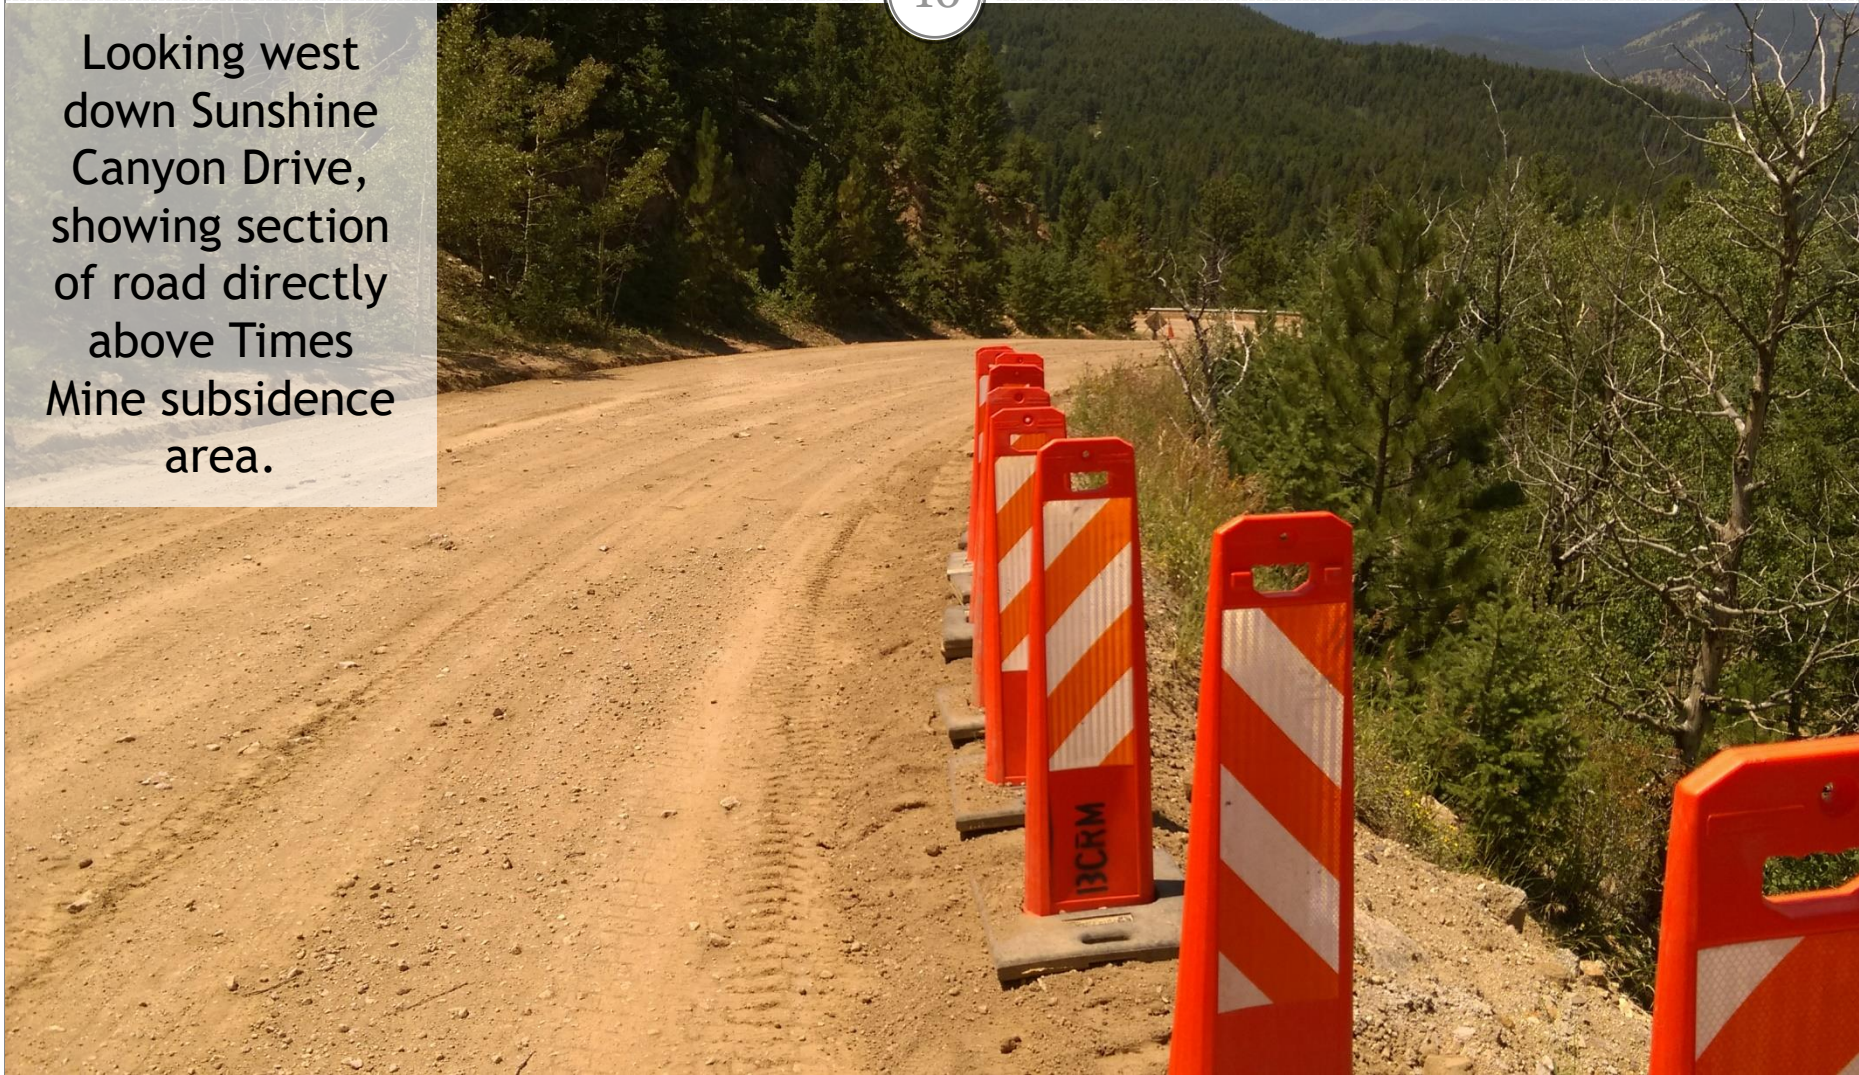
16

Looking west
down Sunshine
Canyon Drive,
showing section
of road directly
above Times
Mine subsidence
area.

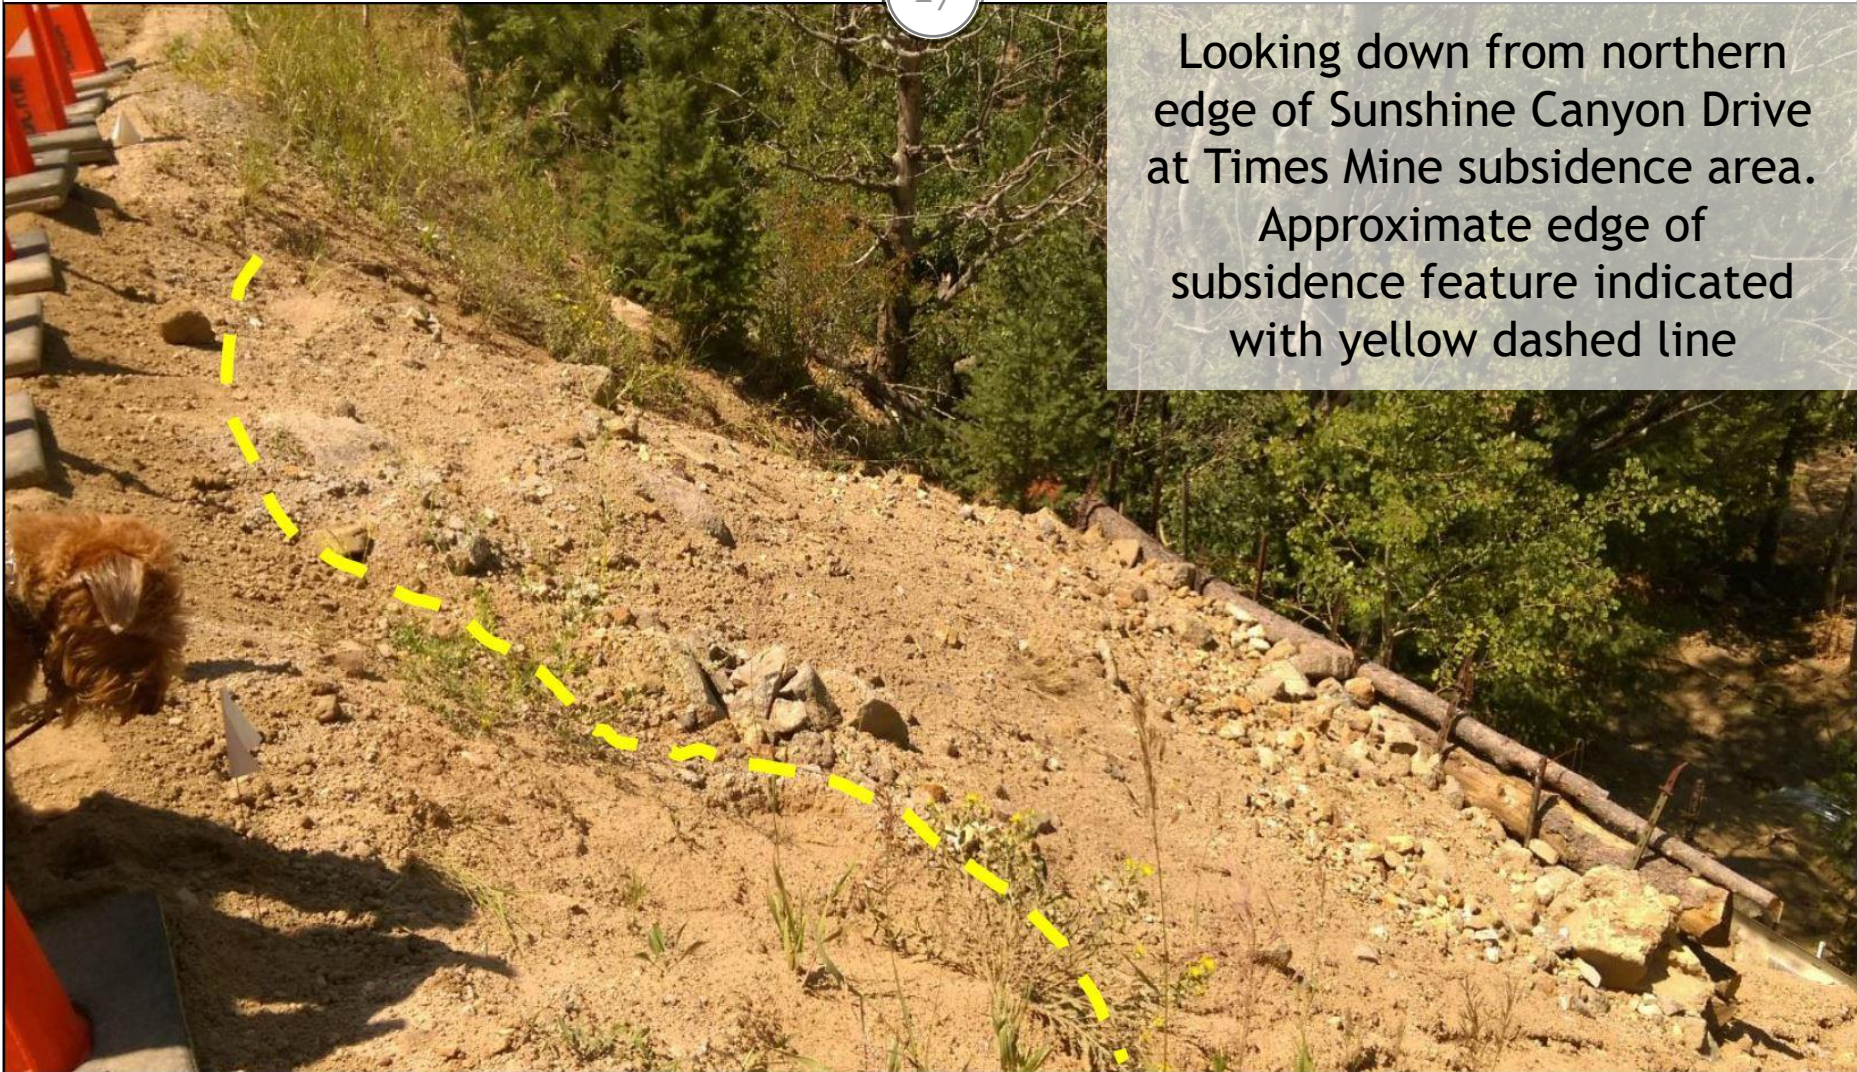
17

Looking down from northern edge of Sunshine Canyon Drive at Times Mine subsidence area.

Approximate edge of subsidence feature indicated with yellow dashed line

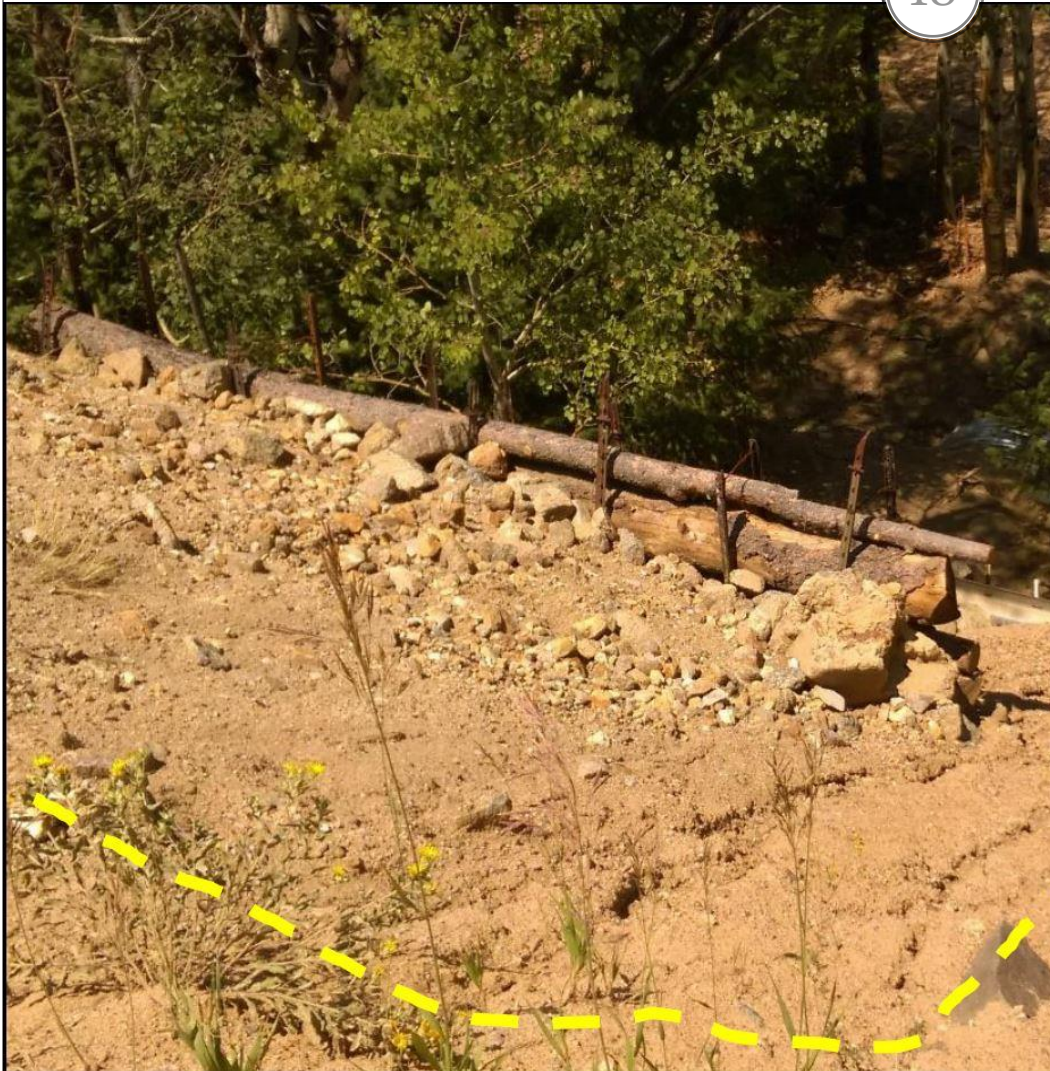
18

Looking down from northern edge of Sunshine Canyon Drive at Times Mine subsidence area. Approximate edge of subsidence feature indicated with yellow dashed line. Note fill material held in place by temporary retaining structure.

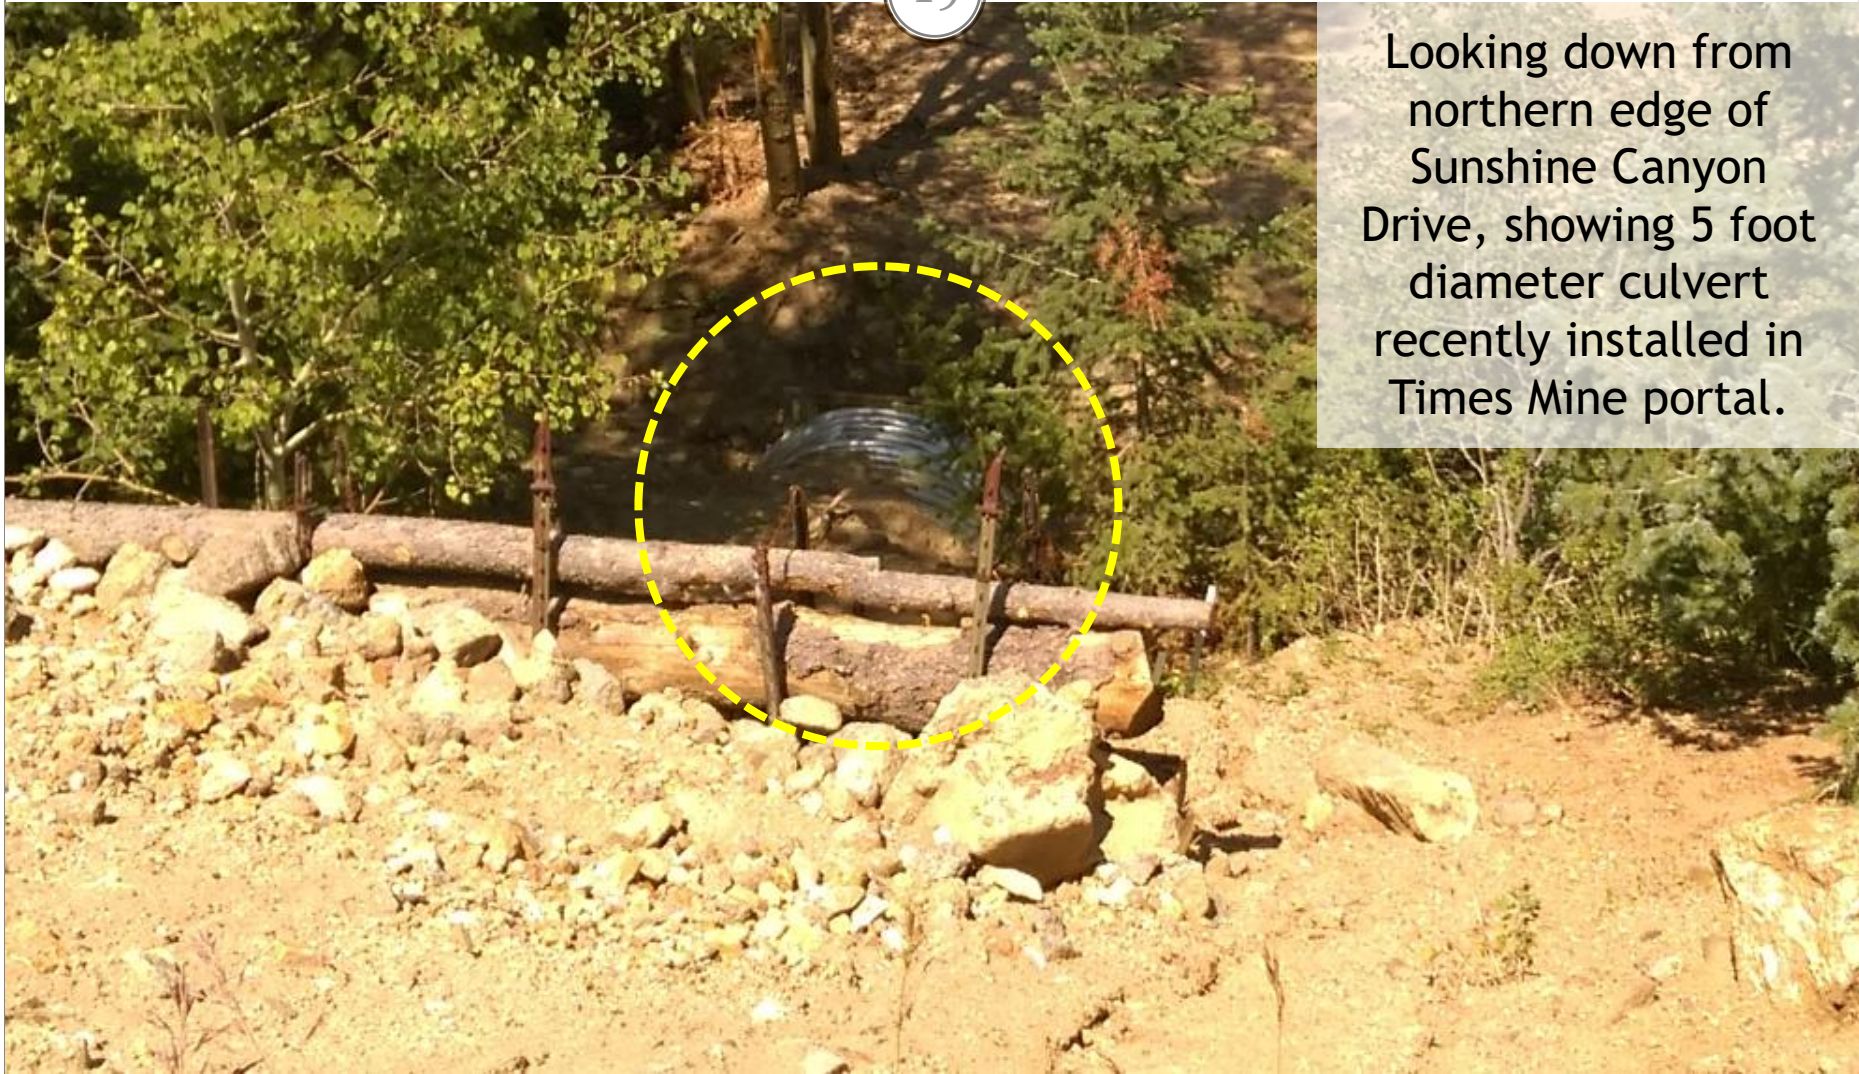
19

Looking down from northern edge of Sunshine Canyon Drive, showing 5 foot diameter culvert recently installed in Times Mine portal.

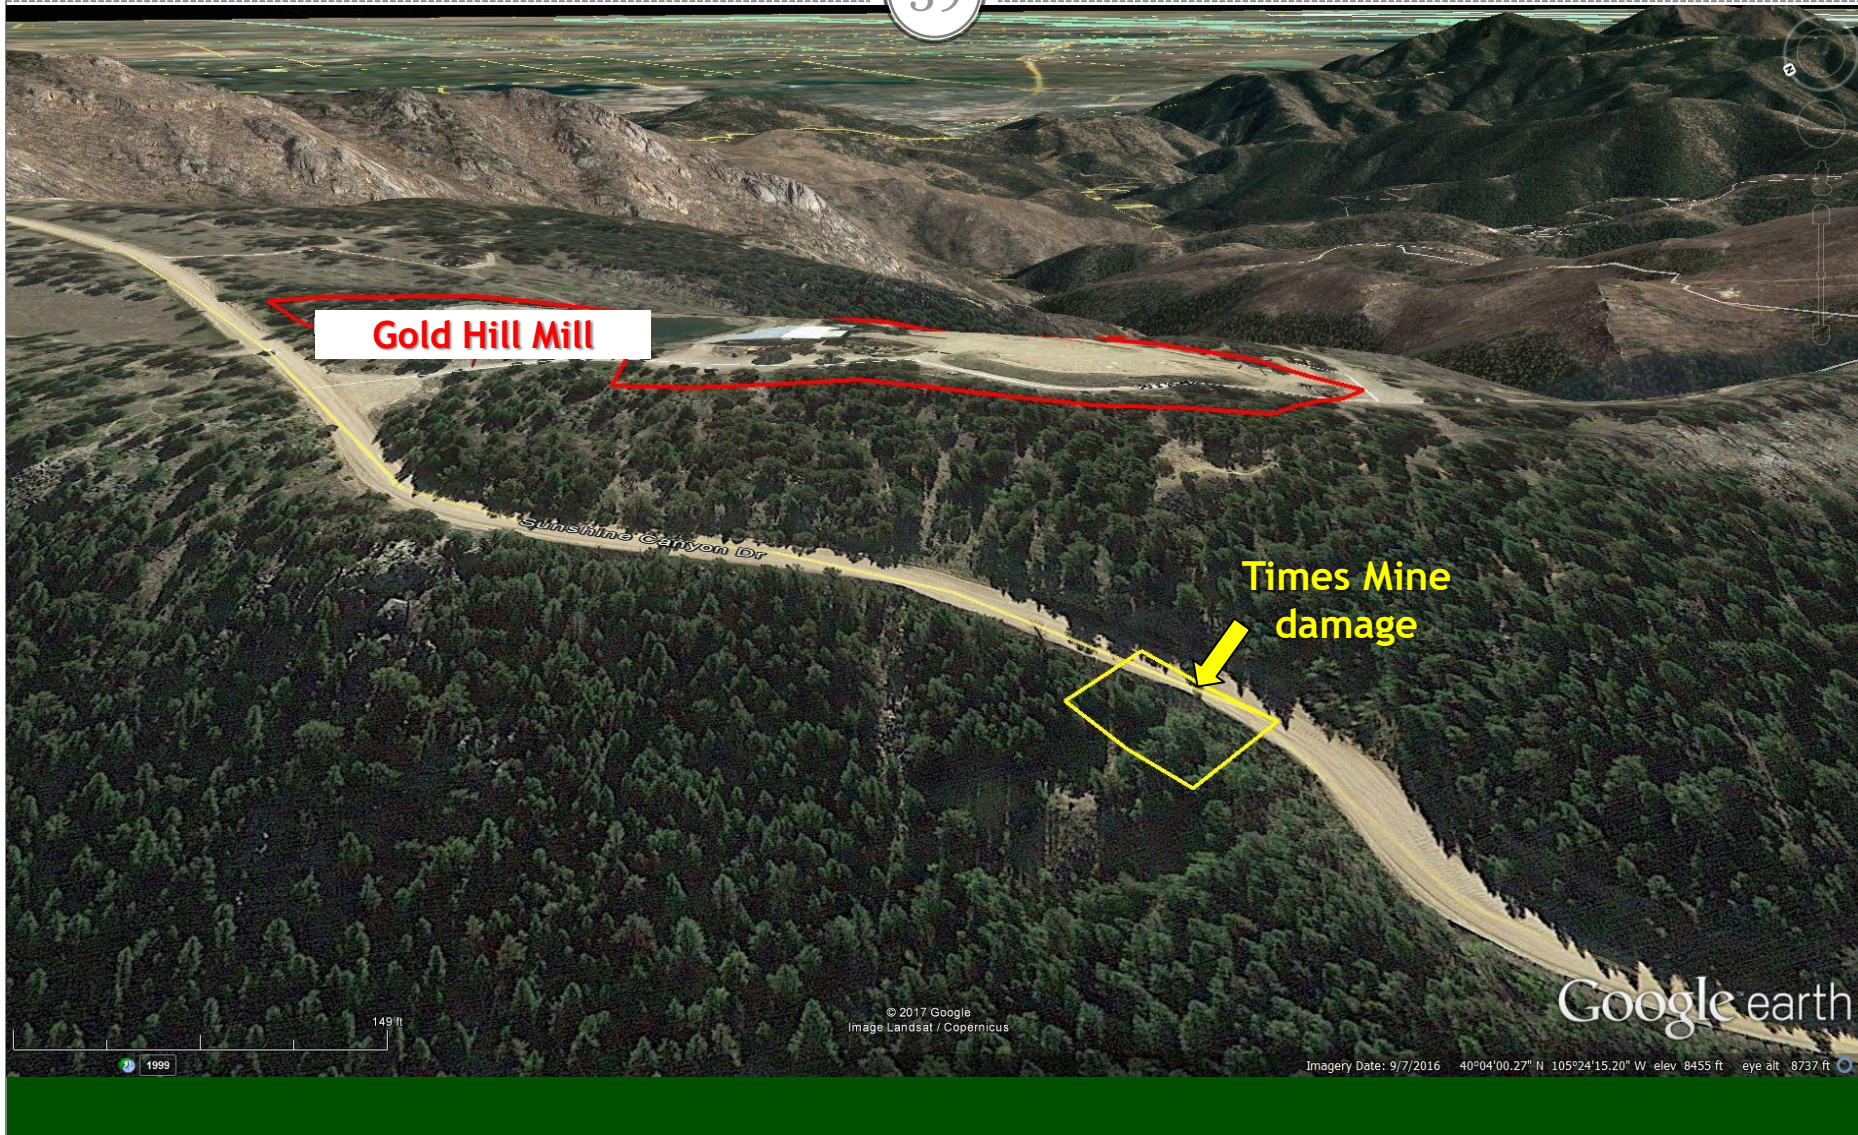
39

View of Times Mine Subsidence Area

**Times Mine
damage**
