RE: SLAG FILTER AS-BUILT CERTIFICATION

SUBJ: GOLDEN WONDER MINE AMD FILTRATION PILOT STUDY, LAKE CITY
COLORADO

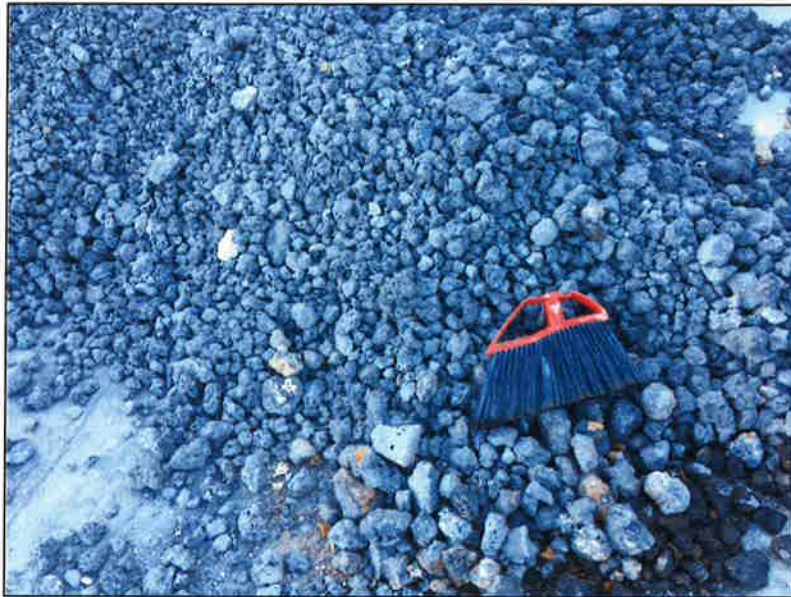
Photo 1. View of slag as delivered from Harsco Industries in Pueblo, Colorado. Note varying size of slag particles. Dust broom is 7 inches wide for scale.

3. The Harsco slag was advertised as a "3/4 inch" slag but was actually material that had been captured by a 3/4" screen and, therefore, ranged from 3/4" to 3 inches in diameter and was poorly graded. Golden Wonder staff crushed and screened the slag through a 5/8" screen to get a consistent filter material which was the intent of our design. See photo below for details of slag before and after on-site processing.

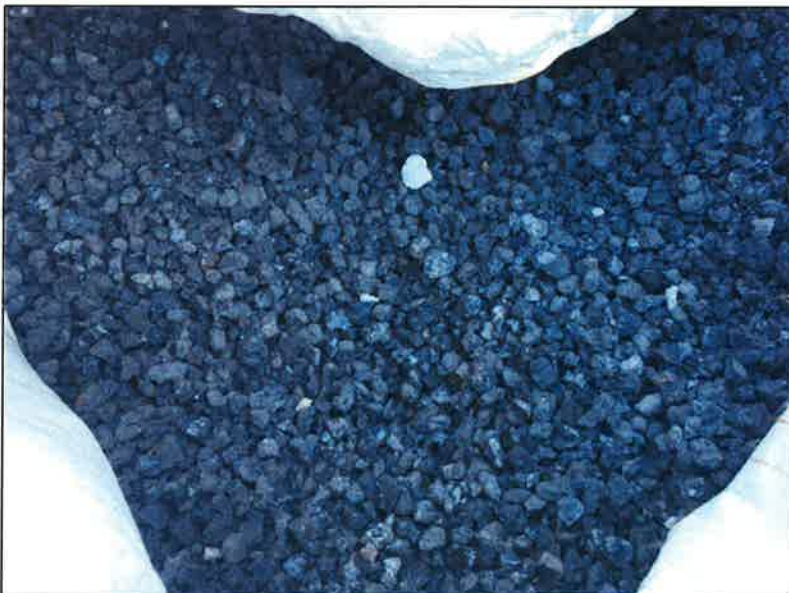
Photo 2. Slag material after processing on site by Golden Wonder staff and screened through 5/8-inch screen. Photo was taken looking into a bag of processed slag.

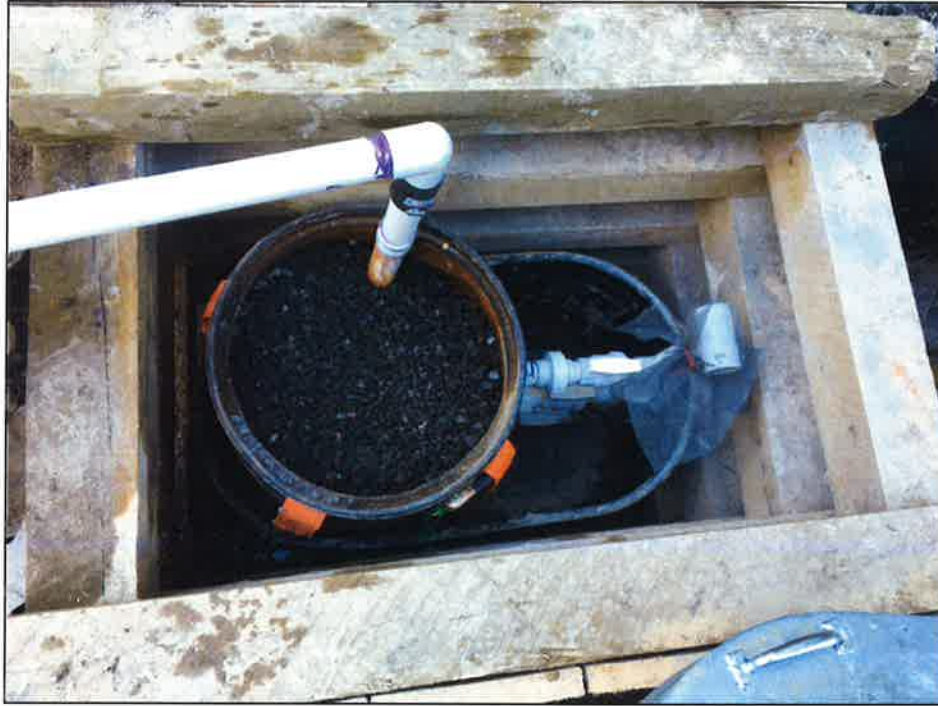
Photo 3. View looking down at slag filter. Note 2-inch PVC AMD distribution pipe which extends to the bottom of the 55-gallon HDPE drum filled with 5/8-inch screened slag. 3 outlets with valves (two are normally closed) are visible on the right side of the barrel.

1. The AMD distribution pipe to the slag was modified from free flowing from above the slag to being introduced from the bottom. pH treatment occurs as the AMD travels up through the slag rather than down. This minimizes the channeling effect that Golden Wonder staff had observed during the first two trials.

2. Two additional valved outlets were installed at the bottom and midpoint of the slag filter to allow for multi-level flow for more treatment options. As pH is increased, having options for varying outlet levels may reduce filter clogging and provide greater control over AMD residence time.

4. Golden Wonder staff located a 55-gallon HDPE barrel in lieu of the 30-gallon barrel we specified which allows for more slag and longer treatment time. Instead of housing the barrel in a vertical 36-inch CMP pipe section, at DRMS's staff request, the new filter was installed on a 3-inch concrete slab with secondary containment constructed of two galvanized, waterproofed stock tanks to create the filter housing.

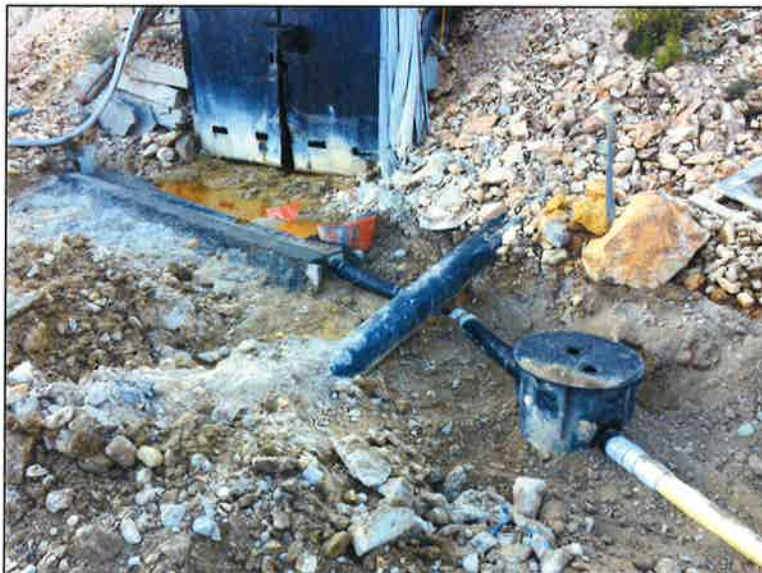
Photo 4. View of the portal at level 6 and the AMD interceptor trench and pre-filtration sediment basin. AMD is captured as it leaves the portal and is conveyed from left to right through 3-inch HDPE pipe to a 30-gallon pre-filtration sediment basin partially filled with 5/8" screened steel slag. From there the drainage is conveyed through 3-inch PVC pipe to the slag filter.

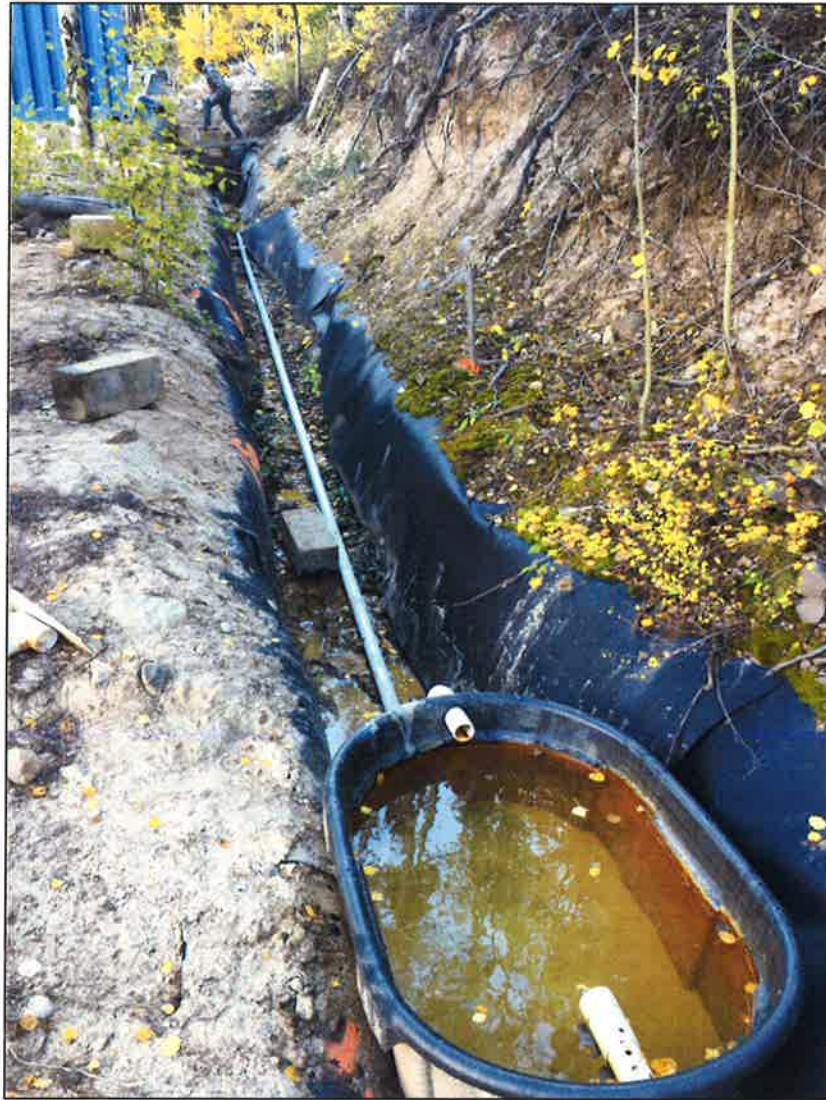
Photo 5. View looking upslope from the post-filtration sediment basin towards the slag filter. Outlet from sediment to basin to Deadman's Gulch and the lower sump is shown at the bottom of the photo.
