**PERMIT INFORMATION**

<b>Permit Number:</b> C-1996-084 <b>Mine Name:</b> Lorencito Canyon Mine <b>Operator:</b> New Elk Coal Company, LLC <b>Operator Address:</b> Mr. Louis Head 12250 Highway 12 Weston, CO 81091	<b>County:</b> Las Animas <b>Operation Type:</b> Surface <b>Permit Status:</b> Permanent Cessation <b>Ownership:</b> Private
	<b>Operator Representative Present:</b>  None
<b>Operator Representative Signature: (Field Issuance Only)</b>

**INSPECTION INFORMATION**

<b>Inspection Start Date:</b> October 11, 2017 <b>Inspection Start Time:</b> 12:34 <b>Inspection End Date:</b> <b>Inspection End Time:</b>	<b>Inspection Type:</b> Aerial Inspection <b>Inspection Reason:</b> Normal I&E Program <b>Weather:</b> Clear		
<b>Joint Inspection Agency:</b>  None	<b>Joint Inspection Contacts:</b>		
<b>Post Inspection Agency:</b>  None	<b>Post Inspection Contacts:</b>		
<b>Inspector(s):</b>  Harry B. Ranney	<table border="0"><tr><td><b>Inspector's Signature:</b>  <i>Robert D. ZL</i></td><td><b>Signature Date:</b>  10/12/2017</td></tr></table>	<b>Inspector's Signature:</b>  <i>Robert D. ZL</i>	<b>Signature Date:</b>  10/12/2017
<b>Inspector's Signature:</b>  <i>Robert D. ZL</i>	<b>Signature

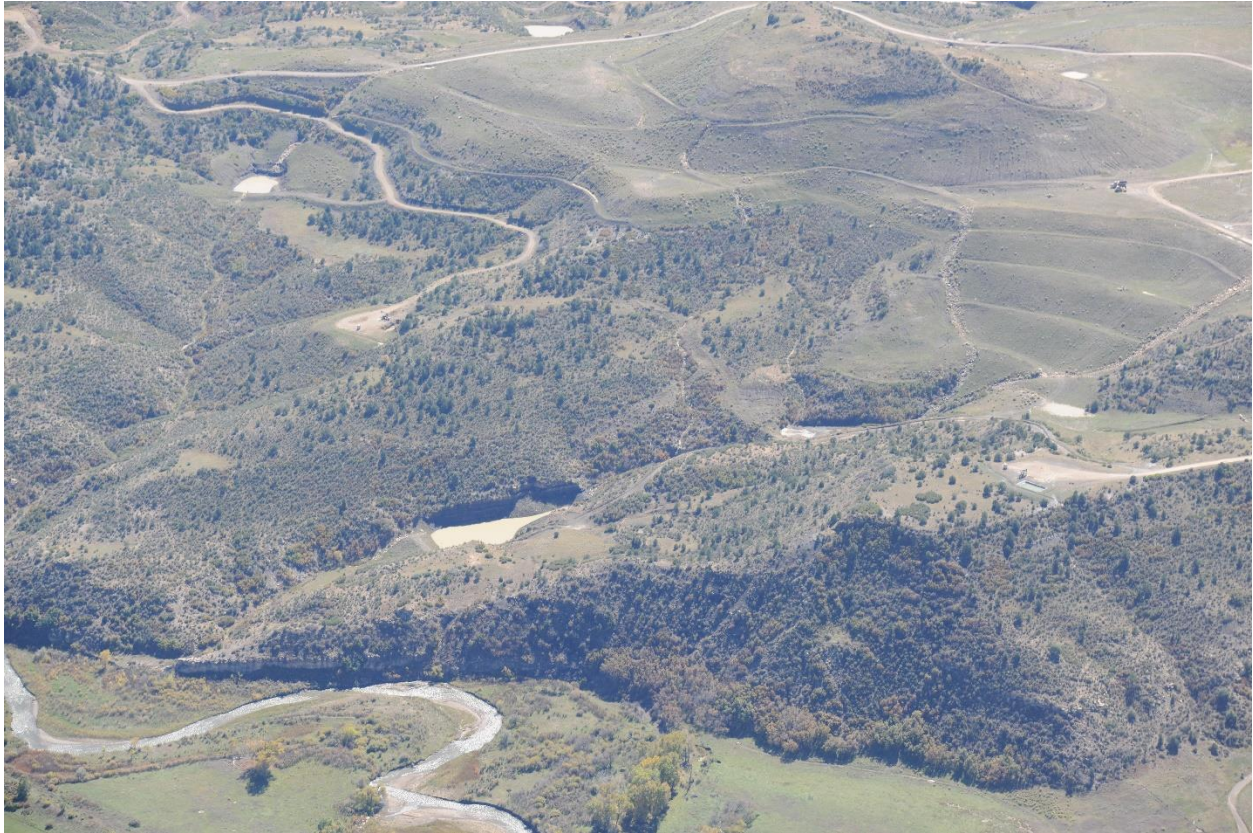
Ponds 8 and 9 were inspected closely, and both contained a large amount of water. No issues were identified with embankments or spillways. As in the past, the bank opposite the Pond 9 embankment (inlet side) is highly eroded.

The northwest portion of the large hill (aka “the knob”) appears to have many rills requiring maintenance. The north and east sides appear to be in good shape. The south side of the knob was not visible in the photos.

**Pond 8 and Fill 8 with “the knob” in upper right part of photo**

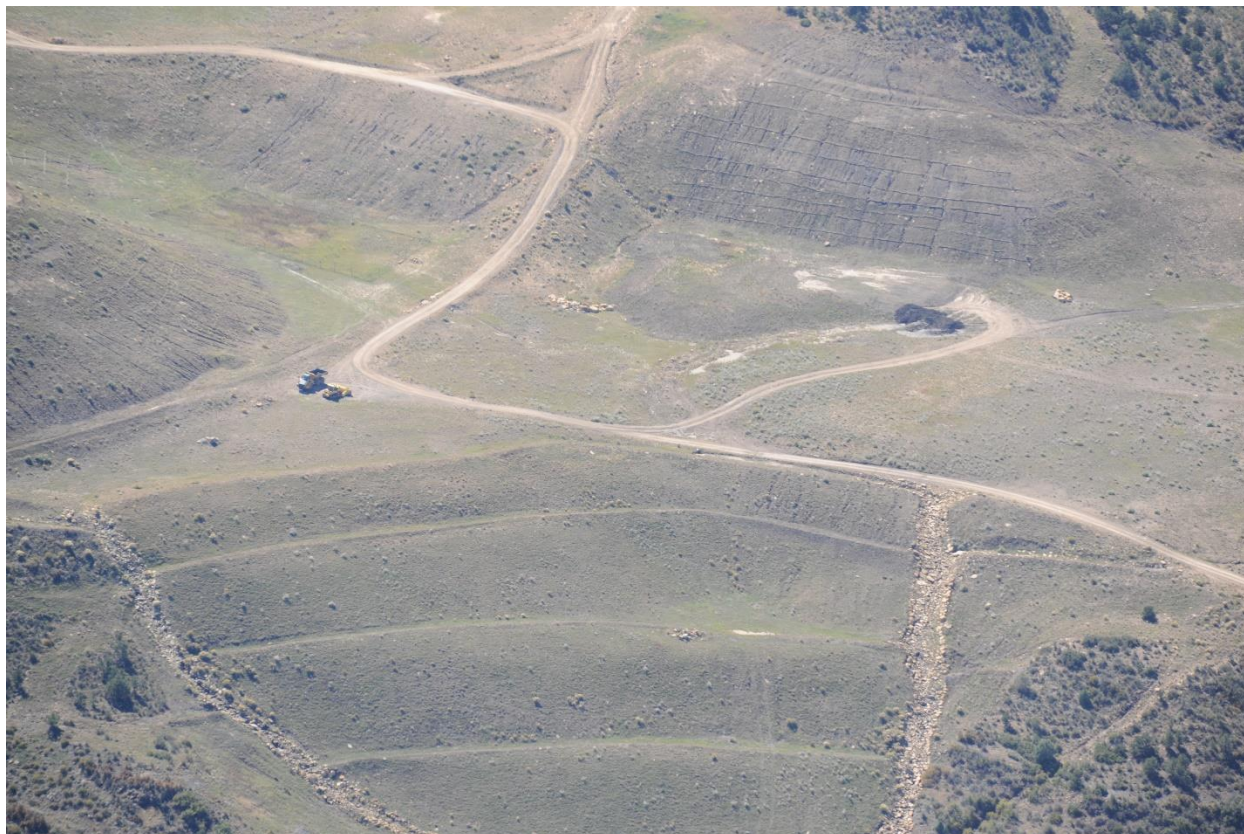
Fills 7, 8, and 9 were generally in good condition.

Rills appear to be stabilizing on the hillside above the area where pond cleanings are dumped.

**Fill 8 and pond cleanings dump area**

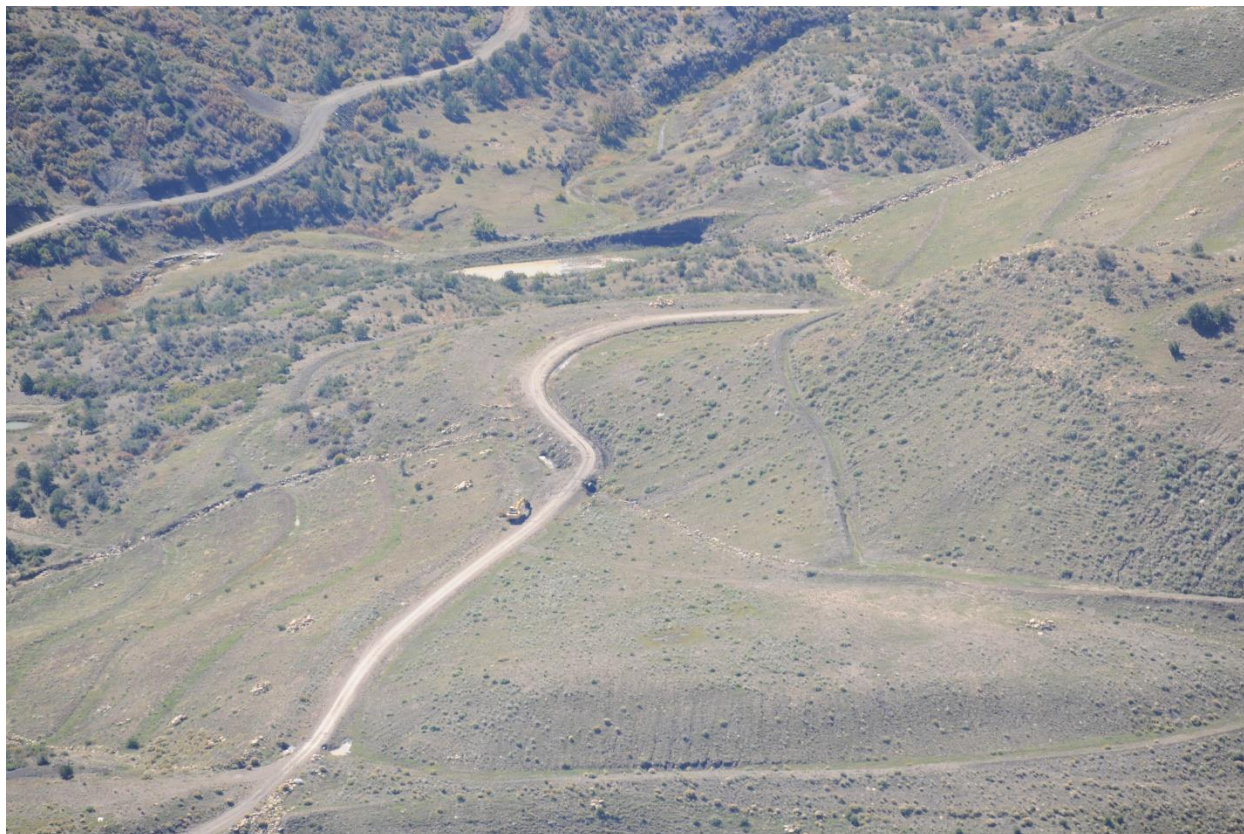
**Fill 9 (lower left) and Fill 7 (upper right)**

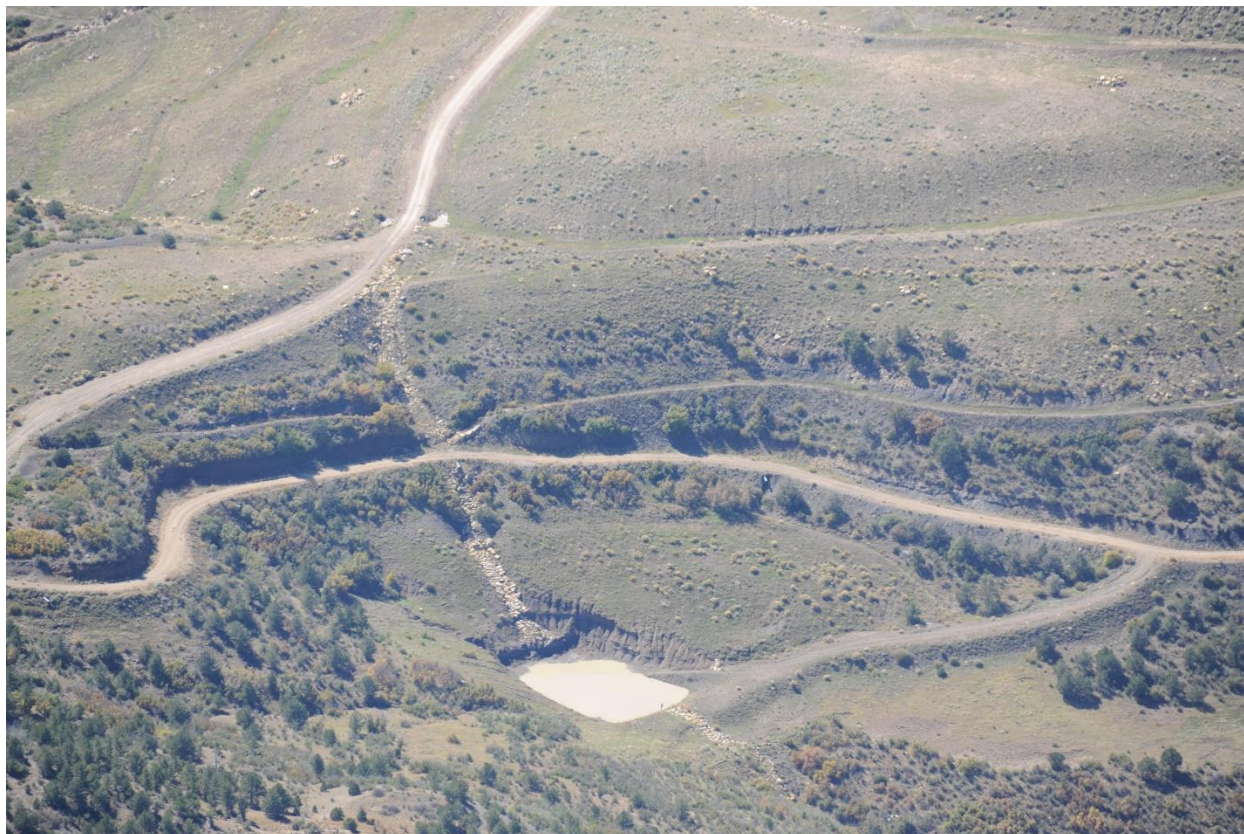
**Pond 9**
