**COLORADO**Division of Reclamation,  
Mining and Safety

**MINERALS PROGRAM INSPECTION REPORT****PHONE: (303) 866-3567**

<b>MINE NAME:</b> Solberg Pit	<b>MINE/PROSPECTING ID#:</b> M-1981-044	<b>MINERAL:</b> Sand and gravel	<b>COUNTY:</b> El Paso
<b>INSPECTION TYPE:</b> Monitoring	<b>INSPECTOR(S):</b> Timothy A. Cazier	<b>INSP. DATE:</b> August 25, 2016	<b>INSP. TIME:</b> 10:30
<b>OPERATOR:</b> Solberg Gravel LLC	<b>OPERATOR REPRESENTATIVE:</b> Wayne Brantley & Jason Ulmer	<b>TYPE OF OPERATION:</b> 112c - Construction Regular Operation

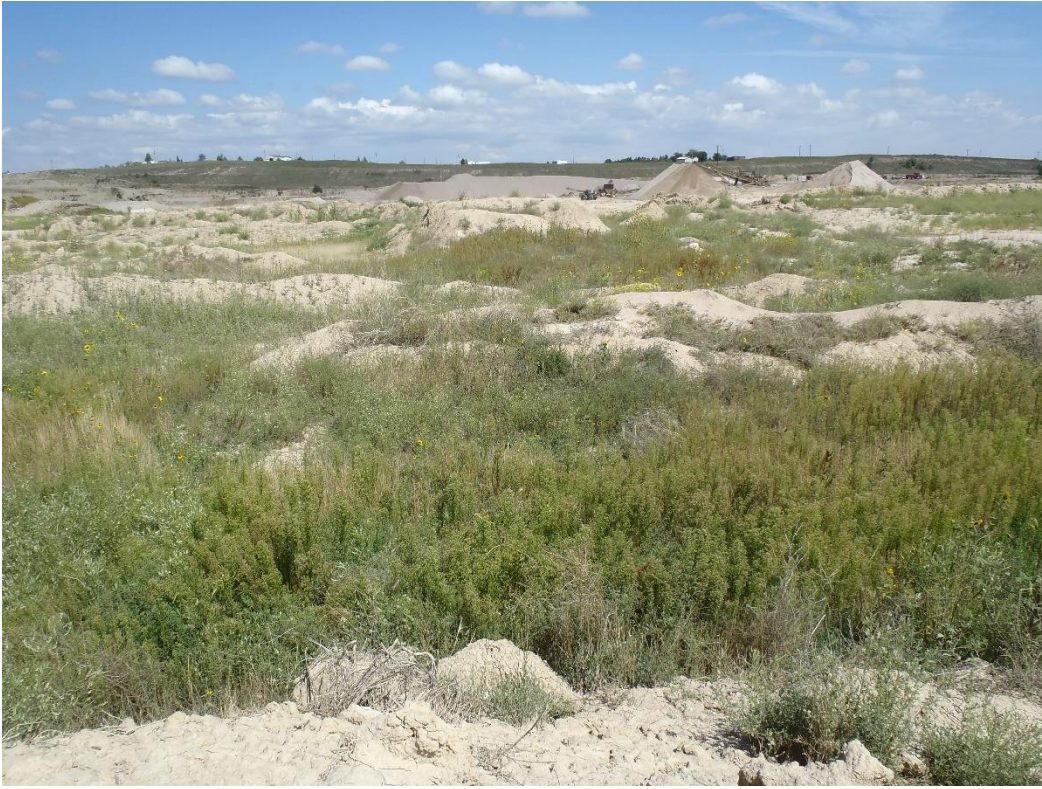
Processing Waste: Site representatives indicated squeegee is sold off. However, wash fines were being placed south of the active pit in an area estimated to be approximately 6 acres in 2015.

Photo 1. Area to south where wash fines were disposed (looking NE).

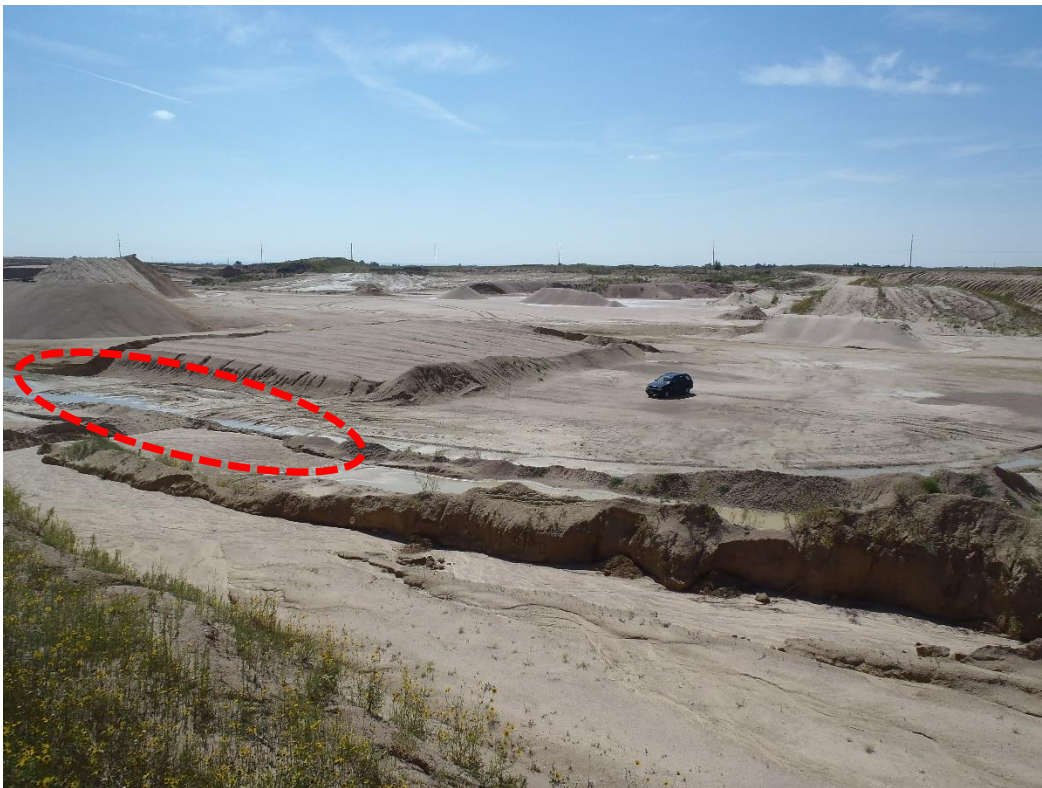
Hydrologic Balance: Some stormwater was observed in the pit (see **Photo 2**) and water/mud was observed in the wash ponds (see **Photo 3**). No exposed groundwater was observed.

Photo 2. Stormwater observed in the pit.

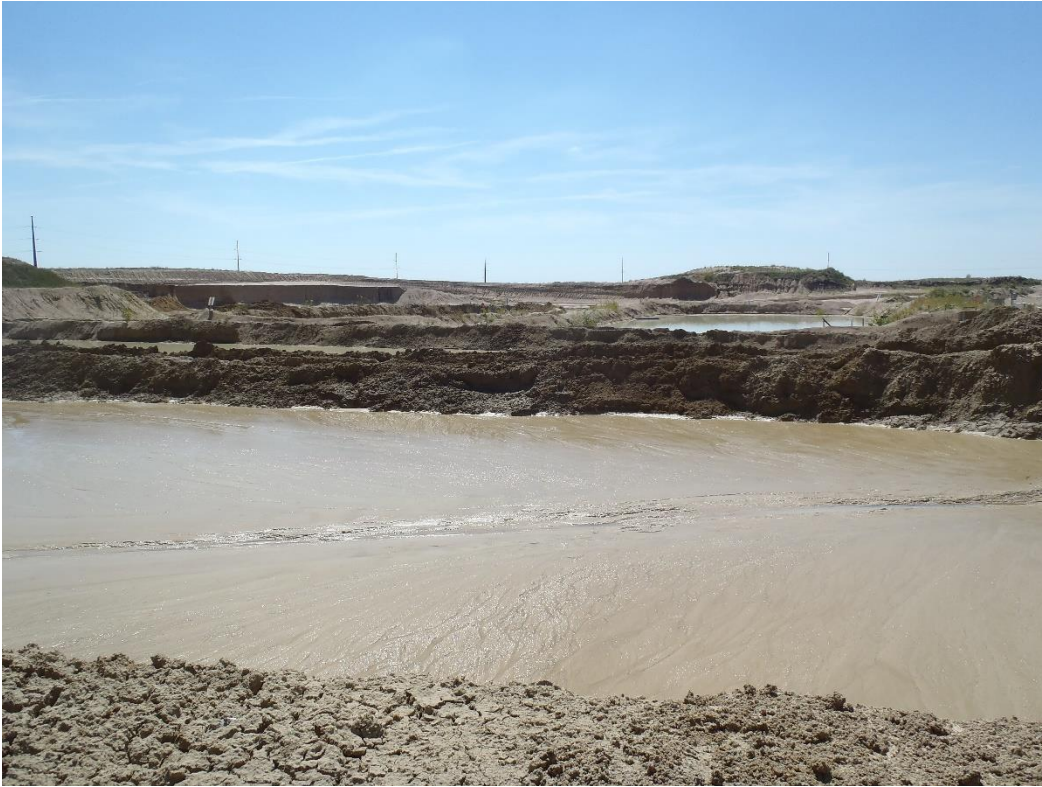
Photo 3. Wash ponds (looking south).

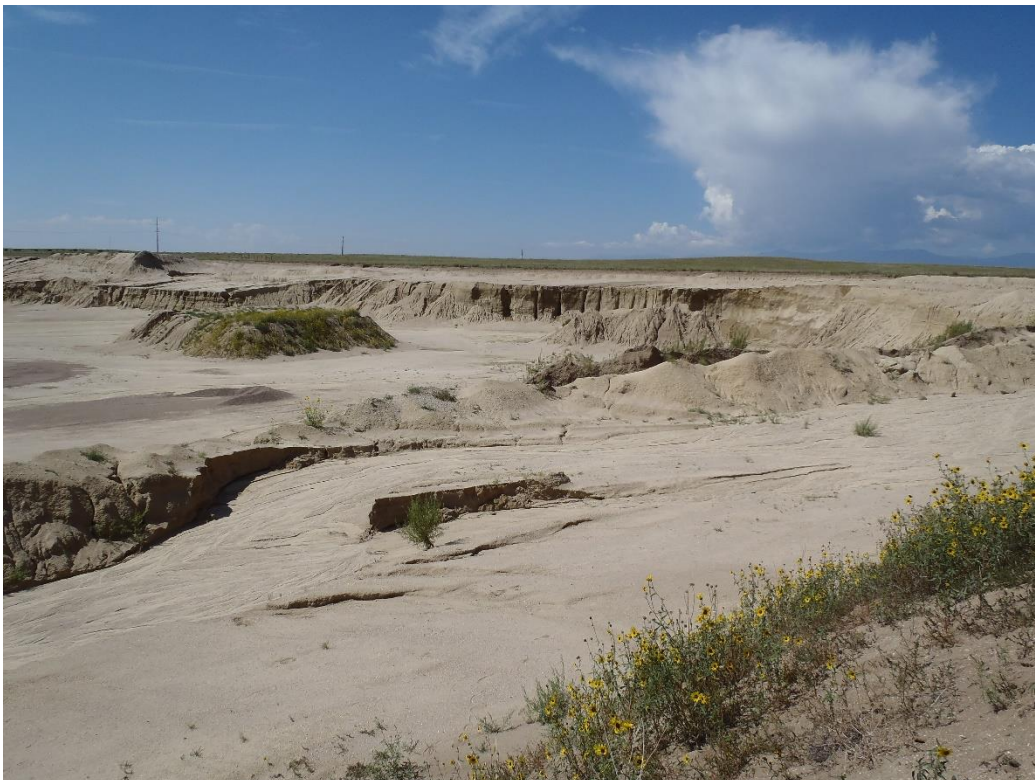
Gen. Compliance with Mine Plan: The operation has exceeded its approved maximum disturbed area. Amendment 2 allows no more than 25 acres of disturbance at one time. Google Earth imagery from November 2, 2015 (see **Post Inspection Map 2**) indicates approximately 83.5 acres are disturbed and another 10.5 acres (along the north boundary) are fairly well vegetated. However the Division has no record of having received an acreage release or surety adjustment for this northern area of the permit. As such, approximately 94 acres are considered disturbed area. AM-02 further delineates the types of disturbance as being either "major", "moderate", or "minor" (which the Division no longer recognizes) with no more than: 5 acres of major disturbance, 12 acres of moderate disturbance, and 8 acres of minor disturbance at one time. **The 83.5 acres of 2015 disturbance is cited as a problem on page 1 of this report.** Highwalls were estimated to vary between 10 and 20 feet in height (see **Photo 4**) and stable for the most part.

Photo 4. Typical higwalls (west end, looking SW).

**CORRECTIVE ACTIONS:** The operator shall submit a Technical Revision, with the required \$216 revision fee, to update and clarify the current approved mine plan to reflect existing and proposed activities by the corrective action date.

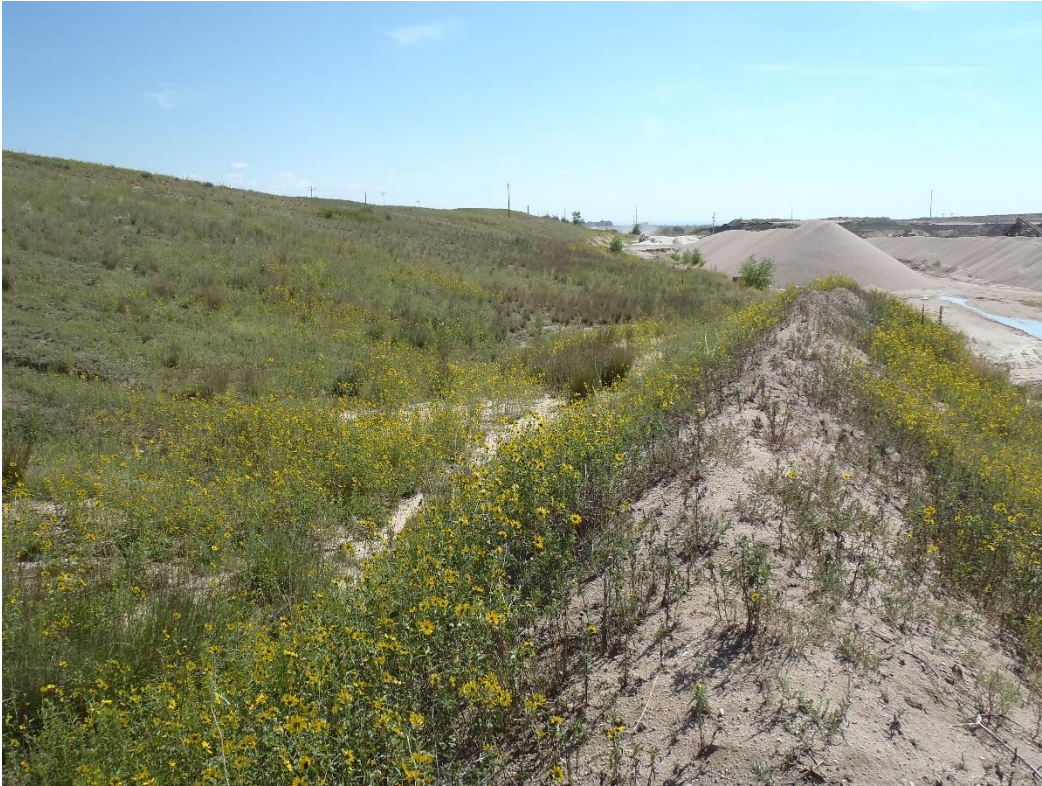
Reclamation Success: The north slope of the pit area (~10.5 acres) was not seeded according to site representatives, but is apparently self-reclaimed (see **Photo 5**). This is the only area of the pit that might be considered for any reclamation credit at the time of the inspection.

Revegetation: Again, the north slope appeared to have fairly well established vegetation (see **Photo 5**). No noxious weeds were observed.

Photo 5. North slope of the pit area (looking east).

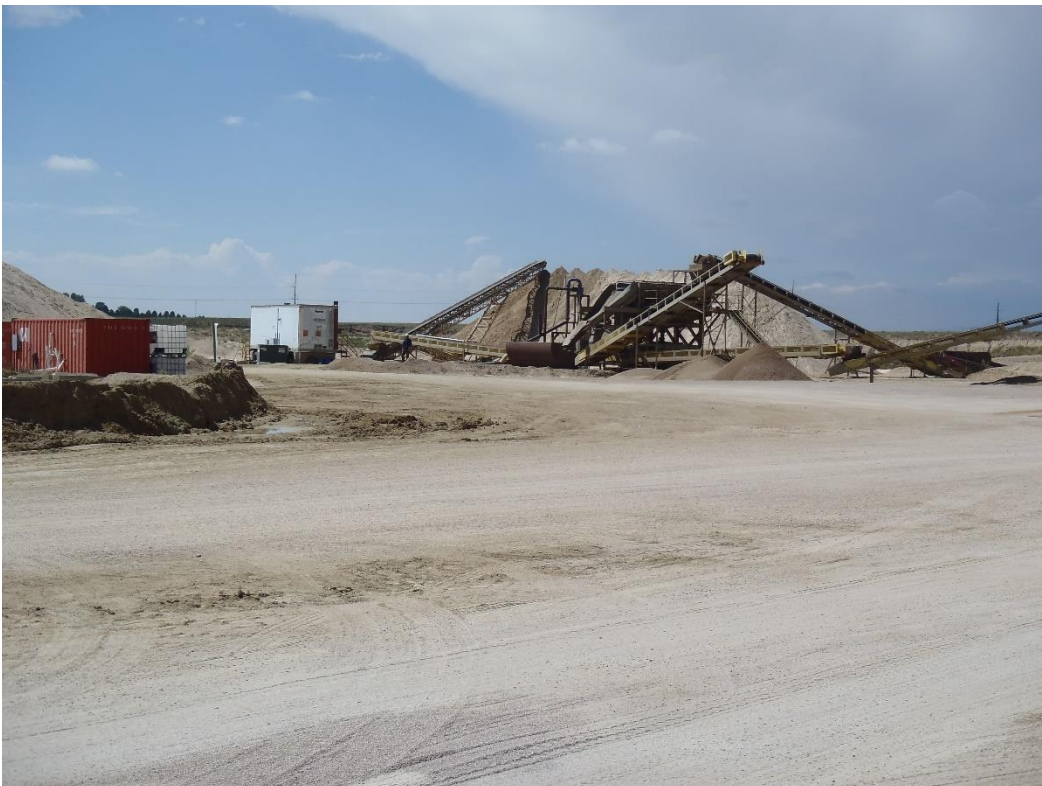
Support Facilities On-site: Screens, loaders and conveyors (see **Photo 6**) were observed during the inspection.

Photo 6. Processing equipment (pit center, looking SW from scale house).

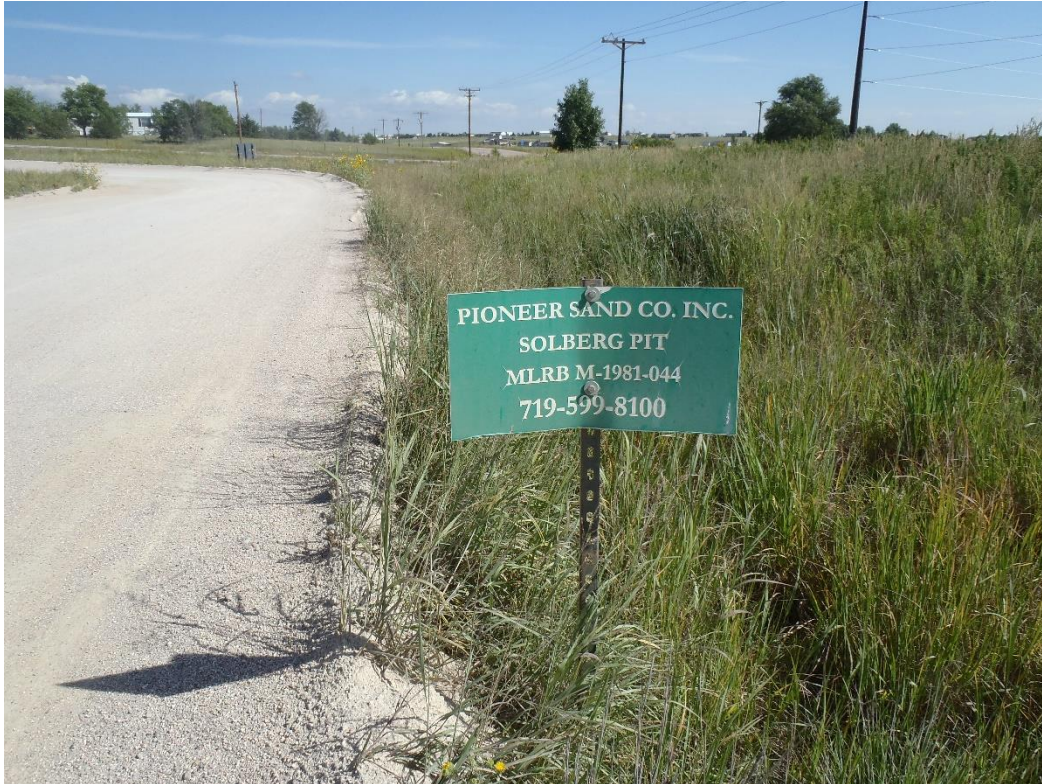
Signs and Markers: The permit sign was properly posted (see **Photo 7**) and the boundary near the active pit was delineated with barbed wire fence (see **Photo 8**).

Photo 7. Permit sign (near entrance).

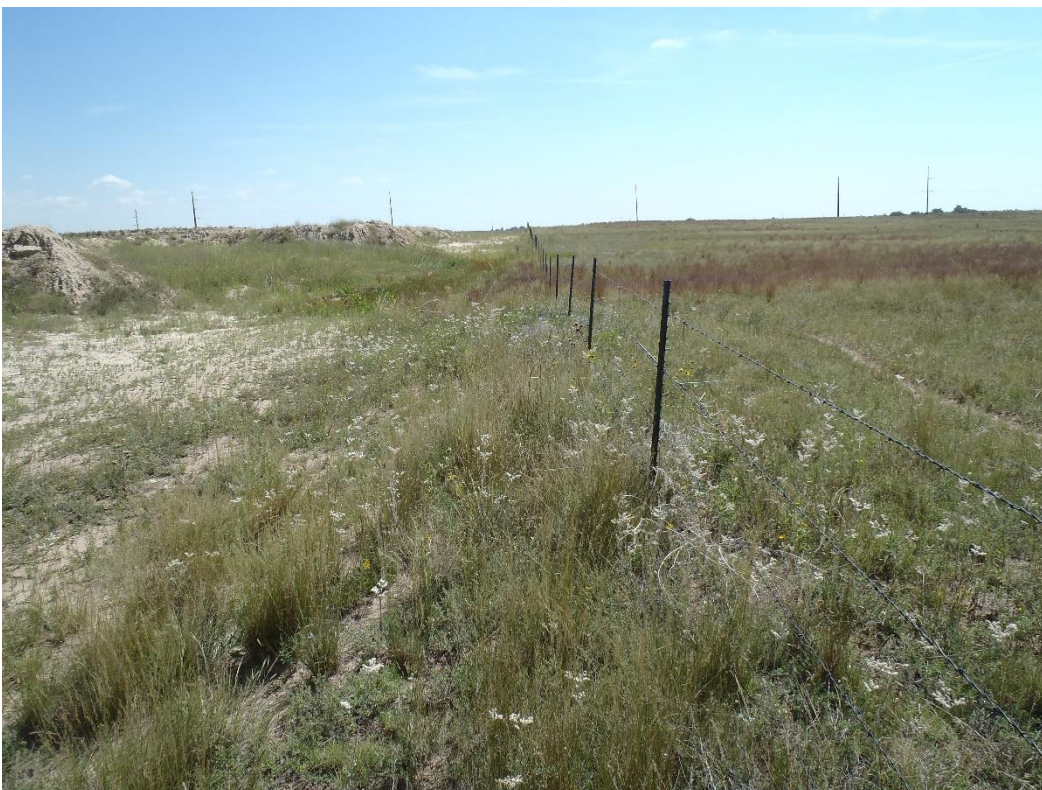
Permit Stipulations: There are no permit stipulations. Site representatives indicated the power lines along the south and east permit boundaries were added a year to a year and a half prior to the inspection. A review of Google Earth historic images indicates the power line was added after October 2011 and before November 2015. The Permittee should get structures agreements with the utility company before the affected area gets within 200 feet of the power line.

Photo 8. Barbed wire fence (looking Easton south side – note powerline in background).

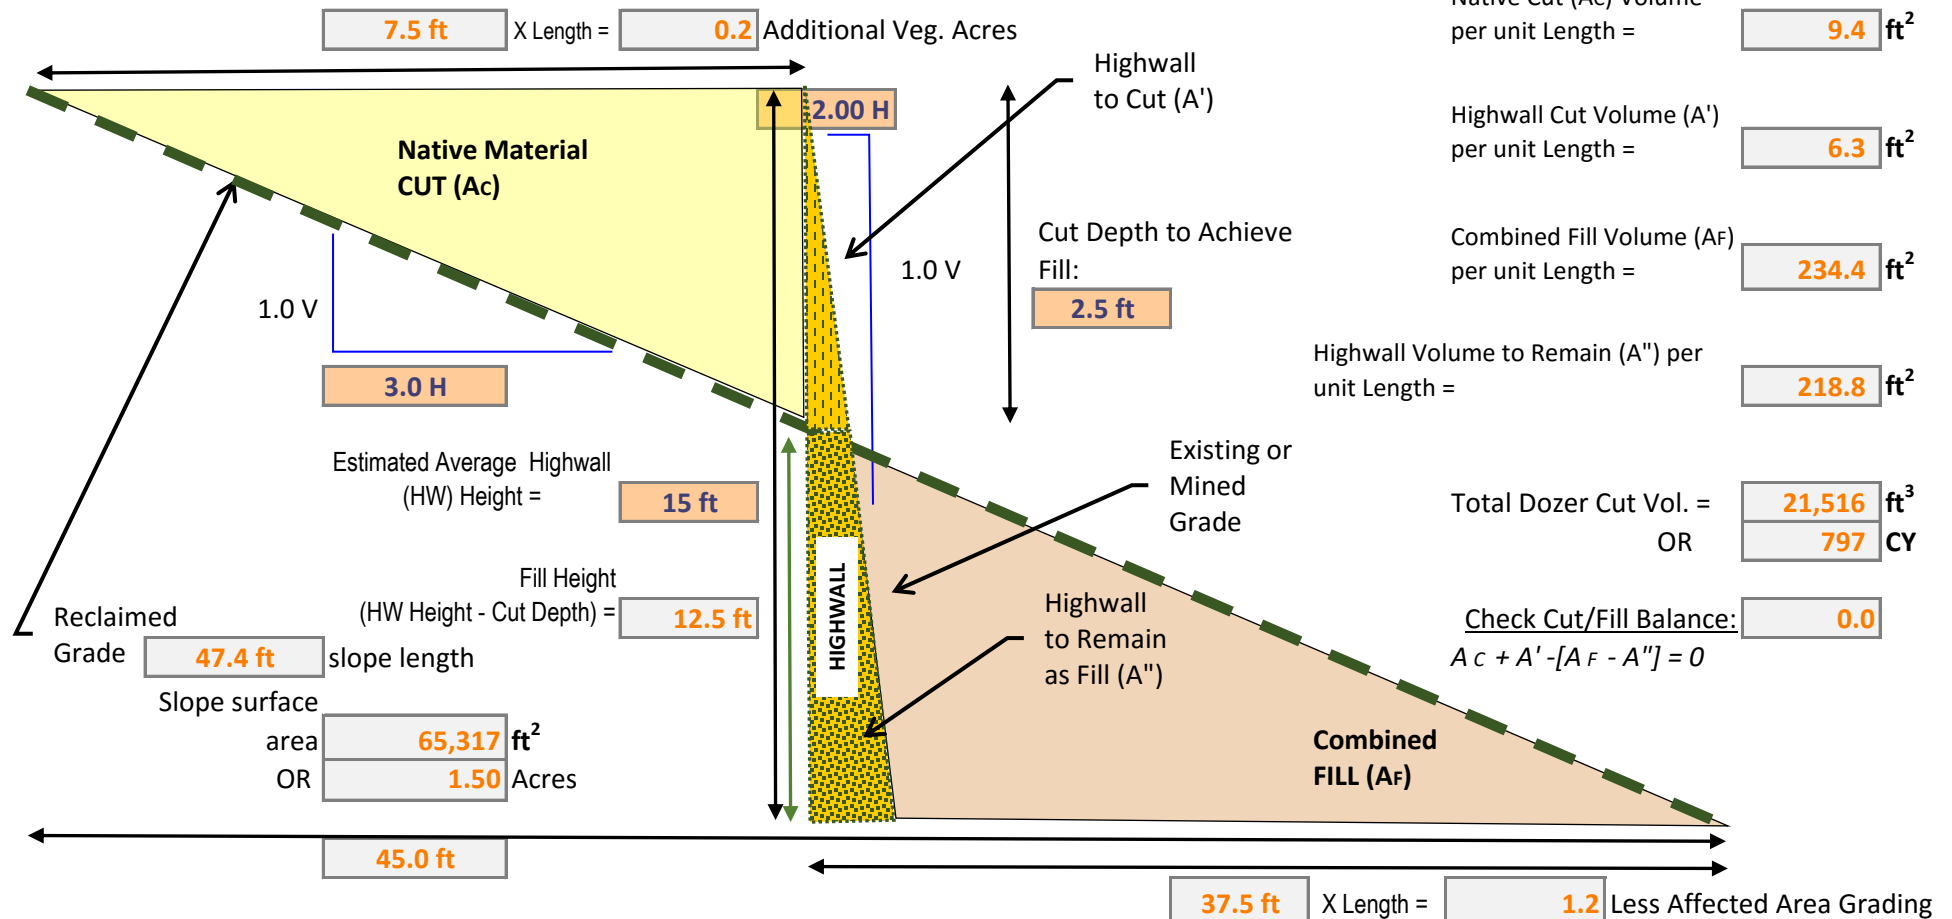
## Task # 010.1 2H:1V Highwall Backfill Volume Estimate

PROJECT: Solberg Pit  
 PERMIT No.: M-1981-044  
 HIGHWALL LOCATION: West End Highwalls (~2H:1V)

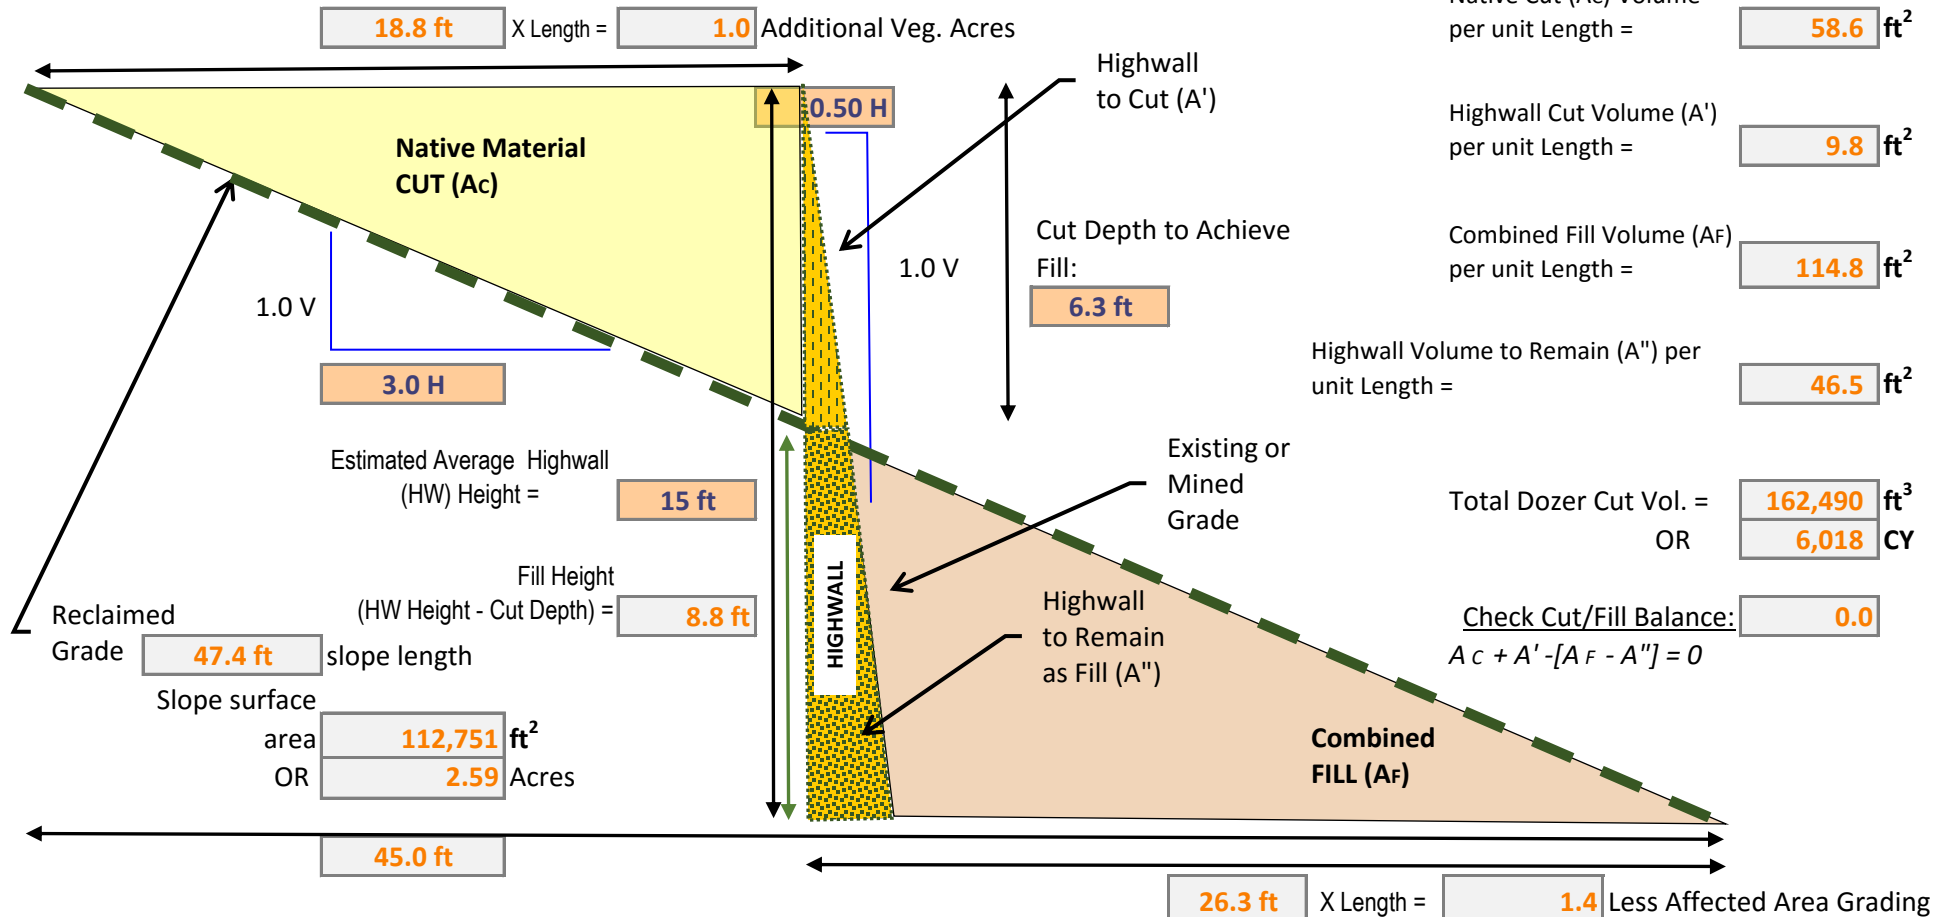
## Task # 011.1 0.5H:1V Highwall Backfill Volume Estimate

PROJECT: Solberg Pit  
 PERMIT No.: M-1981-044  
 HIGHWALL LOCATION: Steep Highwalls (~0.5H:1V)
