**MINERALS PROGRAM INSPECTION REPORT**  
**PHONE: (303) 866-3567**

<b>MINE NAME:</b> 22 West Pit	<b>MINE/PROSPECTING ID#:</b> M-2017-032	<b>MINERAL:</b> Borrow material for construction, sand and gravel	<b>COUNTY:</b> Otero
<b>INSPECTION TYPE:</b> Preoperation Inspection	<b>INSPECTOR(S):</b> Amy Eschberger	<b>INSP. DATE:</b> October 25, 2017	<b>INSP. TIME:</b> 11:00
<b>OPERATOR:</b> Deep Cut LLC	<b>OPERATOR REPRESENTATIVE:</b> Chris Tomky	<b>TYPE OF OPERATION:</b> 112c - Construction Regular Operation

# M-2017-032 / 22 West Pit / Deep Cut, LLC

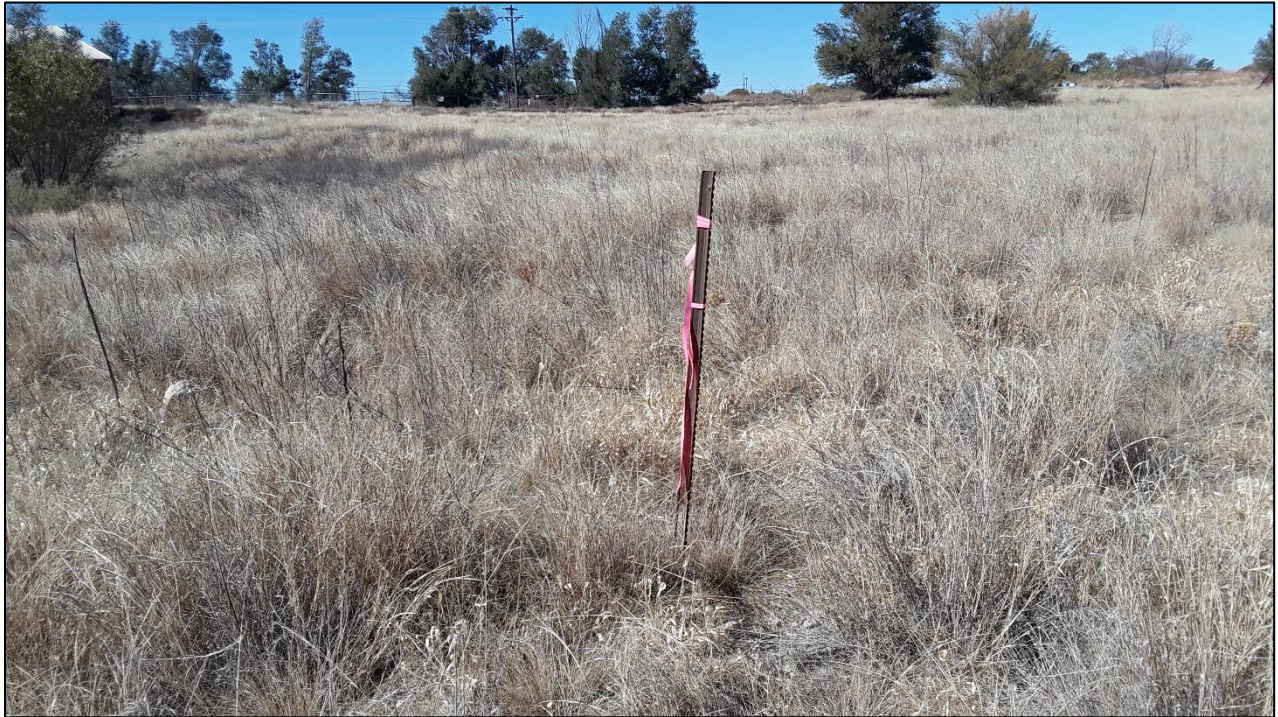
**Photo 1.** View looking southwest toward main site entrance, showing metal stake marking a corner of the proposed southern permit boundary.

Enclosed with the report are **Photos 1-19** taken of the site during the inspection. The Division observed boundary markers have been placed to mark the corners of the proposed permit boundary. Markers included existing fence posts that have been painted orange, and metal stakes where fencing is not present. The only corner not marked is the one located in the middle of the larger pond. The Division discussed with Mr. Tomky potential methods for marking this corner, possibly with a float or buoy. This marker would need to be checked by the operation on a regular basis to be sure it is properly located. Because the southern permit boundary crosses bodies of water, the most important corner markers will be the ones located on either side of the ponds. However, the Division expressed to Mr. Tomky the importance of delineating the entire permit boundary in accordance with Rule 3.1.12(2).

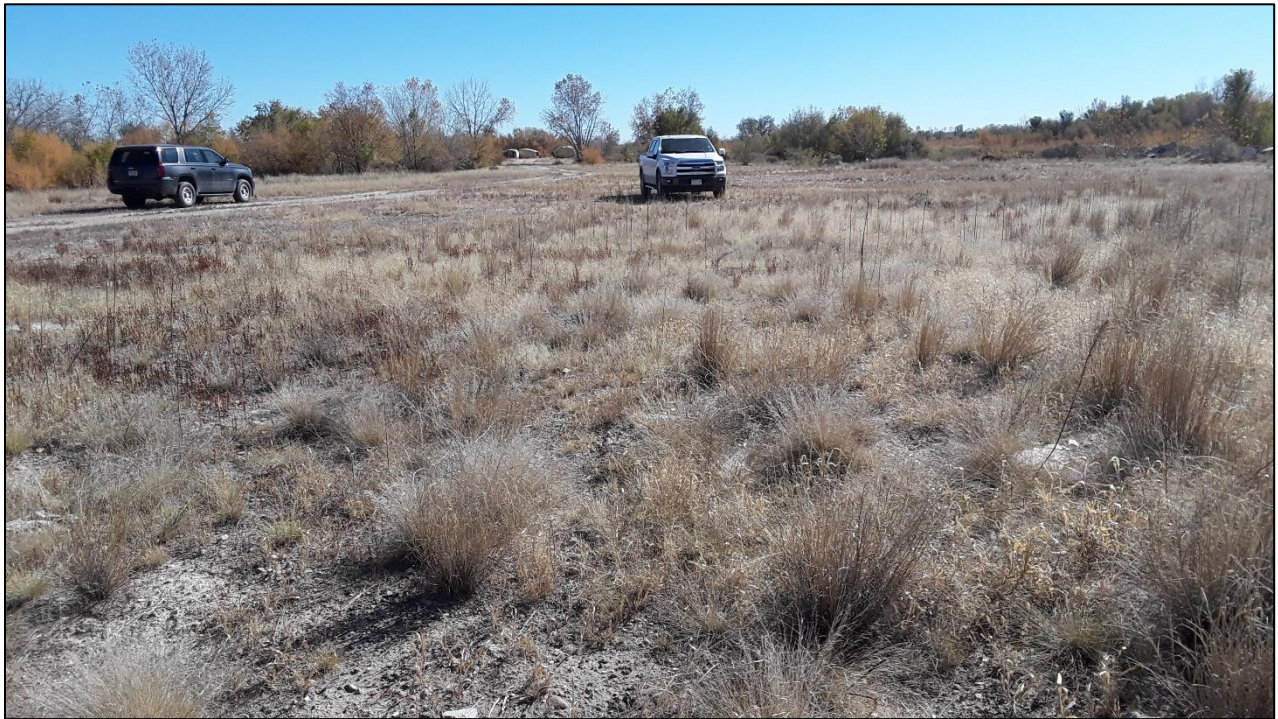
**Photo 2.** View looking east across western portion of proposed permit area to be used as a material and equipment storage area during operations.

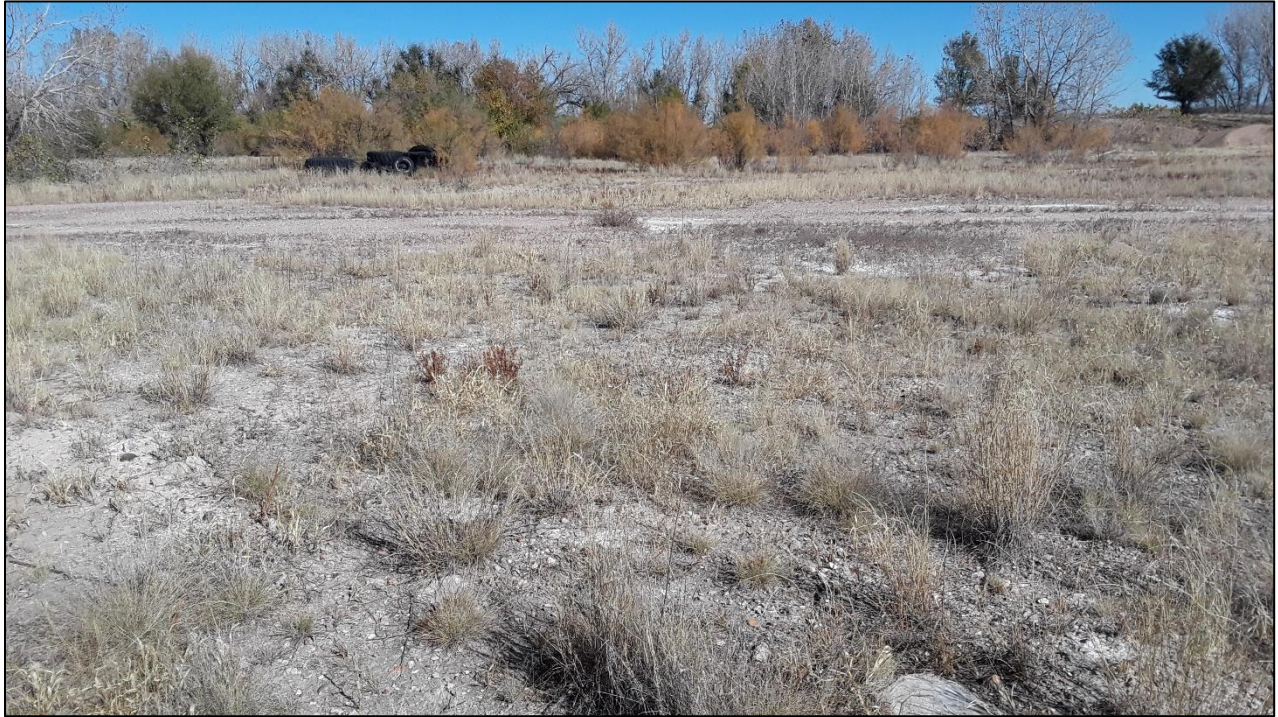
**Photo 3.** View looking north across western portion of proposed permit area to be used as a material and equipment storage area during operations. Later in the operation, the area located north of the access road (area in background with trees) may be excavated to expand the pond westward.

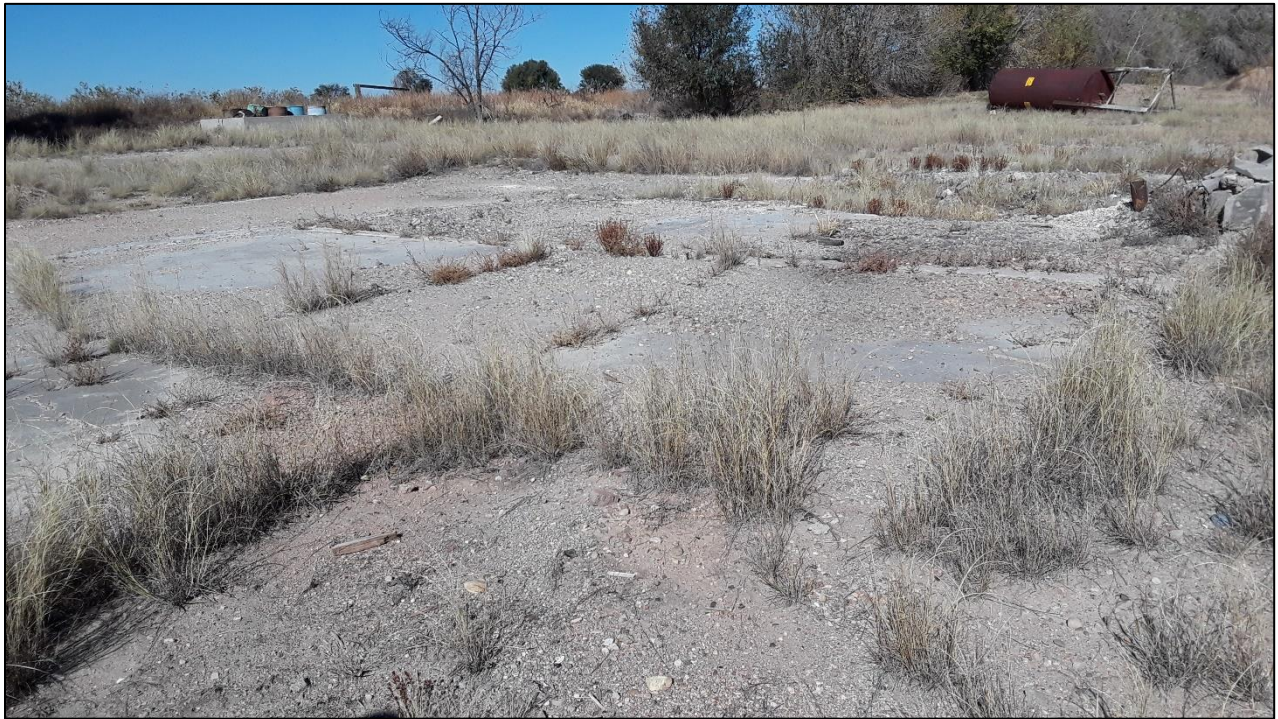
“concrete” on the mining plan map submitted, located in the southwestern portion of the proposed permit area. This concrete feature appears to be the remaining foundation from a batch plant that operated at the site many years ago. The Division has requested clarification on the operation’s potential use and reclamation of this feature. The Division also requested clarification on what the applicant intends to do with the old pieces of equipment and containers that are scattered across the western half of the proposed permit area, some rusting in place. The Division understands these items were left by the previous operation. However, pursuant to C.R.S. 34-32.5-116(4)(e), all refuse shall be disposed of in a manner that controls unsightliness or the deleterious effects of such refuse. If the equipment will not be used by the operation, the applicant will need to either dispose of the items on site (in an acceptable manner), or haul the items off site for disposal.

**Photo 4.** View looking west across concrete feature that exists in southwestern portion of proposed permit area. This feature appears to be the remaining concrete foundation from an old batch plant that operated at the site many years ago.

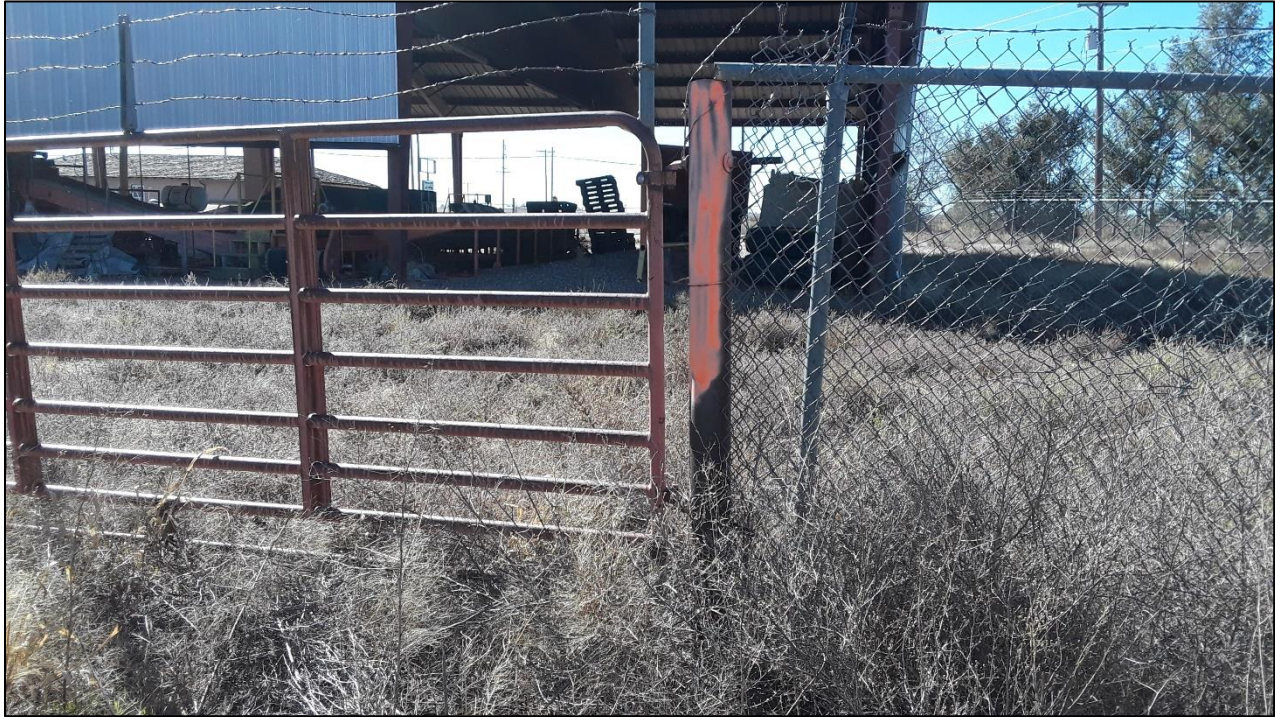
**Photo 5.** View of existing fencepost (painted orange) marking a corner of the proposed southwestern permit boundary, near the main site entrance.

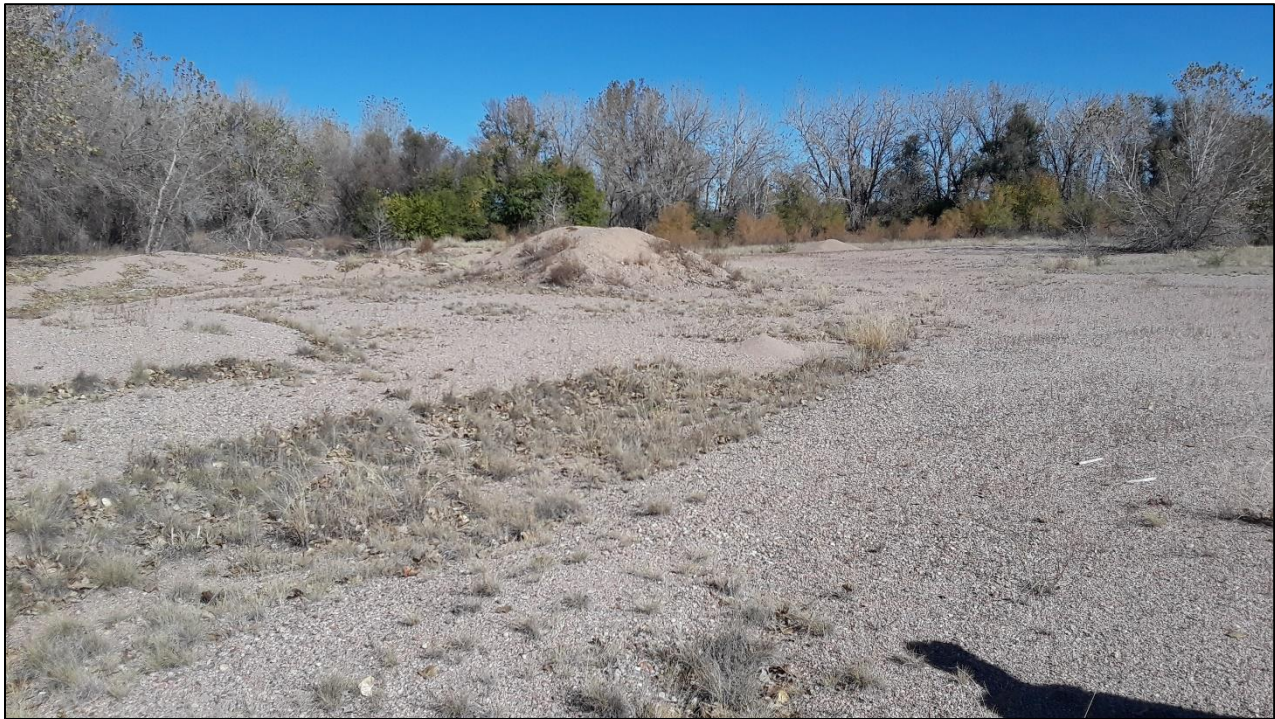
**Photo 6.** View looking north across western portion of proposed permit area which may be the farthest western expansion of the pond later in the operation.

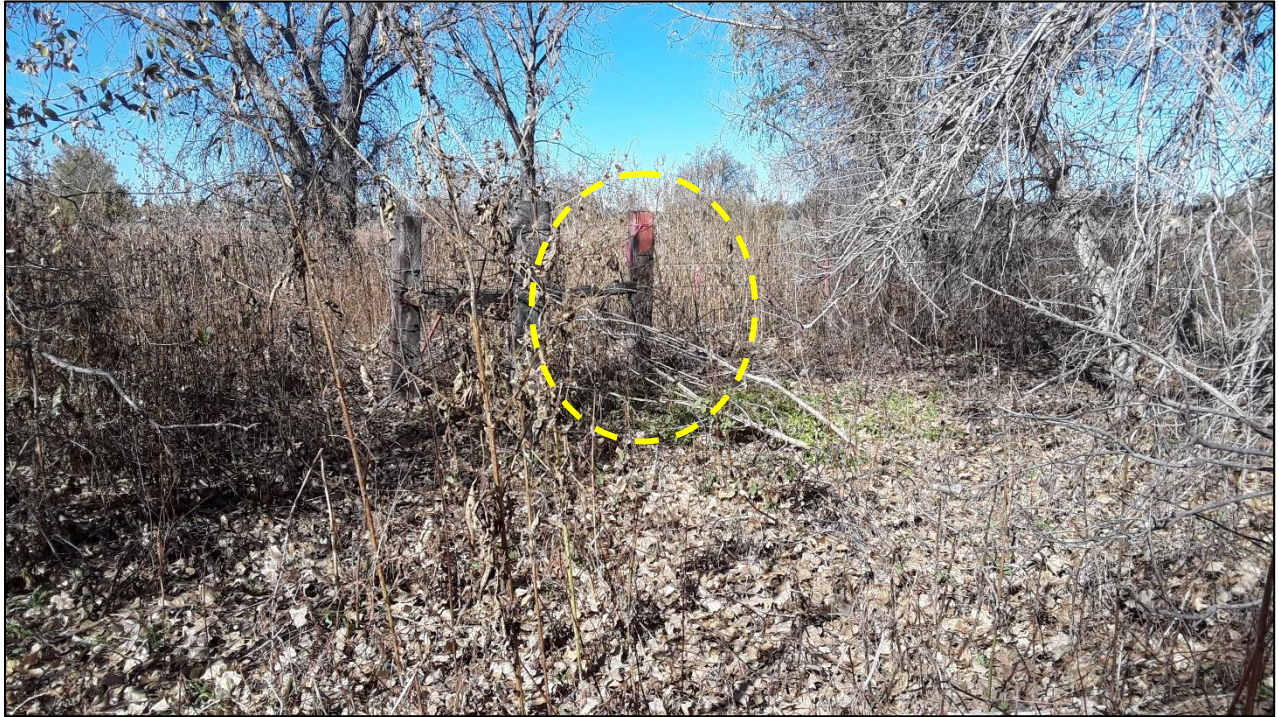
**Photo 7.** View of existing fencepost (painted orange; circled) marking the northwestern corner of the proposed permit boundary.

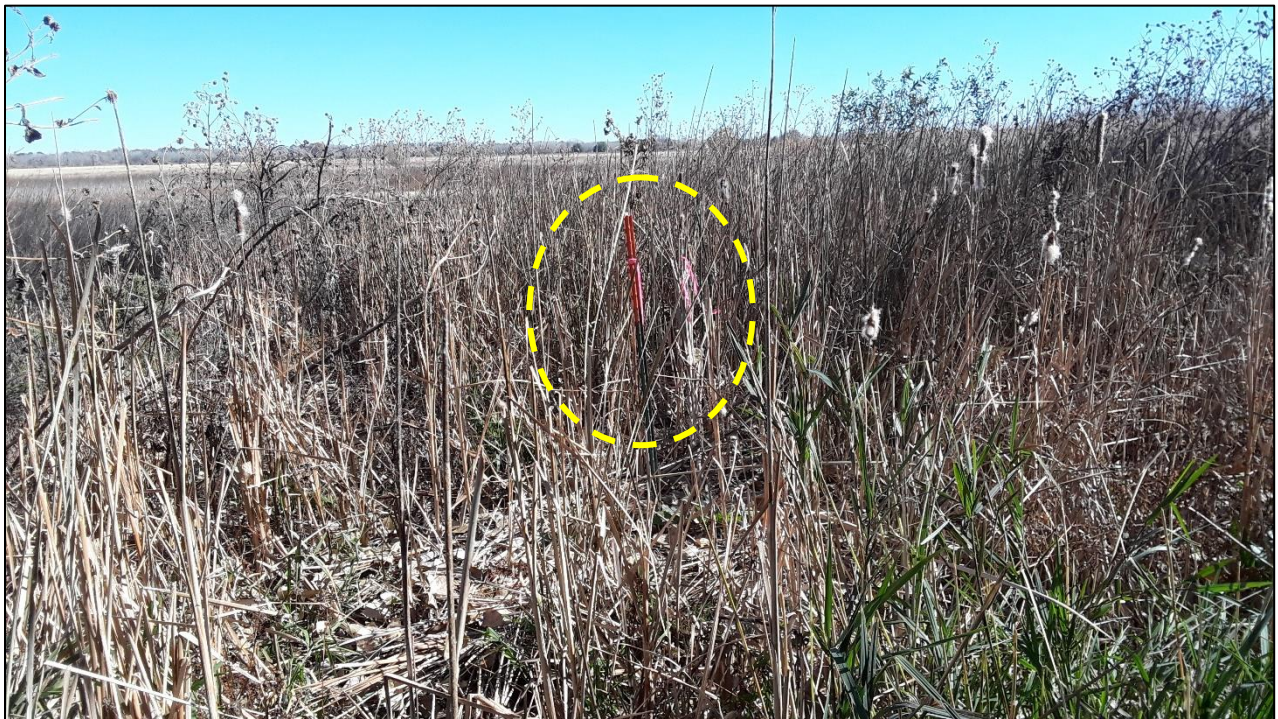
**Photo 8.** View of metal stake (painted orange; circled) marking a northern corner of the proposed permit boundary. This area has dense vegetation.

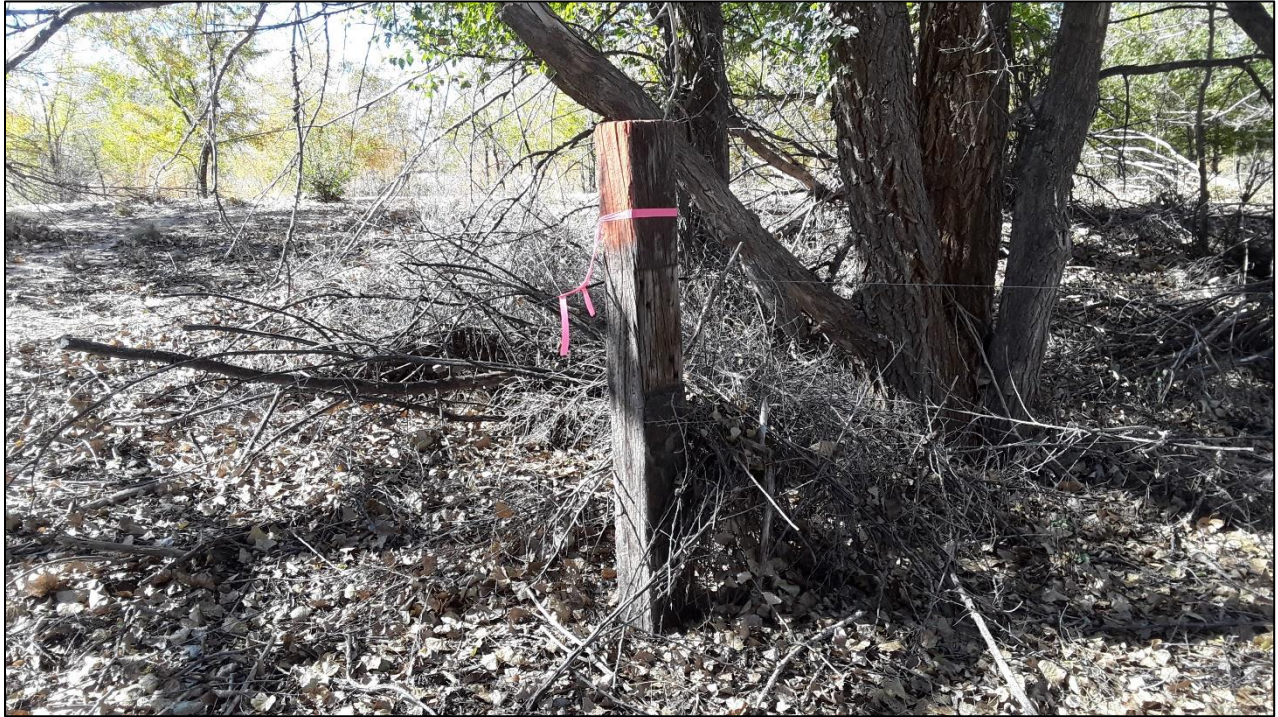
**Photo 9.** View of existing fencepost (painted orange) marking another northern corner of the proposed permit boundary.

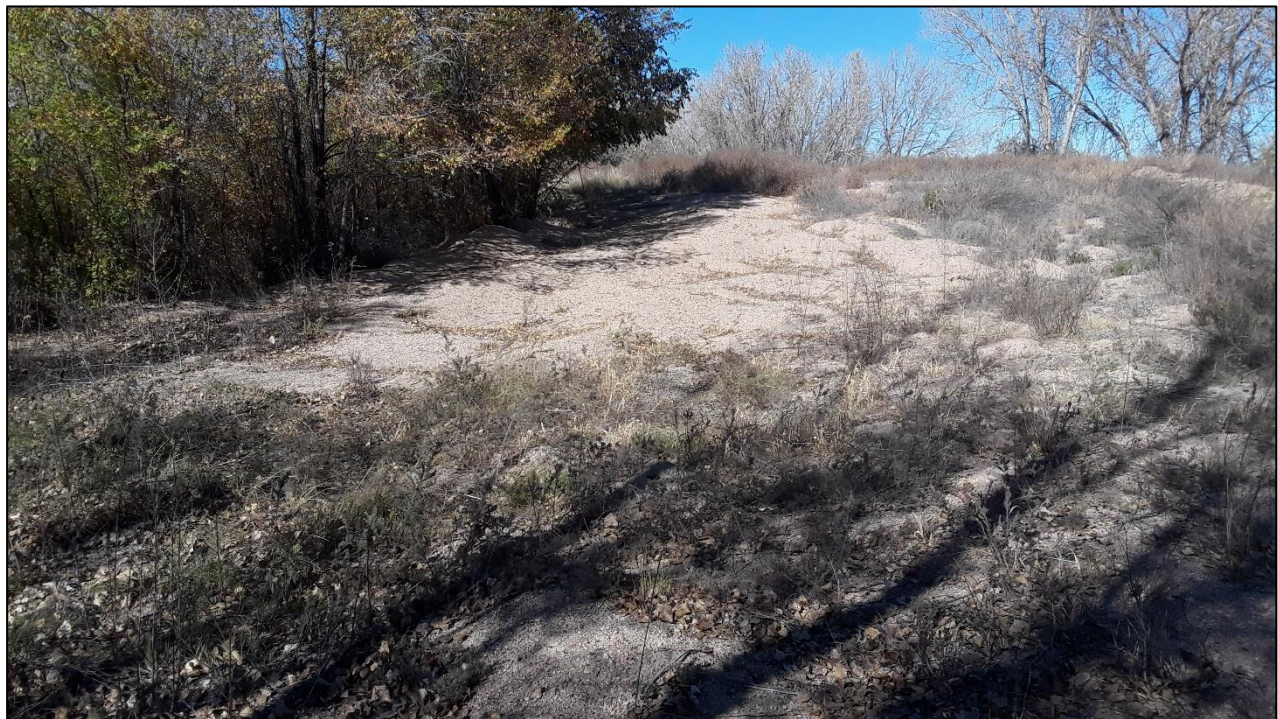
**Photo 10.** View looking west across pre-law disturbed area in northwestern portion of proposed permit area. This area may be redisturbed by the operation to expand the pond westward.

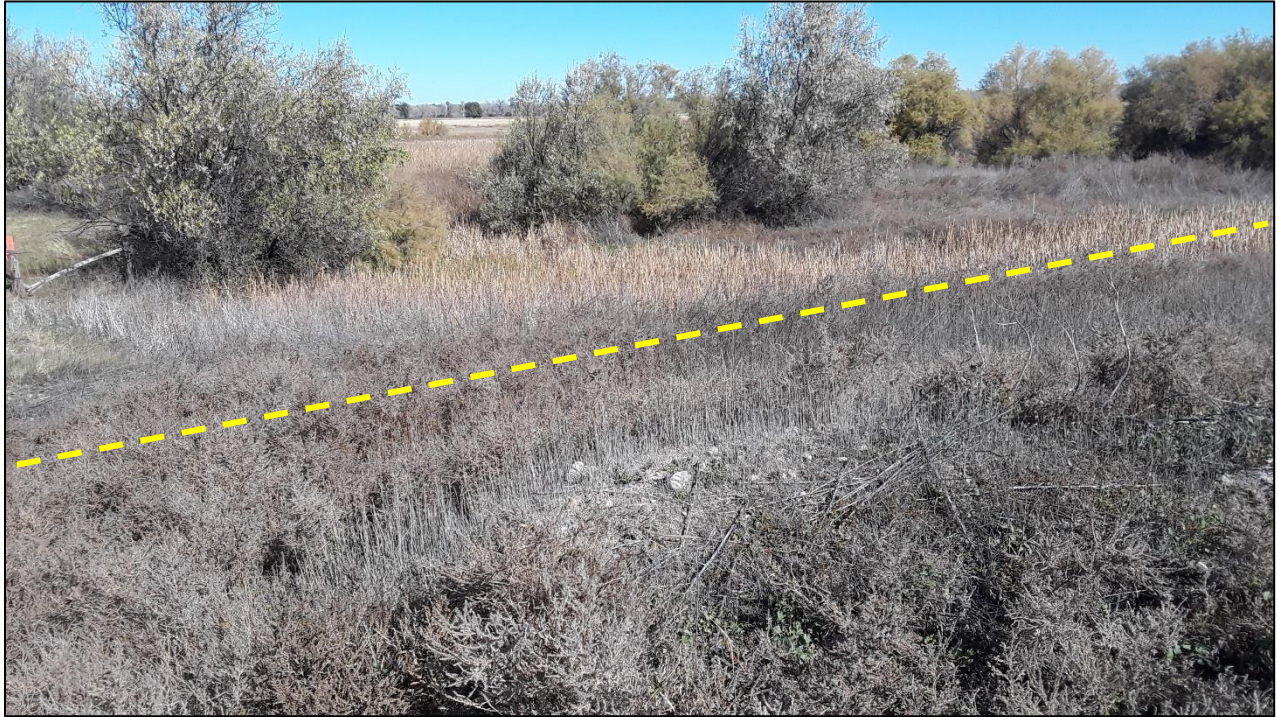
**Photo 11.** View looking north across ditch owned by City of Aurora, located within approximately 50 feet from the proposed northern permit boundary. Yellow dash lined marks approximate center line of ditch. A structure agreement has not yet been obtained for this structure.

The applicant has identified several permanent man-made structures located within 200 feet of the proposed affected land boundary, and a total of seven structure owners. The Division did not observe any structures during the inspection that were unaccounted for in the application. The Division observed the area labeled as

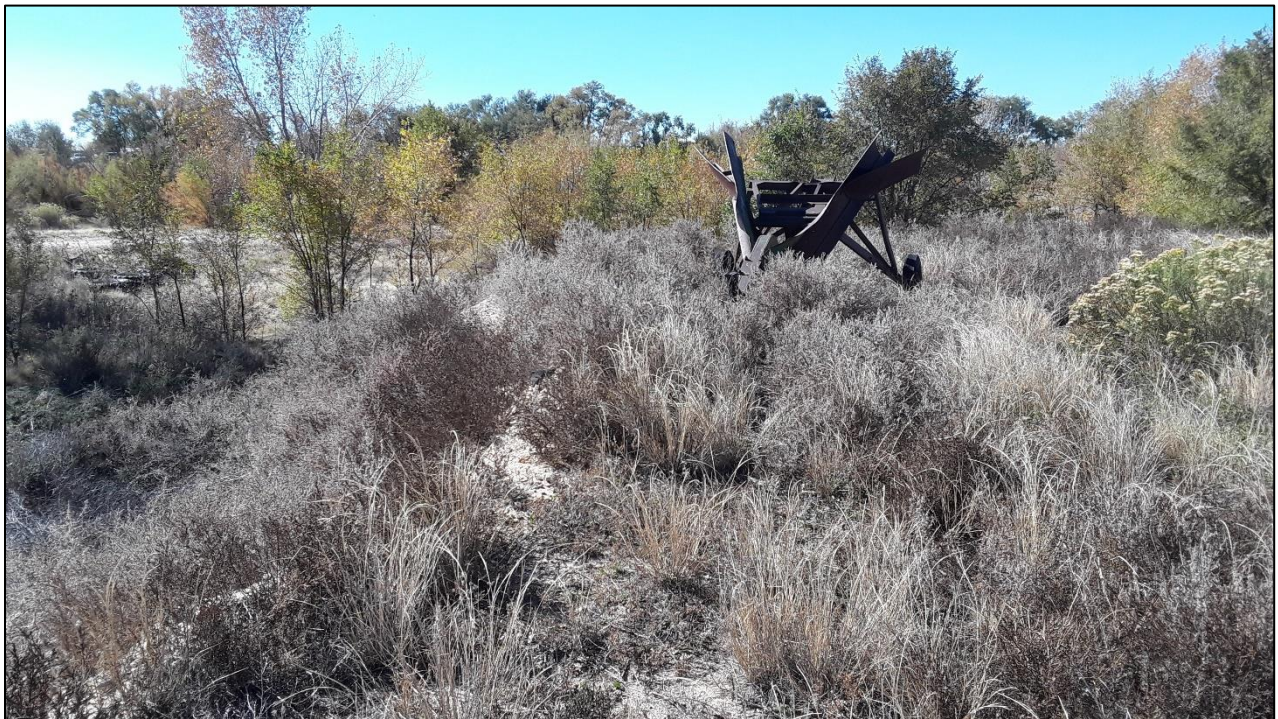
**Photo 12.** View looking south from proposed northern permit boundary, showing land to potentially be mined later in westward expansion of pond. Note old equipment left by earlier operations.

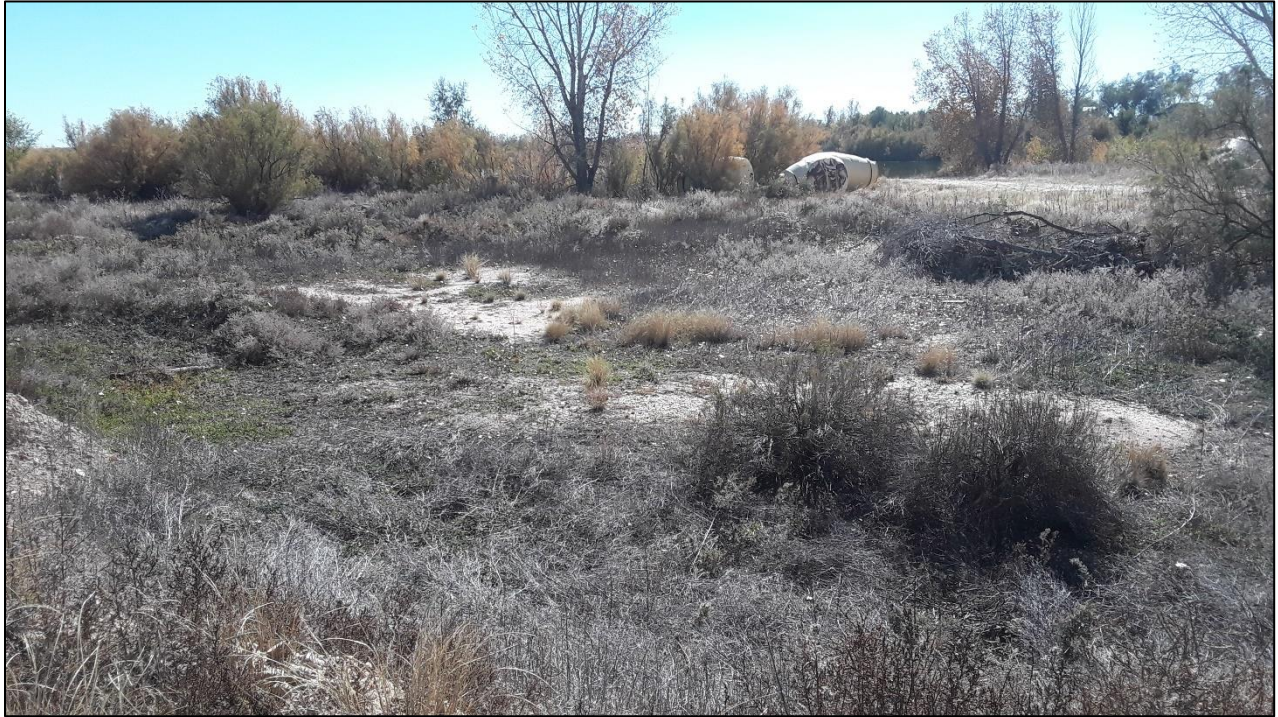
**Photo 13.** View looking south across northern portion of proposed permit area, showing land to potentially be mined later in westward expansion of pond.

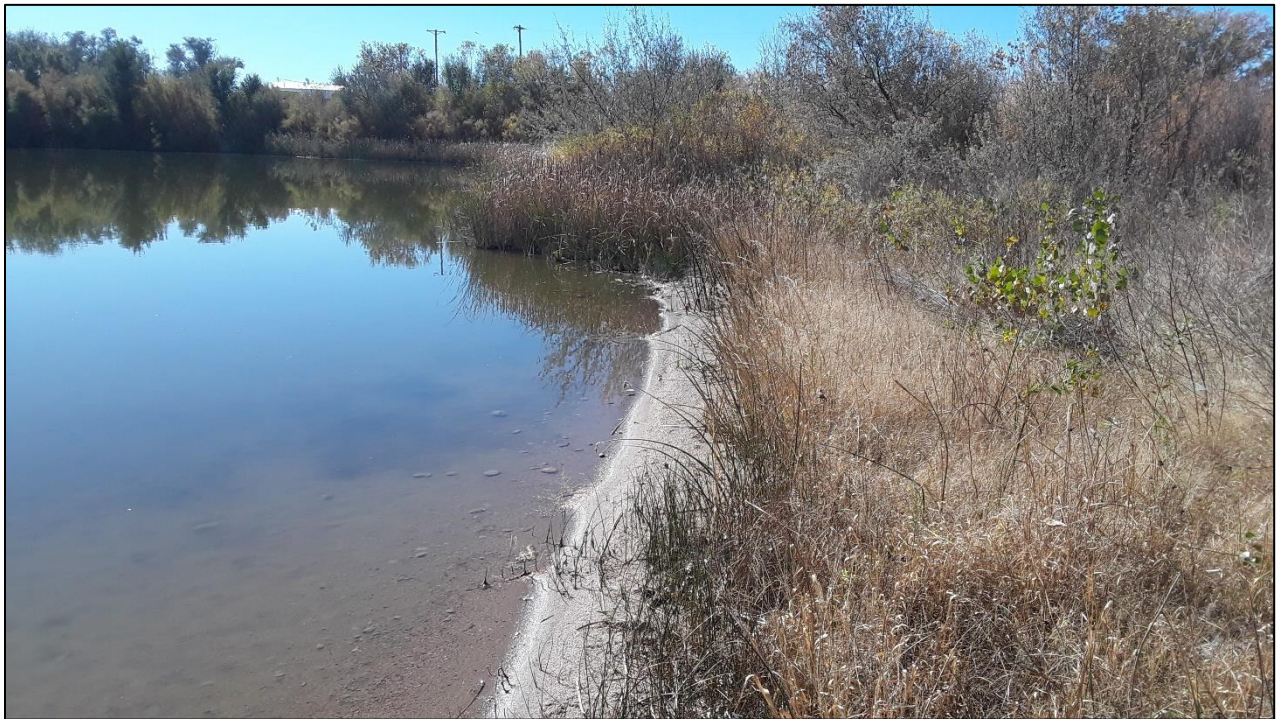
**Photo 14.** View looking southwest across western shoreline of larger existing pond. Shoreline slopes are 3H:1V or flatter and well-vegetated. However, this area will be mined to expand the pond westward.

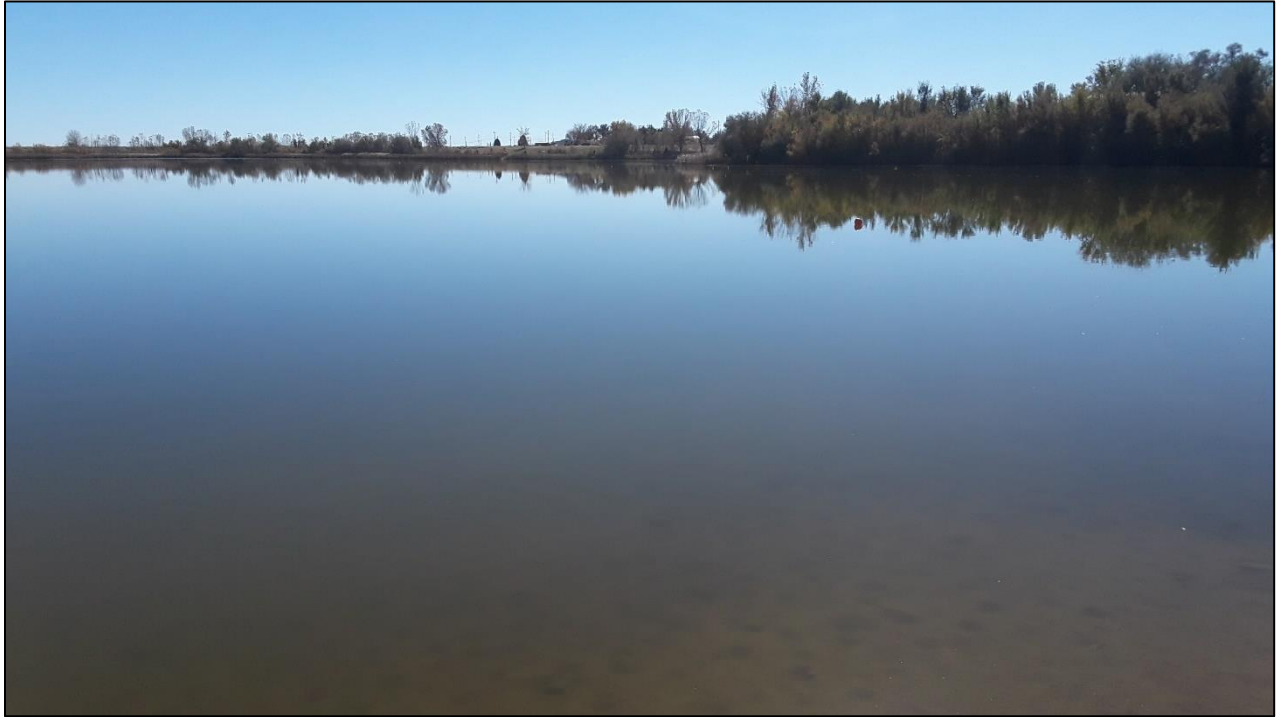
**Photo 15.** View looking southeast across larger existing pond. A corner of the proposed southern permit boundary is located inside the pond approximately near the center of the photo. This boundary corner will need to be delineated somehow, possibly with a buoy or float.

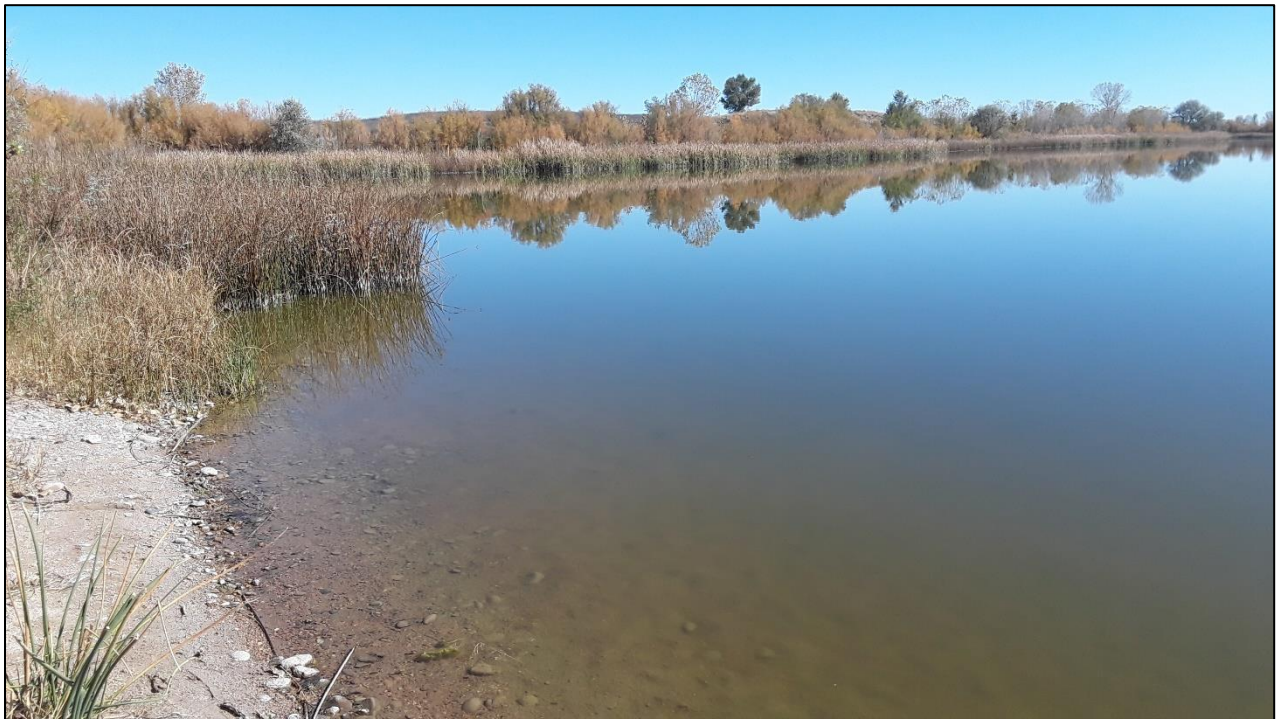
**Photo 16.** View looking north across northwestern portion of larger existing pond. Shoreline slopes are at 3H:1V or flatter and well vegetated. However, this portion of the pond will be expanded westward by the operation.

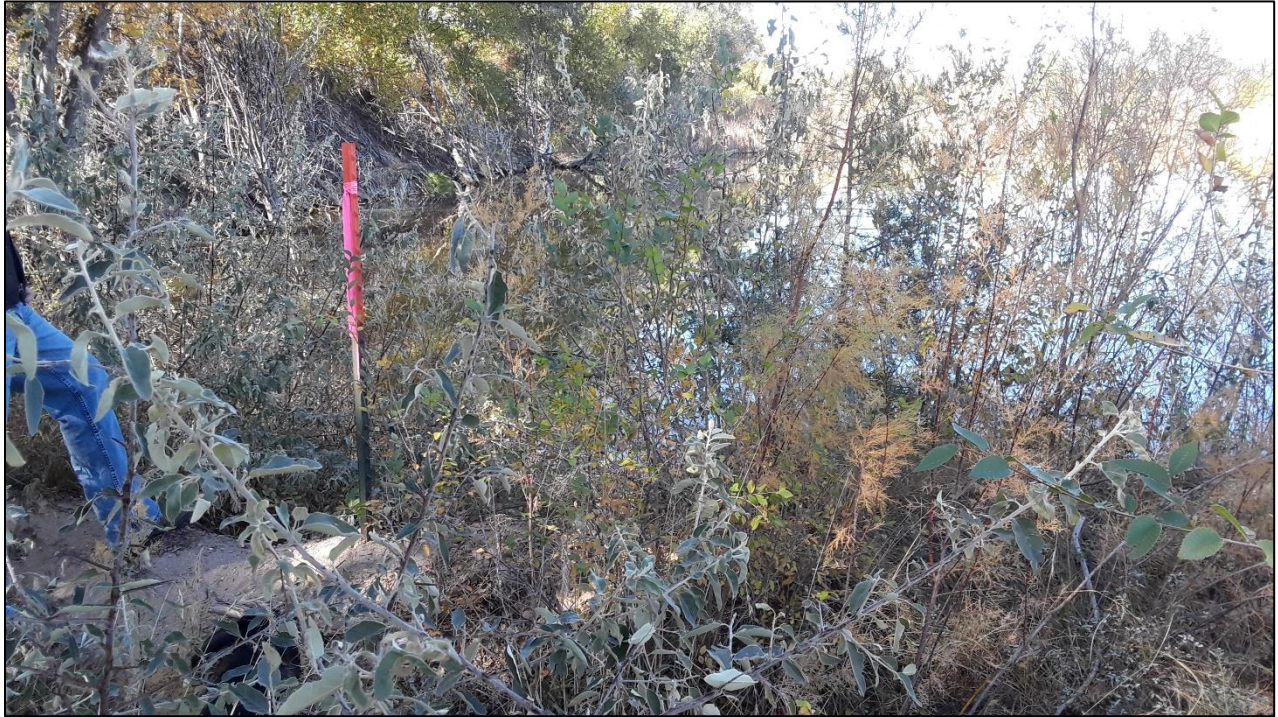
**Photo 17.** View of metal stake (painted orange) marking a corner of the proposed southern permit boundary, located at the southeastern shoreline of the smaller existing pond. This boundary marker will become especially important in preventing offsite damage as the operation connects the two ponds.

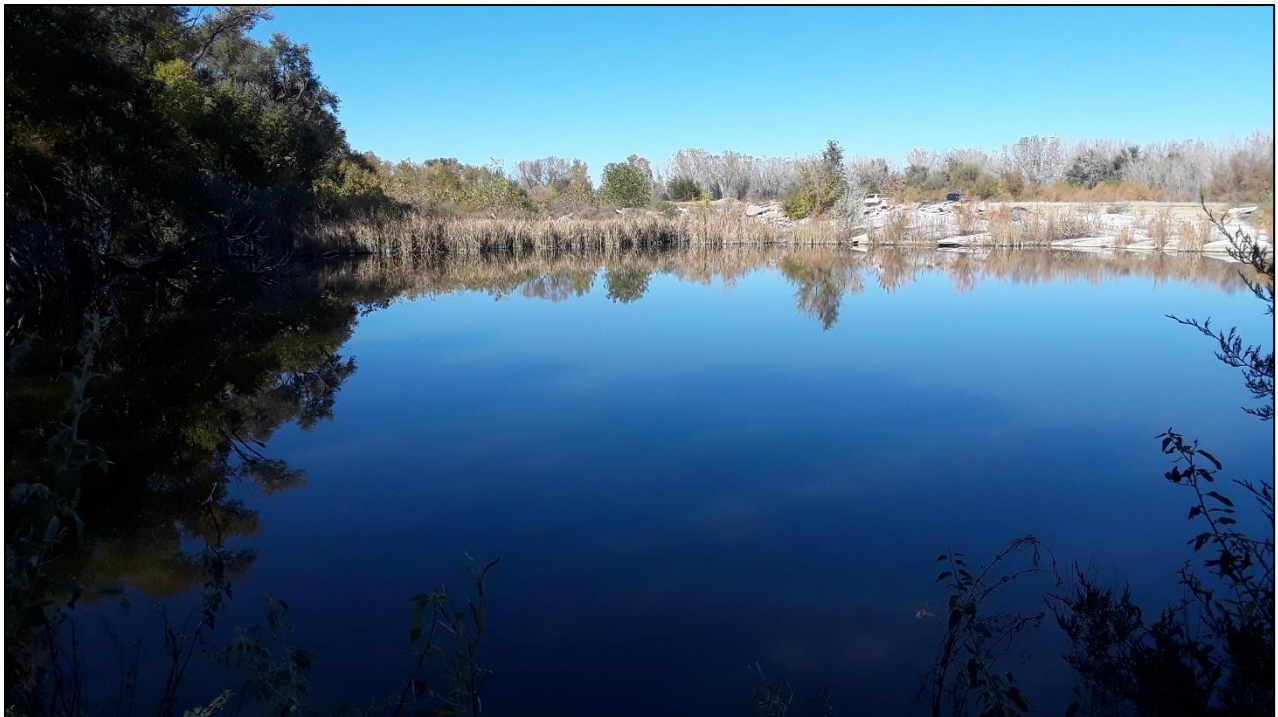
**Photo 18.** View looking northwest across smaller existing pond. The operation intends to connect this pond to the larger pond during the first mining phase. It's northwestern shoreline (shown in background) will be graded 5H:1V for a proposed swimming area.

The proposed affected land includes portions of two ponds that were created by previous mine operations. The applicant estimates there to be 12.65 acres of existing exposed groundwater within the proposed affected land boundary, including 1.05 acres of the smaller pond, and 11.6 acres of the larger pond. The proposed southern permit boundary cuts across the two ponds, separating pre-1981 exposed groundwater to the south (which does not require permanent augmentation), from post-1981 exposed groundwater to the north (which does require permanent augmentation). The applicant has indicated a water court approved augmentation plan is not currently in place for the existing 12.65 acres of groundwater exposed on site. The Division has informed the applicant that, prior to the application decision date, the applicant must submit either a revised Exhibit L including costs for backfilling the pits to a depth of two feet above static water level, or provide documentation from the SEO confirming the applicant has committed the appropriate amount of water shares toward an augmentation plan for the site. A well permit and Substitute Water Supply Plan (SWSP) will be obtained for the operation. The SWSP will cover any evaporative losses while the operation works to obtain an augmentation plan. Given that the proposed mining plan includes expanding the pond, the Division recommends the applicant commit enough water shares to cover the additional exposure anticipated.

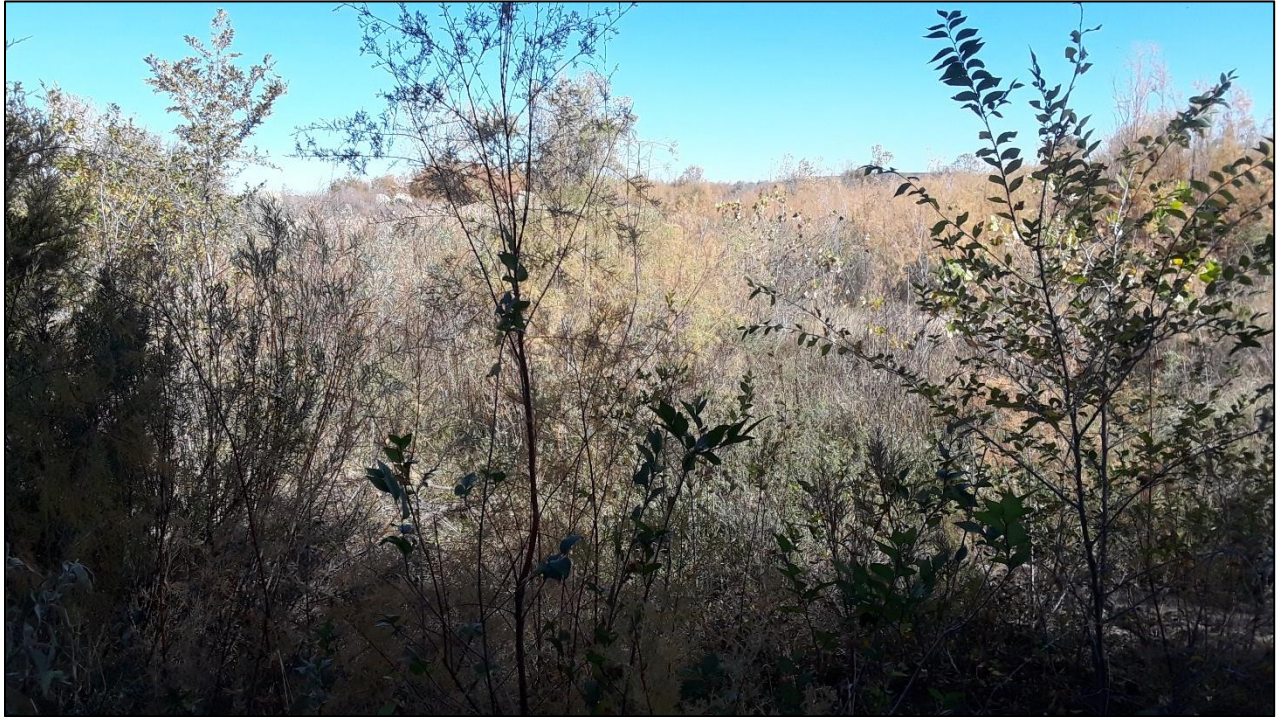
The Division observed several weeds present at the site, including the state-listed noxious weed species, Tamarisk (Salt cedar). These weeds were particularly dense in the area between the two ponds. The Division understands the land between the two ponds would be extracted during the first mining phase. However, pursuant to Rule 3.1.10(6), methods of weed control shall be employed for all prohibited noxious weed species. The applicant has submitted a weed control plan with the application. The Division recommends the weed control plan be implemented at the site after permit issuance, especially for the Tamarisk trees.

**Photo 19.** View looking north across land between two ponds which will be mined during the first mining phase. Note dense vegetation in this area, including several Tamarisk trees. The operator will need to implement the approved weed control plan after permit issuance, especially for state-listed noxious weed species (i.e., Tamarisk).
