**MINERALS PROGRAM INSPECTION REPORT**  
**PHONE: (303) 866-3567**

<b>MINE NAME:</b> 22 West Pit	<b>MINE/PROSPECTING ID#:</b> M-2017-032	<b>MINERAL:</b> Borrow material for construction, sand and gravel	<b>COUNTY:</b> Otero
<b>INSPECTION TYPE:</b> Preoperation Inspection	<b>INSPECTOR(S):</b> Amy Eschberger	<b>INSP. DATE:</b> October 25, 2017	<b>INSP. TIME:</b> 11:00
<b>OPERATOR:</b> Deep Cut LLC	<b>OPERATOR REPRESENTATIVE:</b> Chris Tomky	<b>TYPE OF OPERATION:</b> 112c - Construction Regular Operation

# M-2017-032 / 22 West Pit / Deep Cut, LLC

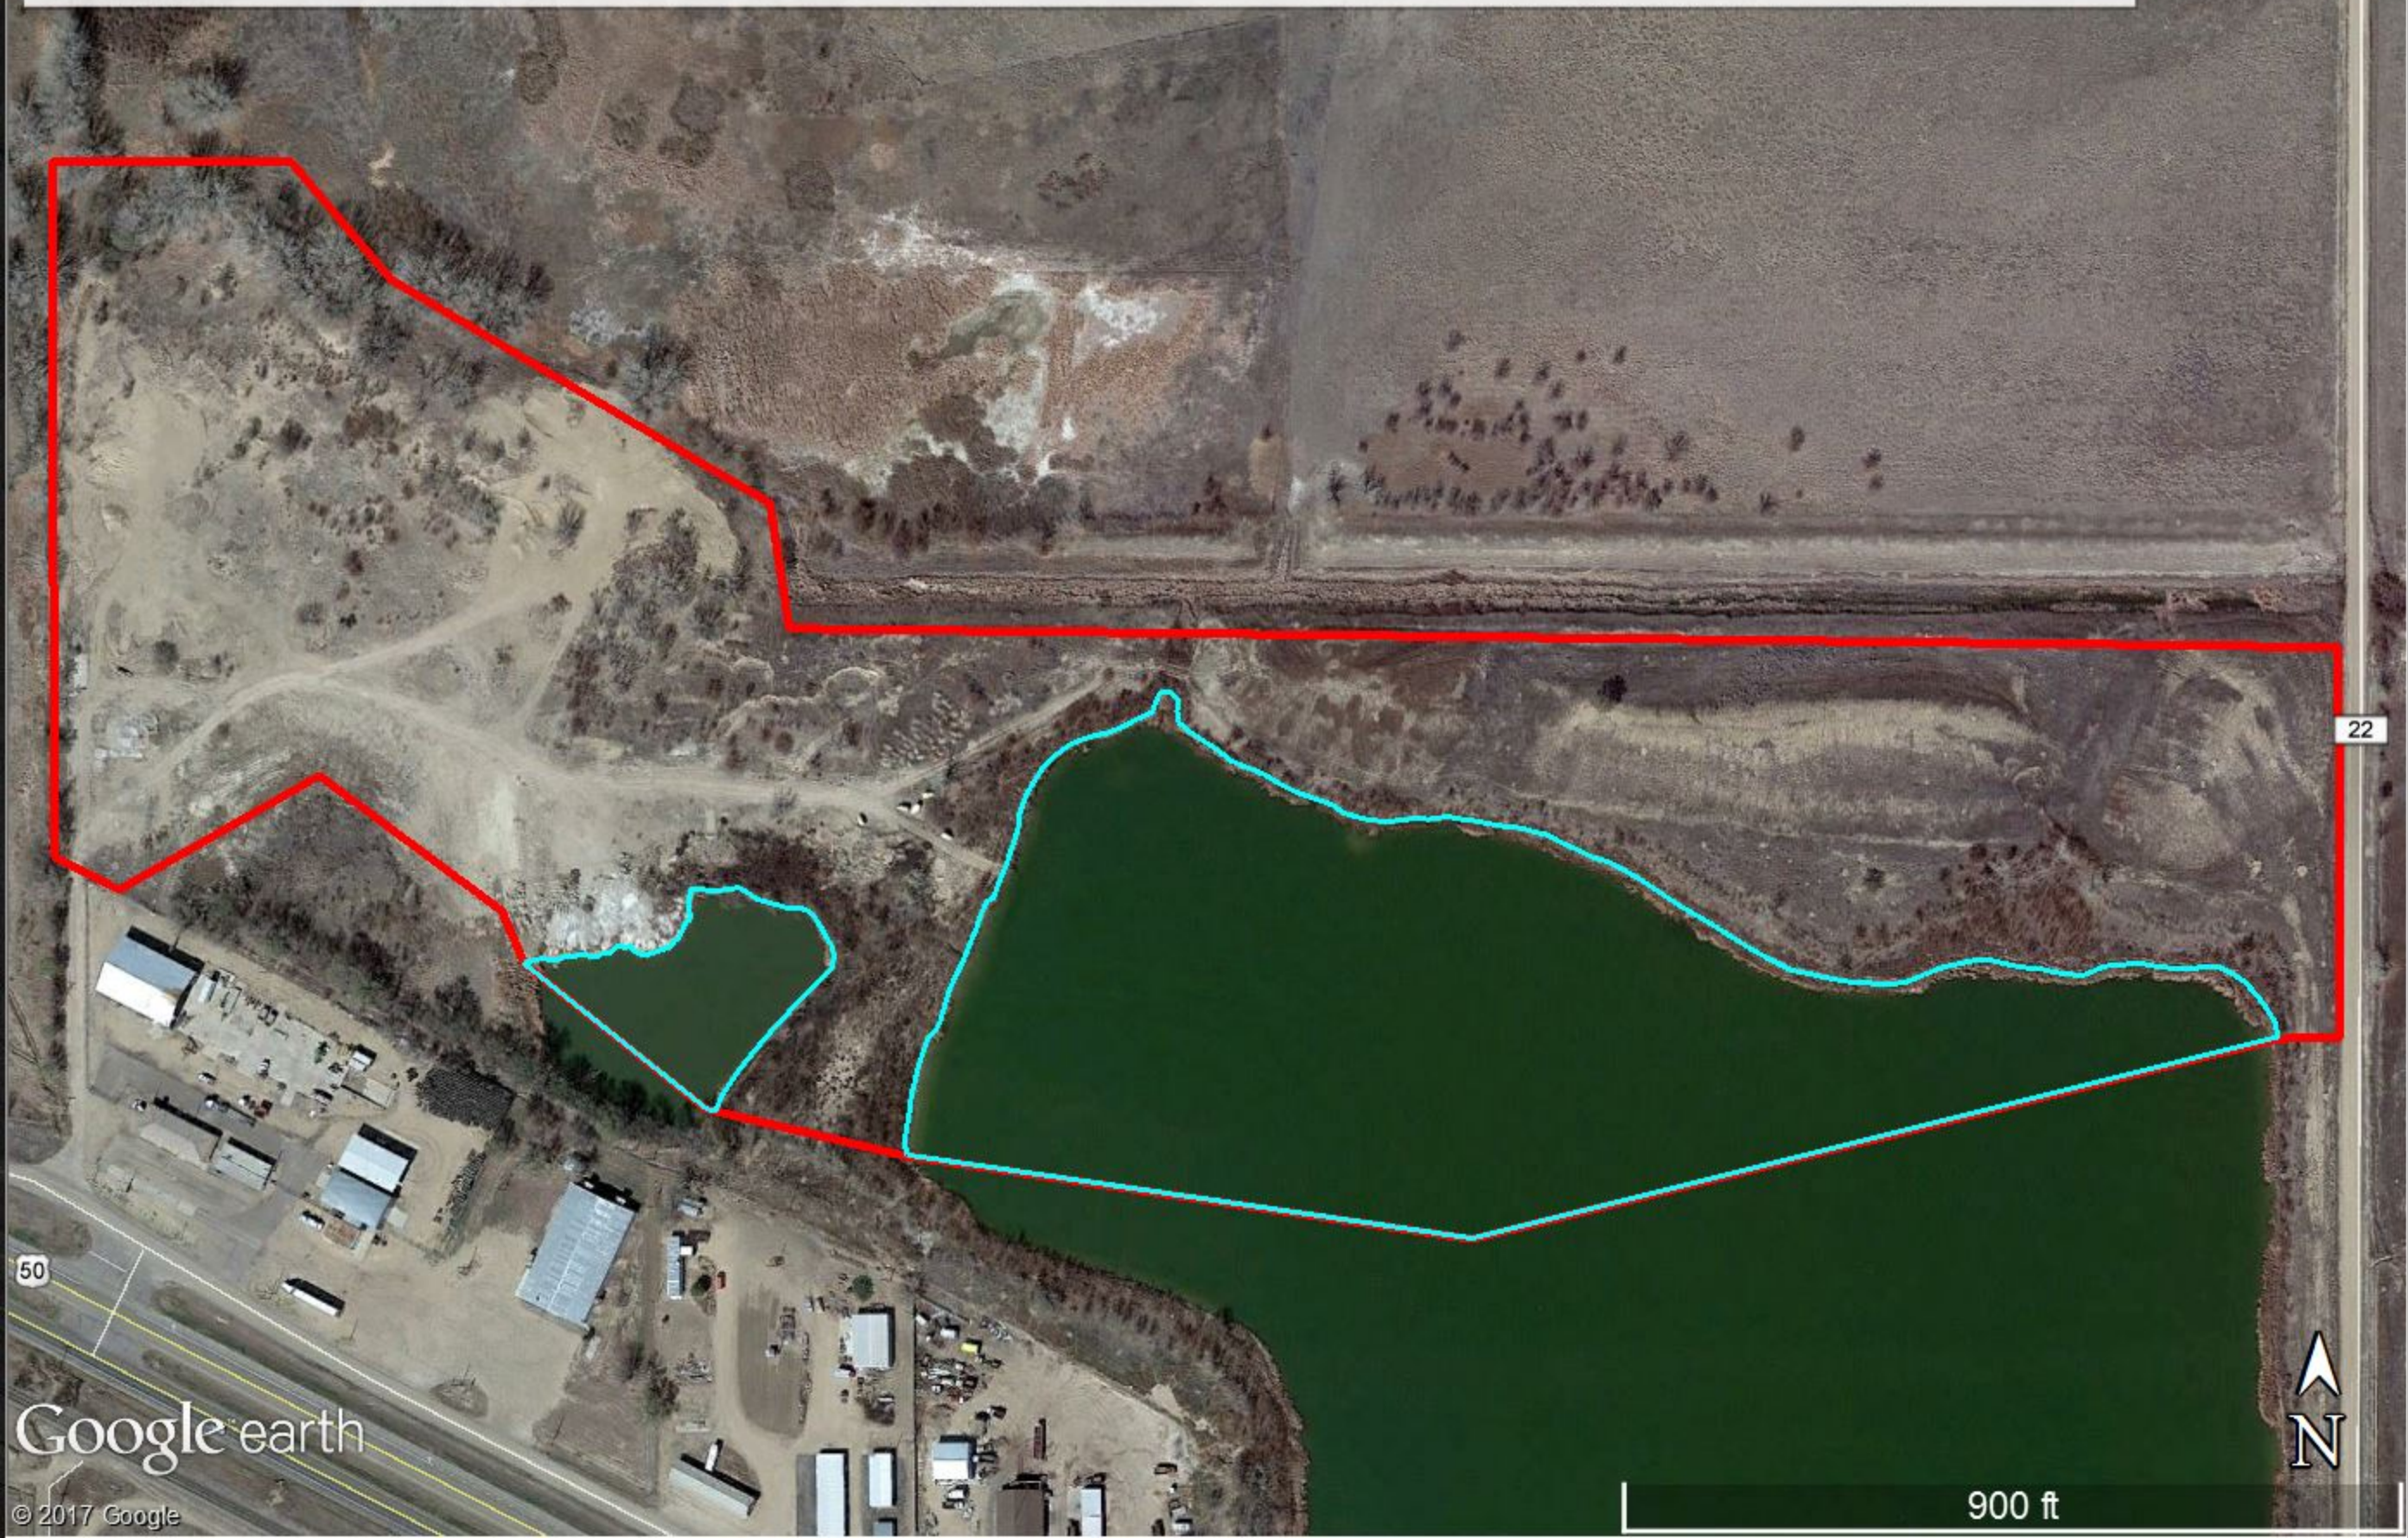
Red Outline = 38.35 acres = Proposed Permit Area

Light Blue Outline = 12.65 acres = Total Pond Surface Area Within Proposed Permit Area (1.05 acre small pond + 12.6 acre large pond)

This is a proposed 112c operation to mine borrow material, sand, and gravel for fill material and specification aggregates. The proposed permit area is 38.35 acres, and includes portions of two existing ponds (see enclosed Google Earth image of site showing proposed permit area). The site has been disturbed by previous mining operations, including some pre-law disturbed areas that were apparently not redisturbed by the M-1977-560 operation. Pre-law disturbance exists in the northeastern portion of the proposed permit area, including old overburden and topsoil stockpiles, and in the northwestern portion of the proposed permit area, now mostly covered by mature trees. The proposed mining plan consists of three primary phases, starting with connection of the two ponds, then expansion of the pond westward, and finally, expansion of the pond eastward (if the northeastern pre-law disturbed area is mined). In its preliminary adequacy review, the Division recommends the applicant clearly differentiate the mining phases in the application, describing the disturbance and reclamation to occur during each phase, and depicting this information on the mining and reclamation plan maps.
