MINERALS PROGRAM INSPECTION REPORT**PHONE: (303) 866-3567**

MINE NAME: Yoder	MINE/PROSPECTING ID#: M-1980-189	MINERAL: Sand and gravel	COUNTY: El Paso
INSPECTION TYPE: Monitoring	INSPECTOR(S): Timothy A. Cazier	INSP. DATE: October 11, 2016	INSP. TIME: 11:30
OPERATOR: Rocky Mountain Materials and Asphalt, Inc.	OPERATOR REPRESENTATIVE: Dave Bieber & Rusty Cochrane	TYPE OF OPERATION: 110c - Construction Limited Impact	
REASON FOR INSPECTION: Normal I&E Program	BOND CALCULATION TYPE: Complete Bond	BOND AMOUNT: \$18,955.00	
DATE OF COMPLAINT: NA	POST INSP. CONTACTS: None	JOINT INSP. AGENCY: None	
WEATHER: Cloudy	INSPECTOR'S SIGNATURE:

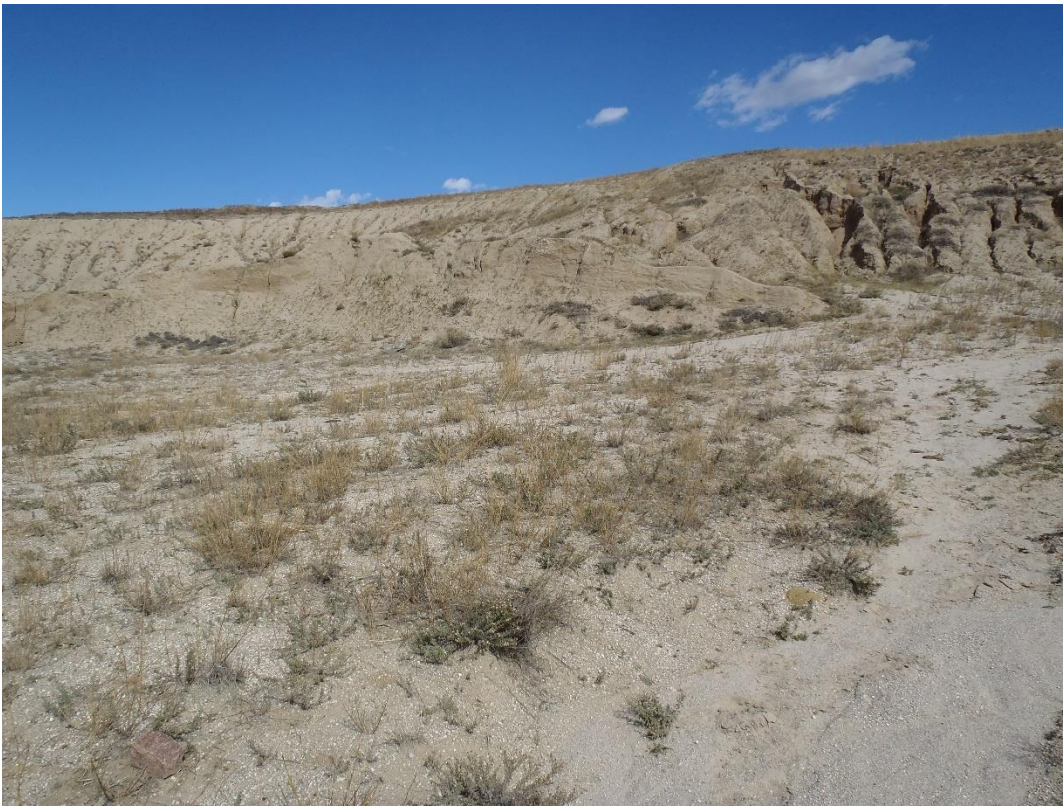
Gen. Compliance with Mine Plan: The operation appeared to be in compliance with the approved mine plan. Google Earth was used to measure the disturbed area, which was estimated to be 7 acres, more or less. Highwalls were estimated to vary between 20 and 30 feet in height and were showing signs of erosion (see **Photo 1**). Site representatives indicated they are looking to transfer the mine reclamation permit to the landowner, or complete reclamation.

Photo 1. Highwalls estimated to vary between 20 and 30 feet in height (looking north).

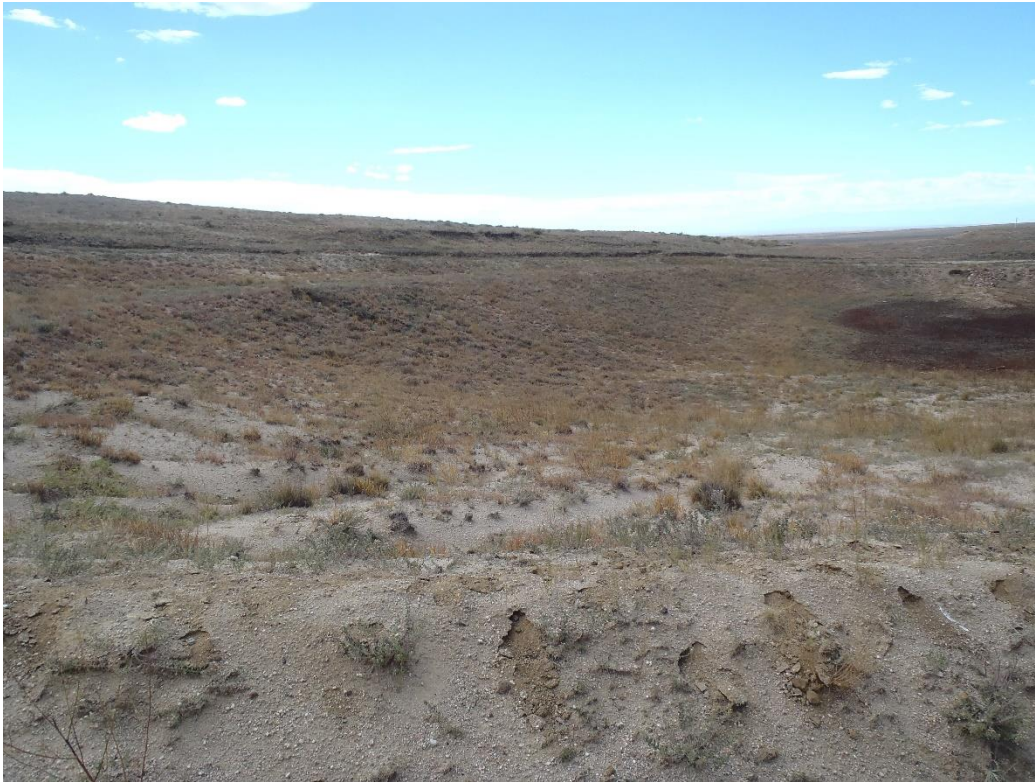
Revegetation: Some revegetation had been initiated on the east side of the pit (see **Photo 2**). No noxious weeds were observed.

Photo 2. Revegetation on the east side of the pit (looking SE).

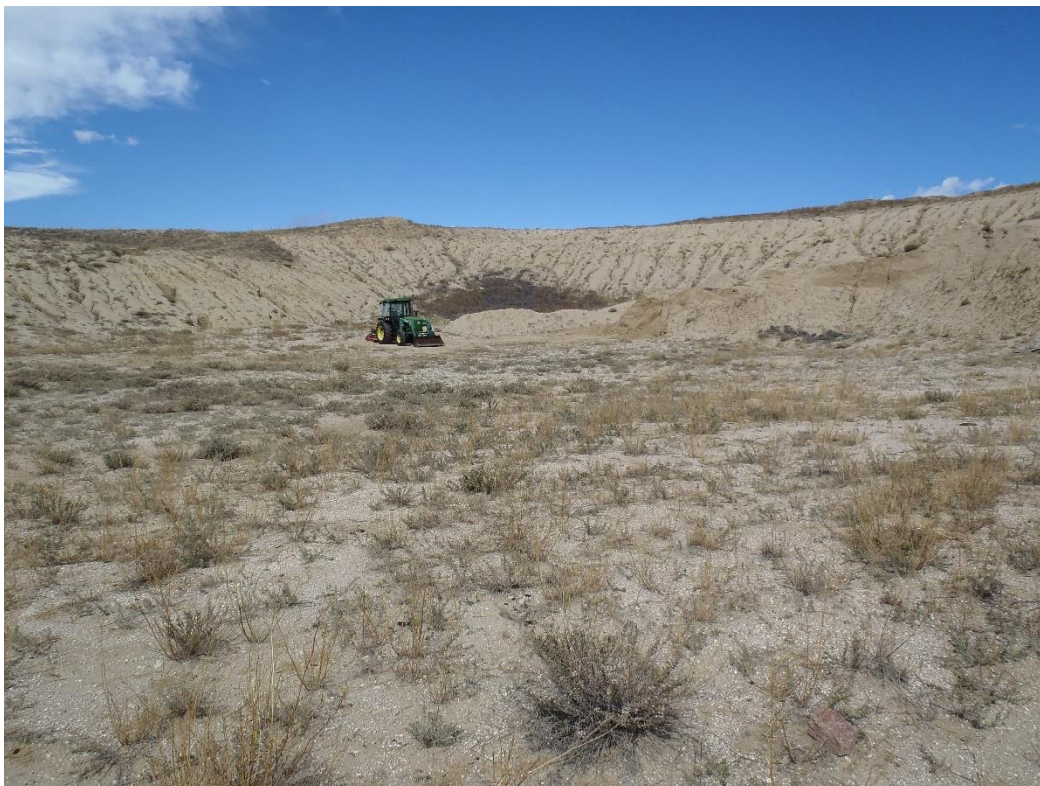
Sediment Control: Erosion rills and gullies were observed on most of the sloped area (see **Photos 3, 4 and 5**). Best management practices (BMPs) for erosion control should be implanted.

Photo 3. Erosion rills and gullies (1 of 3 - NW corner).

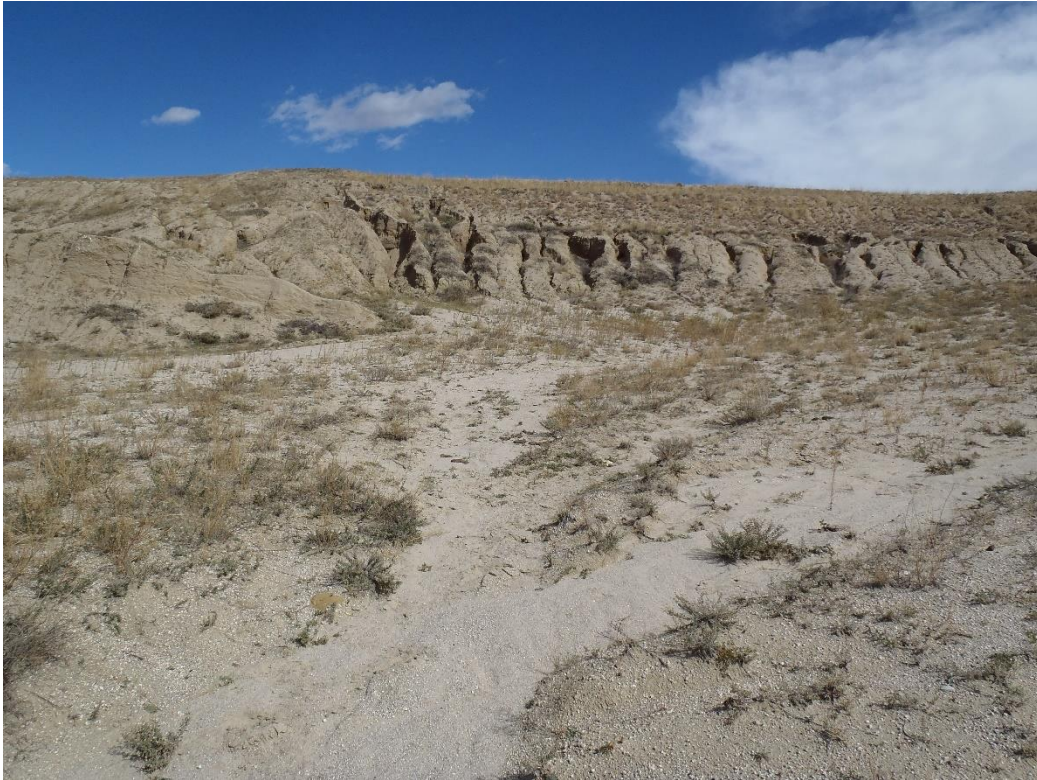
Photo 4. Erosion rills and gullies (2 of 3 – North central, looking north).

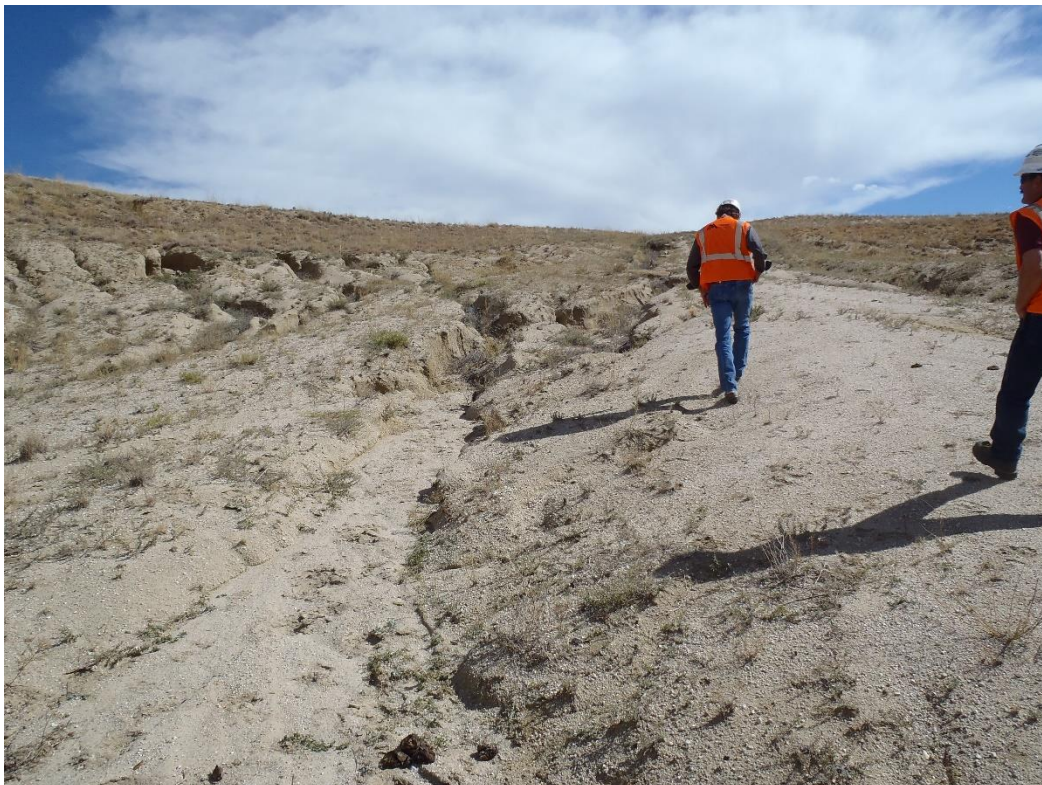
Photo 5. Erosion rills and gullies (3 of 3 - NE corner, adjacent to haul road).

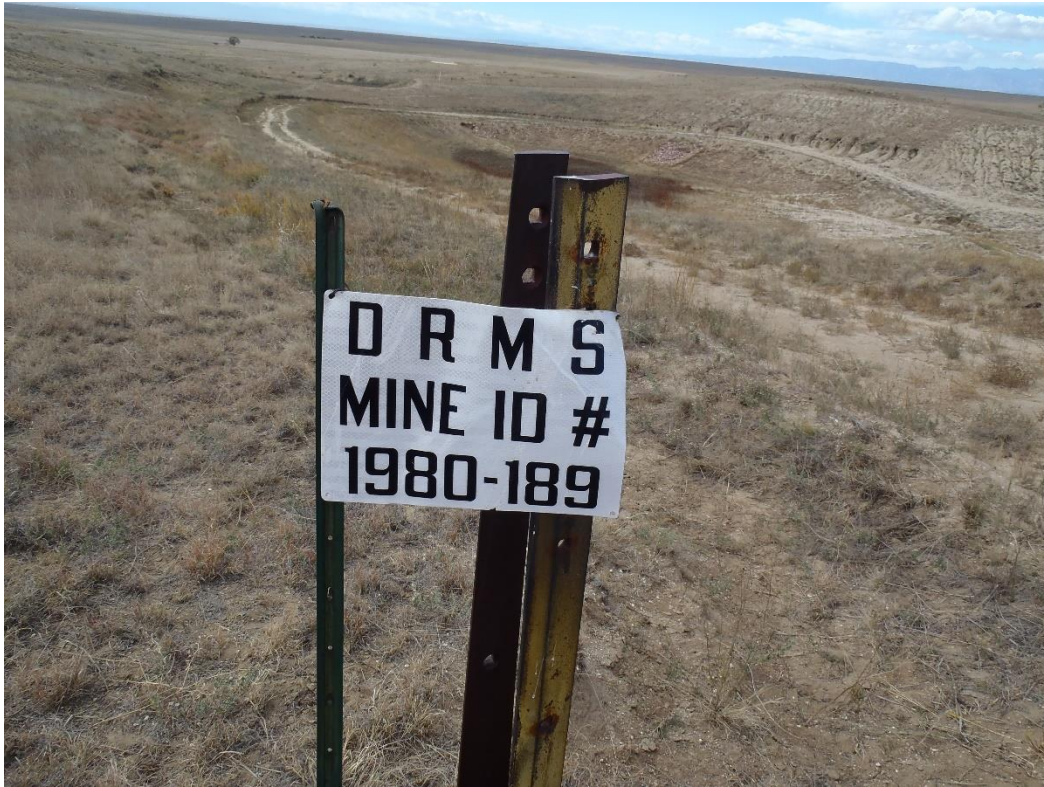
Signs and Markers: The permit sign was properly posted (see **Photo 6**) and wooden post boundary markers

Photo 6. Permit sign (at entrance).

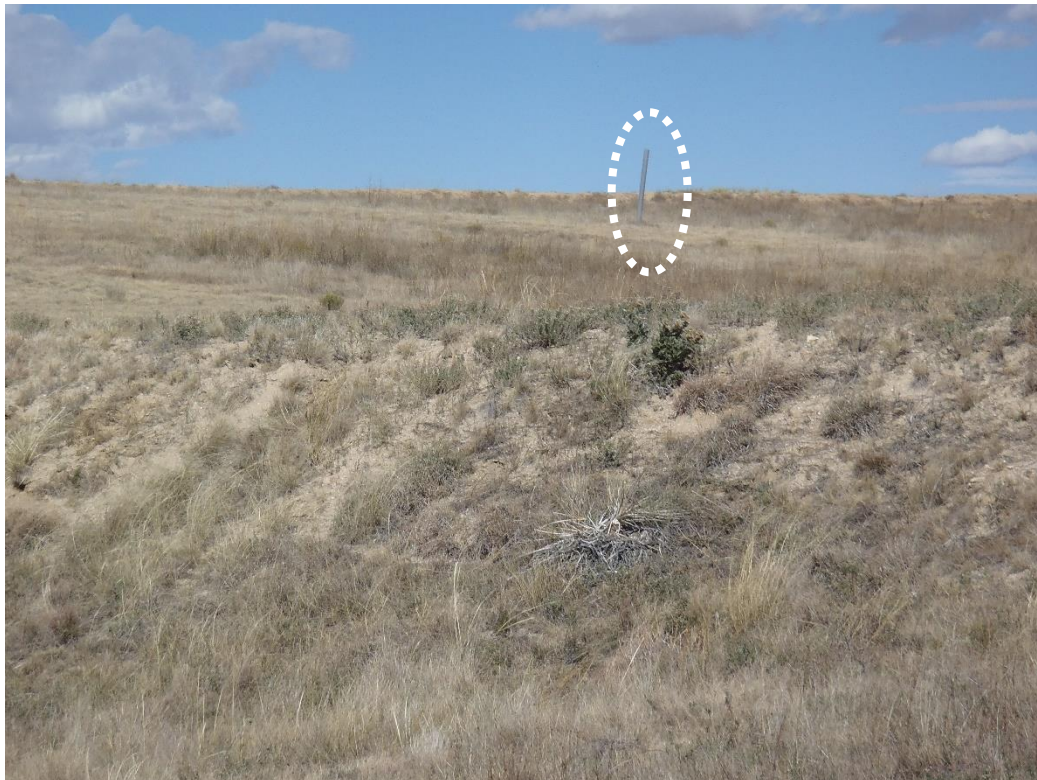
were observed to delineate the permit boundary (see **Photo 7**).

Photo 7. Typical wood post boundary marker (looking south).

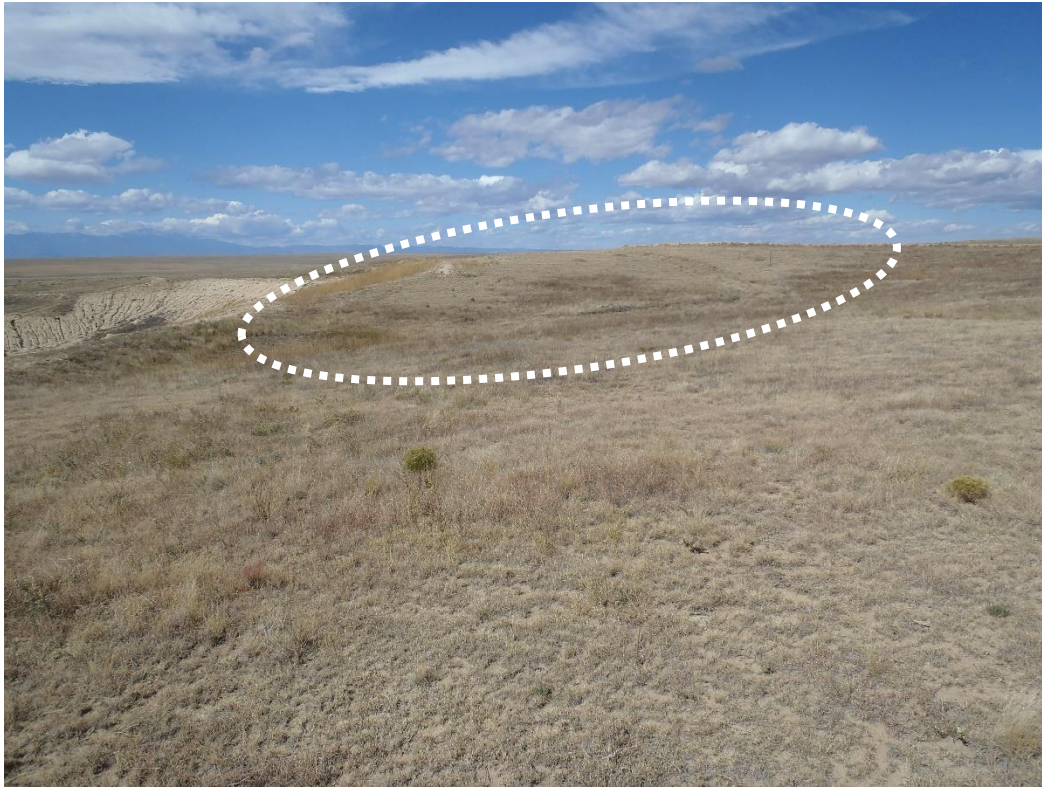
Topsoil: Topsoil was observed stockpiled on the north side at the crest of the highwall (see **Photo 8**).

Photo 8. Topsoil stockpile on north end (looking SW).
