COLORADO
Division of Reclamation,
Mining and Safety
Department of Natural Resources

Permit Number: C-1981-008 Mine Name: New Horizon Mine Operator: Elk Ridge Mining and Reclamation, LLC Operator Address: Mr. Tony Tennyson 5731 State Highway 13 Meeker, CO 81641	County: Montrose Operation Type: Surface Permit Status: Active Ownership: Private
	Operator Representative Present: Frank Ferris
Operator Representative Signature: (Field Issuance Only)

Inspection Start Date: November 7, 2017 Inspection Start Time: 09:00 Inspection End Date: November 7, 2017 Inspection End Time: 15:00		Inspection Type: Coal Partial Inspection Inspection Reason: Normal I&E Program Weather: Clear	
Joint Inspection Agency: None		Joint Inspection Contacts: 	
Post Inspection Agency: None		Post Inspection Contacts: 	
Inspector(s): Brock F. Bowles	Inspector's Signature:

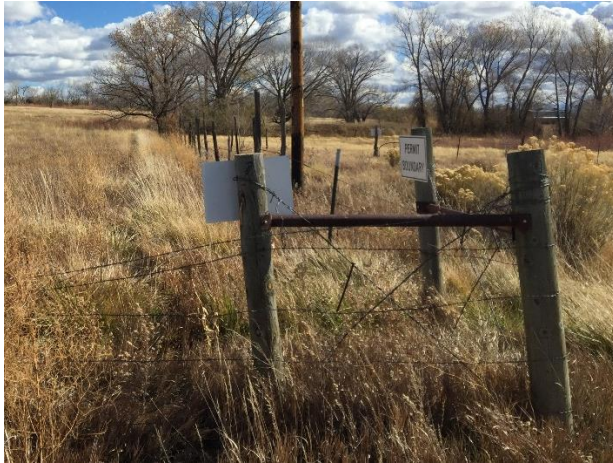
Photo 1 – Corner Permit Boundary Signs

The entire permit boundary was inspected for permit boundary signs and mine entrance signs. Permit boundary signs were in place at each corner with t-posts and/or fencing marking the boundary between each sign (photo 1). The Morgan field had the required corner signs (photo 2) but no signs or posts were in the alfalfa field area. These signs have been omitted so they do not cause damage to machinery. Mine entrance signs (photo 3) were in place at each entrance along Lincoln St, 5th Ave, BB Road and 2700 Road.

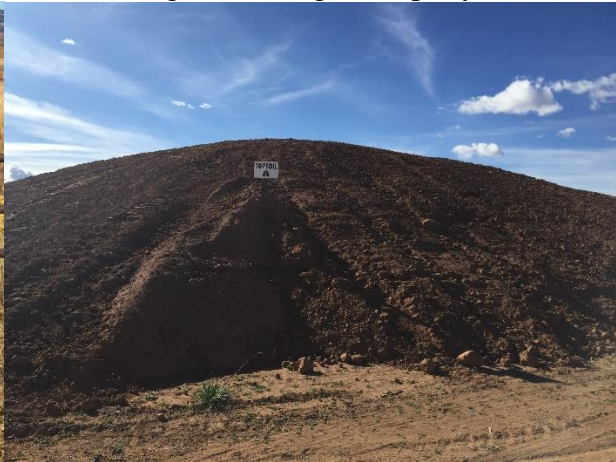
Photo 4 – Topsoil Sign

Topsoil signs were in place at the four piles by the facility area, pond 7 pile, both Morgan piles (photo 4) and stockpile 4. Multiple signs were in place for the stockpile 12 area.
