## MINERALS PROGRAM INSPECTION REPORT

<b>MINE NAME:</b> Debetz Pit	<b>MINE/PROSPECTING ID#:</b> M-1977-283	<b>MINERAL:</b> Sand and gravel	<b>COUNTY:</b> Adams
<b>INSPECTION TYPE:</b> Monitoring	<b>INSPECTOR(S):</b> Jared L. Ebert	<b>INSP. DATE:</b> December 20, 2017	<b>INSP. TIME:</b> 11:50
<b>OPERATOR:</b> Adams County	<b>OPERATOR REPRESENTATIVE:</b> Kurt Carlson and Jennifer Rutter	<b>TYPE OF OPERATION:</b> 112c - Construction Regular Operation

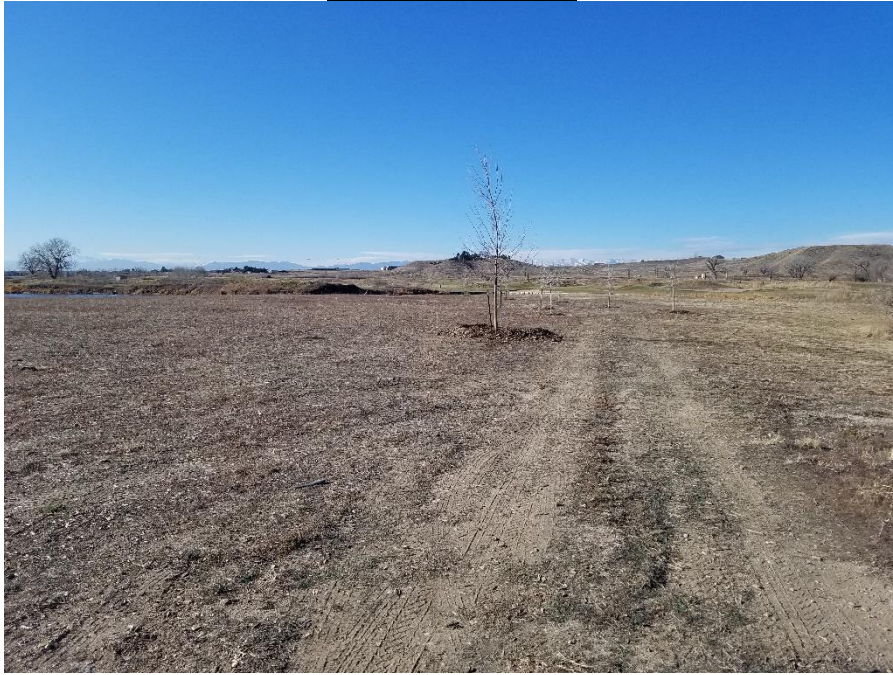
Figure 1. From the north end of the site looking southwest.

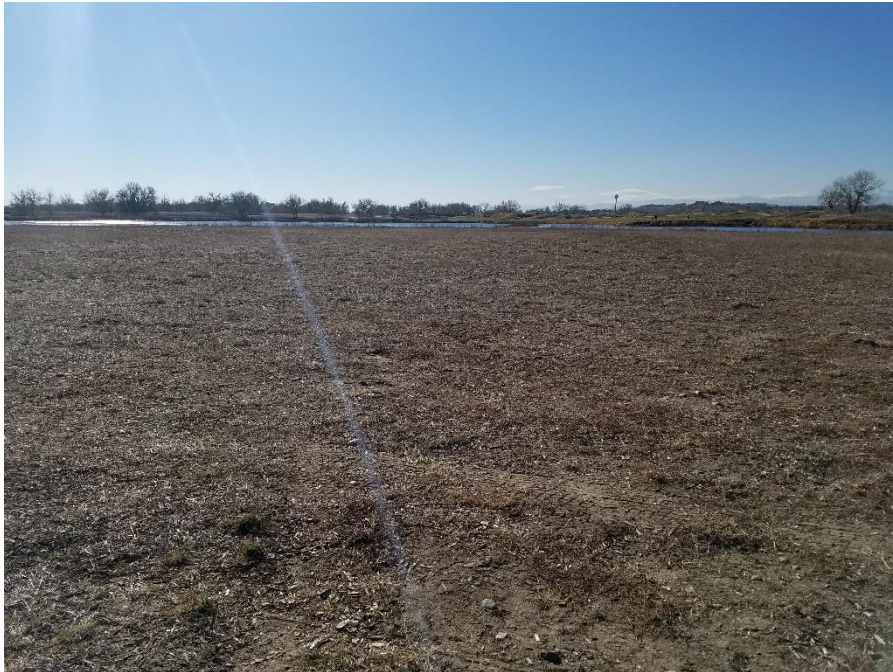
The Operator is approved to backfill a portion of the pit area with inert material. The insert fill operation is complete, however Mr. Carlson indicated that they may bring in more fill in the future if possible. The fill material that was visible appeared to be clean fill dirt.

The inert fill area was graded to a gentle slope and appeared stable. The area was recently seeded and mulched. It was noted during the last Division inspection in 2014 that there were portions of the southern and western pond slopes that have been graded steeper than a 3H:1V ratio and some bank erosion and sluffing was occurring. Adams County submitted and received approval of TR02 in 2014. TR02 provided a description of how localized areas of the pond shoreline will be re-graded and stabilized along the edge of the golf course and southern shoreline and other area will remain "as is". Figure 2 submitted with TR02 depicts where select areas of the shoreline were to have been stabilized. The 150' section along the southern shoreline has been stabilized with rip-rap. It does not appear that the three areas along the western pit slope where stabilization activities were planned have occurred. The 100' section on the north end of the western slope was very steep and appears to continue to erode. Stabilization of the designated areas will need to occur. This issue is cited as a problem at the beginning of this report.

Figure 2. From the north end of the site looking south, inert fill area.

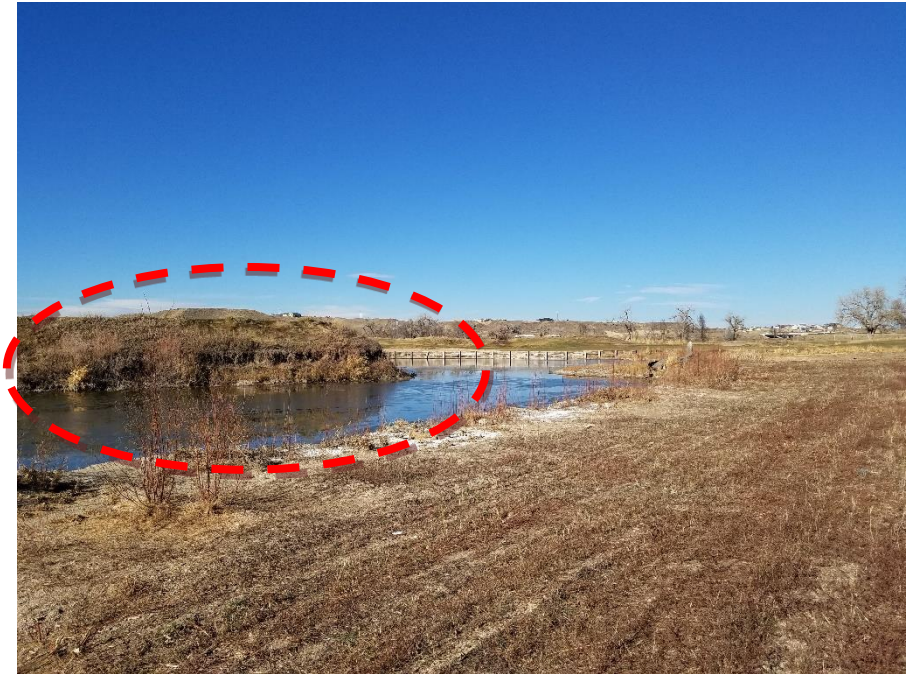
**PROBLEM:** Erosion and shoreline destabilization was observed along the western pond slopes in area approved in TR02 to be repaired and stabilized. This is a problem at this time for failure to protect the affected land from erosion pursuant to C.R.S. 34-32.5-116 (4) (j) and for failure to follow the approved reclamation plan pursuant to C.R.S. 34-32.5-116(1).

Figure 3. Shoreline sluffing and erosion on western slope, approximate 100' section shown on TR02 Figure 2 Map.

**CORRECTIVE ACTIONS:** The Operator shall provide photo documentation to the Division verifying shoreline erosion has been repaired, and that the sites approved with TR02 to be stabilized have been reconstructed and stabilized to prevent erosion damage by the corrective action date.

**CORRECTIVE ACTION DUE DATE:** 5/30/18

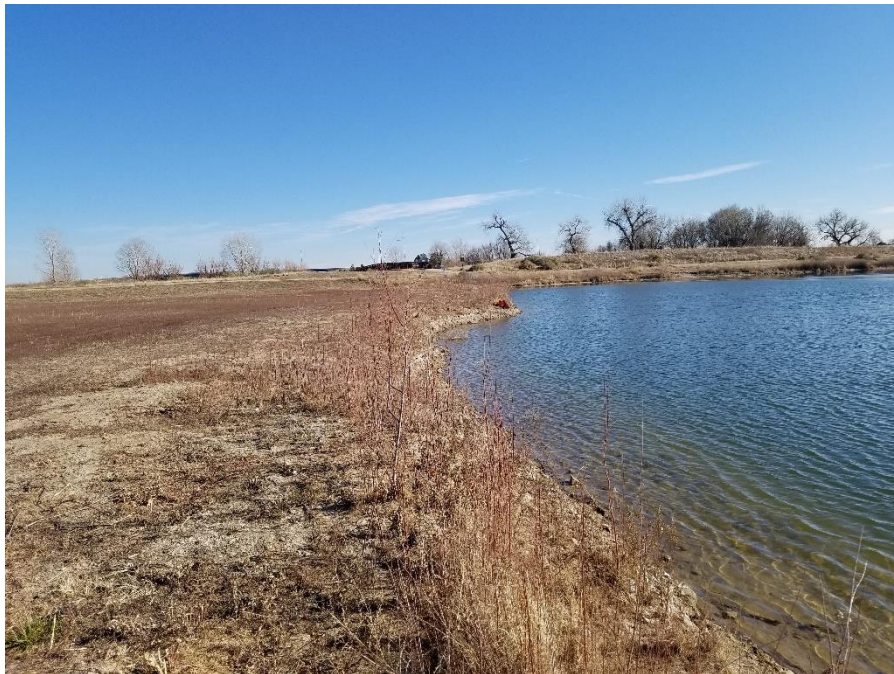
Tamarisk trees have begun to establish along the northern shoreline where the inert filling operation occurred. Mr. Carlson indicated the County plans to conduct weed control measures for the tamarisks.

Figure 4. Northern pond slope looking east.

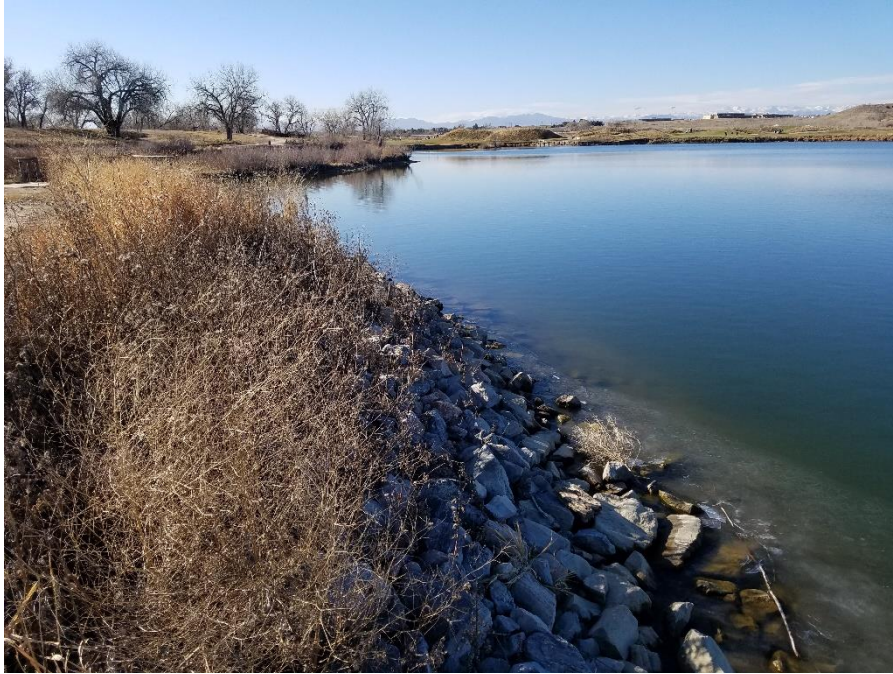
Figure 5. Shoreline stabilization along the southern shore. Looking west.
