**MINERALS PROGRAM INSPECTION REPORT**  
**PHONE: (303) 866-3567**

<b>MINE NAME:</b> San Luis Project	<b>MINE/PROSPECTING ID#:</b> M-1988-112	<b>MINERAL:</b> Gold and silver	<b>COUNTY:</b> Costilla
<b>INSPECTION TYPE:</b> Monitoring	<b>INSPECTOR(S):</b> Lucas J. West	<b>INSP. DATE:</b> December 11, 2017	<b>INSP. TIME:</b> 14:00
<b>OPERATOR:</b> Battle Mountain Resources, Inc.	<b>OPERATOR REPRESENTATIVE:</b> Julio Madrid, Steve Carino , Melissa Chalona	<b>TYPE OF OPERATION:</b> 112d-3 - Designated Mining Operation	
<b>REASON FOR INSPECTION:</b> Normal I&E Program	<b>BOND CALCULATION TYPE:</b> None	<b>BOND AMOUNT:</b> \$7,400,000.00	
<b>DATE OF COMPLAINT:</b> NA	<b>POST INSP. CONTACTS:</b> None	<b>JOINT INSP. AGENCY:</b> None	
<b>WEATHER:</b> Clear	<b>INSPECTOR'S SIGNATURE:</b>

## **OBSERVATIONS**

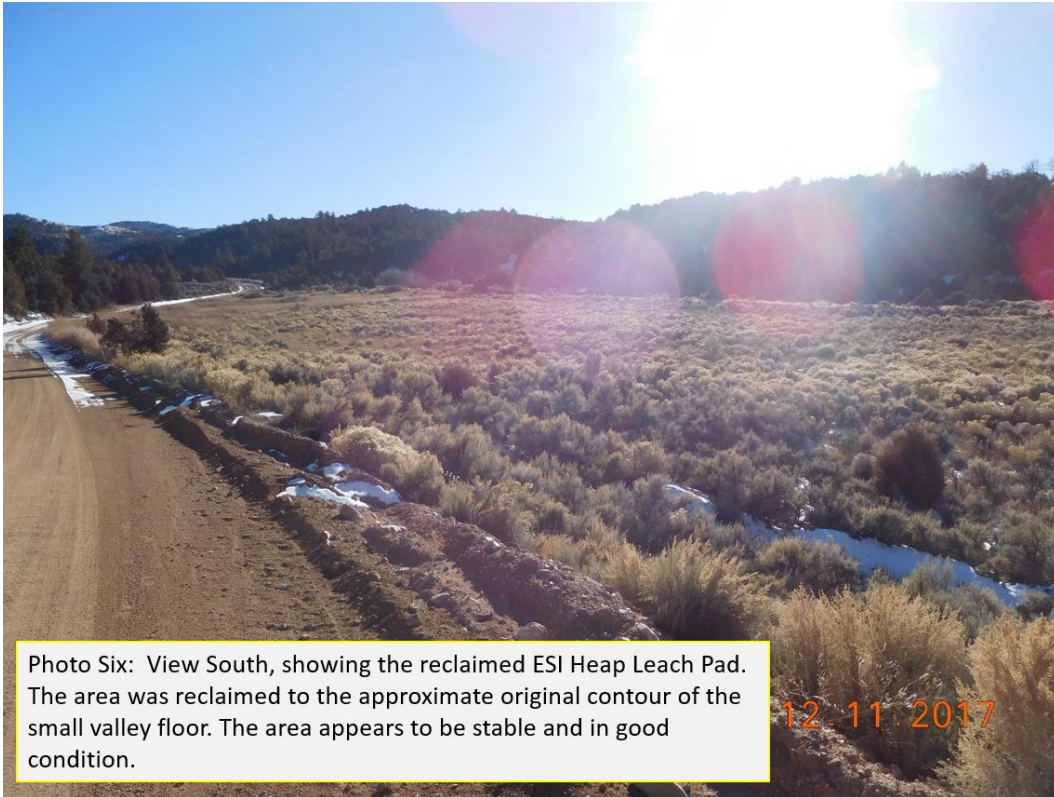
Photo Six: View South, showing the reclaimed ESI Heap Leach Pad. The area was reclaimed to the approximate original contour of the small valley floor. The area appears to be stable and in good condition.
