MINERALS PROGRAM INSPECTION REPORT

MINE NAME: Jolly Pit #3	MINE/PROSPECTING ID#: M-2016-075	MINERAL: Sand and Gravel	COUNTY: Cheyenne
INSPECTION TYPE: Monitoring	INSPECTOR(S): Timothy A. Cazier	INSP. DATE: September 13, 2017	INSP. TIME: 11:00
OPERATOR: Cheyenne County	OPERATOR REPRESENTATIVE: Vic Gibbs	TYPE OF OPERATION: 110c - Construction Limited Impact	
REASON FOR INSPECTION: Normal I&E Program	BOND CALCULATION TYPE: None	BOND AMOUNT: \$0.00	
DATE OF COMPLAINT: NA	POST INSP. CONTACTS: None	JOINT INSP. AGENCY: None	
WEATHER: Clear	INSPECTOR'S SIGNATURE:

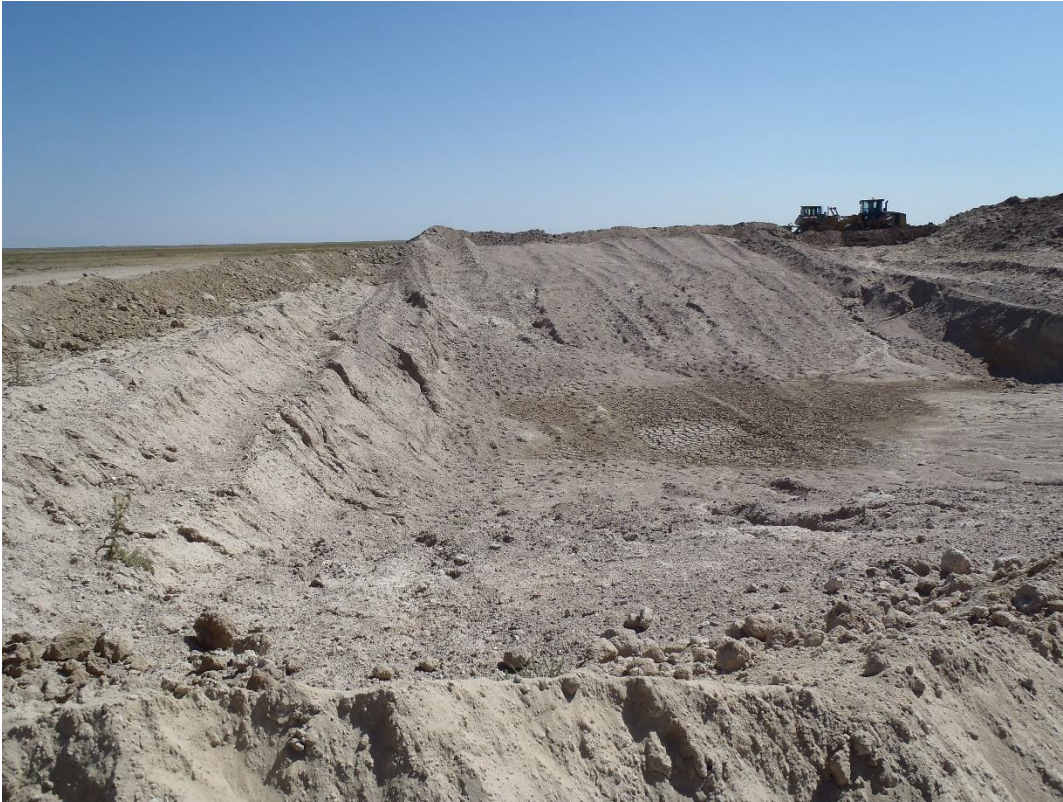
Photo 1. Active pit area, bottom (1 of 2, looking east from NW corner of pit).

Backfilling and Grading: The east and west slopes were flatter than 3H:1V (see **Photo 1**). The north and south slopes were benched and slightly steeper than 3H:1V. No backfill was needed at the time of the inspection.

Gen. Compliance with Mine Plan: The operation appeared to be in compliance with the approved mine plan. High walls were estimated to be 9 to 12 feet in height and appeared stable (see **Photos 1 and 2**).

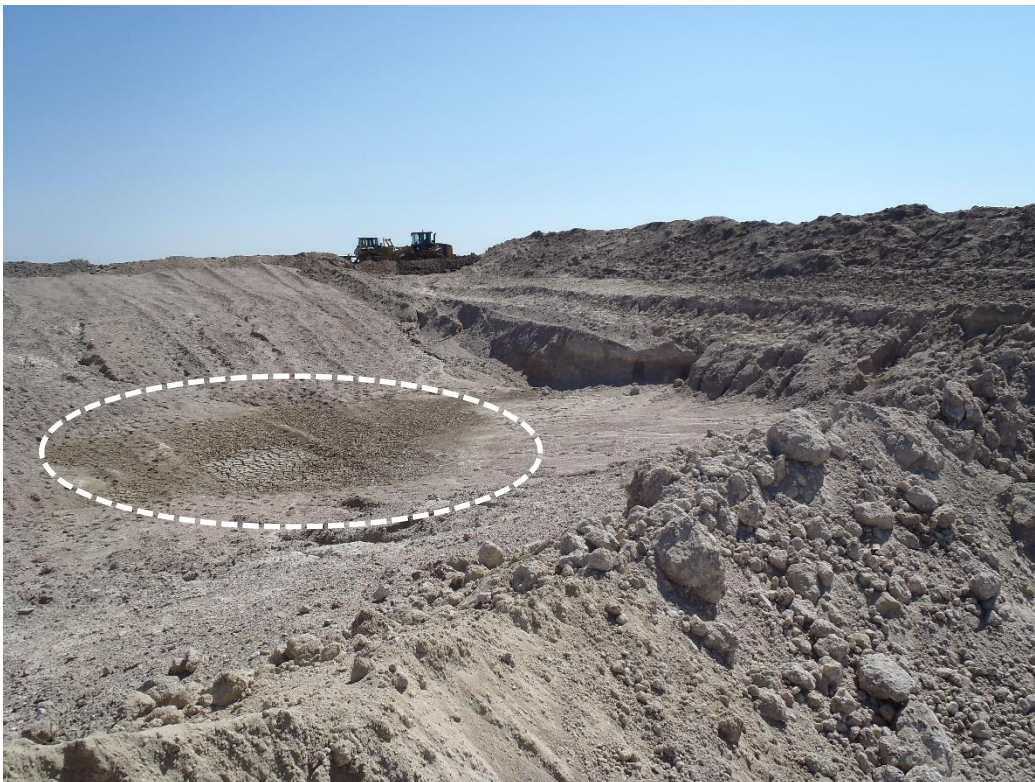
Photo 2. Active pit area, bottom (2 of 2, looking SE from NW corner of pit, note dried mud).

Storm Water MGT Plan: No oil or fuel spills observed. Stormwater drains to the pit and infiltrates as the dried mud in **Photo 2** suggests.

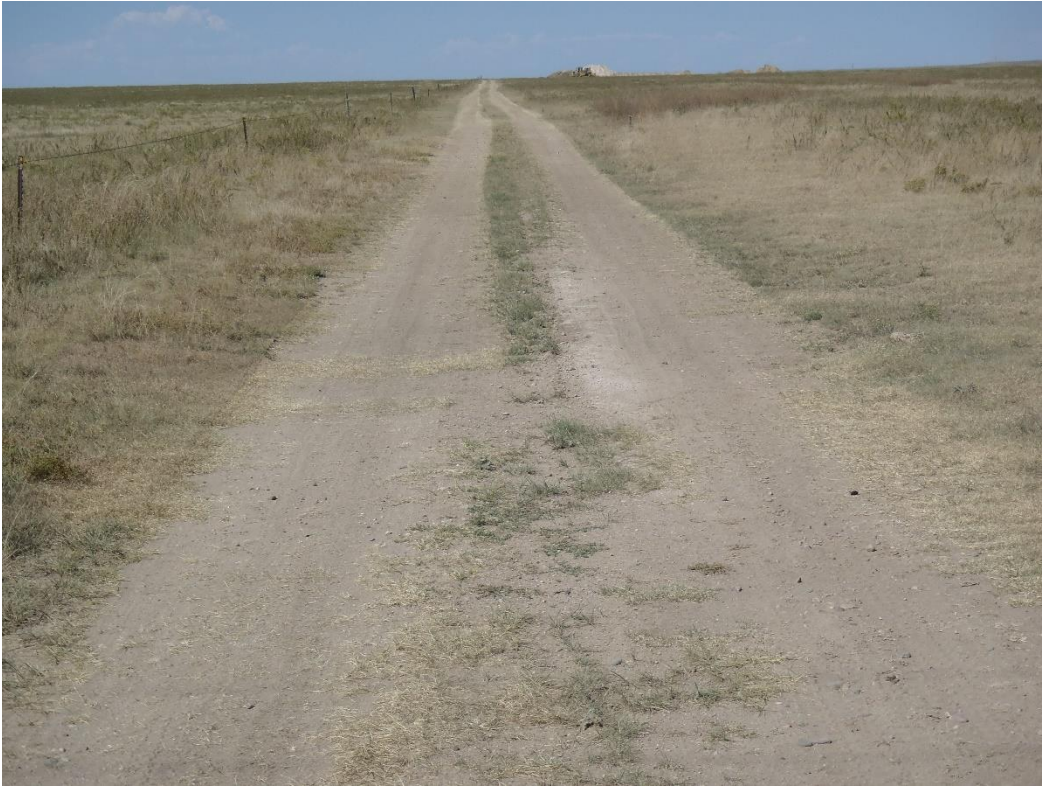
Photo 3. Haul/access road (looking west from County roads 22 & EE).

Roads: The haul/access road (see **Photo 3**) is included in this 110c permit boundary and are marked with survey flags and rebar survey markers (see **Photo 4**).

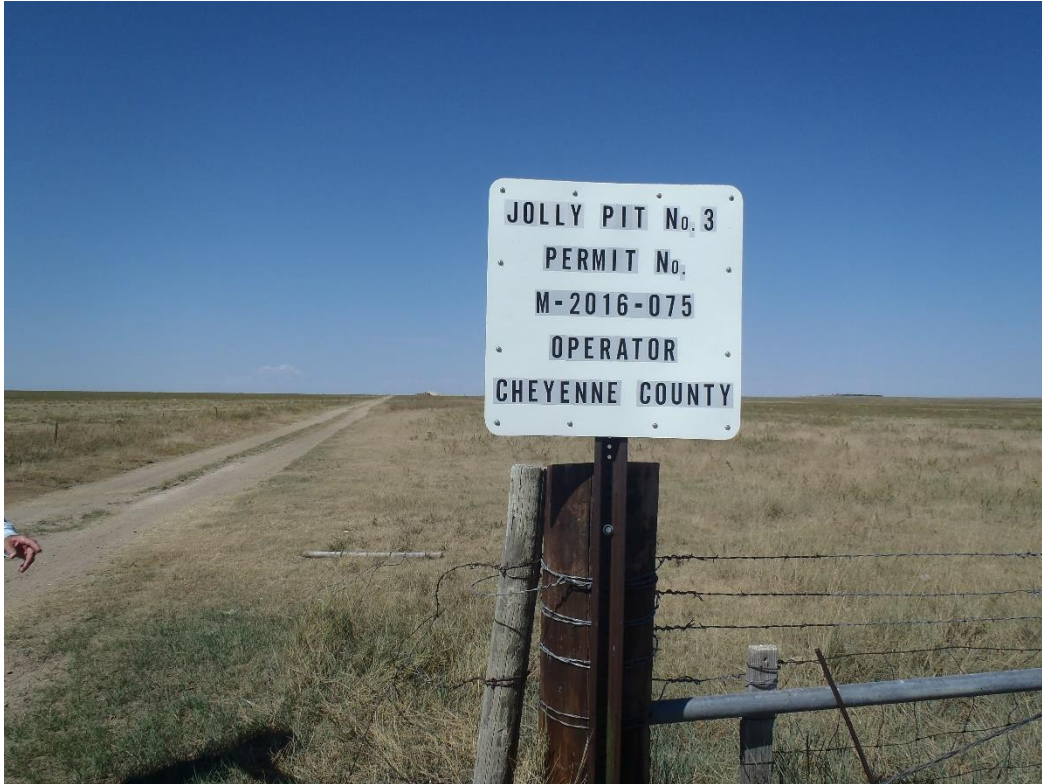
Photo 5. Permit sign (looking west from entrance off County roads).

Signs and Markers: A permit sign was posted (see **Photo 5**). The permit boundary corners were marked with T-posts, each protected by a large tractor tires (see **Photo 6**).

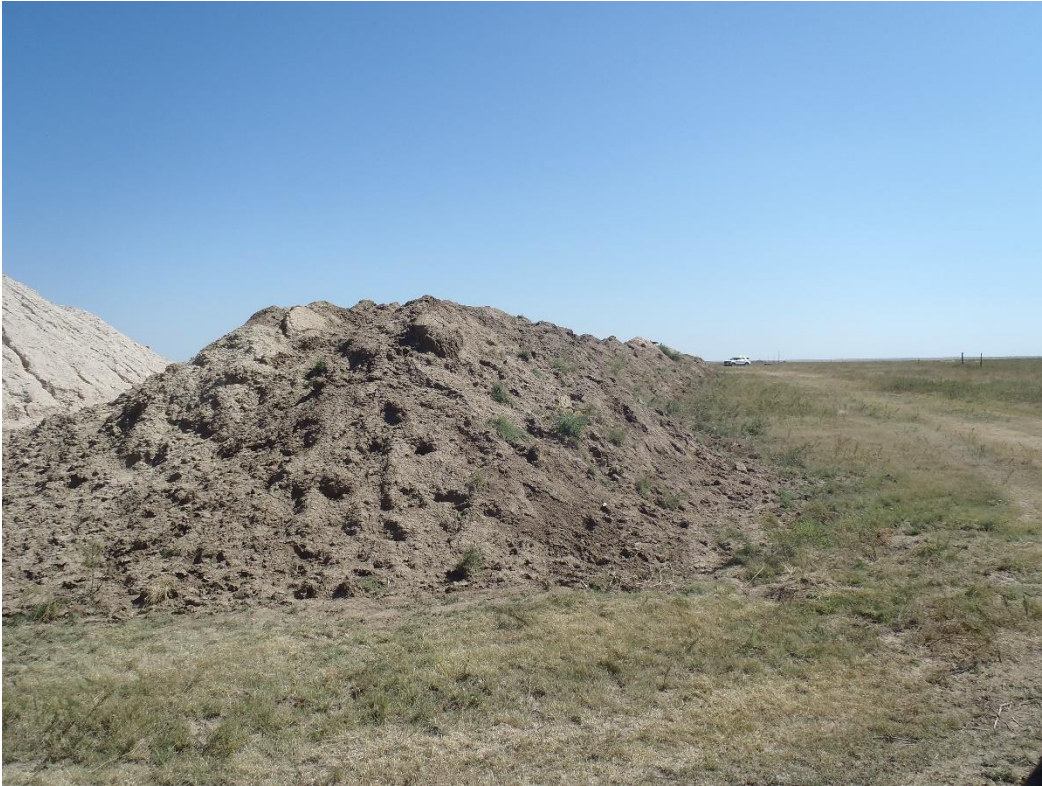
Photo 7. Topsoil stockpile on south side of pit (looking east).

Topsoil: Topsoil stockpiles was observed on the north and south sides of the working area (see **Photo 7**).

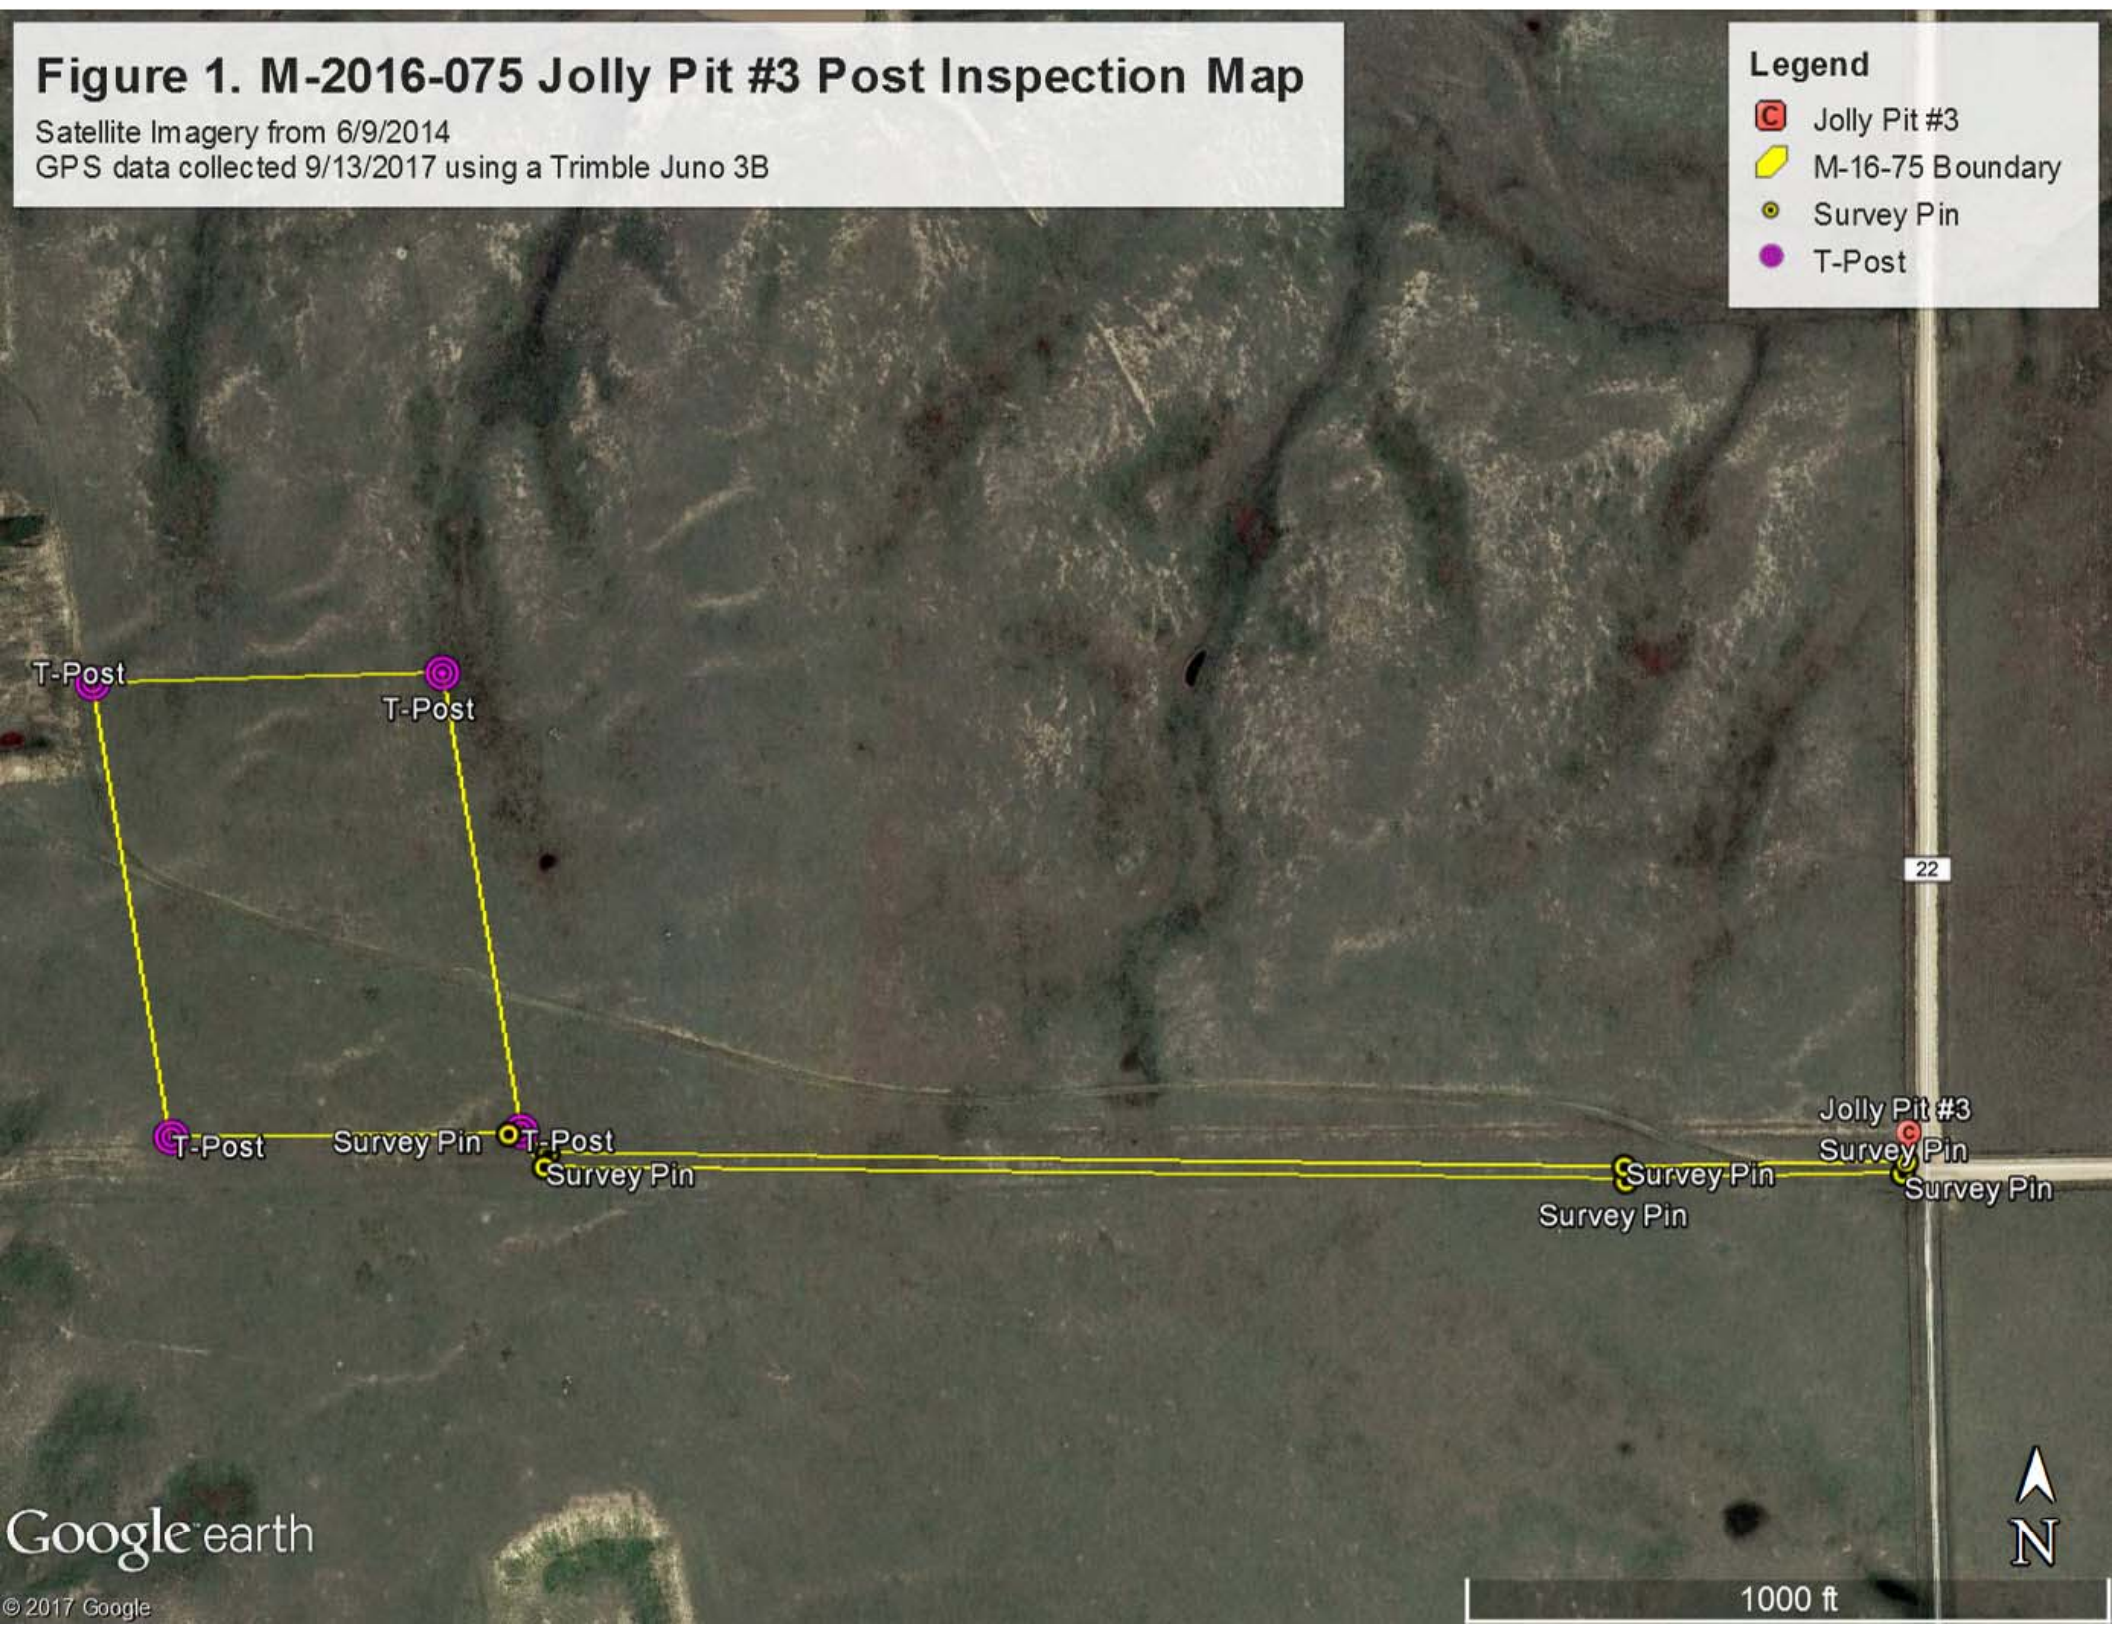
Figure 1. M-2016-075 Jolly Pit #3 Post Inspection Map

Off-site Damage: The operation was confined to the permit boundary. A handheld GPS unit (Trimble Juno 3B) was used to collect location points for the four permit boundary corners and survey pins marking the access road that is included in the permit boundary. The resulting data is presented in **Figure 1**.

Satellite Imagery from 6/9/2014
GPS data collected 9/13/2017 using a Trimble Juno 3B
