United States
Department of
Agriculture

Forest
Service

Aspen-Sopris Ranger District

MINING INSPECTION FORM

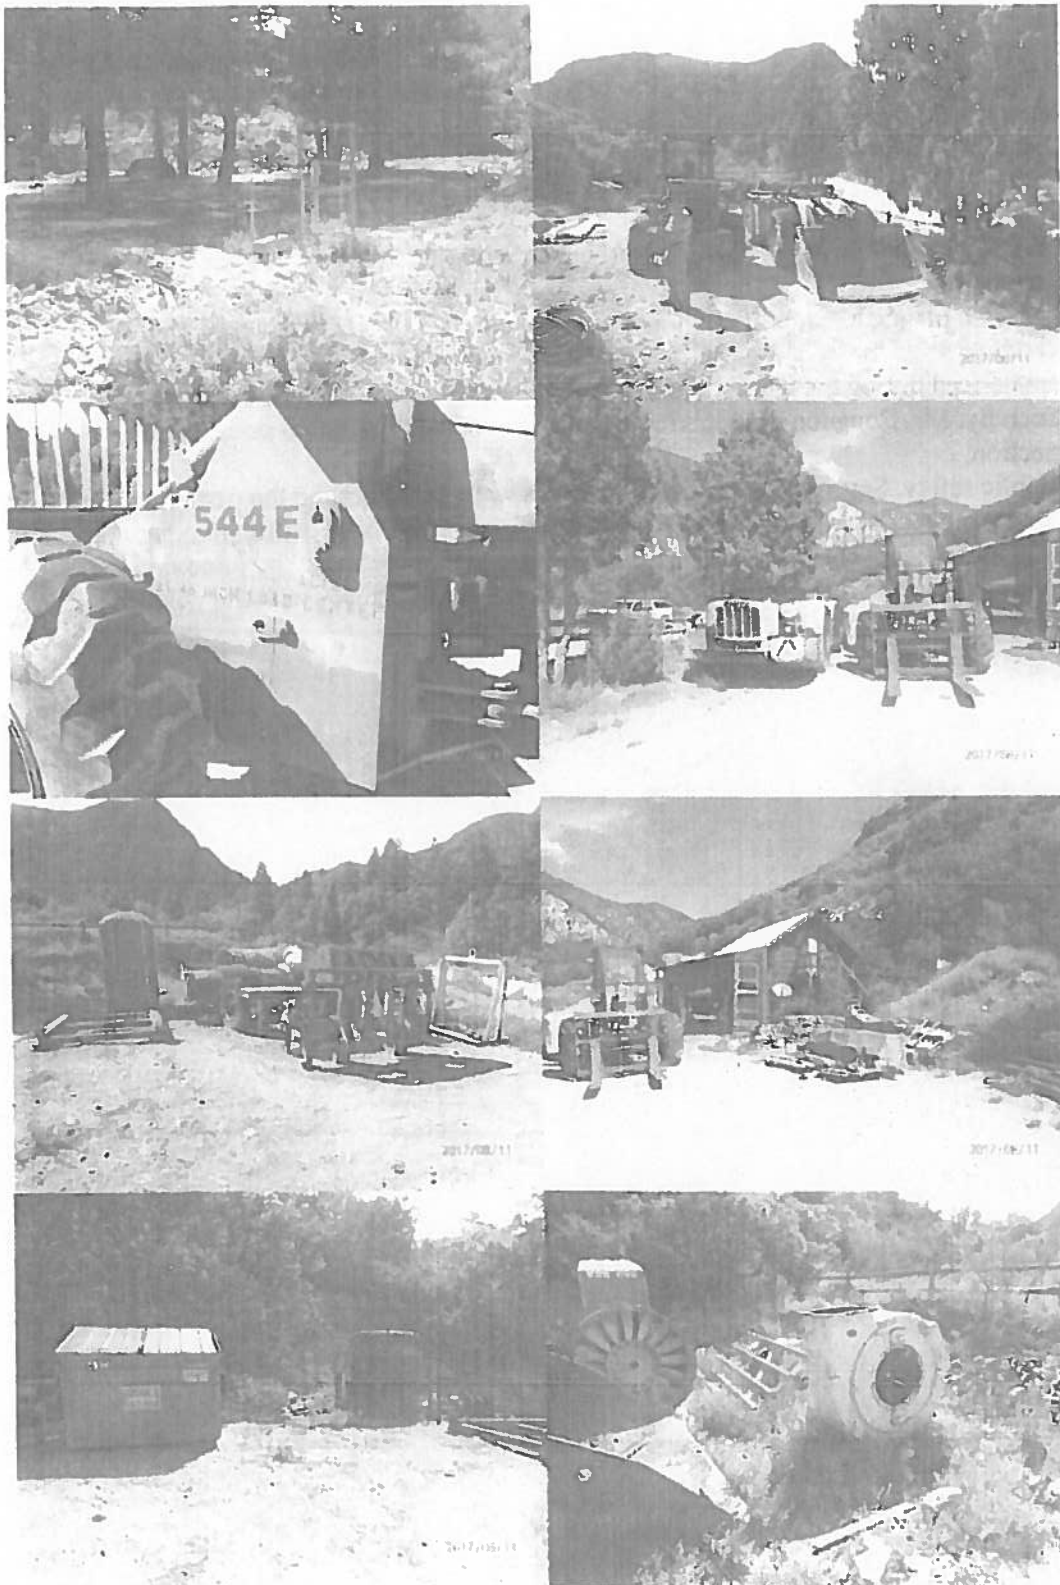
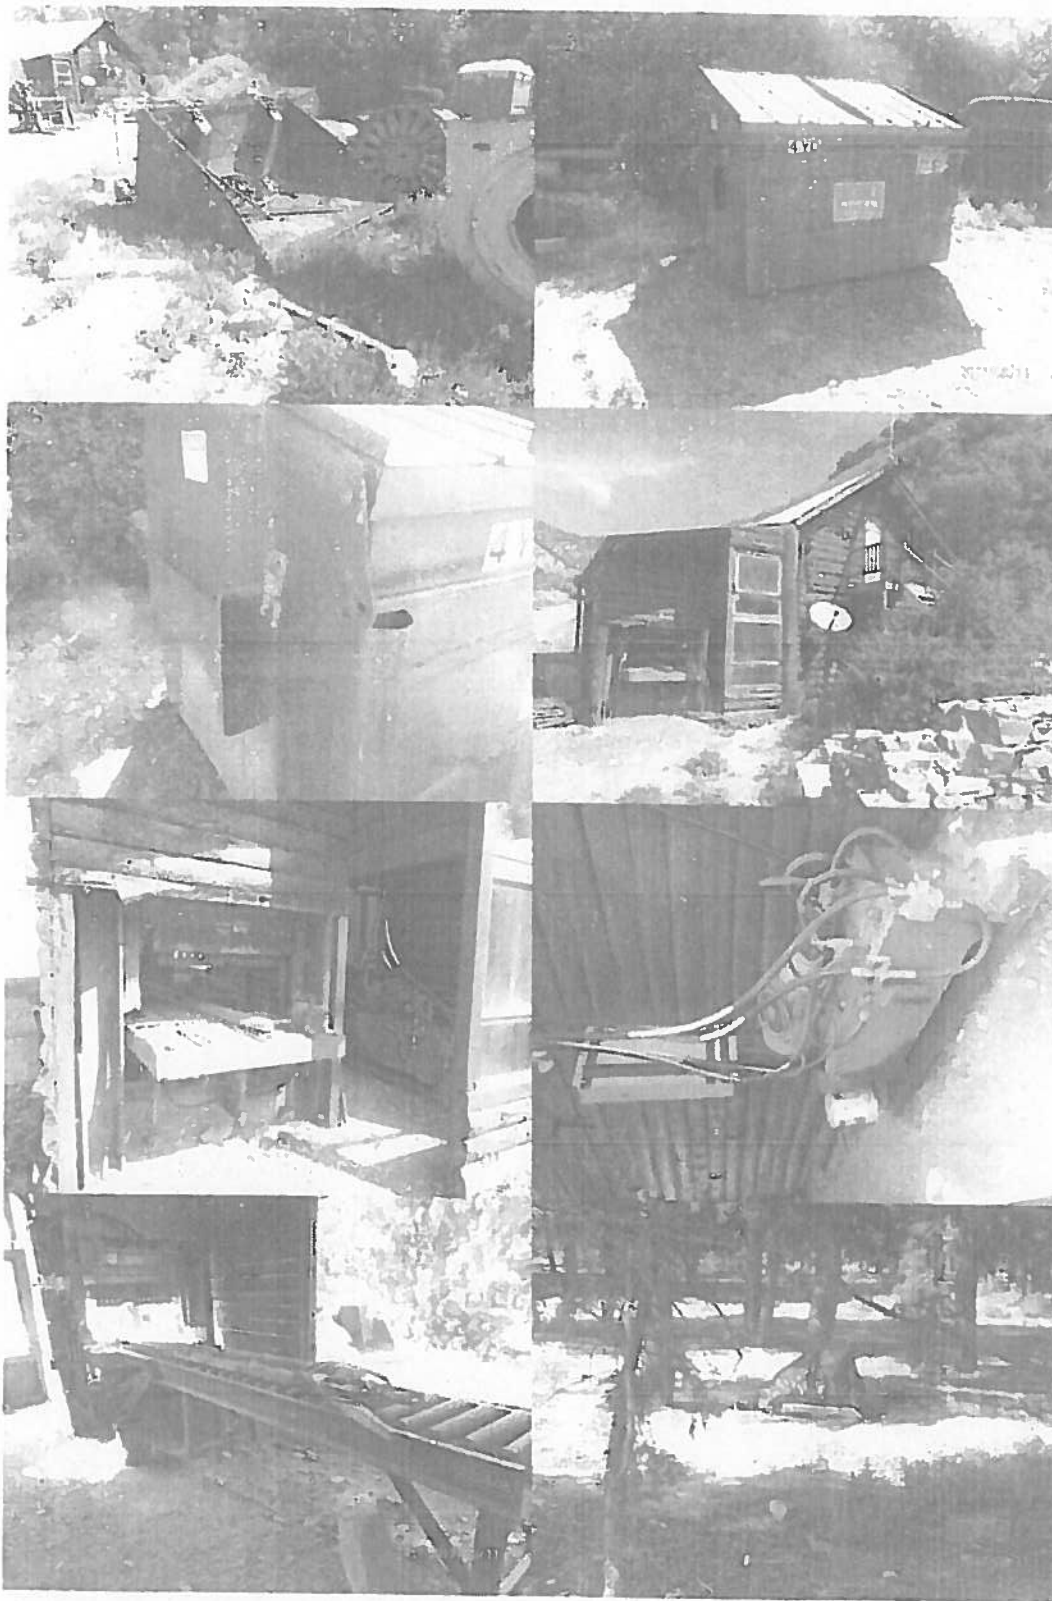
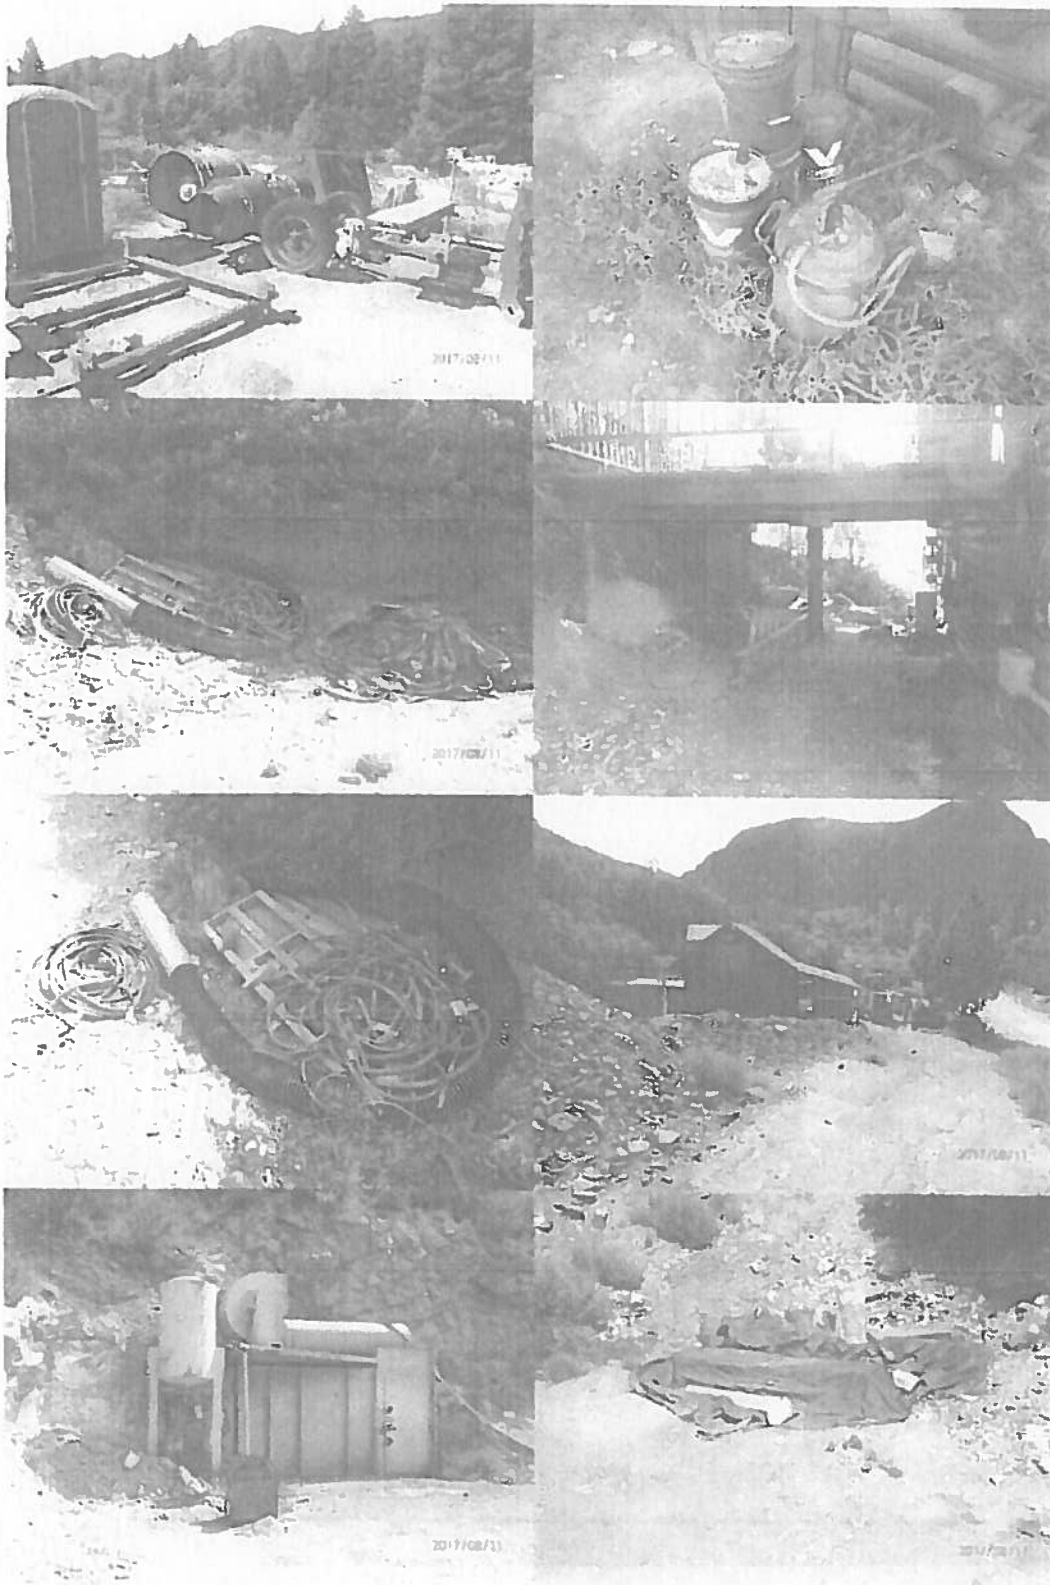
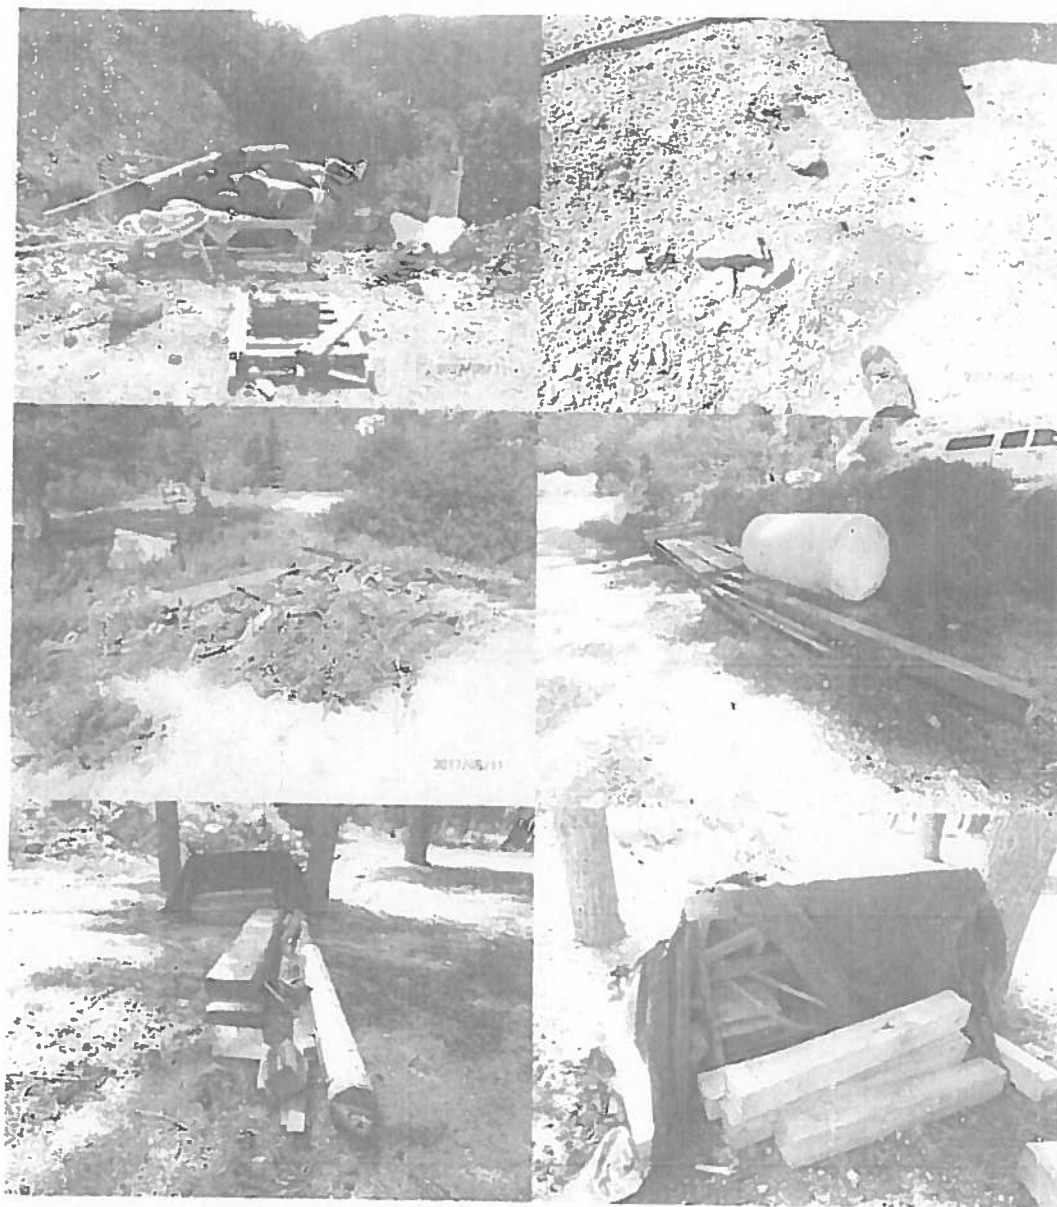
Photos are attached.

1. As seen in the inspection photos, several piles of garbage/debris were found around the project area. Garbage and debris must be removed from the site. If you are keeping anything for future use, please store it behind your office building, out of site from the road.
2. The garbage dumpster was not locked/latched to prevent bears and other wildlife from getting into garbage. Please either lock or remove the dumpster.

3. Petroleum stained soil from leaking equipment was discovered. Please either repair the leaks or remove the equipment.

Signing is adequate for public safety. Several piles of garbage/debris were found around the permit area and the garbage dumpster was not locked/latched to prevent bears and other wildlife from getting into garbage. Soil is stained from leaking equipment. These violations must be addressed immediately by removing the garbage/debris from the permit area and repairing the latch on the dumpster to comply with the wildlife design criteria.

Again, these issues must be addressed immediately. Please contact Jason and/or me when you have resolved the issues. We will do a follow-up inspection, if conditions allow.
