## MINERALS PROGRAM INSPECTION REPORT

<b>MINE NAME:</b> Latham - Burkett Pit	<b>MINE/PROSPECTING ID#:</b> M-1983-013	<b>MINERAL:</b> Sand and gravel	<b>COUNTY:</b> Mesa
<b>INSPECTION TYPE:</b> Monitoring	<b>INSPECTOR(S):</b> Amy C. Yeldell	<b>INSP. DATE:</b> January 31, 2018	<b>INSP. TIME:</b> 10:30
<b>OPERATOR:</b> Oldcastle SW Group, Inc. dba United Compai County	<b>OPERATOR REPRESENTATIVE:</b> Jason Burkey	<b>TYPE OF OPERATION:</b> 112c - Construction Regular Operation	
<b>REASON FOR INSPECTION:</b> Normal I&E Program	<b>BOND CALCULATION TYPE:</b> None	<b>BOND AMOUNT:</b> \$41,884.00	
<b>DATE OF COMPLAINT:</b> NA	<b>POST INSP. CONTACTS:</b> None	<b>JOINT INSP. AGENCY:</b> None	
<b>WEATHER:</b> Clear	<b>INSPECTOR'S SIGNATURE:</b>

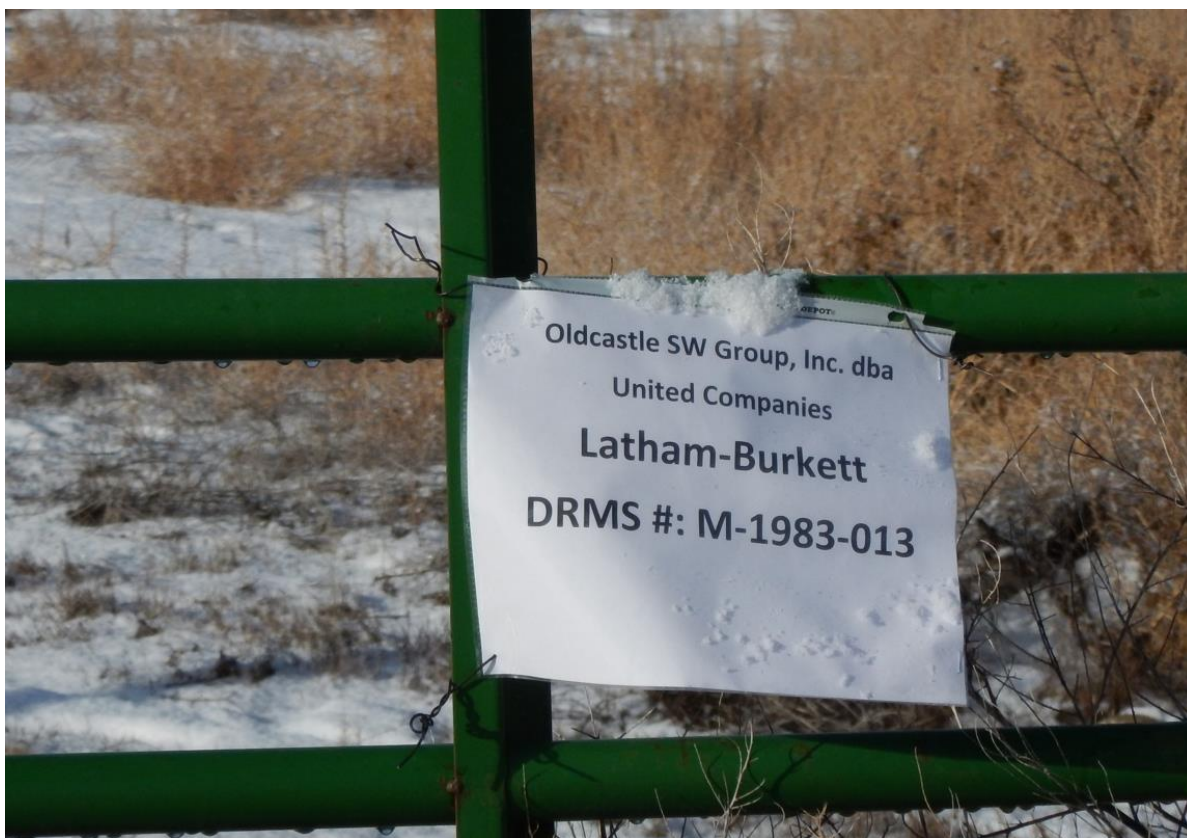
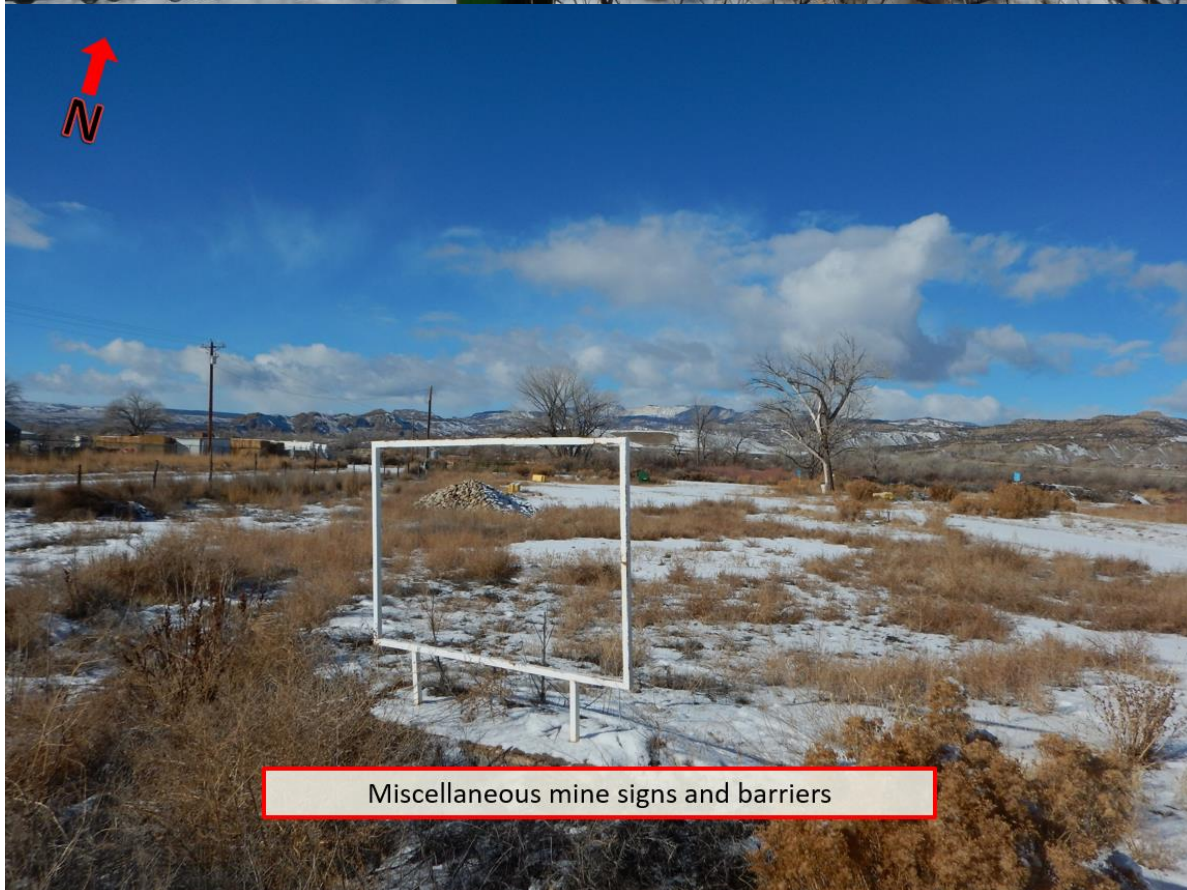
This site was inactive at the time of the inspection and is in final reclamation. There is no equipment, fuel or structures related to mining on site. Some cement barriers and signs still remain.

Miscellaneous mine signs and barriers
