Estimated St Vrain Breaches and flow during 2013 flood

Lyons Pit	
2018 DRMS Annual Report	
Not to scale	02-14-18

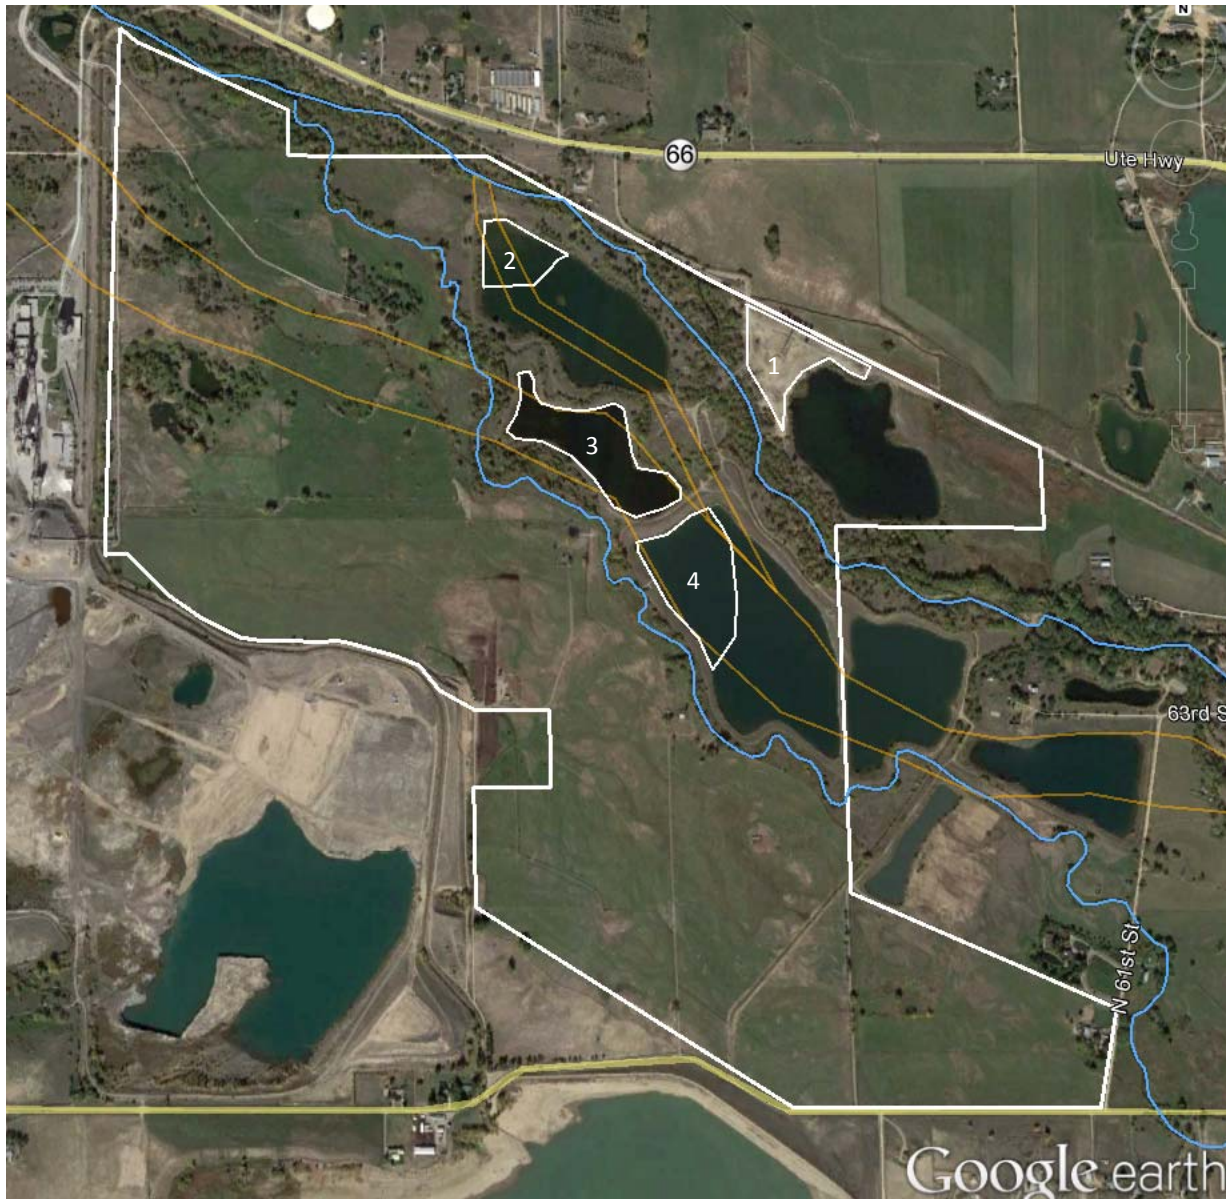
- 1 Plant Site – 5 acres
Waiting on Boulder County review before we can prepare site to begin mining again.
- 2 Sediment deposited by St. Vrain Creek from Breach 1 - 4.5 acres*
- 3 Sediment deposited by St. Vrain Creek from Breach 2 - 10.5 acres*
- 4 Sediment deposited by St. Vrain Creek from Breach 2. Boulder County Parks and Open Space working with FEMA to reestablish water storage reservoir and remove sediment - 10 acres

*MM intends to re-mine to re-establish prior reclamation, Boulder County would like for it to remain as-is. Discussions will continue thru 2018.
