MINERALS PROGRAM INSPECTION REPORT**PHONE: (303) 866-3567**

MINE NAME: Peck Pit	MINE/PROSPECTING ID#: M-1992-049	MINERAL: Gravel	COUNTY: Ouray
INSPECTION TYPE: Monitoring	INSPECTOR(S): Travis H. Marshall	INSP. DATE: March 6, 2018	INSP. TIME: 10:30
OPERATOR: Vista Verde Village, LLC.	OPERATOR REPRESENTATIVE: N/A	TYPE OF OPERATION: 110c - Construction Limited Impact

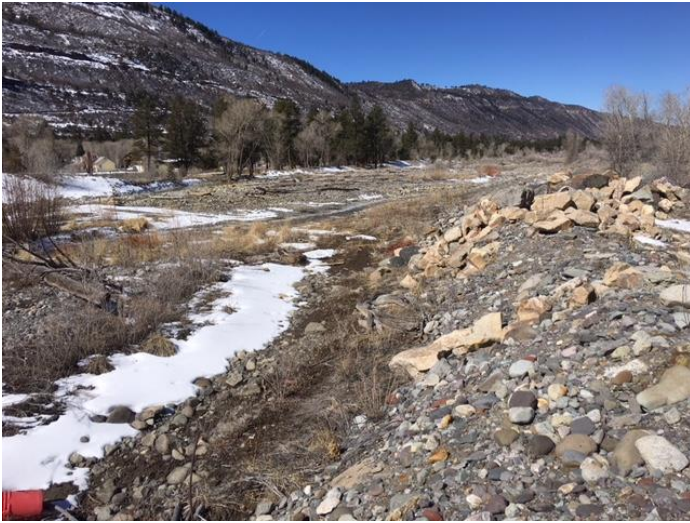
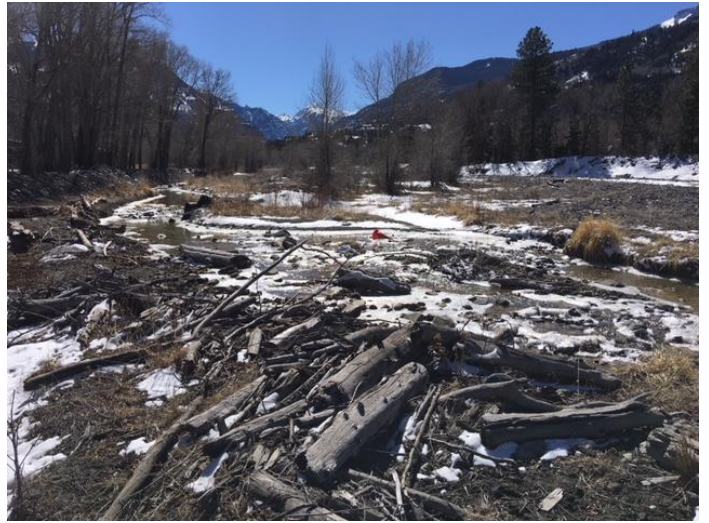
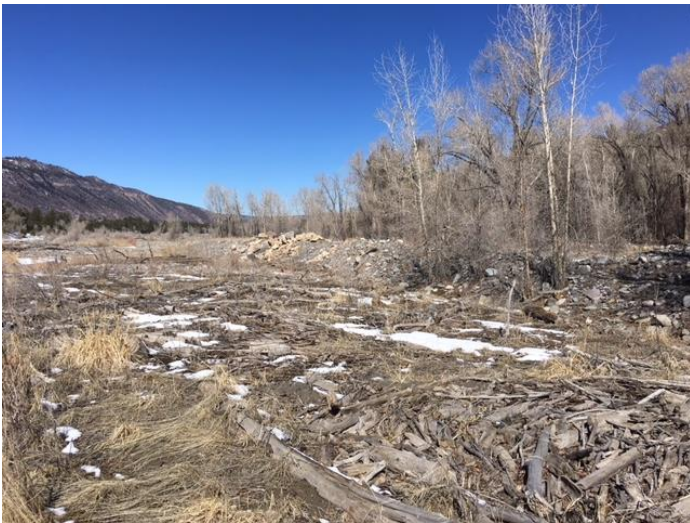
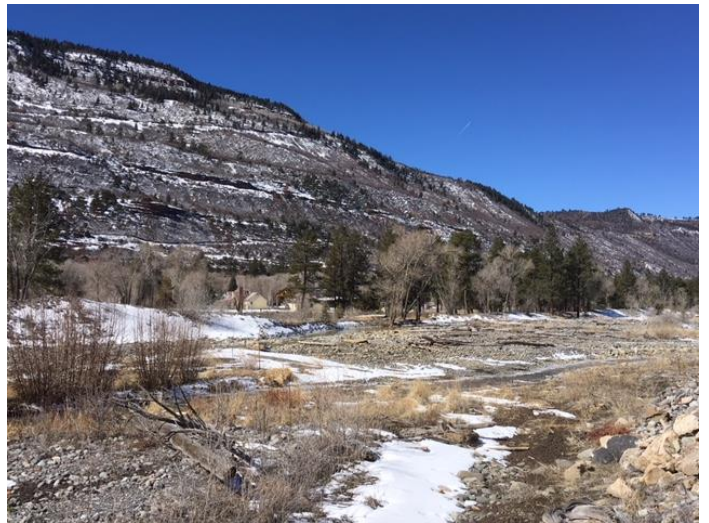
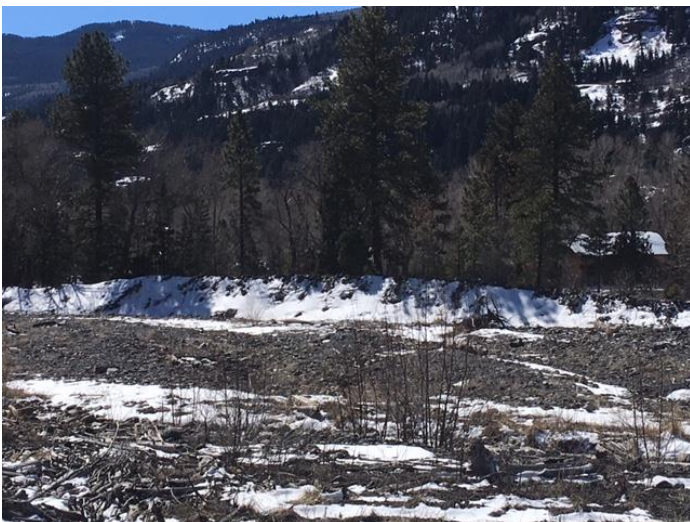
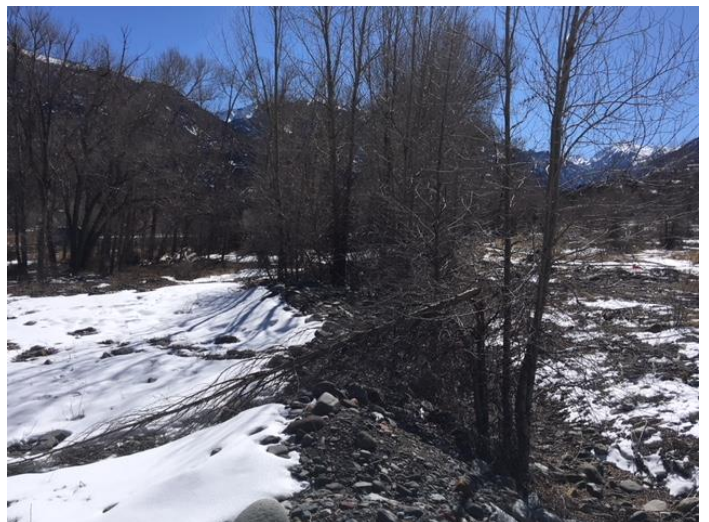
PHOTOGRAPHS

The mine site has yet to be active. No mining related disturbance was observed during the inspection. The currently held reclamation bond of \$3,000.00 is considered sufficient to ensure reclamation.

Neither a mine identification sign nor permit boundary markers were observed during the inspection. In order to bring the site in compliance with Rule 3.1.12 the operator must post a mine identification sign at the main entrance and permit boundary markers clearly delineating the permit boundary. The lack of sign and permit boundary markers is considered a problem at this time. In order to avoid enforcement action photo-documentation of the mine sign and permit boundary markers must be submitted to this office no later than April 10, 2018.

Photos that show the conditions observed on March 6, 2018 are included with this report.

CORRECTIVE ACTIONS: The operator must post a sign at the entrance to the mine site which shall be clearly visible from the access road and specify the following; the name of the operator, indicate that a reclamation permit for the operation has been issued by the Colorado Mined Land Reclamation Board, and the permit number. The boundaries of the affected area must be marked by monuments or other markers that are clearly visible and adequate to delineate such boundaries.
