MINERALS PROGRAM INSPECTION REPORT

MINE NAME: Rock School Lease Experimental Nahcolite M	MINE/PROSPECTING ID#: M-1999-051	MINERAL: Carbonates	COUNTY: Rio Blanco
INSPECTION TYPE: Monitoring	INSPECTOR(S): Travis Marshall	INSP. DATE: March 27, 2018	INSP. TIME: 14:30
OPERATOR: Natural Soda LLC	OPERATOR REPRESENTATIVE: Kirk Daehling	TYPE OF OPERATION: 112 - Hard Rock Regular Operation

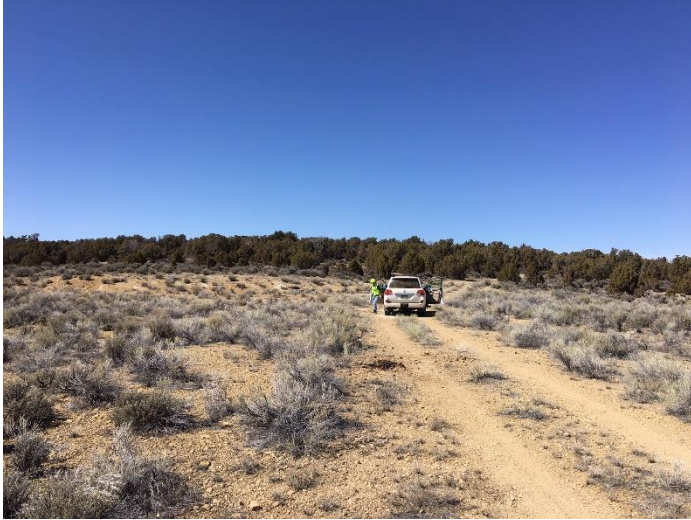
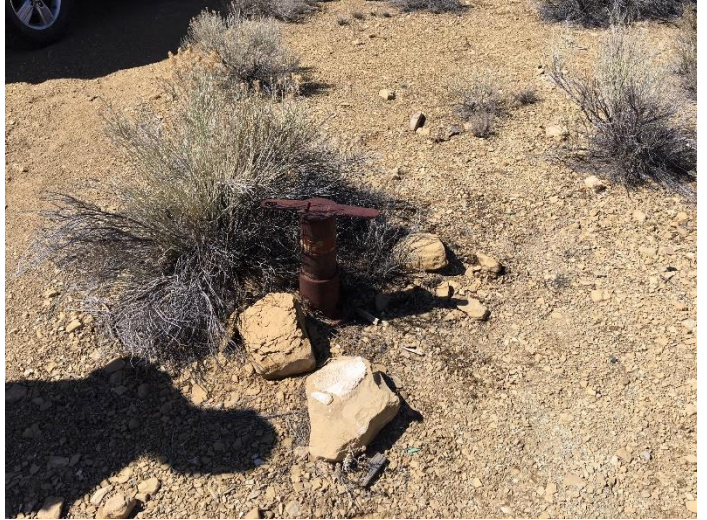
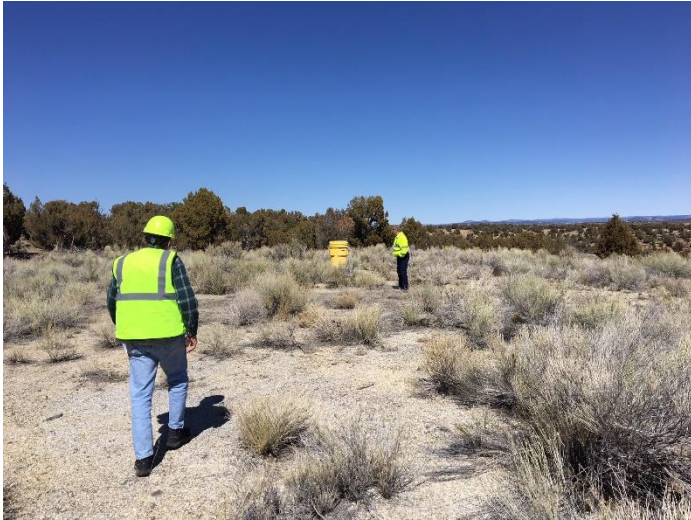
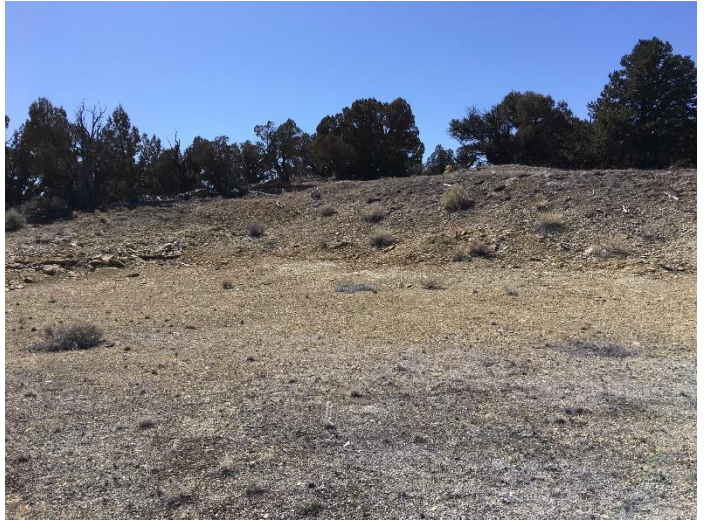
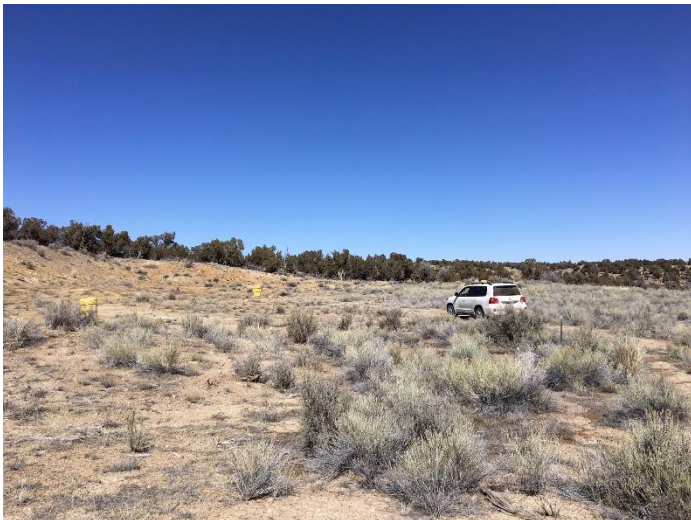
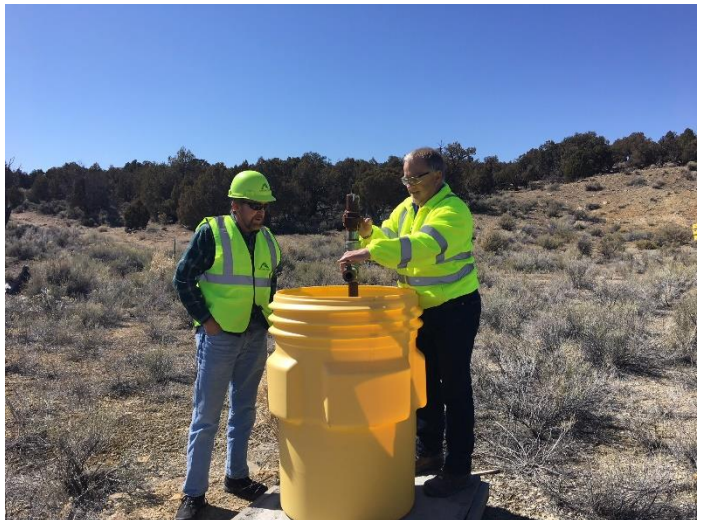
PHOTOGRAPHS

All hydrology monitoring pads and wells were observed during the inspection. The hydrology pads were covered with volunteer vegetation consisting of grasses and shrubs primarily broom snakeweed, sage brush and rubber rabbit brush. No changes have occurred since the July 2013 site inspection.

One problem was identified during the inspection. A sign was not observed at the main entrance to the site. Failure to post a mine identification sign as required by Section 3.1.12(1) of the rule is noted as a problem with a corrective action deadline of May 4, 2018.
