**MINERALS PROGRAM INSPECTION REPORT**  
**PHONE: (303) 866-3567**

| <b>MINE NAME:</b><br>Henderson Mine | <b>MINE/PROSPECTING ID#:</b><br>M-1977-342 | <b>MINERAL:</b><br>Molybdenum | <b>COUNTY:</b><br>Clear Creek, Grand |
| <b>INSPECTION TYPE:</b><br>Monitoring | <b>INSPECTOR(S):</b><br>Michael A. Cunningham | <b>INSP. DATE:</b><br>March 14, 2018 | <b>INSP. TIME:</b><br>10:00 |

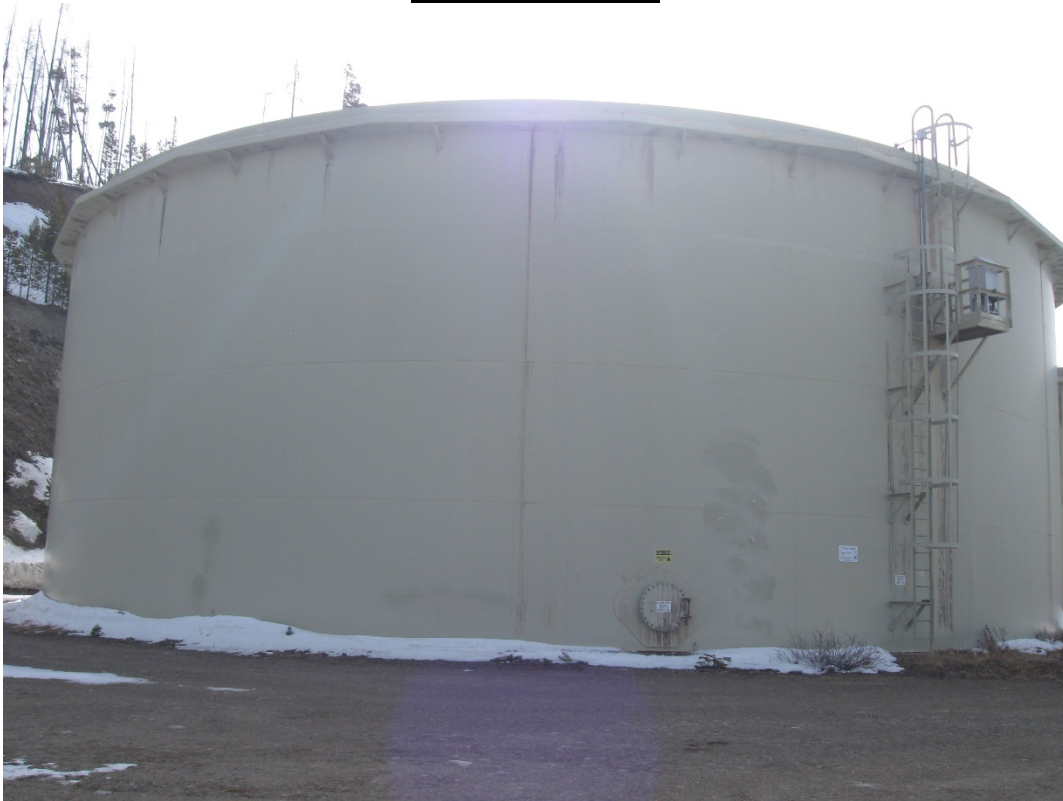
Two 1.5 million gallon steel tanks are located to the east of the mill building. The steel tanks are situated upgradient of the mill facility and provide water for the various processing circuits via a gravity fed line. The Operator reserves 500,000 gallons in each tank for firefighting purposes. Based on visual observations, the

tanks were found to be in good condition and the Division did not observe any signs of discharge from the tanks. The signage on both tanks indicates the individual tank capacity is 1,000,000 gallons. The Operator has acknowledged the discrepancy between the EPP and the sign on the tanks. The tank volume will be verified and signs will be updated as necessary.

**1. Process Water Storage tank.**

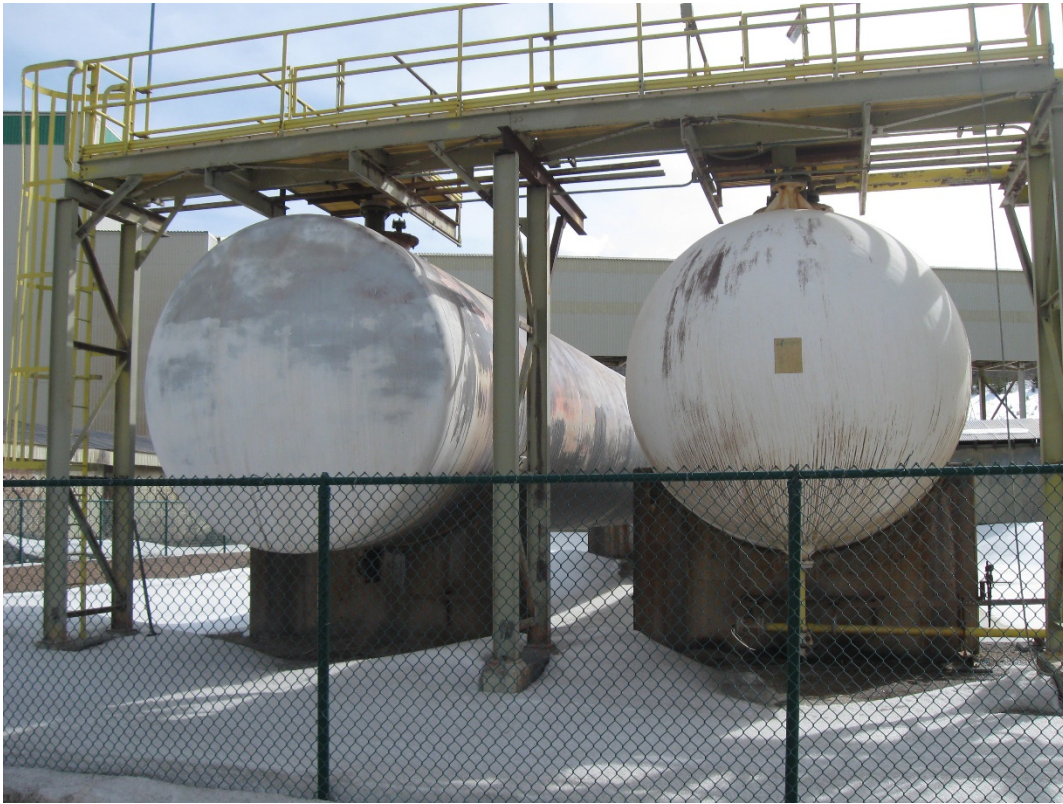
Hydrochloric Acid is stored in a single 50,000 gallon fiberglass tank located to the north of the mill building. A second 50,000 gallon tank which has been decommissioned is stored in the same location. The Operator informed the Division they are currently trying to find contractor to perform integrity testing on the 50,000 gallon tank. The limestone berm which surrounds the storage area and serves as secondary containment was in good shape. No problems were observed in the Hydrochloric Acid Storage area.

**3. Hydrochloric Acid Storage Area.**

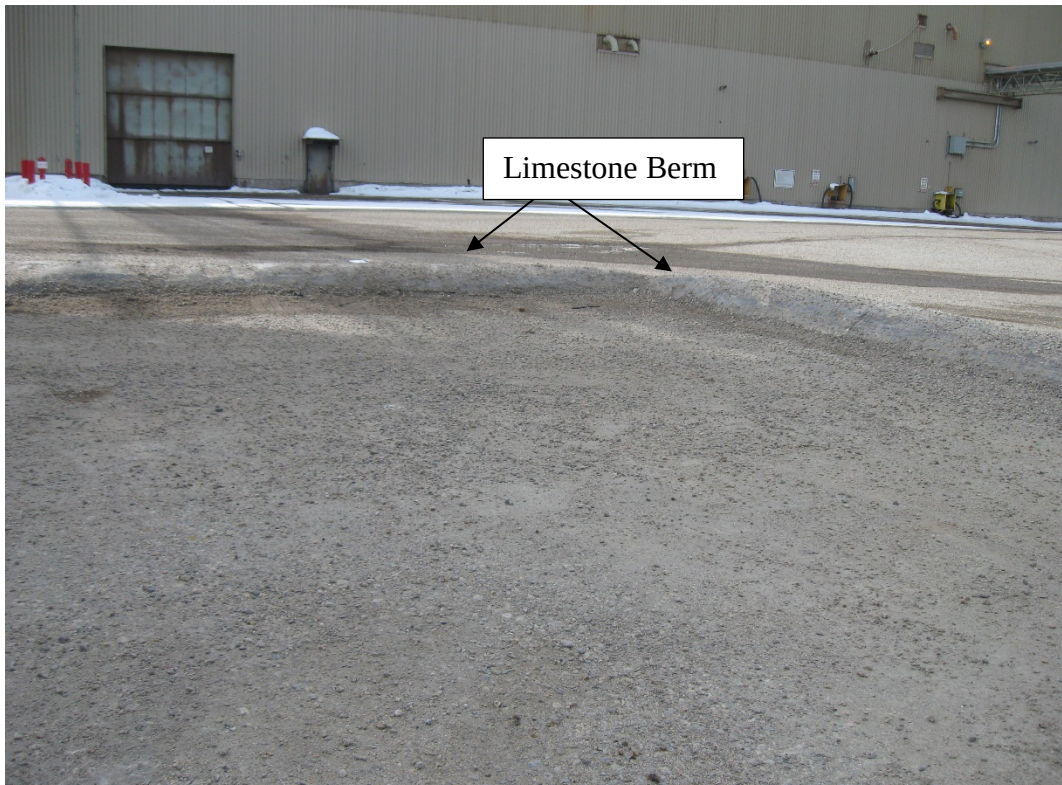
**4. Secondary containment for Hydrochloric Acid Storage Area.**

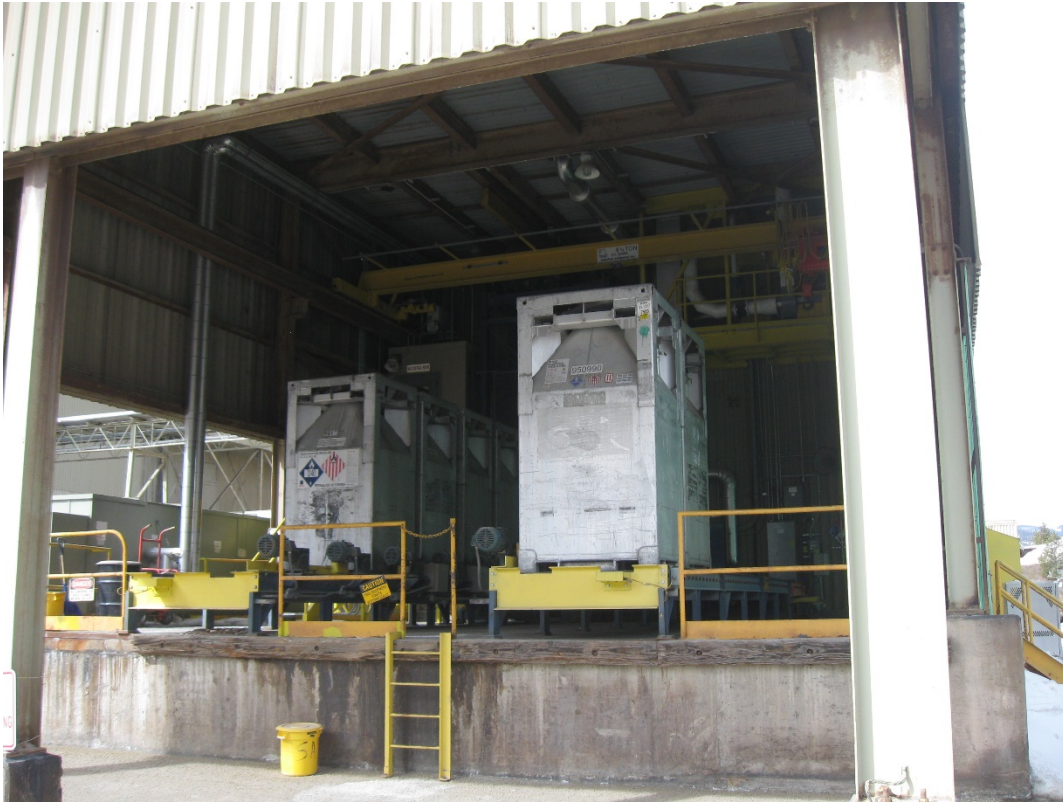
The Nokes Building stores two 12,300 gallon tanks which store liquid sodium hydroxide. In addition, dry phosphorus pentasulfide is stored in 4,000 pound aluminum tote bins, with a total storage capacity of 80,000 pounds. The sodium hydroxide is mixed with the phosphorus pentasulfide in a 10,500 gallon tank to create the Nokes reagent. The facility mixes Nokes reagent which is utilized at the Henderson Mill and the Climax Mine (M-1977-493). A complete overhaul of the interior mixing tank, including addition of an epoxy shield to the base of the tank, was performed in January 2018. No problems were observed in the Designated Chemical Storage Facilities.

5. Nokes Building - phosphorus pentasulfide tote storage.

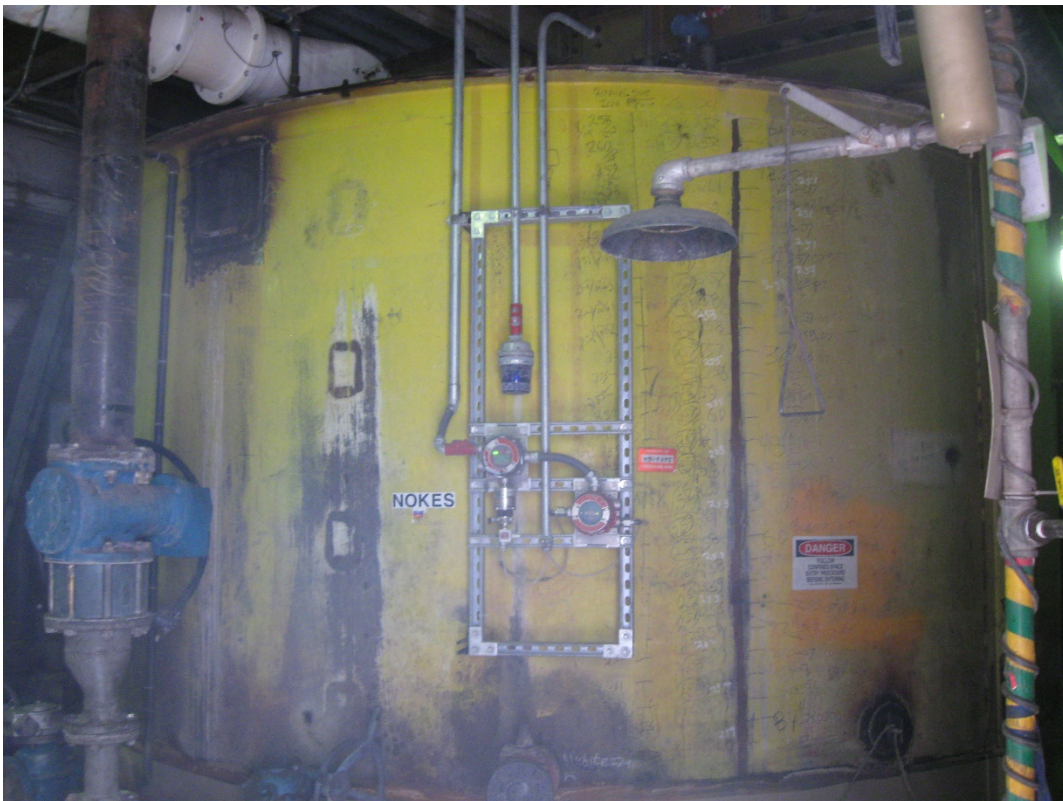
6. Nokes mixing tank.

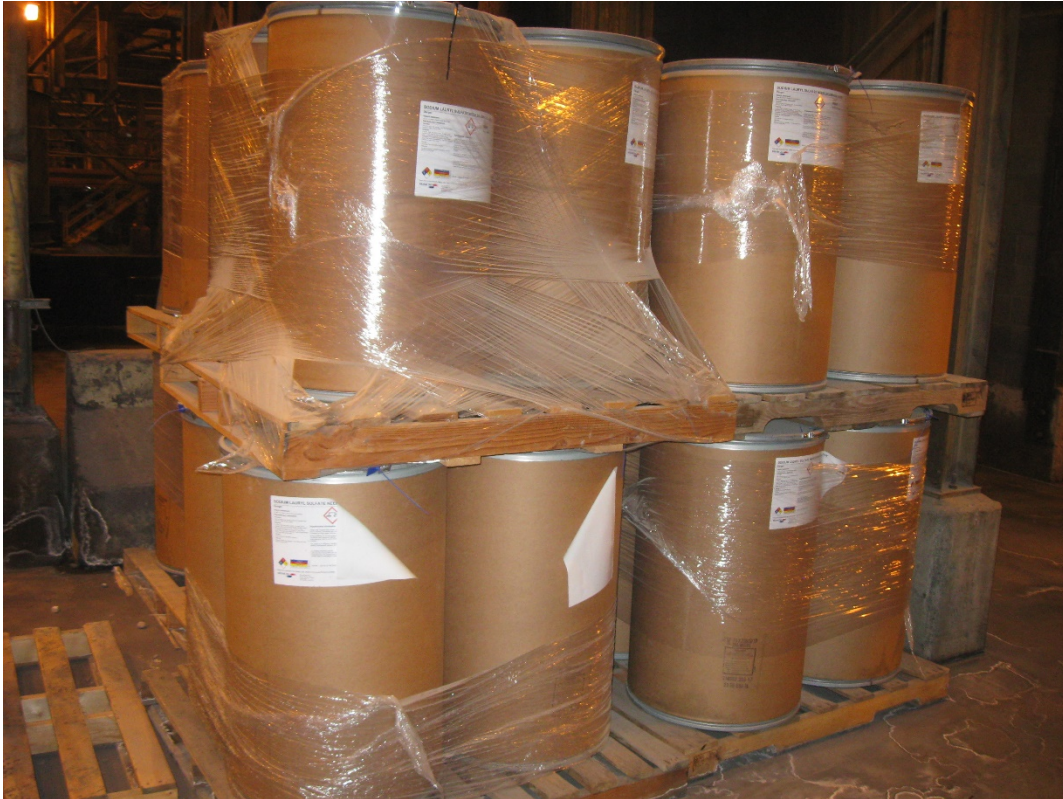
Sodium Lauryl Sulfate, also referred to as Witconate, is stored in 200 pound drums within the mill building. The EPP specifies the maximum storage quantity of Witconate is 50 drums. The Division observed 41 drums during the inspection. The drums were stored off of the ground on wood pallets. No problems were observed in the Sodium Lauryl Sulfate Storage area.

7. Sodium Lauryl Sulfate Storage.

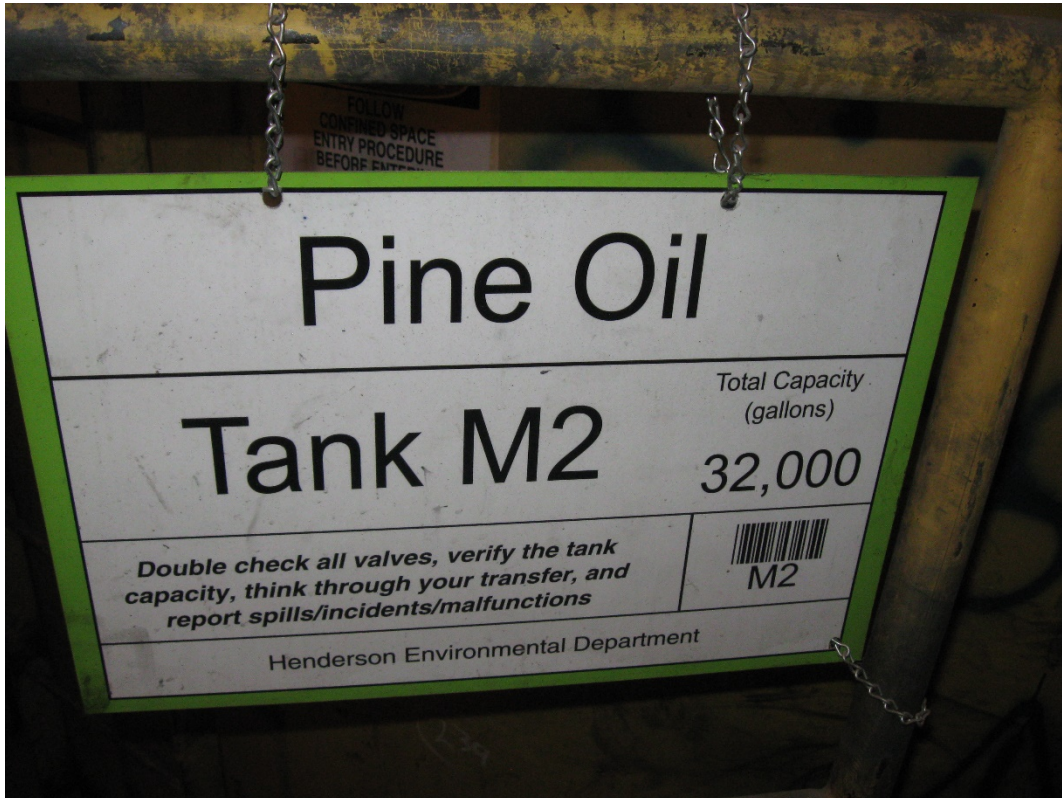
Pine oil is stored in a steel tank within the oil room in the mill building. The EPP specifies pine oil is to be stored in a 14,400 gallon tank. However, a sign on the tank indicates the tank capacity is 32,000 gallons. The Operator has acknowledged the discrepancy between the EPP and the sign on the tank. The tank volume will be verified and the sign will be updated as necessary. The Division observed pine oil on the side of the tank. In addition, absorbent pads had been placed at the base of the tank to capture the discharge. The pine oil discharge appeared to originate from the top of the tank and likely occurred when the tank was being filled. Any releases in the oil room are contained by a concrete wall and are directed to the mill sump system. The Operator informed the Division all of the tanks in the oil room underwent integrity testing in 2017.

9. Signage adjacent to Pine Oil Storage tank.

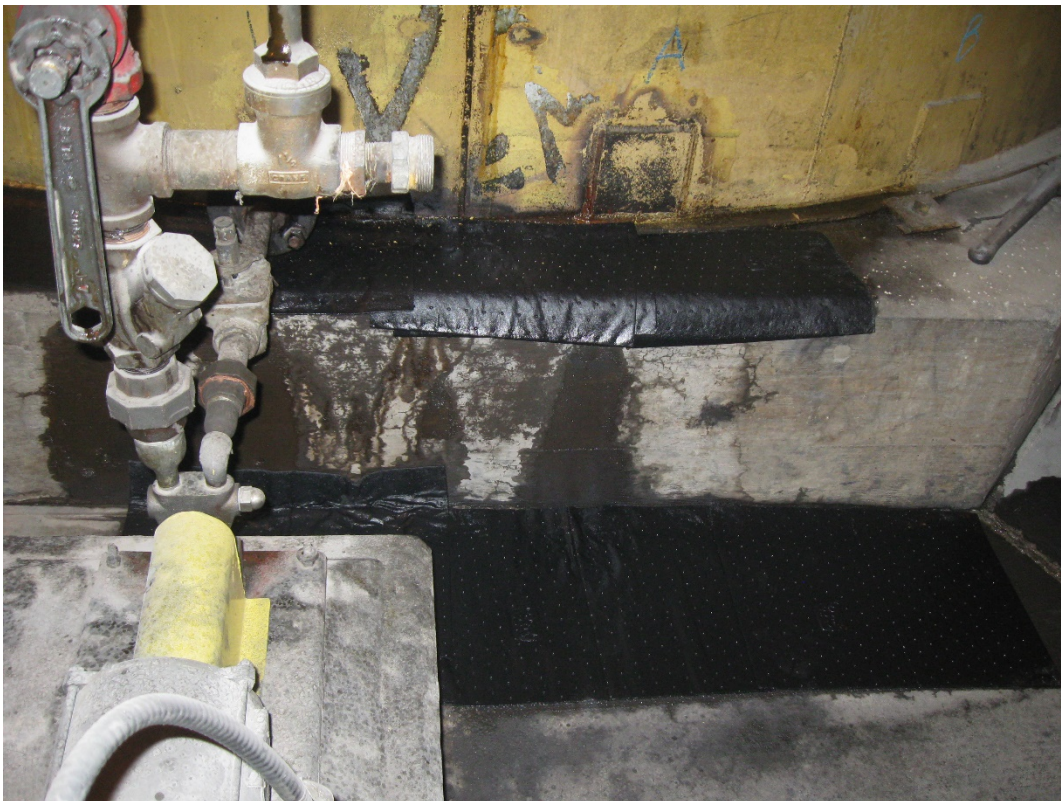
10. Absorbent pads at base of Pine Oil Storage tank.

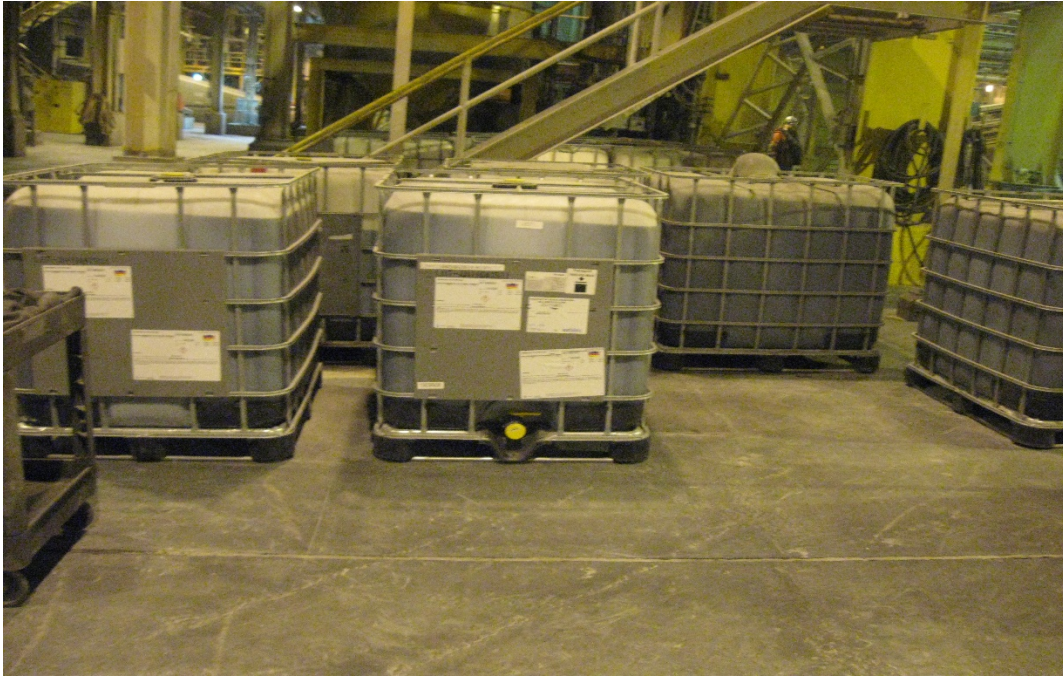
OrePrep F-579, a frothing agent used in the flotation process, is stored in 250 gallon totes. In addition, Orform D8 Depressant, a suppressant used in the flotation process, is stored in 450 gallon totes. The totes are stored within the mill building and any release of chemicals would be captured by the mill sump system. No problems were observed in the Flotation Chemical Storage area.

**11. Flotation Chemical Storage Area.**

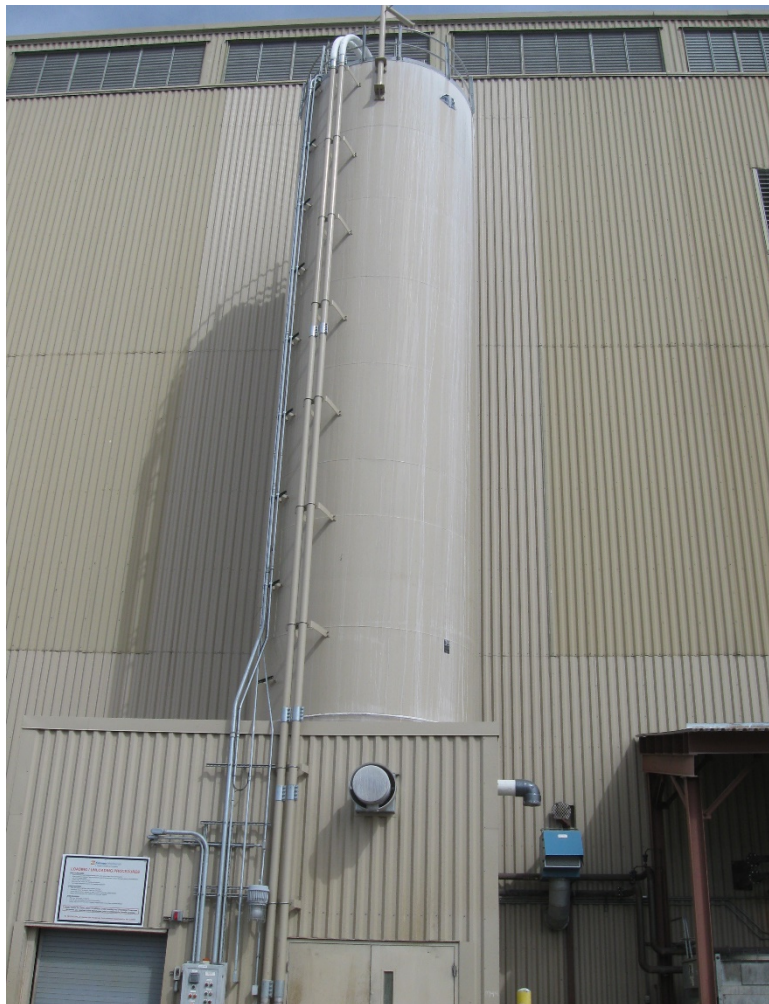
The Lime Slaker is attached to the mill building and is accessed through an external entryway. The lime storage silo has a capacity of 125 tons. The Lime Slaker building has a 2 foot high containment wall to capture any overflow, which is directed to the tailing discharge line. As previously noted, the Lime Slaker has not been included in the EPP. No problems were observed in the Lime Slaker area.

**12. Lime Slaker silo.**

Upon review of the current Environmental Protection Plan (EPP), the Division found the Lime Slaker has not been included under the EPP which was approved under Technical Revision No. 18. The Lime Slaker was approved as an EPF under Technical Revision No. 4. Subsequent revisions to the EPP shall include the Lime Slaker as an EPF. Additionally, the Operator should review the current EPP to ensure the details of all previously approved EPFs, including design details, have been included.
