MINERALS PROGRAM INSPECTION REPORT**PHONE: (303) 866-3567**

MINE NAME: Meeker Pit	MINE/PROSPECTING ID#: M-1976-038	MINERAL: Sand and gravel	COUNTY: Rio Blanco
INSPECTION TYPE: Monitoring	INSPECTOR(S): Travis H. Marshall	INSP. DATE: April 17, 2018	INSP. TIME: 11:45
OPERATOR: Meeker Sand & Gravel, Inc.	OPERATOR REPRESENTATIVE: Katie Conrado	TYPE OF OPERATION: 112c - Construction Regular Operation

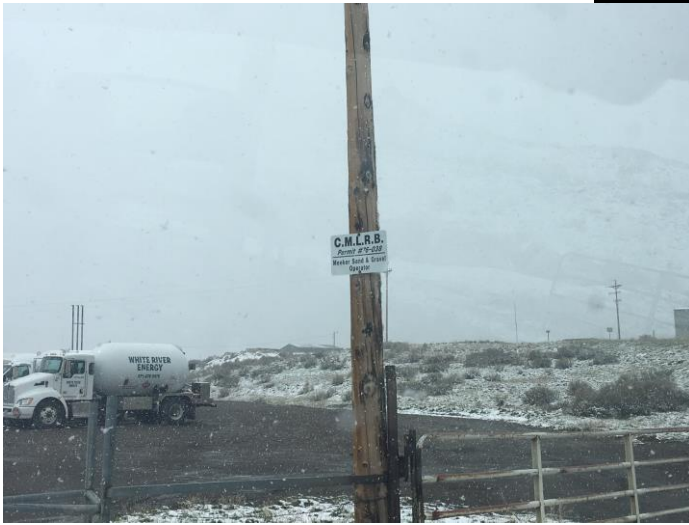
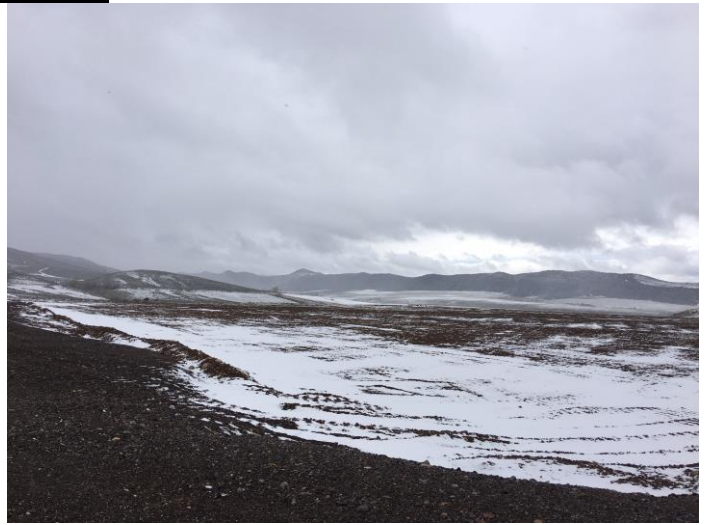
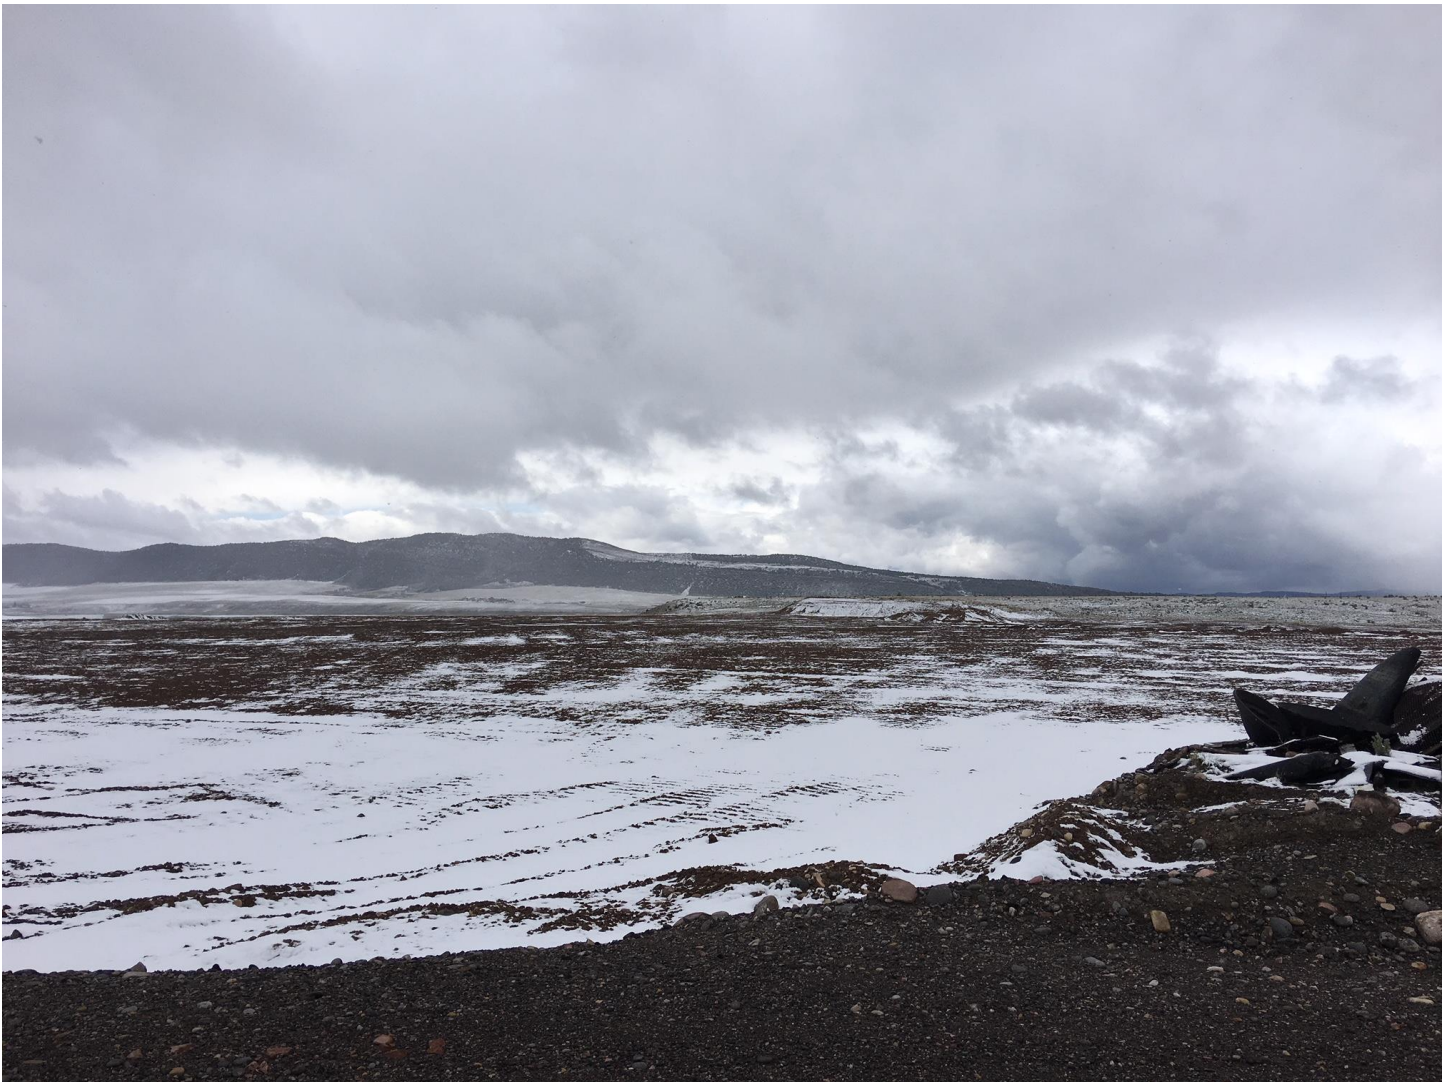
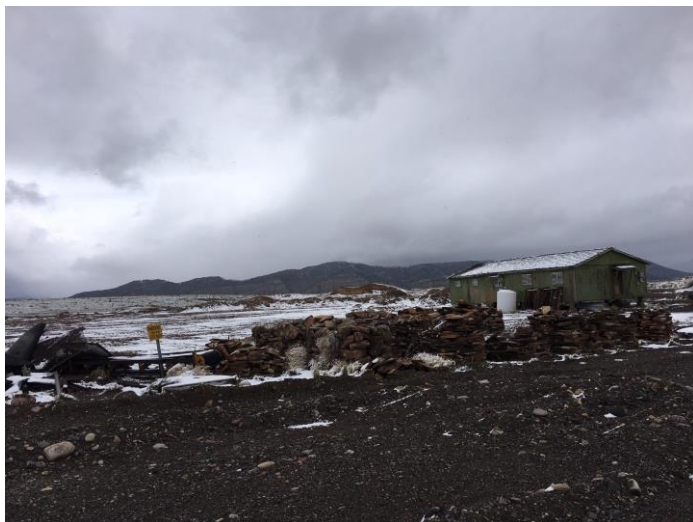
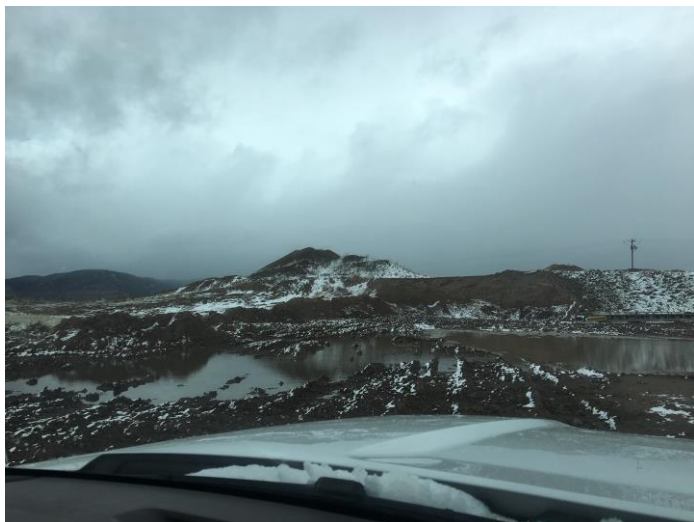
PHOTOGRAPHS

Stockpiles of various construction materials were observed at various locations around the site. Some active excavation equipment was observed during the inspection. The site was free of any unnecessary debris and appeared to be well kept.

20 acres of re-graded and re-topsoiled disturbed area located in the southwest vicinity of the permit area was observed during the inspection. The 20 acres is ready for seeding and the operator stated that the seed has been selected and purchased and is to be delivered in the near future.
