MINERALS PROGRAM INSPECTION REPORT

MINE NAME: 19 Road Pit	MINE/PROSPECTING ID#: M-2002-110	MINERAL: Sand and gravel	COUNTY: Mesa
INSPECTION TYPE: Surety Release Inspection	INSPECTOR(S): Amy C. Yeldell	INSP. DATE: May 15, 2018	INSP. TIME: 15:00
OPERATOR: Oldcastle SW Group, Inc. dba United Compas County	OPERATOR REPRESENTATIVE: None	TYPE OF OPERATION: 110c - Construction Limited Impact

REASON FOR INSPECTION: Surety Release Requested	BOND CALCULATION TYPE: Complete Bond	BOND AMOUNT: \$49,157.00
DATE OF COMPLAINT: NA	POST INSP. CONTACTS: None	JOINT INSP. AGENCY: None
WEATHER: Clear	INSPECTOR'S SIGNATURE:

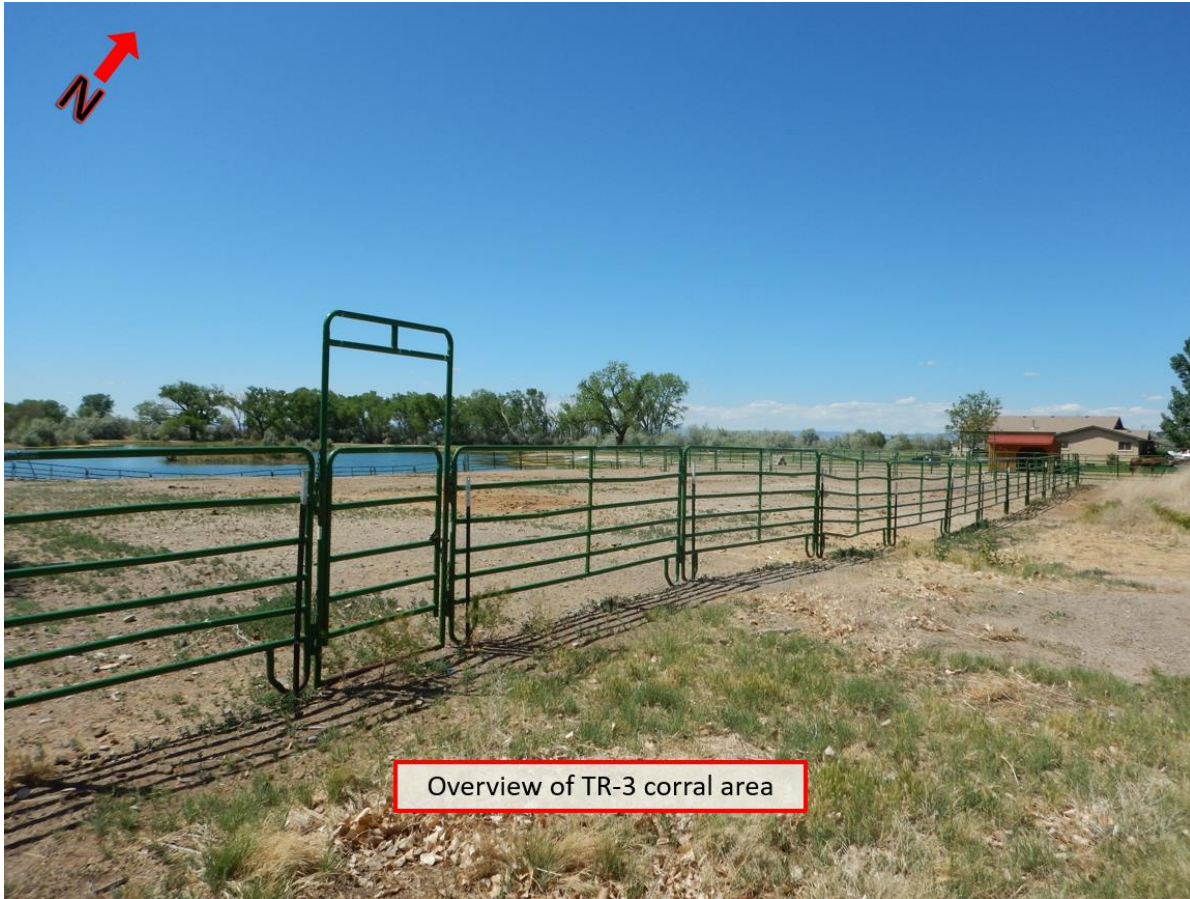
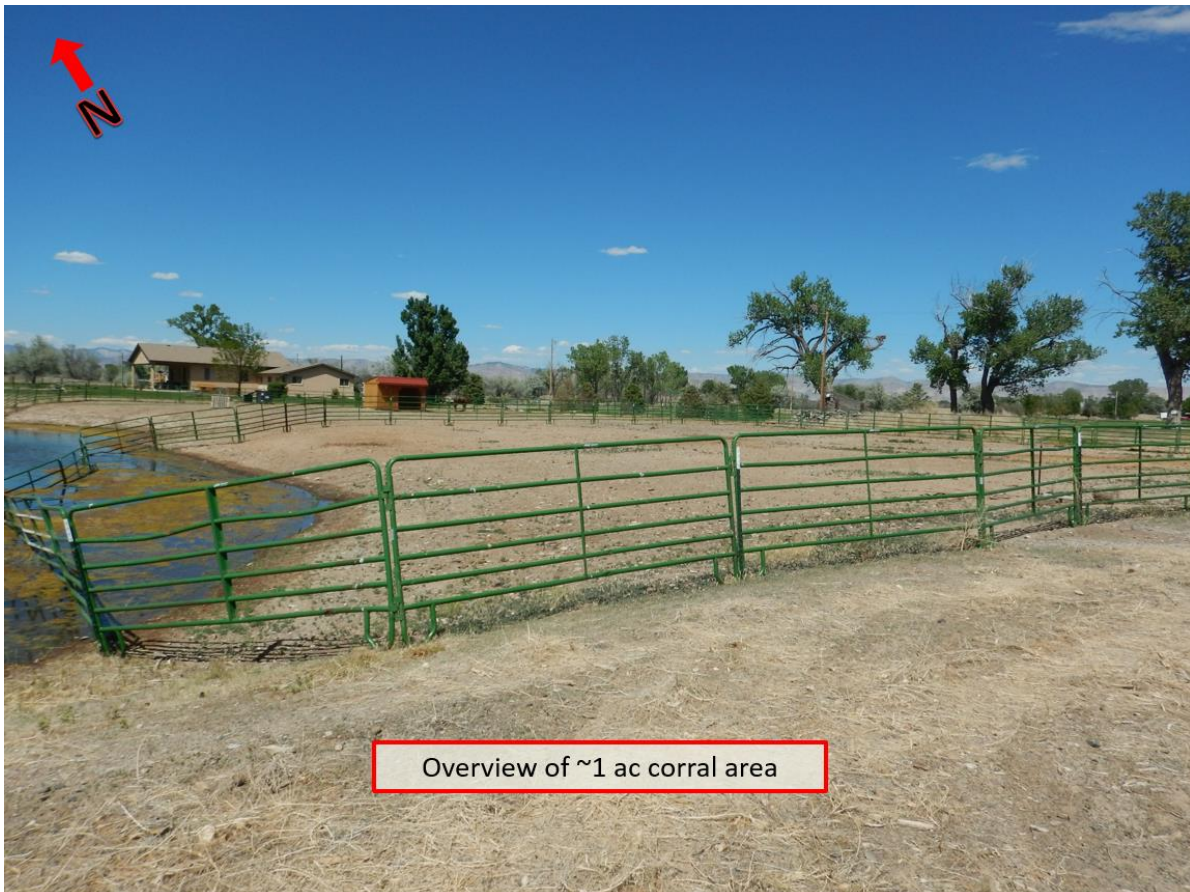
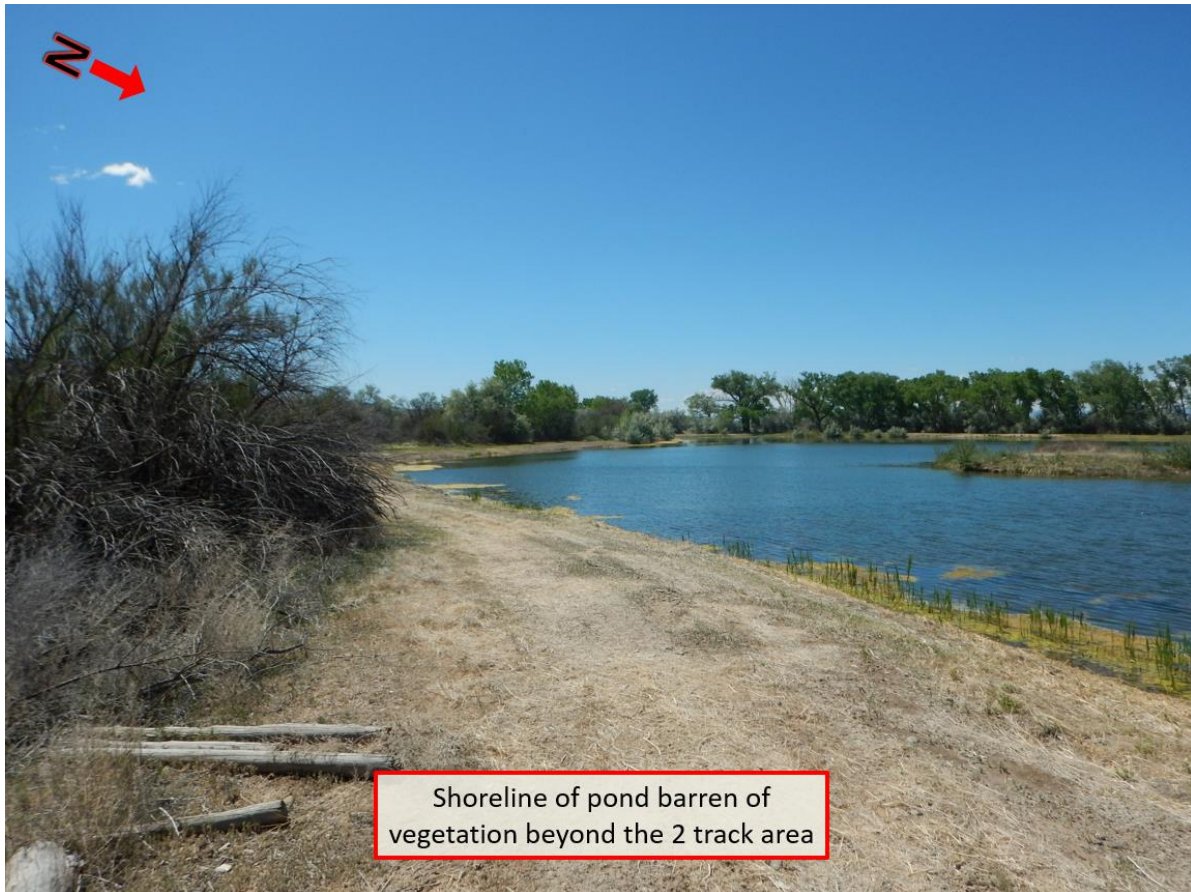
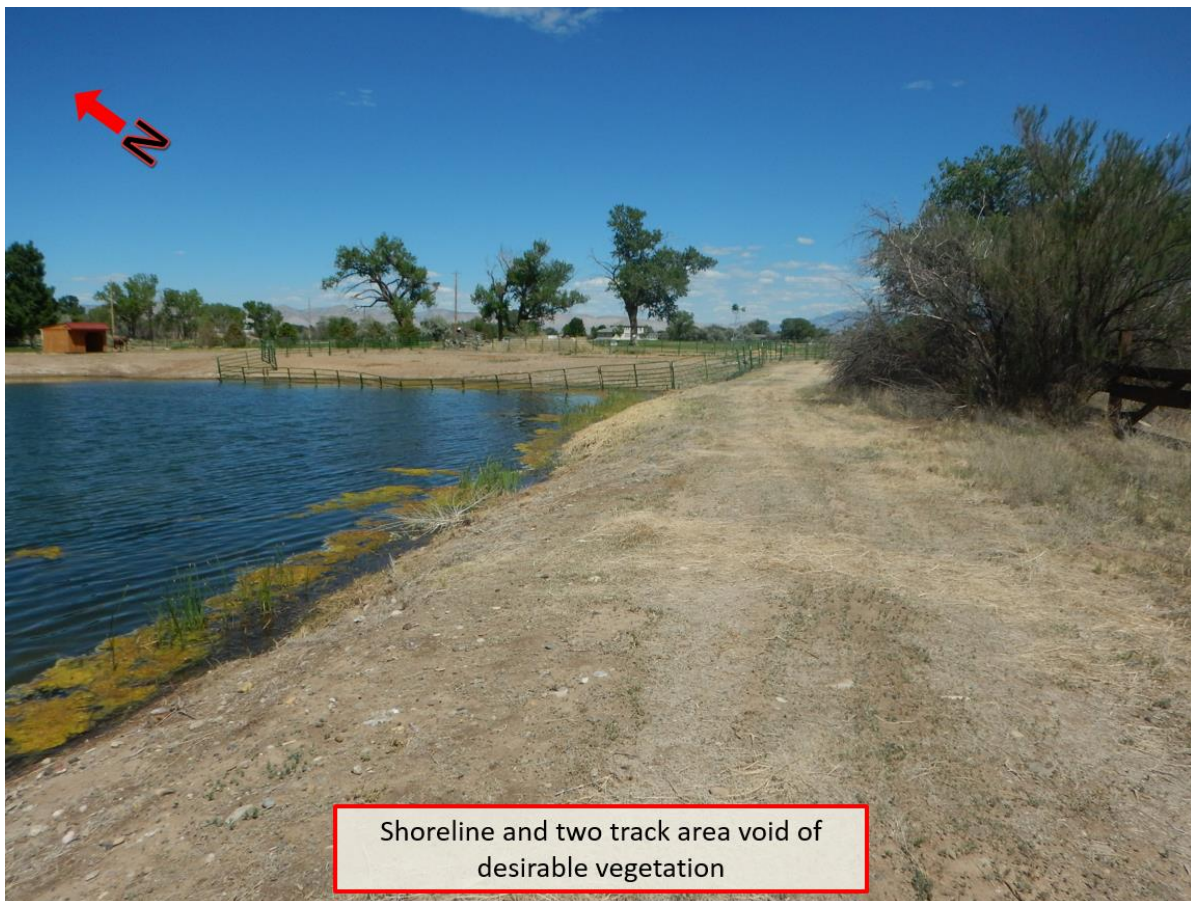
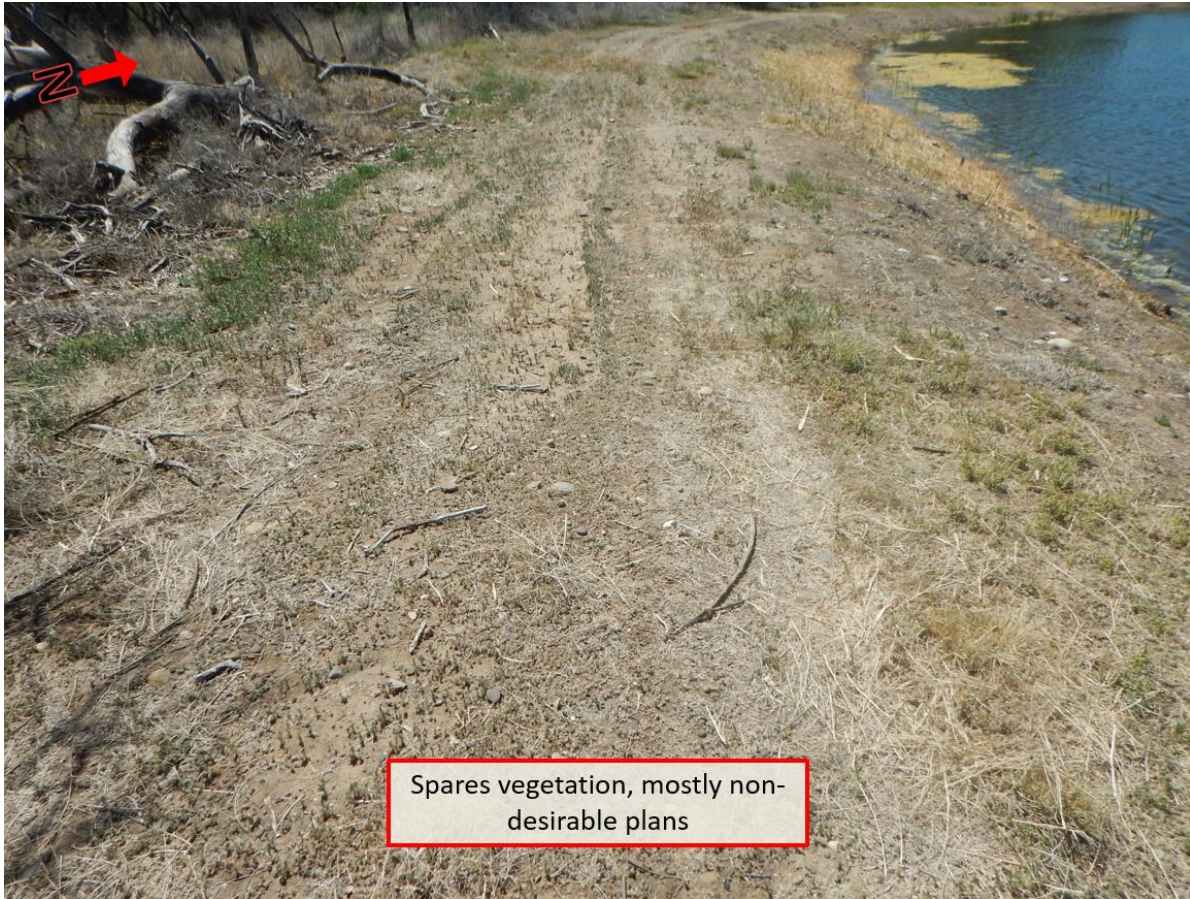
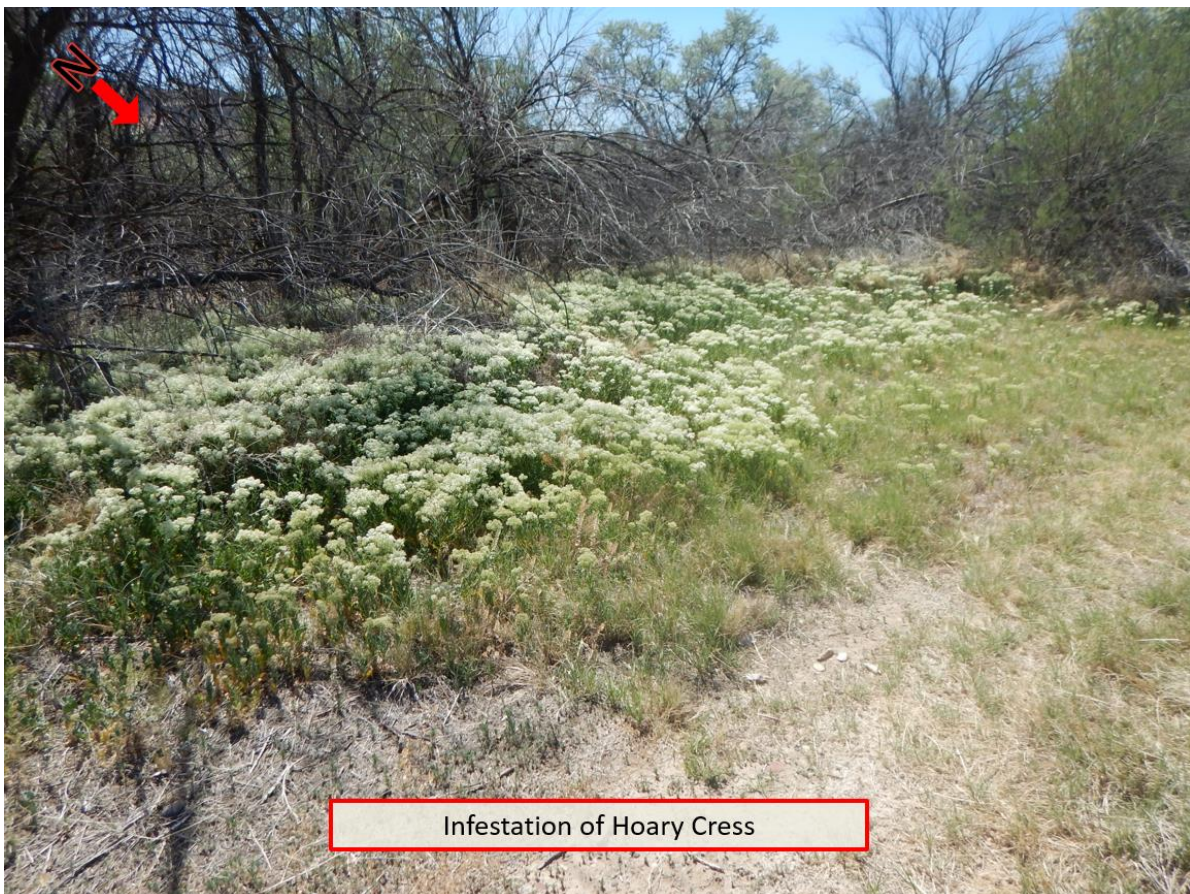
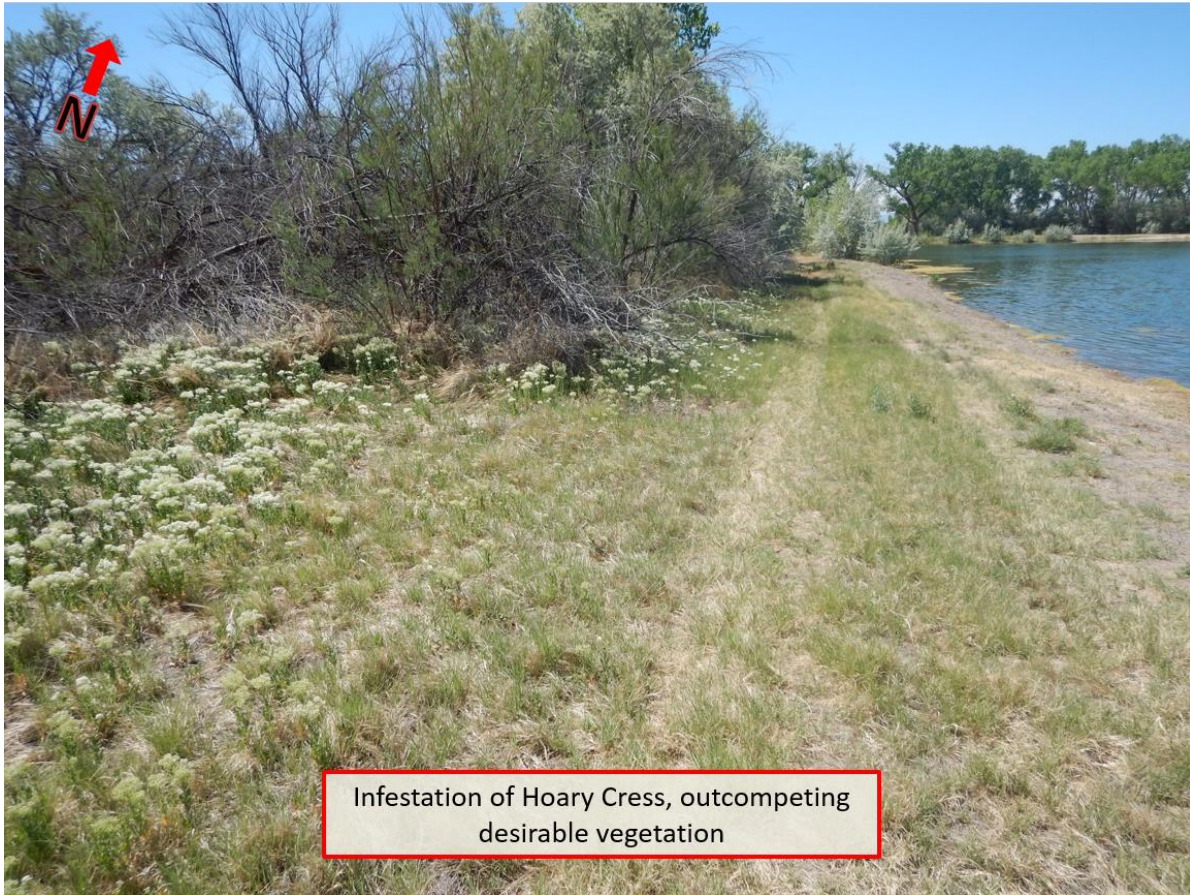
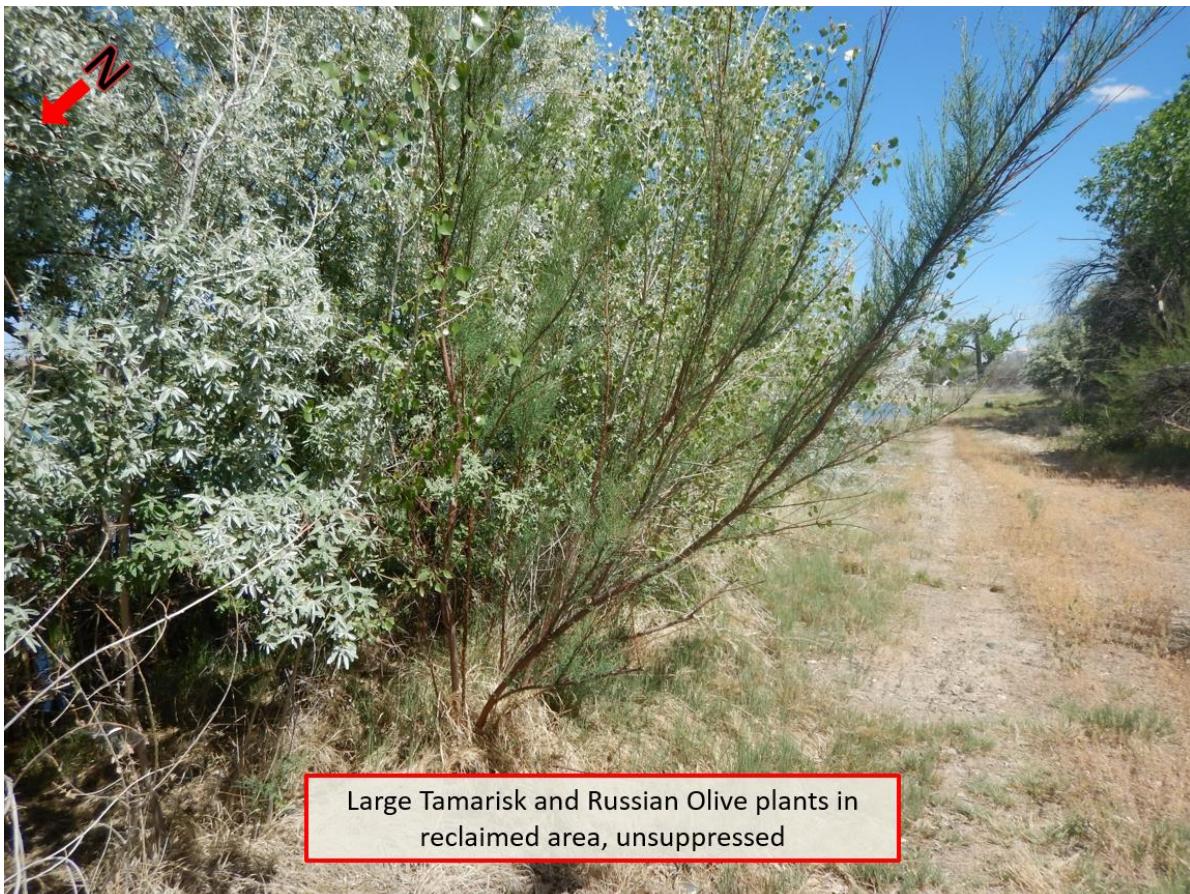
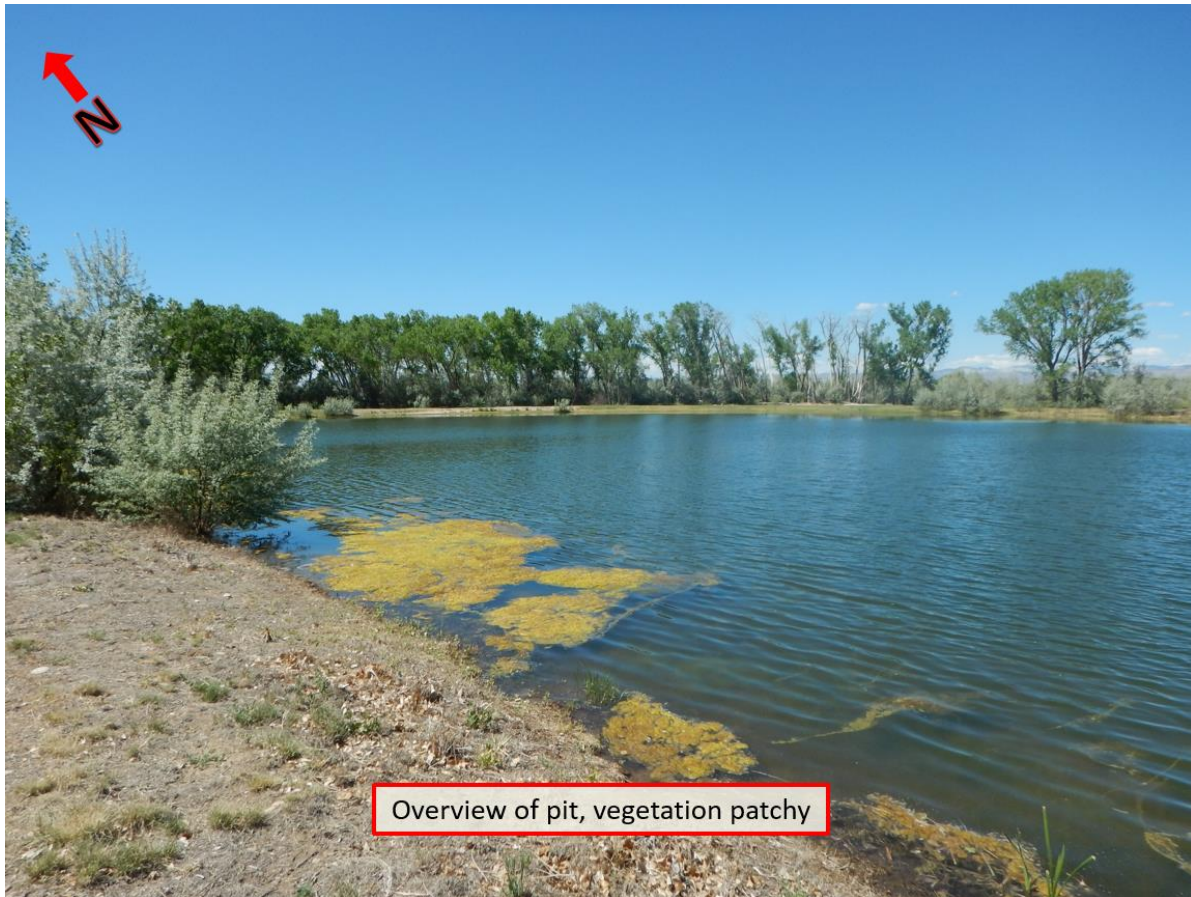
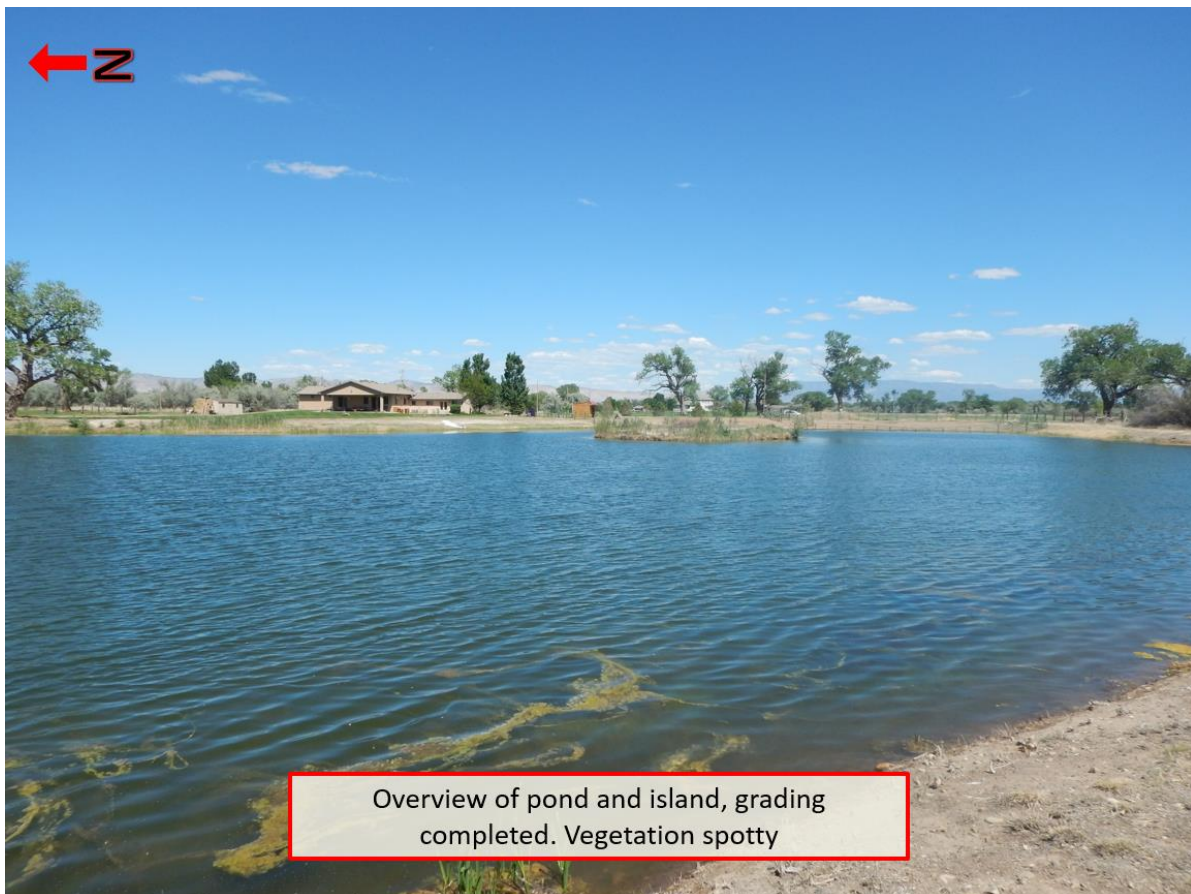
PHOTOGRAPHS

Most recently TR-3 was approved on March 14, 2018. TR-3 allows for up to an acre area of horse corrals to be apart of the post mining land use/ reclamation plan. This area was observed to be in place as depicted on TR-3 and supporting maps.

No equipment, fuel or other mining related debris is on site. All grading of slopes is complete. Mining has resulted in an irregular shaped pond with one small island. A two track road is permitted to remain post mining.

Vegetation establishment is spotty. In several areas the bare ground extends far past what would be a two track road. In other areas, slopes are bare up to the waters edge. Of the established vegetation nearly half is non desirable plants. Areas that appear to be once a part of the horse corral are void of vegetation. Patches of established desirable vegetation are being outcompeted by Hoary Cress. Additionally Russian Olive, Tamarisk and Alyssum were also present throughout the pit. This reclamation was completed after January 2005 therefore the operator needs to suppress these species. Noxious weeds is cited as a problem for failure to implement the approved noxious weed management plan. The operator shall provide photo document proof that spring weed treatments have occurred as per the approved plan. This site would also benefit from an additional round of seeding.

PROBLEM/POSSIBLE VIOLATION: Problem: There are state-listed noxious weeds present on site. This is a problem for failure to employ weed control methods for state listed noxious weed species within the permitted area, and to reduce the spread of weeds to nearby areas as required by Section 3.1.10 (6) of the rule.

CORRECTIVE ACTIONS: Implement approved weed control plan and provide proof to the Division that this has been done by the corrective action date.
