MINERALS PROGRAM INSPECTION REPORT

MINE NAME: West End Gravel Pit #1	MINE/PROSPECTING ID#: M-1994-011	MINERAL: Gravel	COUNTY: Montrose
INSPECTION TYPE: Monitoring	INSPECTOR(S): Dustin M. Czapla	INSP. DATE: May 22, 2018	INSP. TIME: 11:30
OPERATOR: West End Gravel Company	OPERATOR REPRESENTATIVE:	TYPE OF OPERATION: 112c - Construction Regular Operation

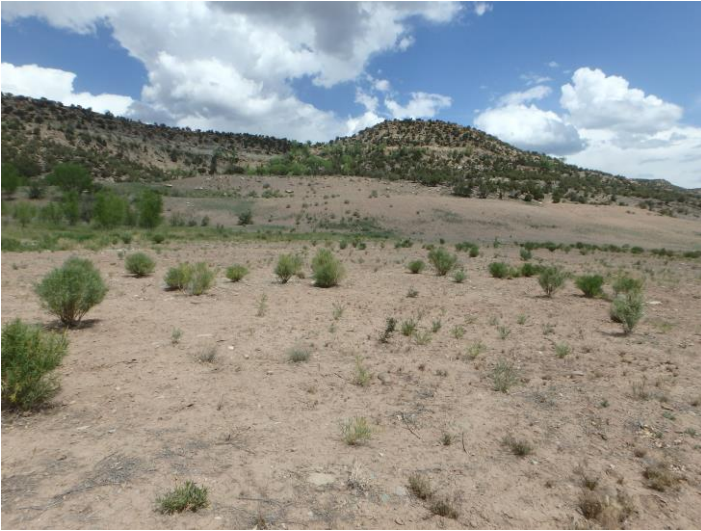
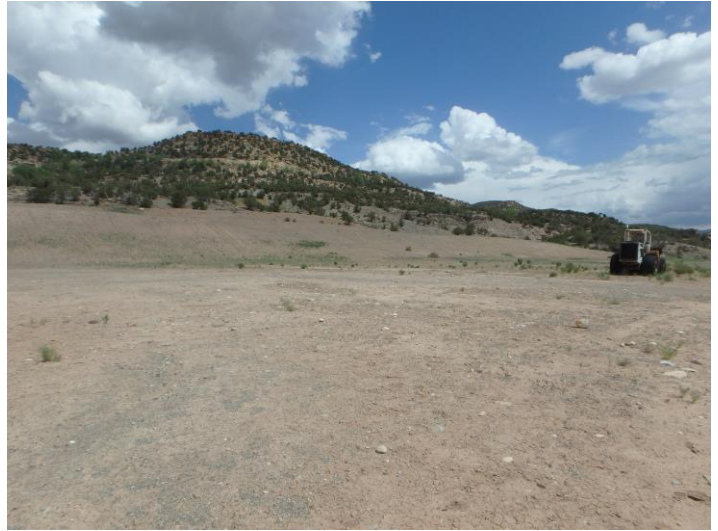
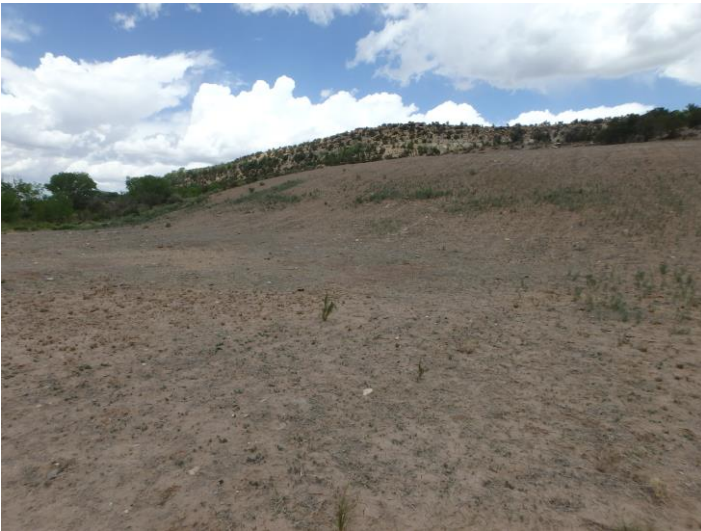
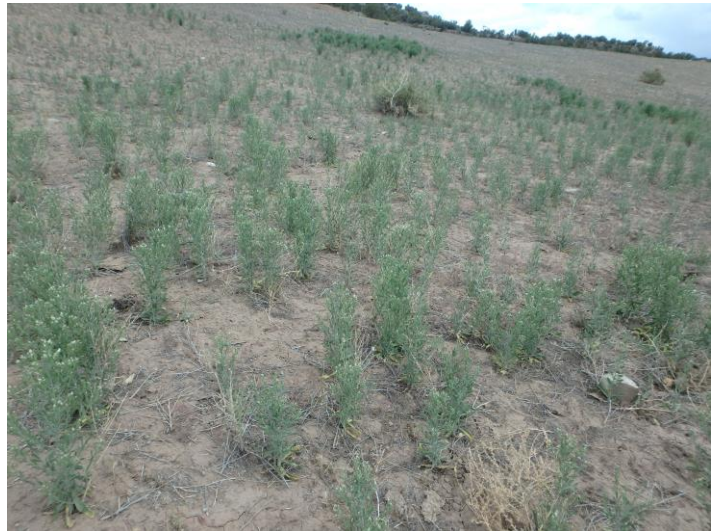
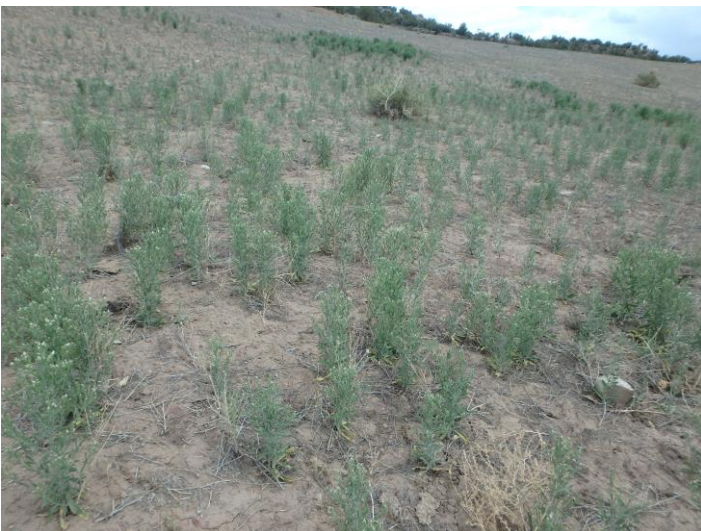
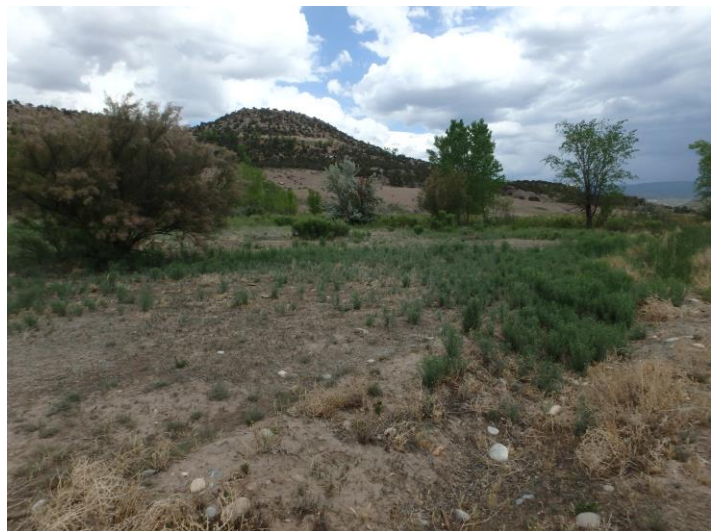
PHOTOGRAPHS

PROBLEM: A vegetative cover is not yet established at the site and reseeding efforts will be necessary. The site has been in final reclamation for greater than five years.

PROBLEM: Several infestations of knapweed were noted throughout the site.

On June 28, 2012 the Mined Land Reclamation Board found the operator in violation for failure to complete final reclamation of the site within five years of completion of mining, and ordered the operator to begin reclamation of the site. At this time all reclamation earthwork has been adequately completed. However, an adequate vegetative cover is not yet established. C.R.S. 34-32.5-116 (4)(f) requires that a diverse, effective and long-lasting vegetative cover be established that is capable of self-regeneration and is at least equal, with respect to extent of cover, to the natural vegetation of the surrounding area. Volunteer vegetation, such as sagebrush and rabbit brush, is becoming established in parts of the permit area, but the majority of the affected area remains barren of desirable vegetation. Reseeding the site will be necessary in order to reestablish vegetative cover at the site. Additionally, because of the lack of desirable vegetative cover, the site is susceptible to noxious weed infestations. Knapweed was noted throughout the site and should be treated immediately.

CORRECTIVE ACTIONS: Reseed the site in accordance with the approved reclamation plan. Provide documentation to the Division demonstrating that reseeding efforts have been completed.

CORRECTIVE ACTIONS: Treat the knapweed in accordance with the approved weed control plan. Provide documentation to the Division demonstrating the weed control efforts have been performed.
