Bureau of Land Management Kremmling Field Office Solid Minerals Inspection Report

General Information	
Date	6/22/2018
Project Name	Evenstad Trespass/Unauthorized Occupancy
Operator	Christopher Evenstad
Serial Number	COC-078704
Project Classification	Mineral Trespass and Unauthorized Mining-Related Occupancy
Project Location	T11N R81W Sec23, Jackson County
Inspection Purpose	Site inspection
Time Period Onsite	2 hours
Attendees	Jessica Lopez Pearce, BLM Geologist
	Darren Entrican, BLM Law Enforcement Officer
	Christopher Evanstad, mining claimant
	Eric McFarland, associate of mining claimant

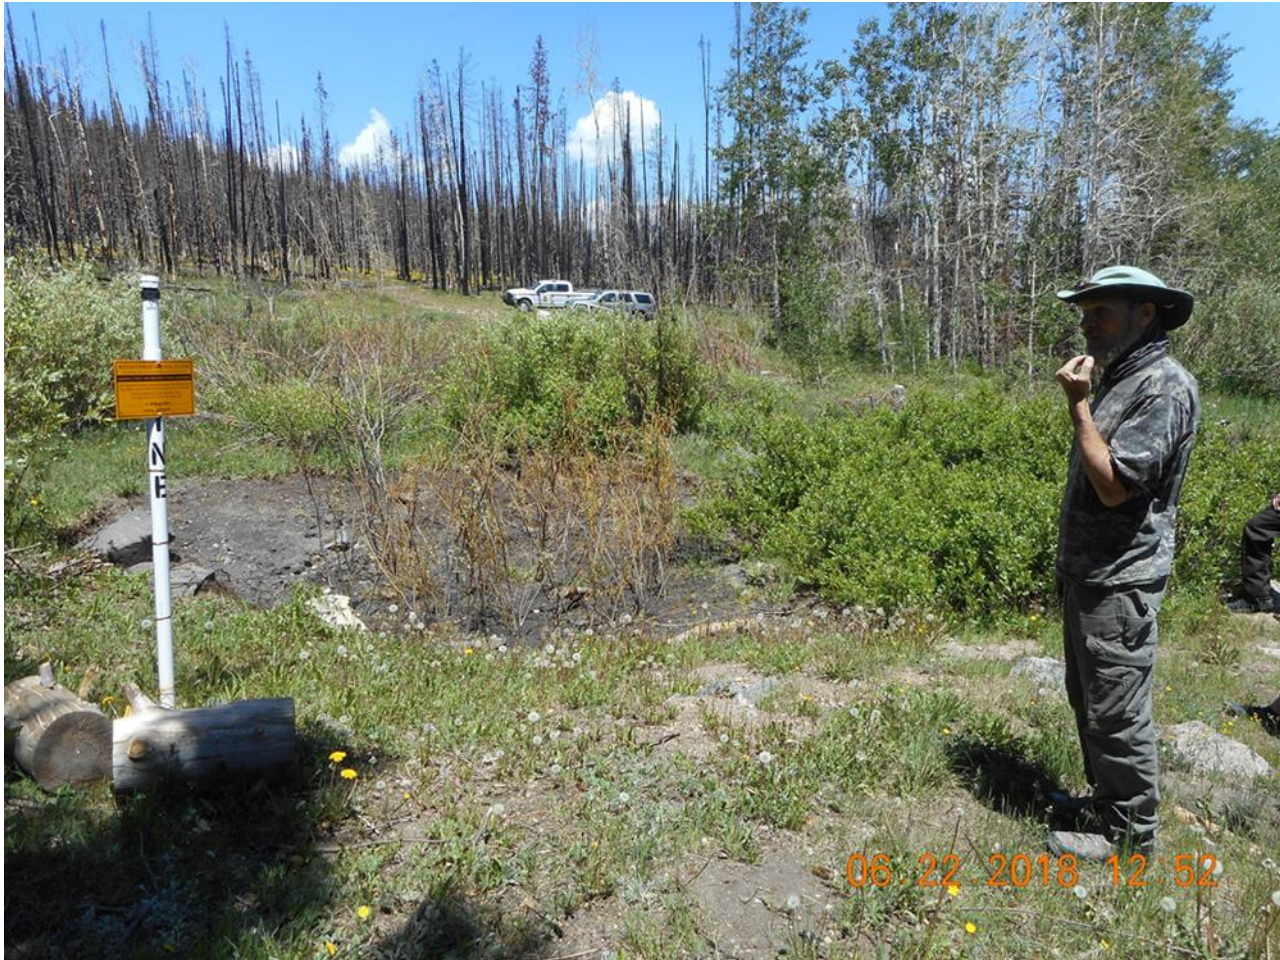
After an initial discussion about BLM regulations and required authorizations, Christopher Evanstad, Eric McFarland, Darren Entrican, and I walked around the reclamation. First, we walked over to the east side of Mitchell Placer pond, where I observed a shallow circular depression 15 feet in diameter with small willows within it. Christopher Evanstad stated that the hole used to be approximately 6 feet deep and he had recently backfilled the excavation and planted the willows and grasses. To the southeast of the backfilled excavation, there was a 3-foot tall white post that had the word "MINE" spelled vertically on it. This post is the claimant's discovery marker.

Photo 1. Looking northwest at reclaimed trench (center) and mining claim location marker (left).

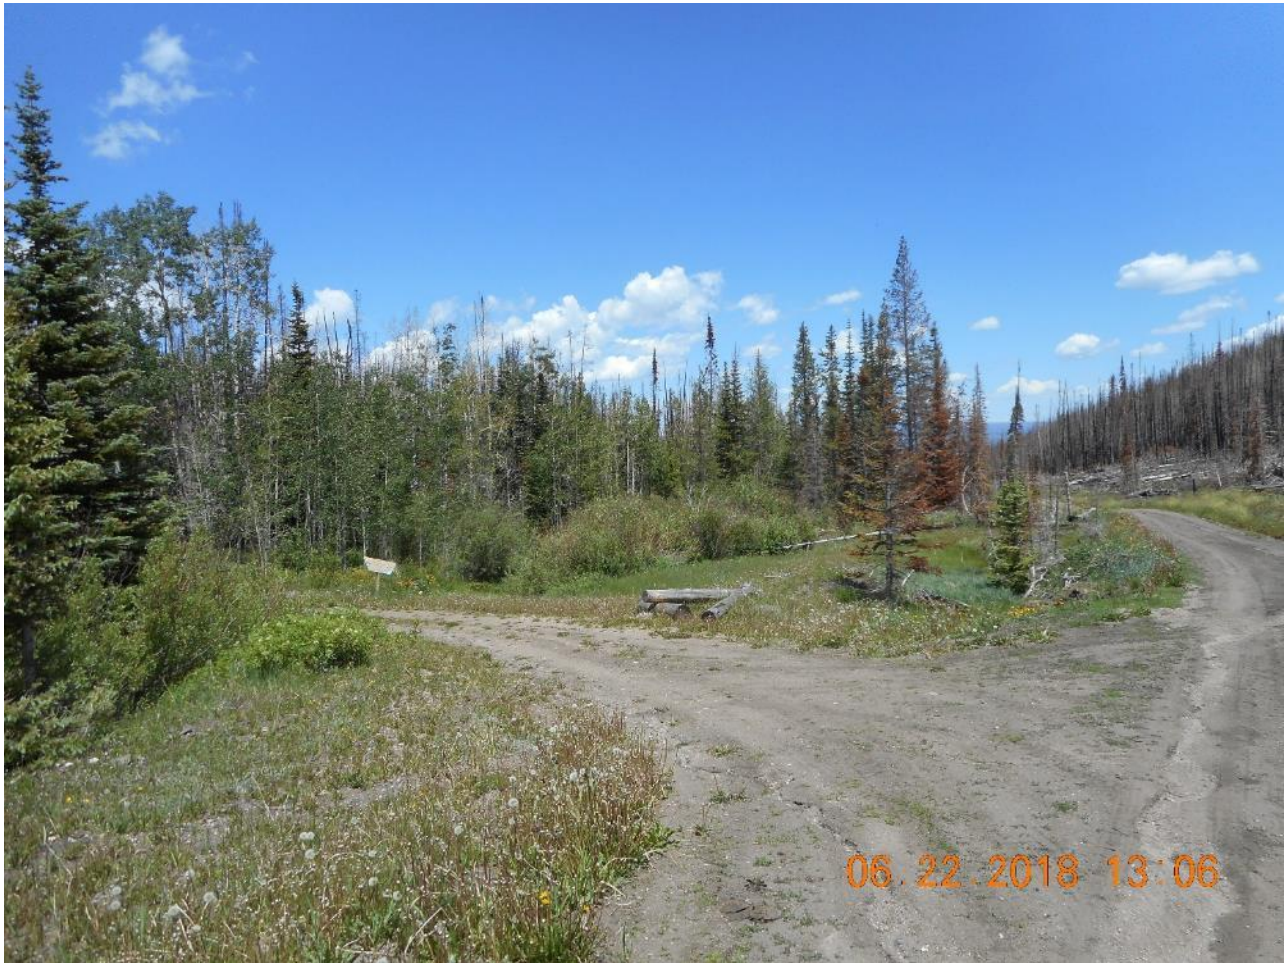
We then walked down to the site entrance at the junction of BLM Route 2510 (also known as Three Mile Creek Road) and BLM Route 2511 (which is designated and administrative use only). This was the former location of the unauthorized gate and signage that I observed on August 21, 2017. All of the 4-foot tall wooden posts with signs, the chain gate and wood posts, and associated signage and solar-powered lighting that were located on the west side of BLM Road 2510 were no longer present at the time of my inspection. Christopher Evanstad stated that these items were removed shortly after he received the BLM correspondence dated September 26, 2017.

Photo 2. Looking north to intersection of BLM Route 2510 (right) and BLM Route 2511 (left). The chain gate and signage that used to be located here has been removed.

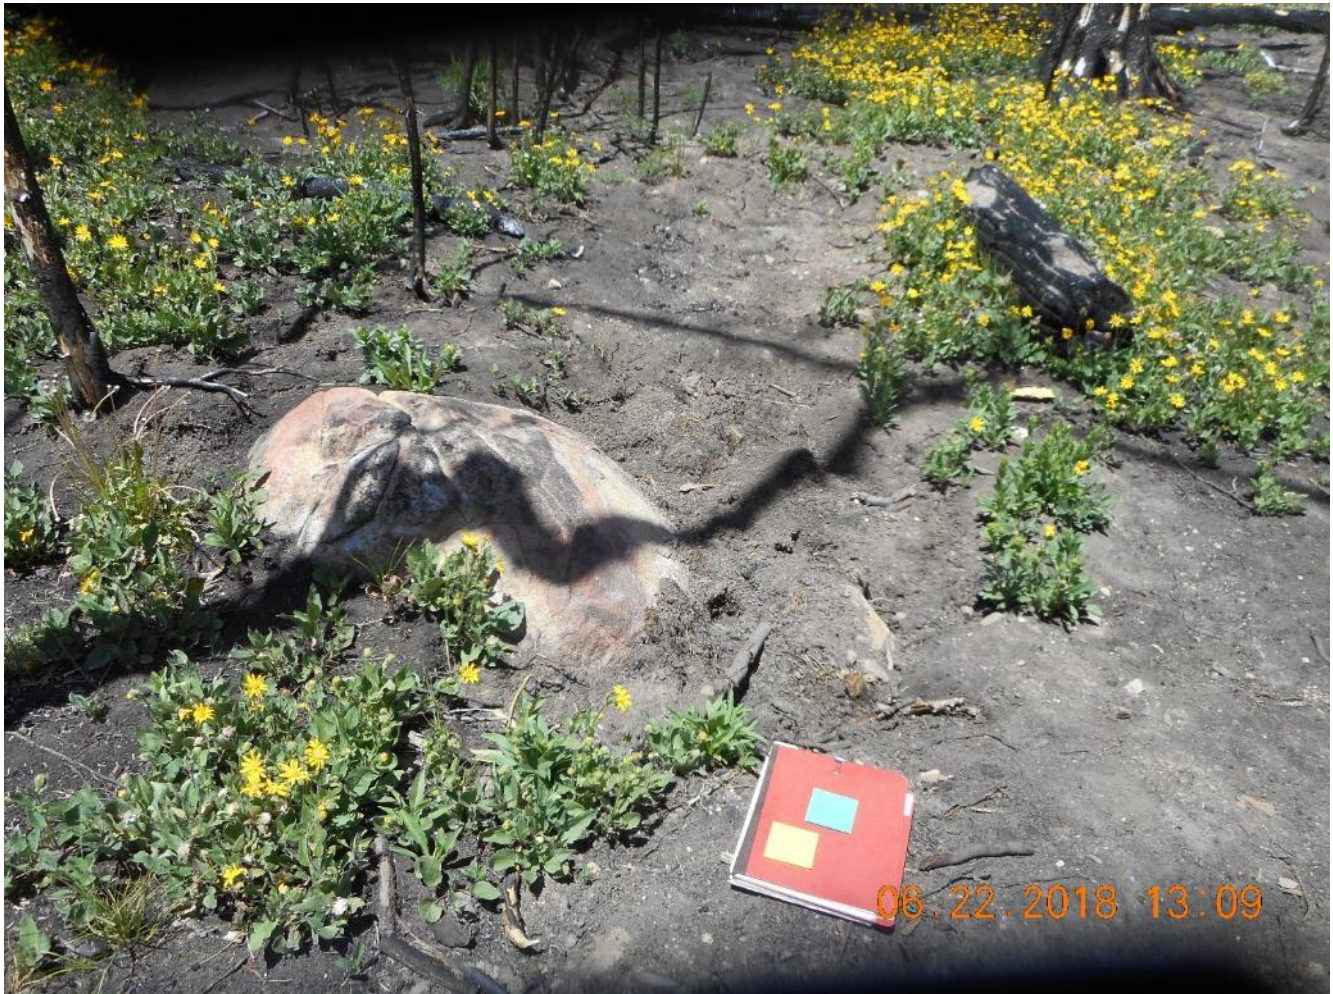
The group then walked north of the camp area and observed three smaller trenches that had been backfilled and/or regraded. The backfilled area for one trench was approximately 1 foot wide and three feet long. The two other trenches, which were side-cuts into a very large and previously excavated trench not associated with this operation, were approximately 1 foot wide and 2 feet tall.

Photo 3. North of the camp area, looking north to the reclaimed trench (right of the boulder). File for scale.

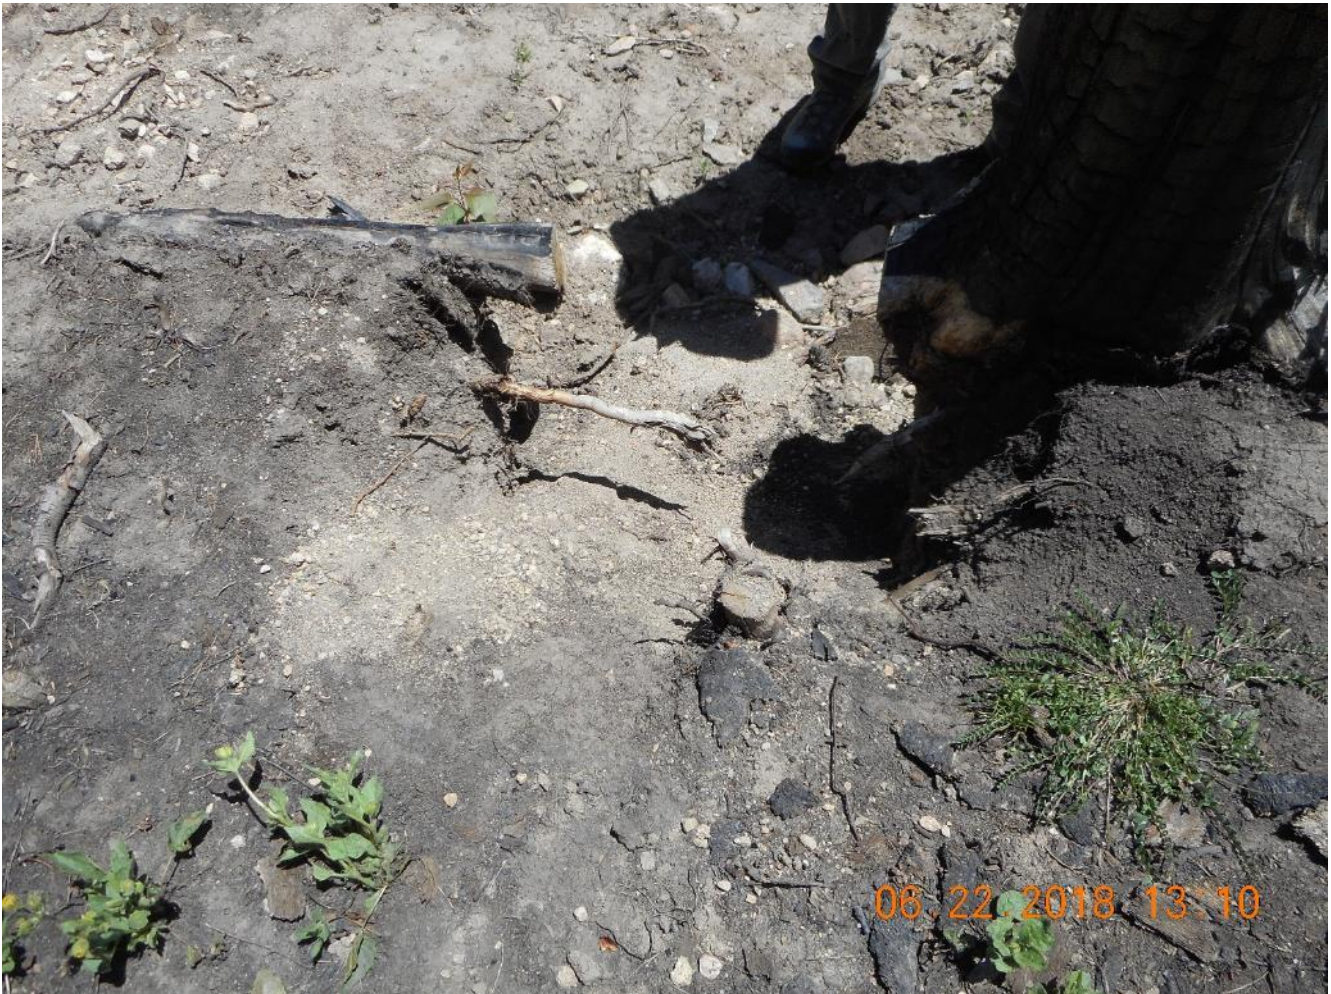
Photo 4. North of the camp area, looking east and downslope to the second reggraded trench.

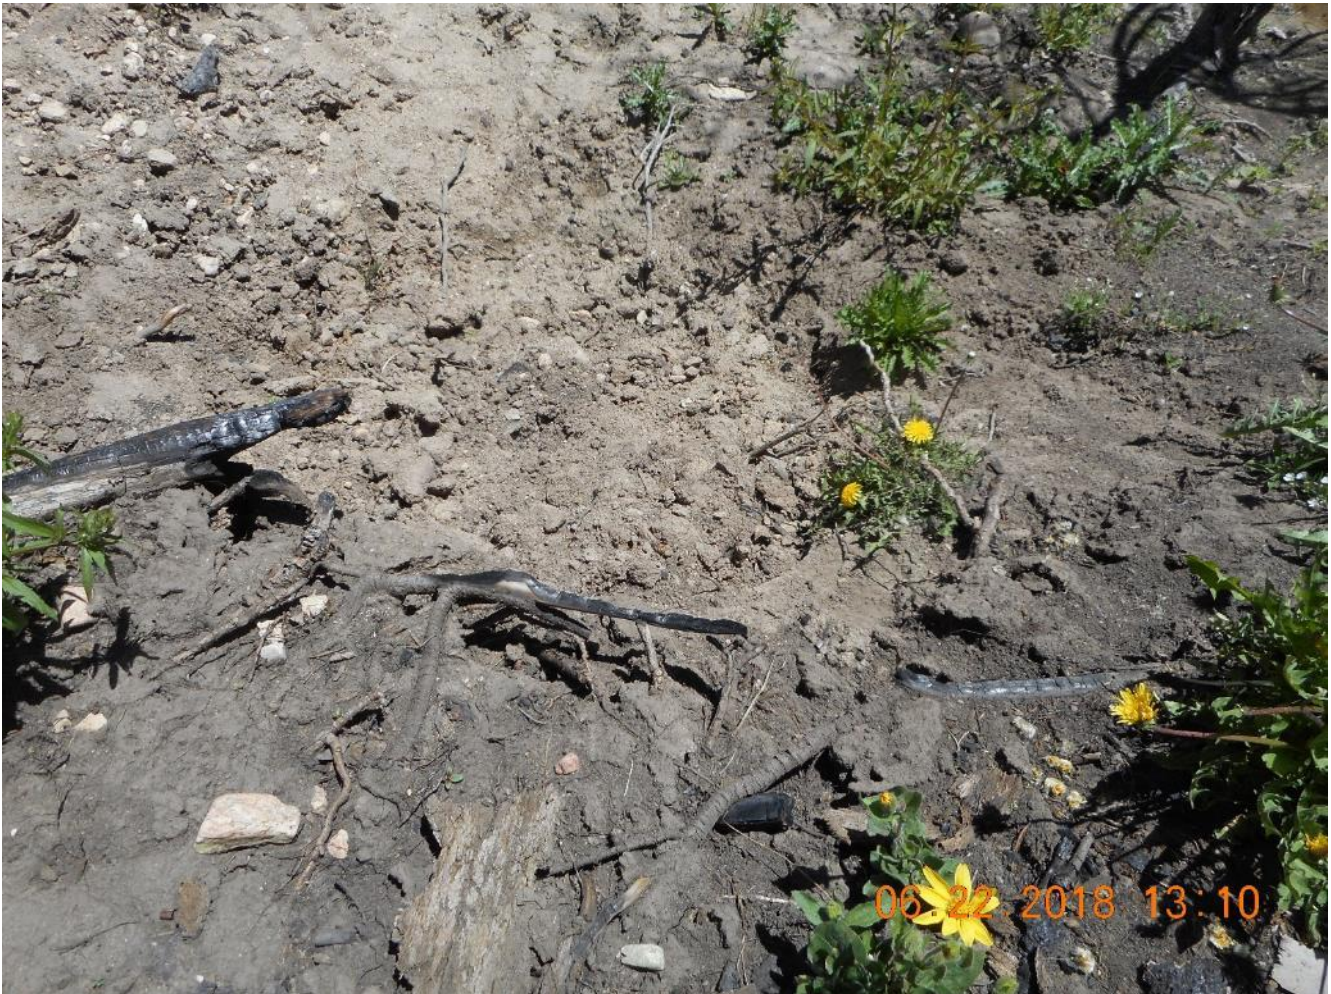
Photo 5. North of the camp area, looking east and downgradient to the third regraded trench.

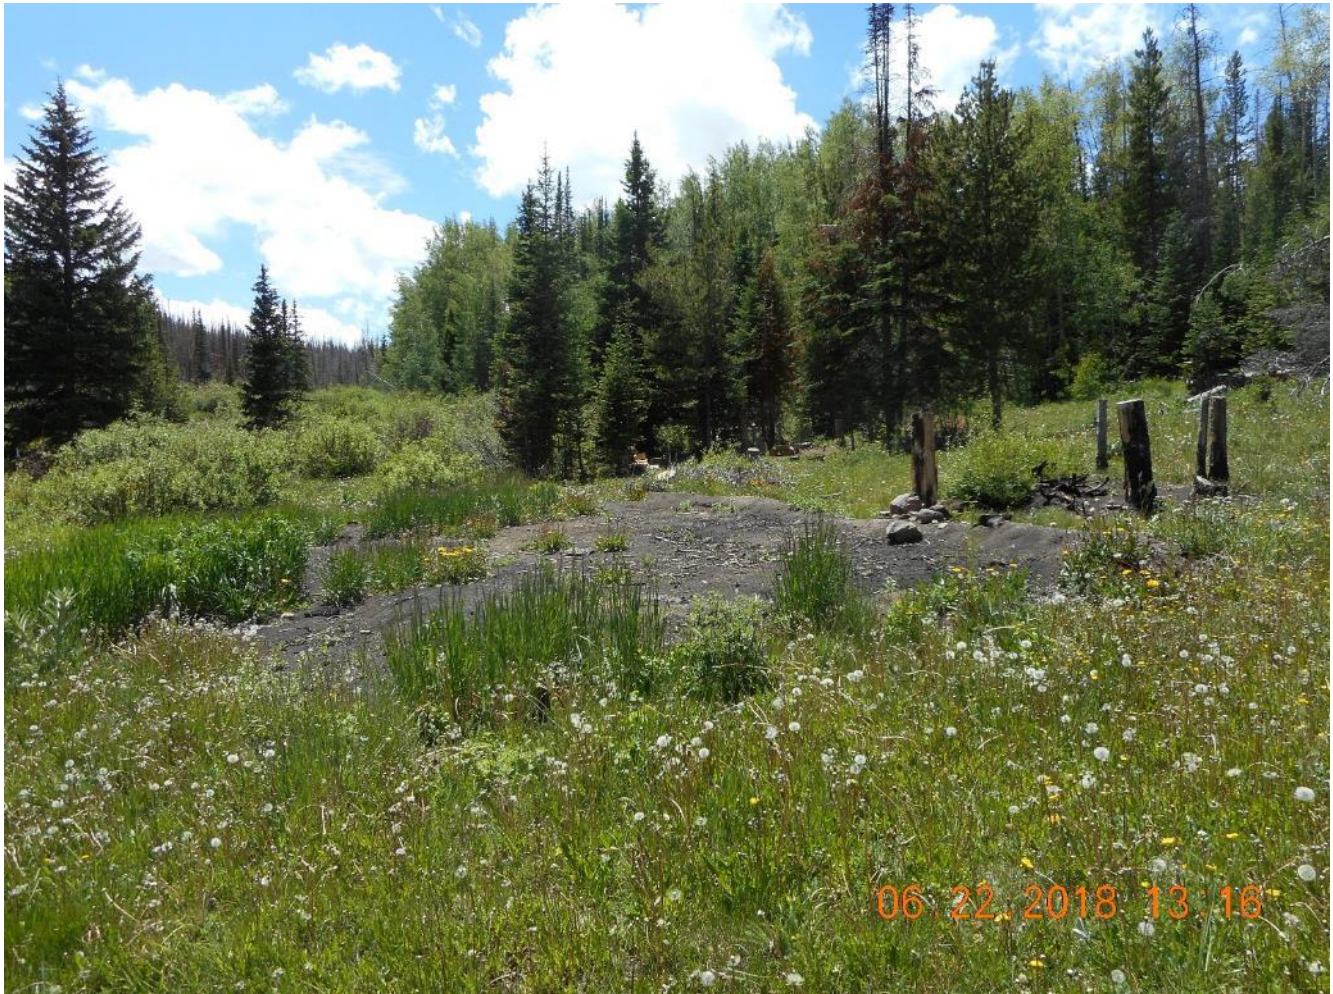
In the camp area, immediately south of BLM Route 2511 and approximately 200 feet west of BLM Route 2510, the items that I had observed during my August 21, 2017 inspection: a small, white, single-axle camper; a brown tarp that covered unknown items; a blue tarp; and a portable toilet in a 5-gallon bucket were no longer present. A rock fire ring and several tree stumps for seating or firewood remained.

Photo 6. Looking south from BLM Route 2511 to the camp area. The camper, equipment, and tarps that were observed during my August 21, 2017 inspection have been removed.

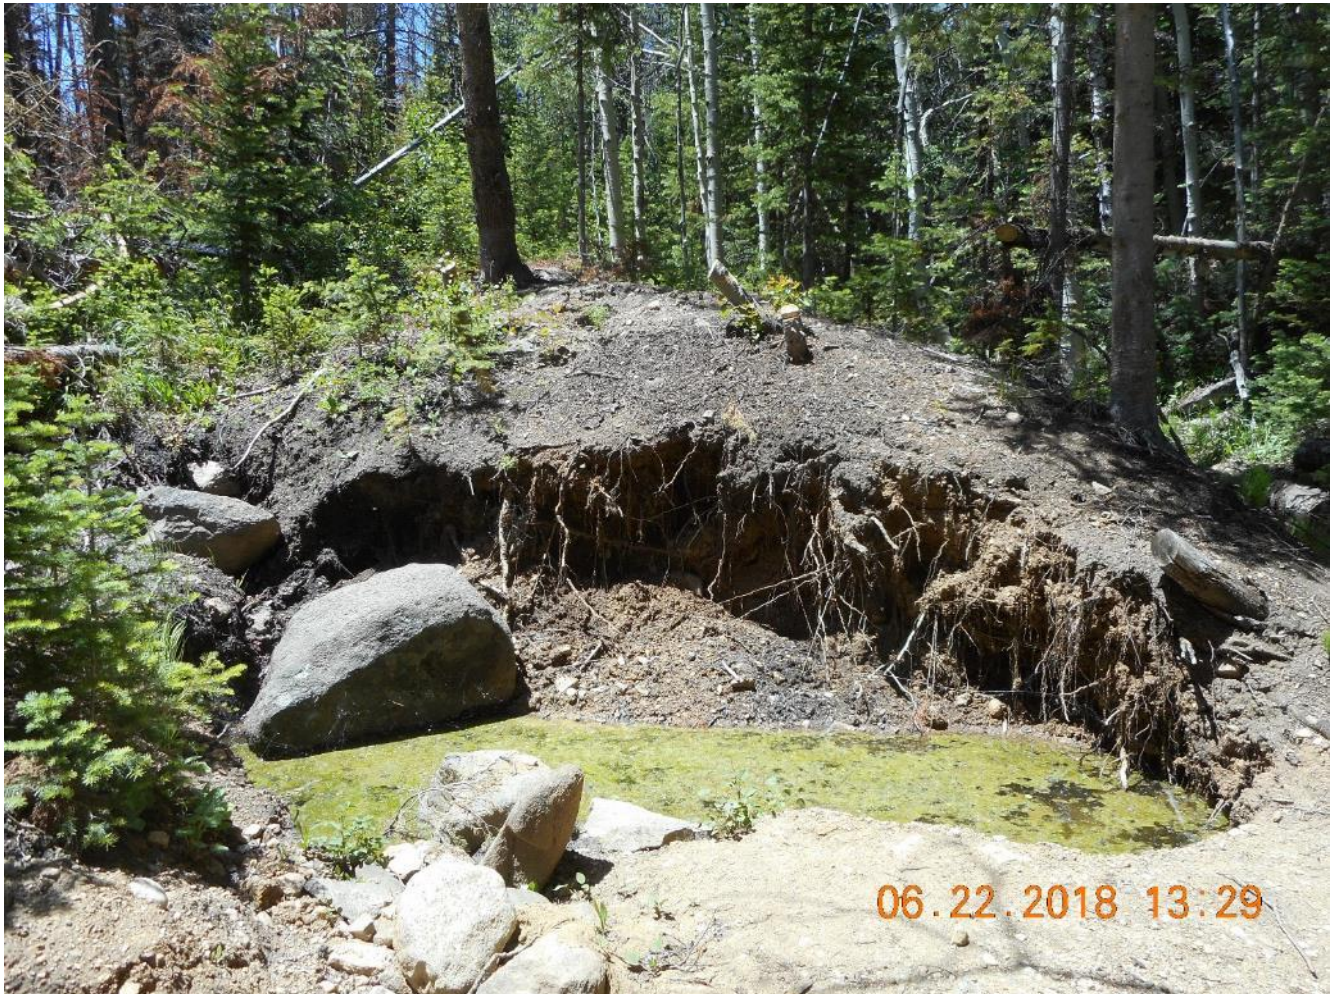
We then took an established path through the forest to an existing open trench. This trench was approximately 7 feet long, 3 feet wide, and 18 inches deep. It was located directly south of an unnamed seasonal stream and was filled with water and algae. Christopher Evanstad refused to backfill and reclaim this trench. He stated that he was working on this trench and it would make no sense to reclaim it before his exploration work was complete. I expressed to him that this open trench could not be considered casual use and he must submit a Notice for this operation as well as an occupancy request under 43 CFR 3715 for the proposed camp facilities. Additionally, a reclamation bond must be in place before this operation could be authorized.

Photo 7. Looking west to the open trench. This trench is not reclaimed and full of water and algae. It is directly south of an unnamed seasonal stream that runs west to east.

- The mining claimant, Christopher Evanstad, must immediately cease operations on the existing trench and submit to the Kremmling Field Office a Notice and occupancy request for the existing operation and proposed camp and signage facilities. An acknowledged Notice and occupancy concurrence are required before any surface disturbing activities exceeding casual use (as defined by 43 CFR 3809.5) and occupancy may occur.
