MINERALS PROGRAM INSPECTION REPORT

MINE NAME: Wattenberg Lakes	MINE/PROSPECTING ID#: M-2004-051	MINERAL: Aggregate	COUNTY: Weld
INSPECTION TYPE: Monitoring	INSPECTOR(S): Peter S. Hays	INSP. DATE: June 28, 2018	INSP. TIME: 12:30
OPERATOR: Aggregate Industries - WCR, Inc.	OPERATOR REPRESENTATIVE: Connie Davis, Christine Felz	TYPE OF OPERATION: 112c - Construction Regular Operation	
REASON FOR INSPECTION: Normal I&E Program	BOND CALCULATION TYPE: Complete Bond	BOND AMOUNT: \$520,000.00	
DATE OF COMPLAINT: NA	POST INSP. CONTACTS: None	JOINT INSP. AGENCY: None	
WEATHER: Clear	INSPECTOR'S SIGNATURE:

The Wattenberg Lakes site was inspected by Peter Hays with the Division of Reclamation, Mining and Safety (Division/DRMS) as part of the Division's monitoring inspection program. Mrs. Connie Davis and Mrs. Christine Felz with Aggregate Industries, Inc. were present during the inspection. The site was previously inspected by the Division on December 1, 2014. An inspection map created following the inspection is attached.

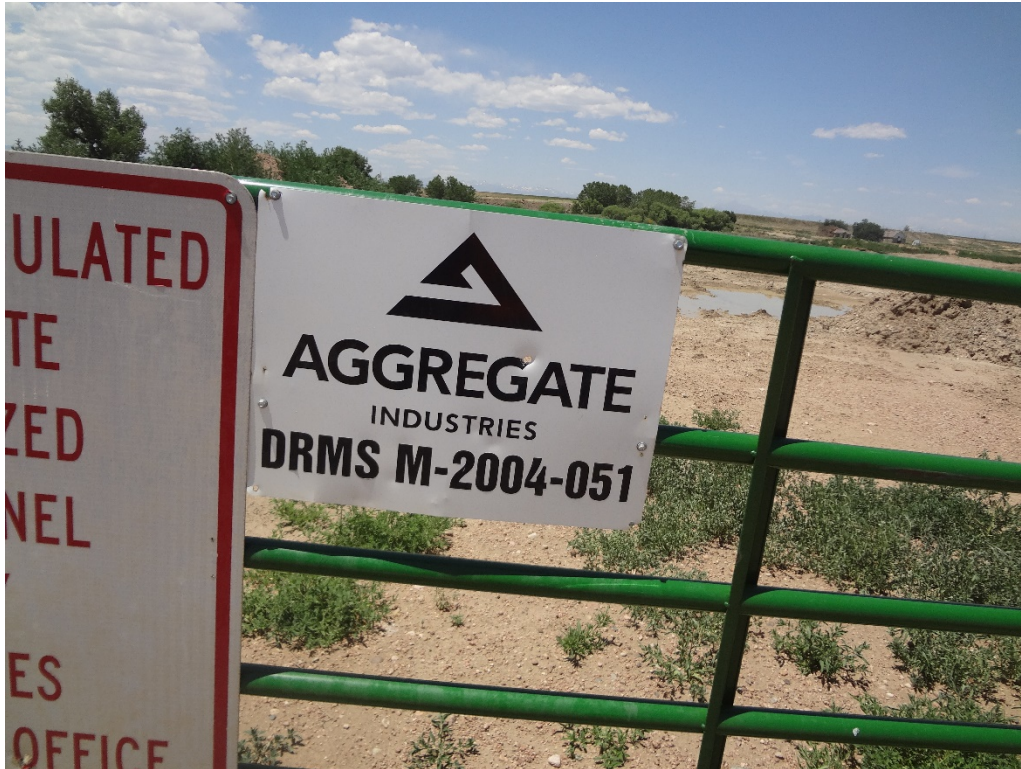
The Wattenberg Lakes 112c permit was issued with conditions by the Division on February 10, 2005. The site is permitted for 420.8 acres with 245 acres of mining disturbance. No revisions to the original Mining and Reclamation Plans have been submitted by the Operator. The Operator is required to notify adjoining landowners, including Peter L. Baurer and Carl C. Eiberger, of any technical revisions submitted to the Division per the permit approval stipulation. The Operator has recently purchased the Baurer property. The site entrance has moved since the last inspection. The entrance is now from CR 23 ½, instead of from CR 23 ¾. The required mine sign was observed at the entrance gate and the site boundaries were well defined pursuant to Rule 3.1.12.

Wattenberg Lakes mine sign

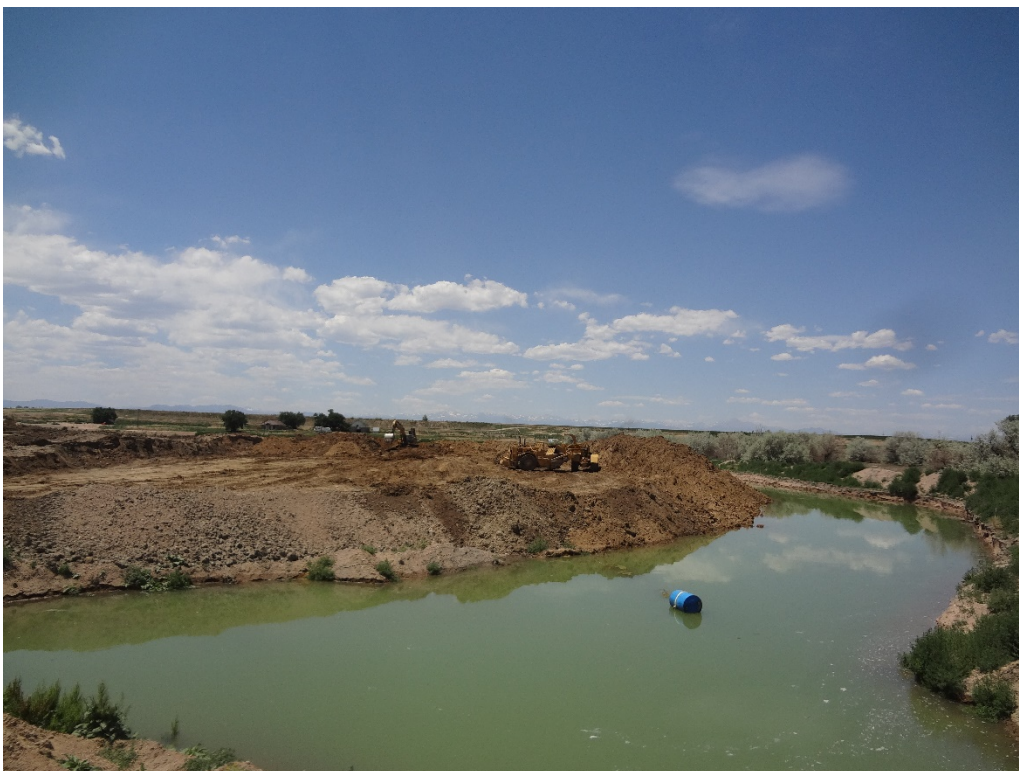
Phase 1 / Mining Area 3 – The phase has been mined and was being backfilled with mud material from Phase 2 / Pond 1. The final grade to create the approved wetland mitigation area reclamation will occur later according to the Operator.

Phase 1 / Mining Area 3 backfill activity looking SW from NW corner of phase

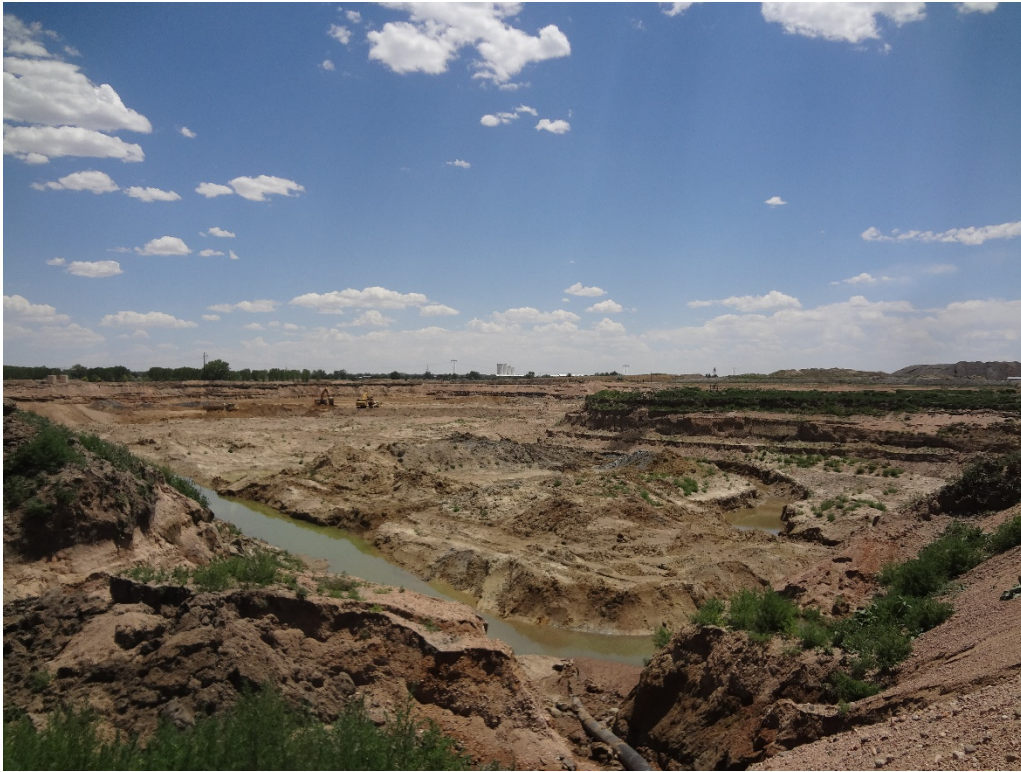
Phase 2 / Pond 1 Mining Area – The phase was actively being mined during the inspection. An approximately 8 foot thick seam of mud was discovered between the sand and gravel resource in the phase. The mud was being transported to Phase 1 / Mining Area 3 to backfill the phase to the approved wetland mitigation area reclamation. The depth of excavation was estimated at 25 feet. The cell was being dewatered during the inspection.

Phase 2 / Pond 2 Mining area from the NW corner looking SE

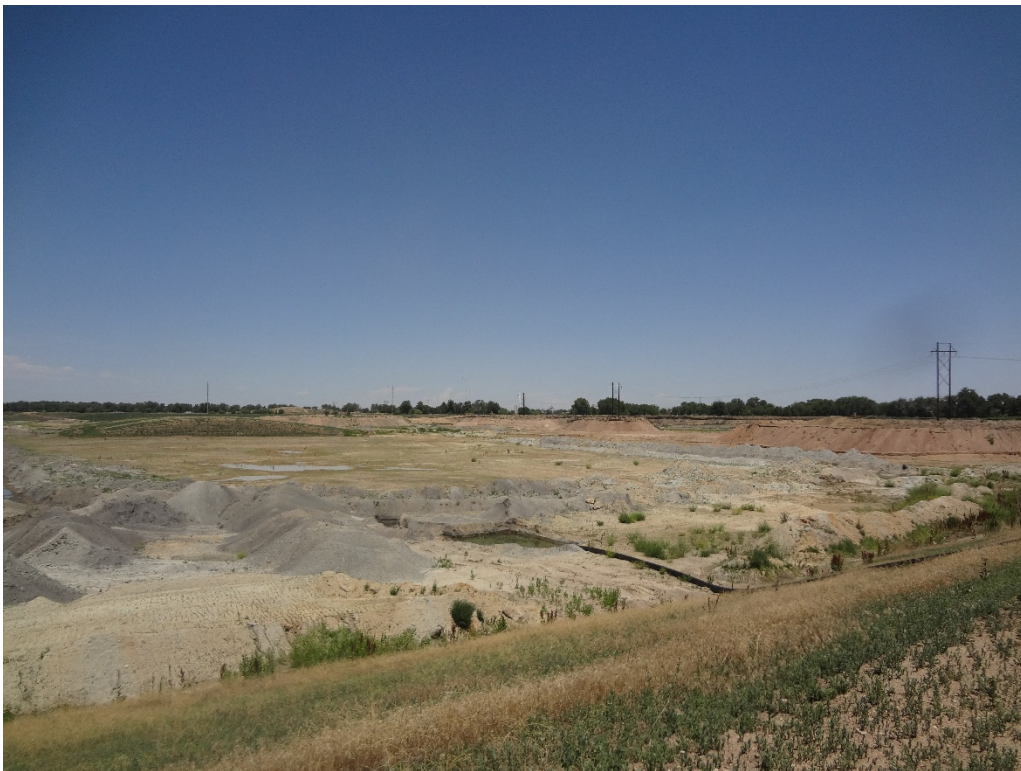
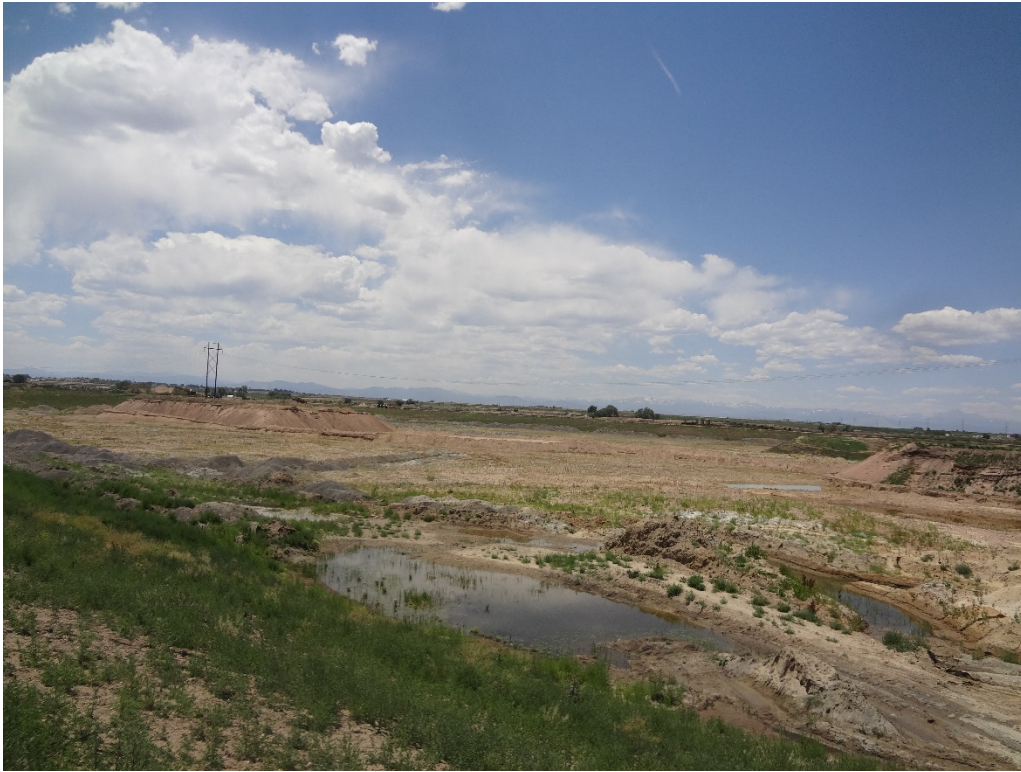
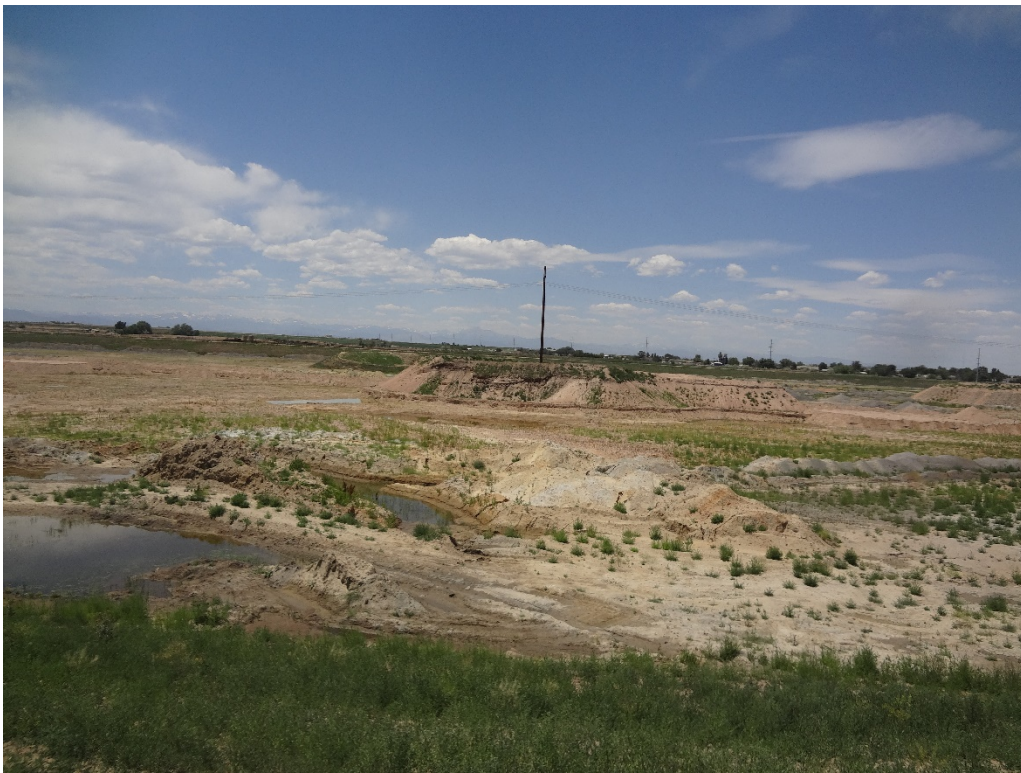
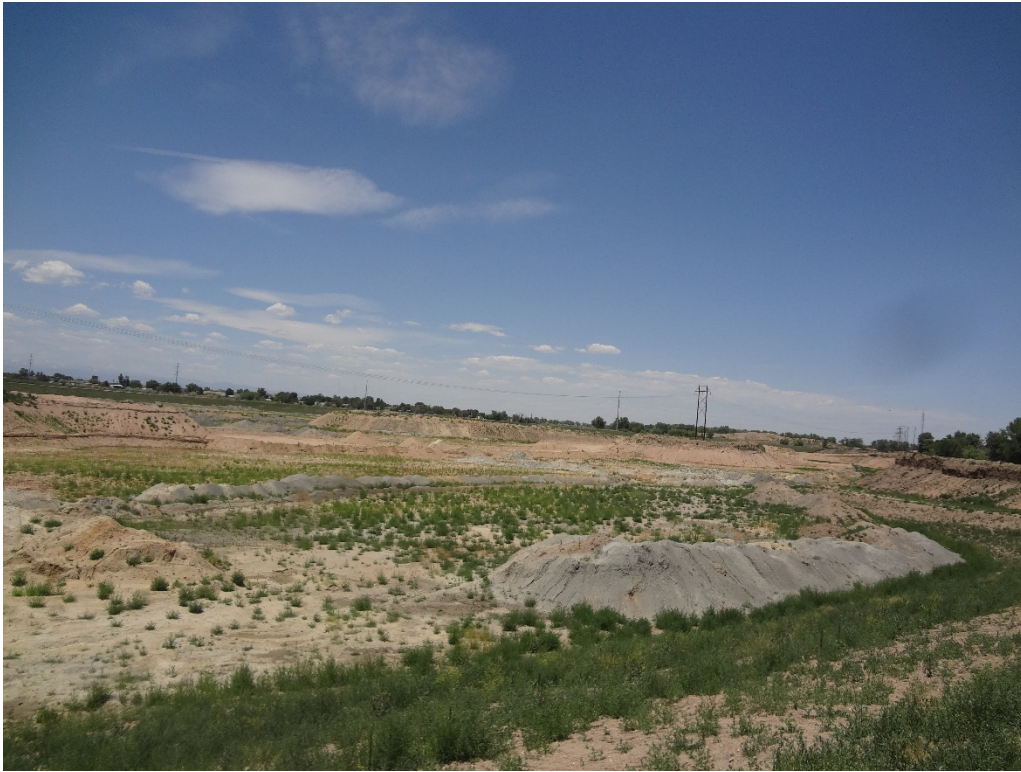
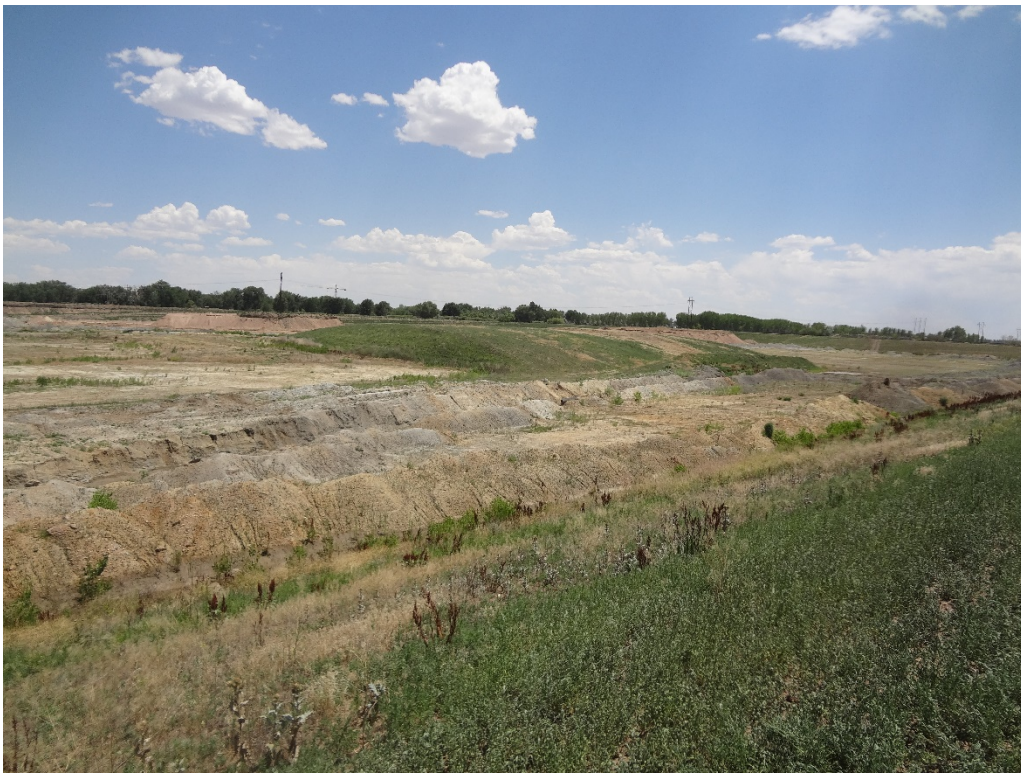
Phase 3 / Pond 3 Mining Area – The phase is mostly mined out except for the powerline islands around the power poles. The perimeter highwalls have been graded to the final 3H:1V slope except for a 1000 foot section of highwall south of the conveyor along the east side of the phase. Stockpiles of overburden and topsoil to complete the reclamation of the remaining highwall were observed on the pit floor. The Operator is working on an agreement with Xcel Energy to move the powerline along the west side of the phase to allow the remaining island to be excavated. The slurry wall around Phase 3 – Pond 3 was installed in 2013. T-posts indicating the centerline of the slurry wall were observed during the inspection. The Division does not have proof of SEO approval of the slurry wall. The approved mining plan states an offset of 40 feet will be maintained from the slurry wall. The required Platte River offset of 200 feet was not confirmed during the inspection, since mining activity did not appear to be closer than 300 feet from the river.

Phase 3 / Pond 3 Mining Area from south side looking NE

Phase 3 / Pond 3 Mining Area from east side looking SW

Phase 3 / Pond 3 Mining Area from east side looking west

Phase 3 / Pond 3 Mining Area from east side looking NW

Phase 3 / Pond 3 Mining Area from west side looking SE

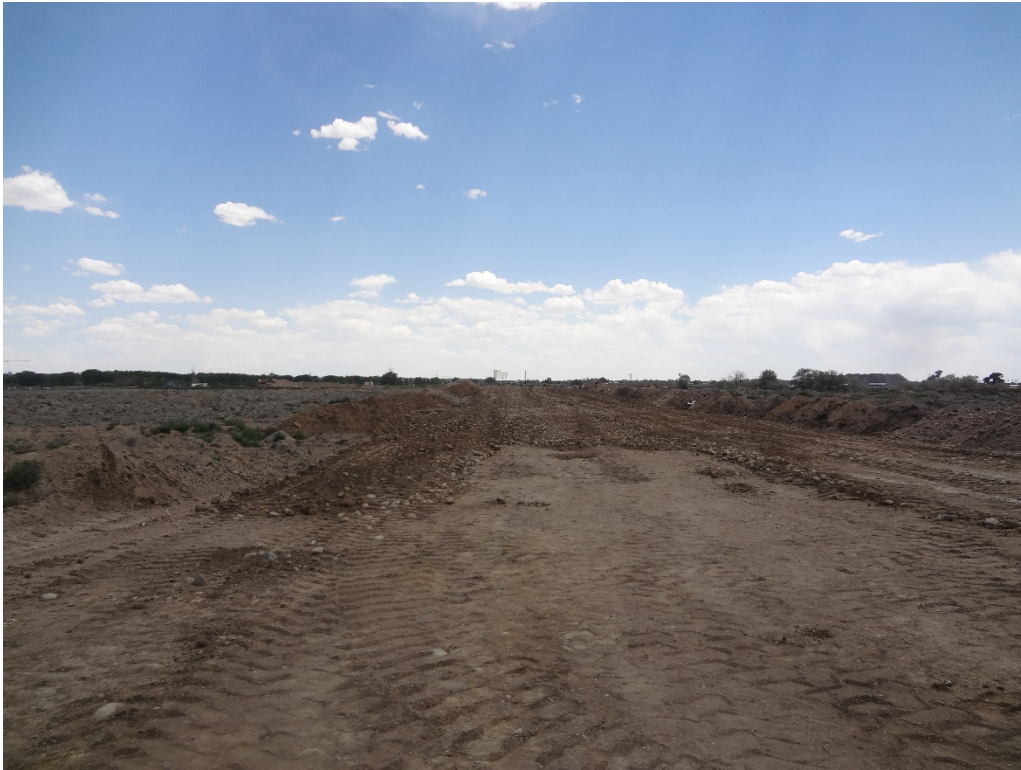
Phase 1 / Mining Area 2 – The phase has been mined and backfilled by the Operator. A road has been built through the phase to access Phase 1 / Pond 2. The final grade to create the approved wetland mitigation area reclamation will occur later according to the Operator.

Phase 1 / Mining Area 2 from north side looking south

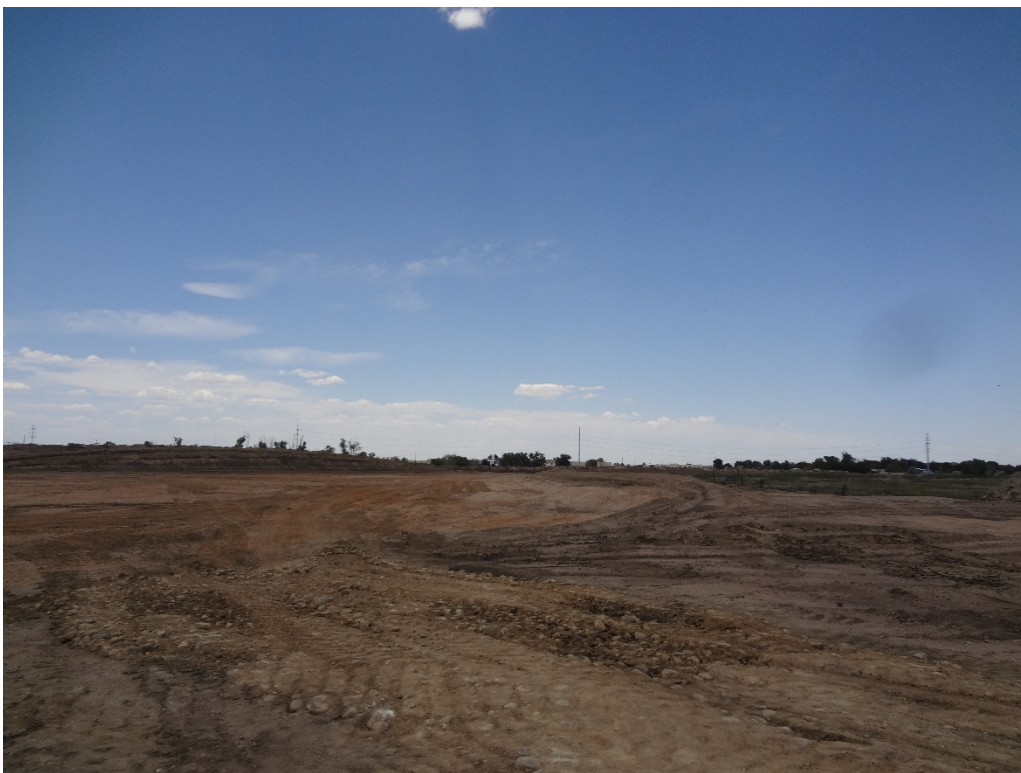
Phase 1 / Pond 2 Mining Area – The phase has been stripped of topsoil and overburden south, east and northeast of the oil and gas well. The topsoil was stockpiled around the perimeter of the phase. The overburden was stockpiled south of the oil and gas well on the stripped sand and gravel surface. The Operator intends to concurrently reclaim the phase as mining progresses. The Operator stated the phase will be backfilled instead of lined to create a reservoir as currently approve in the Reclamation Plan. The Division will require the Operator to update the Reclamation Plan in the future to reflect the change. The Operator stated the oil and gas wells in Phase 1 / Pond 2 mining area might be abandoned by the oil and gas company.

Phase 1 / Pond 2 Mining Area from south side looking north
