**Minerals Plan of Operations Inspection**  
**U.S. Department of the Interior**  
**Bureau of Land Management**  
**Royal Gorge Field Office**

<b>Date:</b> 08/10/2018 <b>Time:</b> 11:24 am <b>Weather:</b> Sunny	<b>Operation Name:</b> Gold Tamers-Field of Dreams Mine <b>Operator:</b> Gold Tamers <b>Case Number:</b> COC73930 <b>CDRMS #:</b> M-2009-056
<b><u>Attendees</u></b> BLM: Amber Sanderson & Sam Marolt  Operator(s): Contacted, but not present  Other(s): None	<b><u>General</u></b> Operation(s) are in compliance with documentation on file <input type="checkbox"/> Yes <input checked="" type="checkbox"/> No <input type="checkbox"/> N/A Operation(s) and disturbance on-site coincide with the operations and access on file <input type="checkbox"/> Yes <input checked="" type="checkbox"/> No <input type="checkbox"/> N/A

**Inspection Purpose:** ☐ Pre-Operations ☒ General ☐ Final ☐ Trespass ☐ Complaint

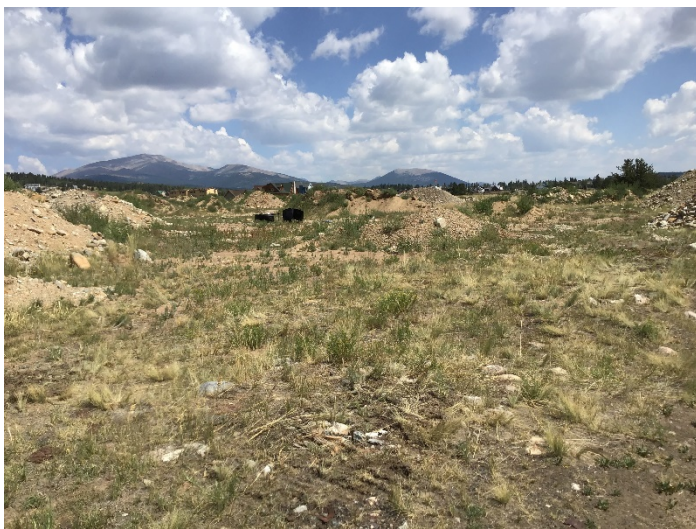
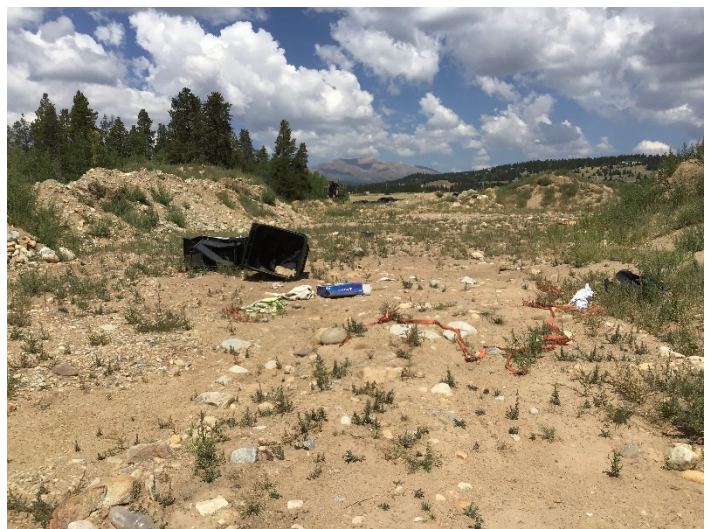
**Image 1:**

Comment: Camper trailer and porta-potty removed, however housekeeping still in non-compliance (e.g. old grill and dumped over garbage can)

3.d. Some of the trash and other mining related materials have been picked up and removed from the site to correct non-compliance item #6, however there is still quite a bit of trash and mining related materials being improperly stored and managed at the site (Refer to map and images below).

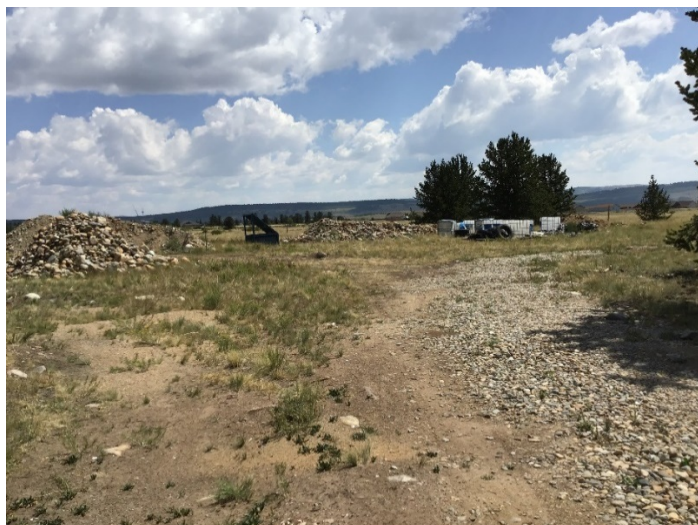
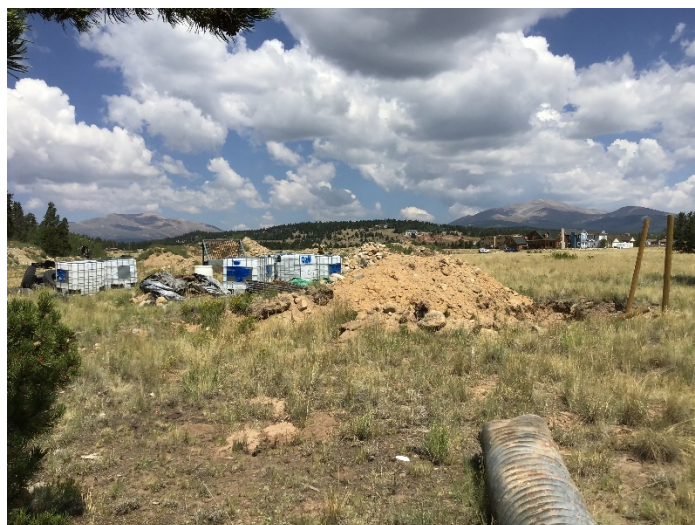
**Image 2:**

Comment: Area where generators, batteries and propane tanks were concentrated (Non-compliance item #3 & #5)

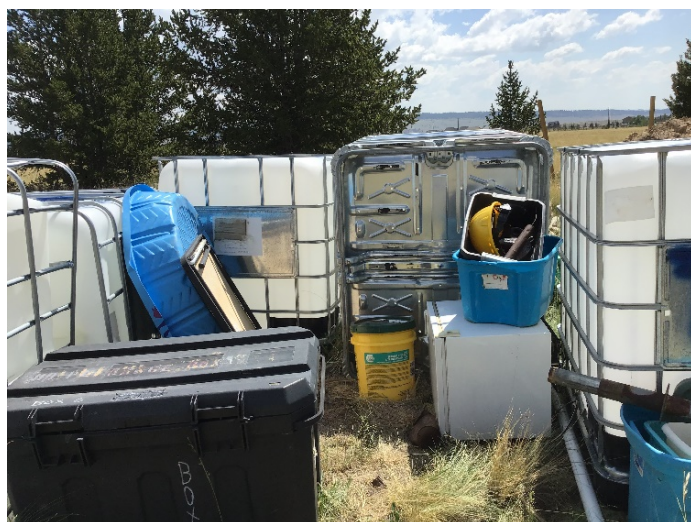
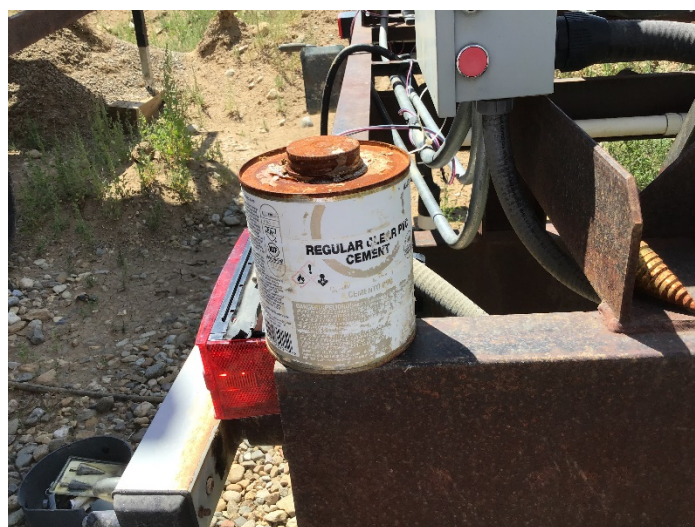
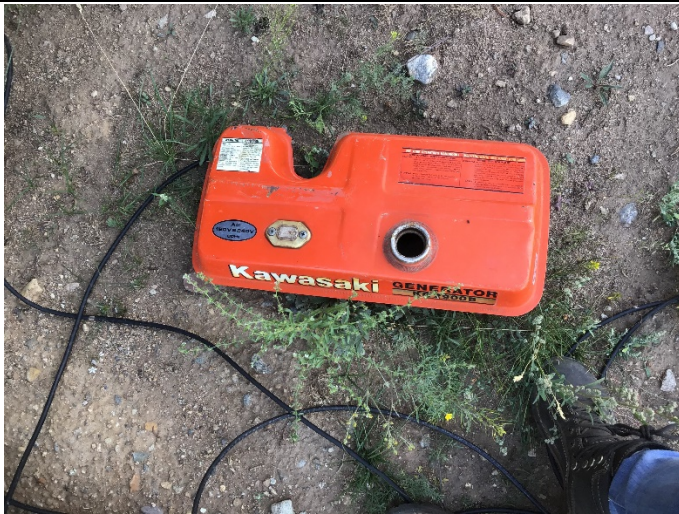
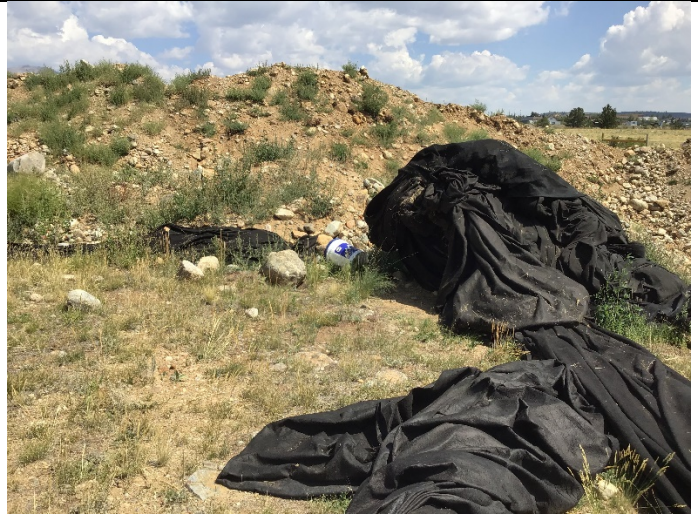
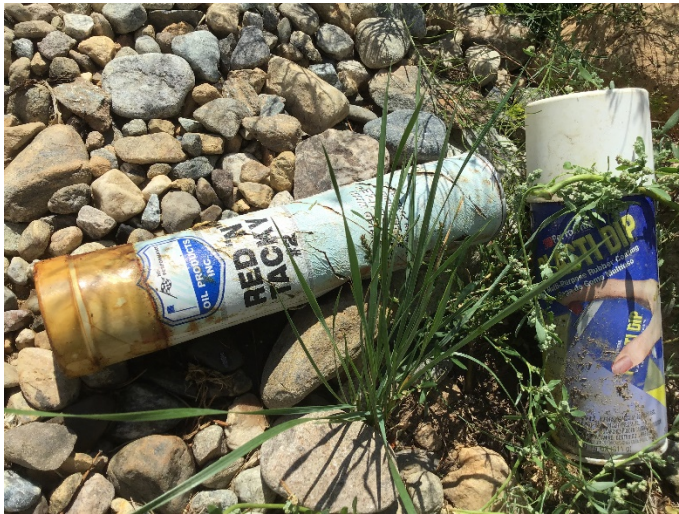
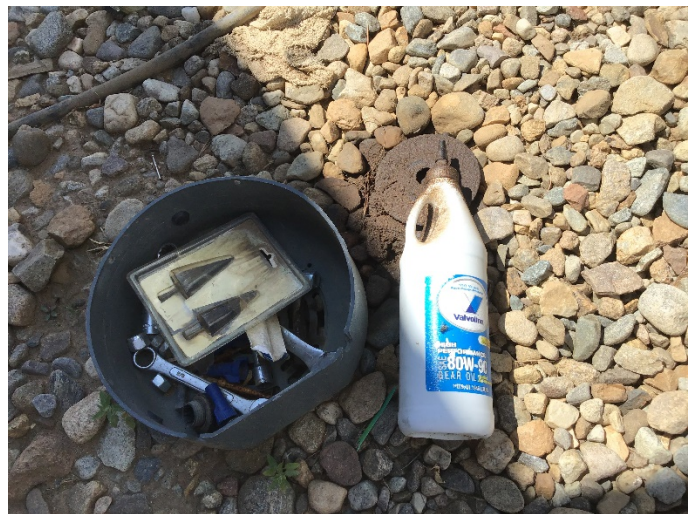
**Image 3:**

3.a. A majority of the POL containers have been removed from the site to correct non-compliance item #4, however, there are still some containers remaining (Refer to map and images below).

Comment: POL containers at the site (Non-compliance item #4)

#4 Matt stated all items were removed. BLM verified and documented PARTIAL compliance with this item, as some POL containers are still improperly stored and managed across the site. Pictures will need to be provided to BLM to finalize compliance status.

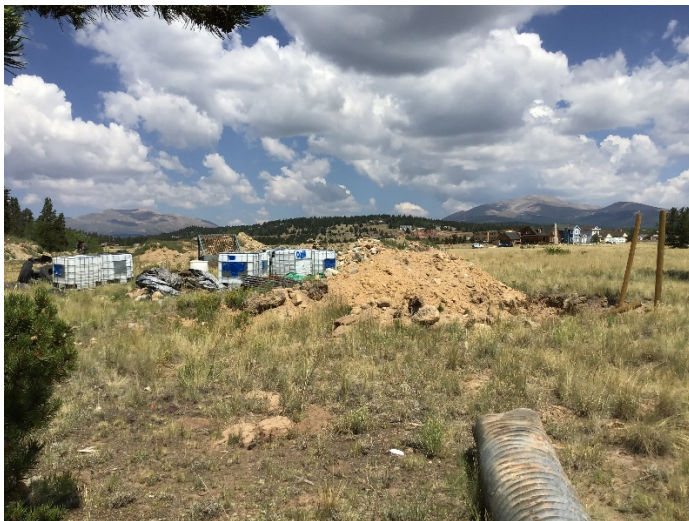
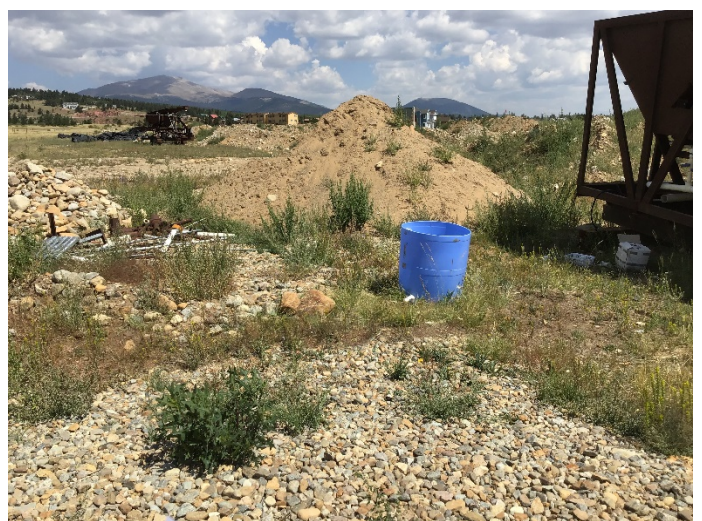
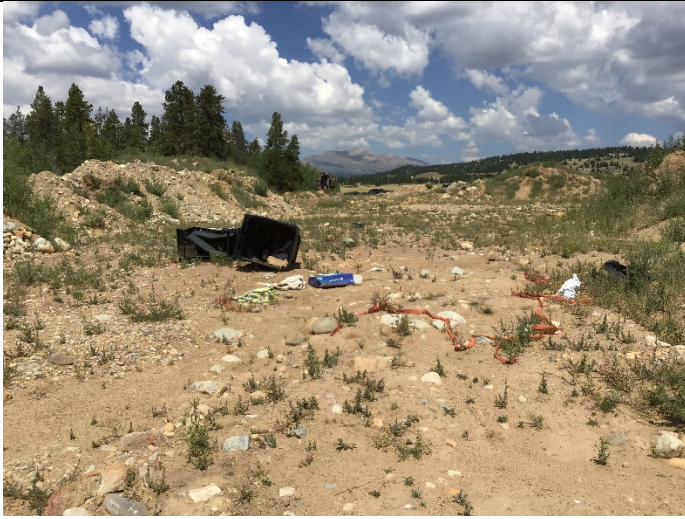
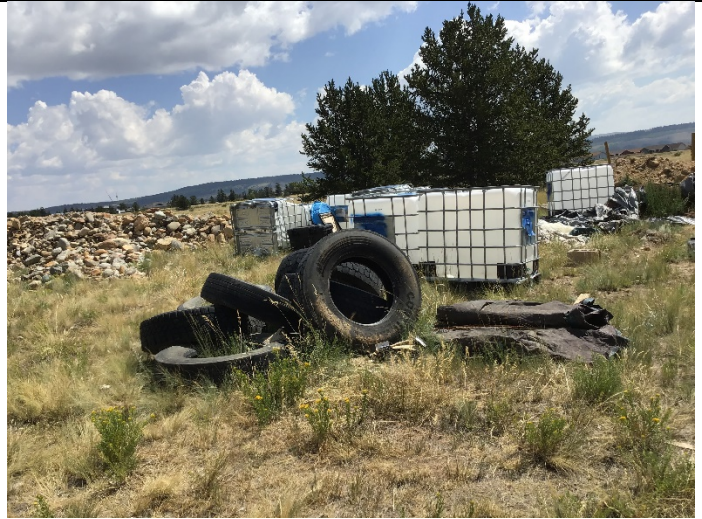
**Image 4:**

Comment: Trash and other mining related materials not properly managed or stored (Non-compliance item #6)

#6 Matt stated some trash was removed, but the rest is being removed today. The tires will be removed tomorrow (along with the dump truck). BLM verified and documented PARTIAL compliance with this item. Pictures will need to be provided to BLM to finalize compliance status.

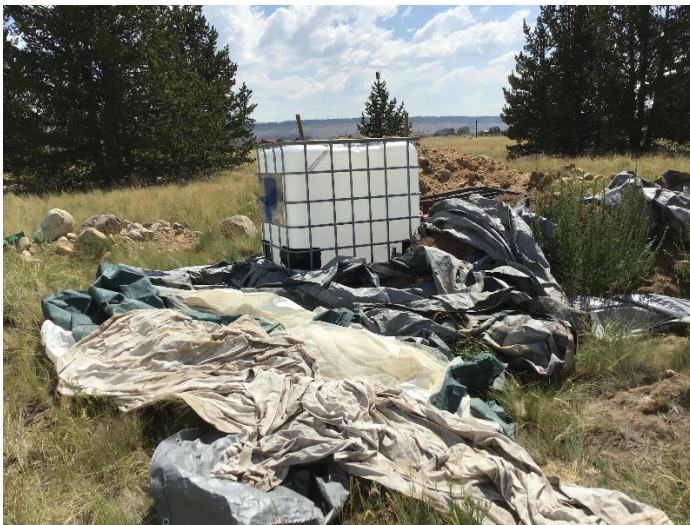
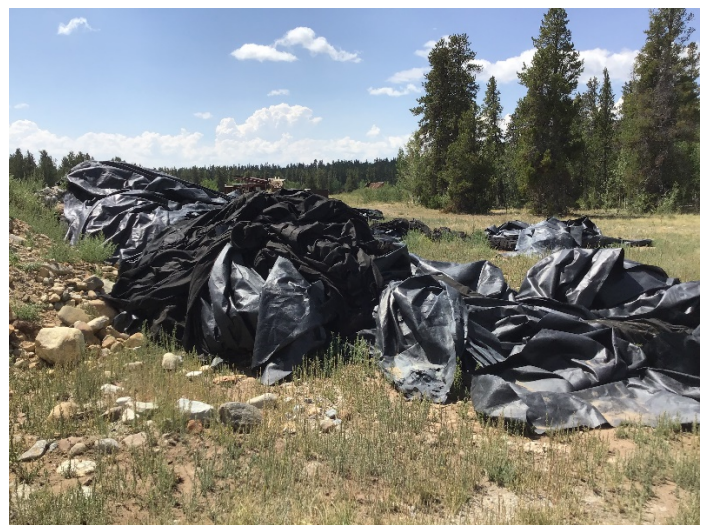
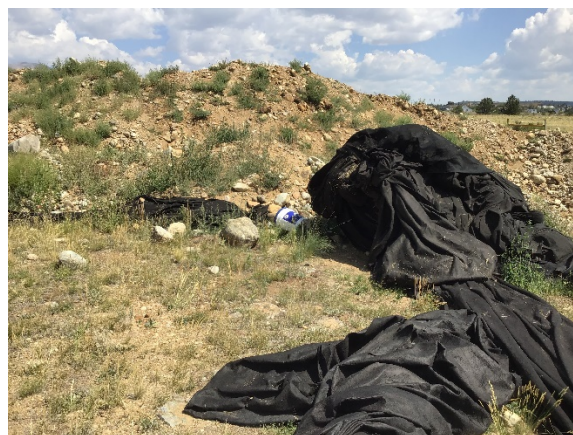
**Image 5:**

Comment: Black pong liner littered throughout the site (Non-compliance item #7)

#7 Matt stated item will be removed within the next three days. BLM verified and documented PARTIAL compliance with this item, as efforts have been made to remove the liner, with advertising it for sale. Pictures will need to be provided to BLM to finalize compliance status.

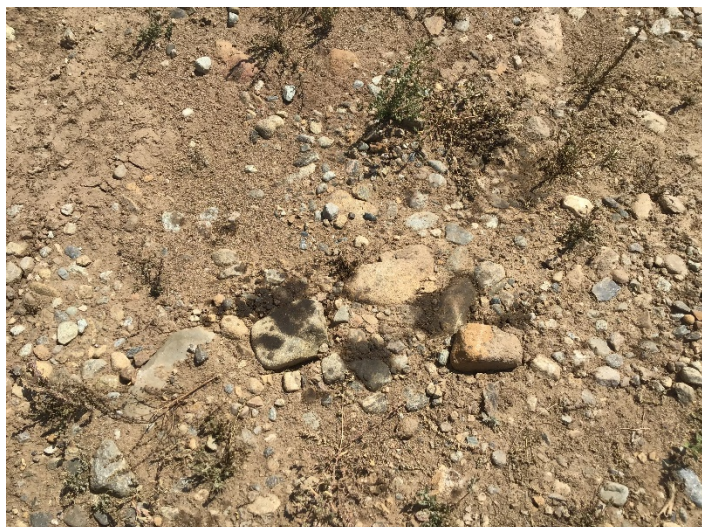
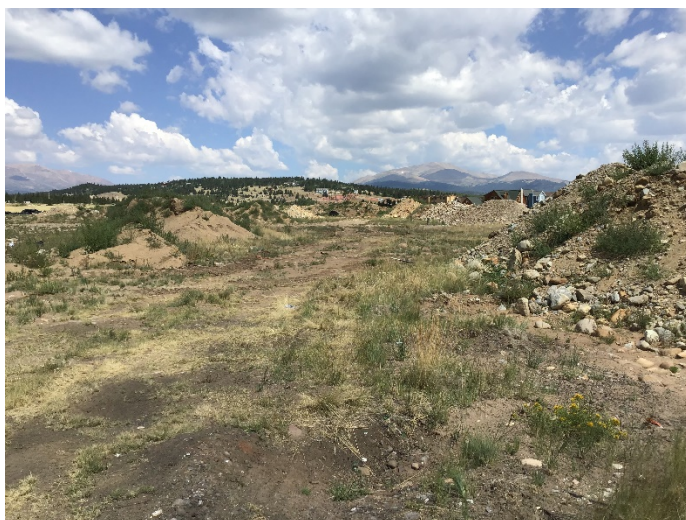
**Image 6:**

3.b. \*Oil staining in two separate areas along the eastern region. These areas need to be cleaned and all contaminated soils should be disposed of according to the spill contingency plan documented in your mining plan (Refer to map and images below).

Comment: Oil spills that need to be cleaned and disposed of according to the spill contingency plan on file.

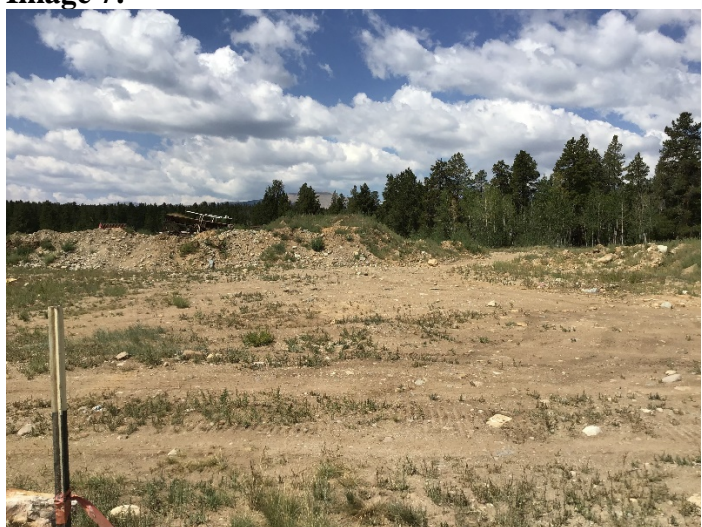
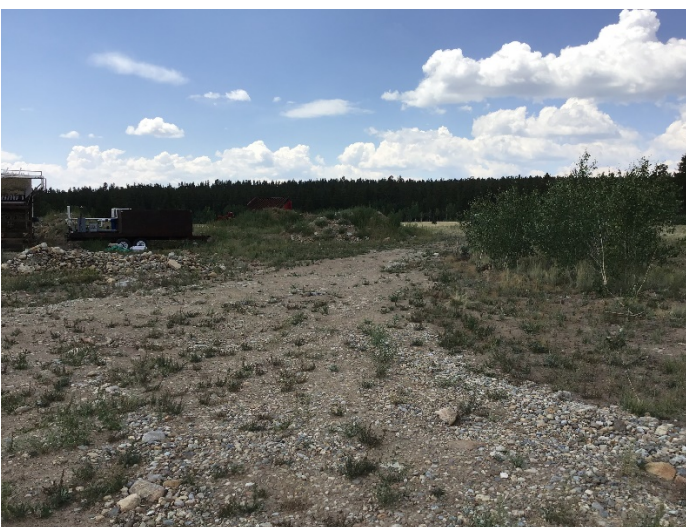
**Image 7:**

1.b.ii. No dirt work has been performed to correct non-compliance item #8 that was included with the 07/05/18 BLM non-compliance order.

Comment: SW Stockpile still remains outside of authorized operational boundary (Non-compliance item #8)

#8 Matt stated item could not be completed as of yet, because they have no equipment available. INCOMPLETE. This item will need to be completed NLT 8/8/18.

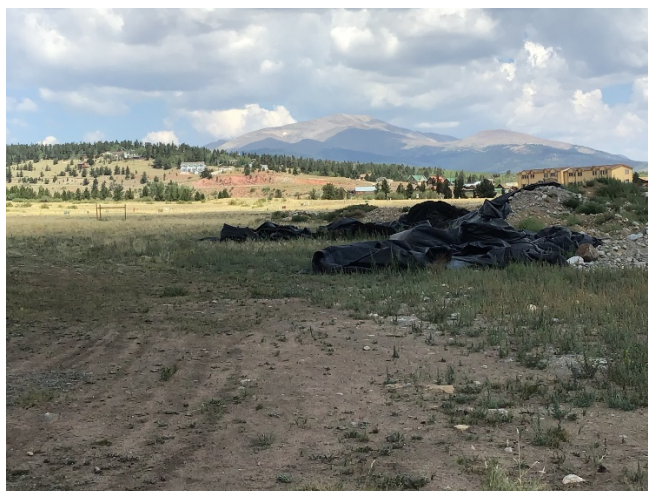
**Image 8:**

Comment: NW Stockpile still remains outside of authorized operational boundary (Non-compliance item #8)

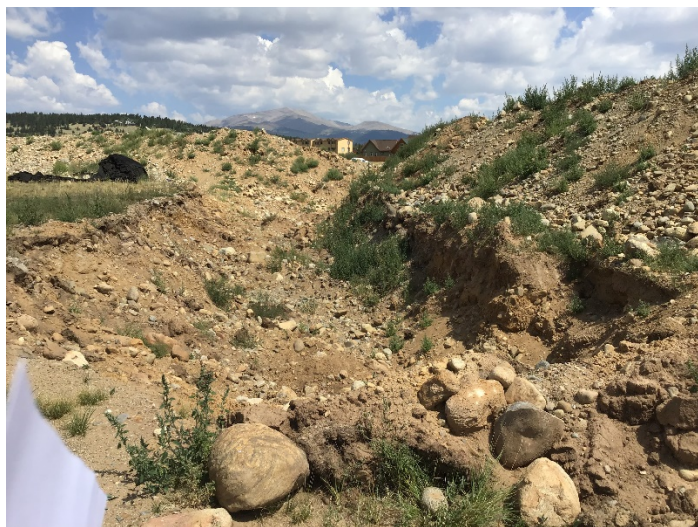
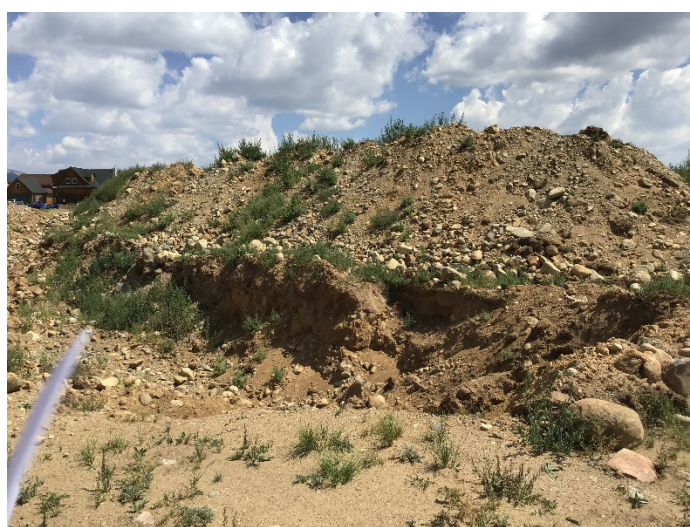
**Image 9:**

1.b.i. No dirt work has been performed to correct non-compliance item #9 that was included with the 07/05/18 BLM non-compliance order.

Comment: Stockpiles along the NE trench still remain < 1 foot from the trench bank and contain steep slopes (Non-compliance item #9)

#9 Matt stated item could not be completed as of yet, because they have no equipment available. INCOMPLETE. This item will need to be completed NLT 8/8/18.

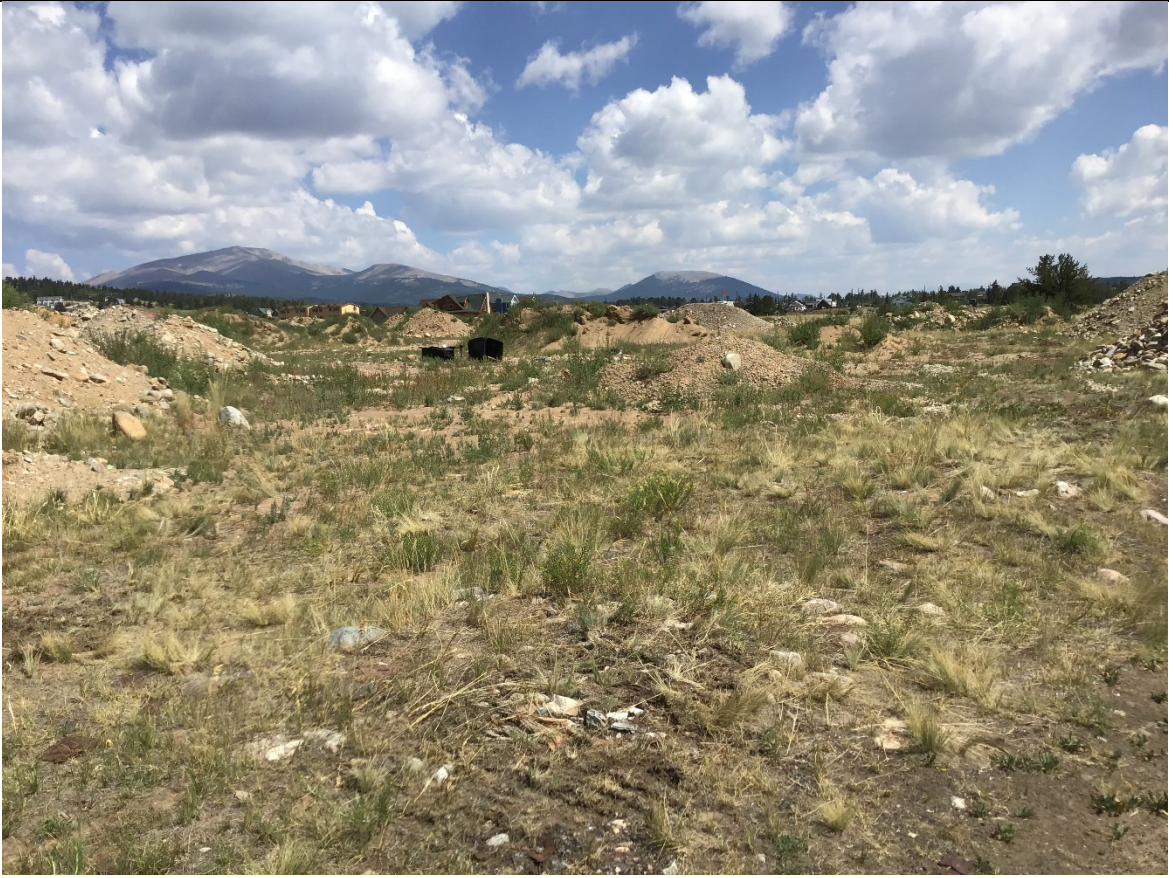
Comment: General site overviews
