**PERMIT INFORMATION**

<b>Permit Number:</b> C-1981-028 <b>Mine Name:</b> Keenesburg Strip Mine <b>Operator:</b> Coors Energy Company <b>Operator Address:</b> Mr. Danny Kipp P.O Box 467 Golden , CO 80402	<b>County:</b> Weld <b>Operation Type:</b> Surface <b>Permit Status:</b> Active <b>Ownership:</b> Private
	<b>Operator Representative Present:</b>  Danny Kipp
<b>Operator Representative Signature: (Field Issuance Only)</b>

<b>Inspection Start Date:</b> August 14, 2018 <b>Inspection Start Time:</b> 09:30 <b>Inspection End Date:</b> August 14, 2018 <b>Inspection End Time:</b> 14:00		<b>Inspection Type:</b> Coal Partial Inspection <b>Inspection Reason:</b> Normal I&E Program <b>Weather:</b> Cloudy	
<b>Joint Inspection Agency:</b>  None		<b>Joint Inspection Contacts:</b>  	
<b>Post Inspection Agency:</b>  None		<b>Post Inspection Contacts:</b>  	
<b>Inspector(s):</b>  Janet H. Binns  Robert D. Zuber, P.E.	<b>Inspector's Signature:</b>

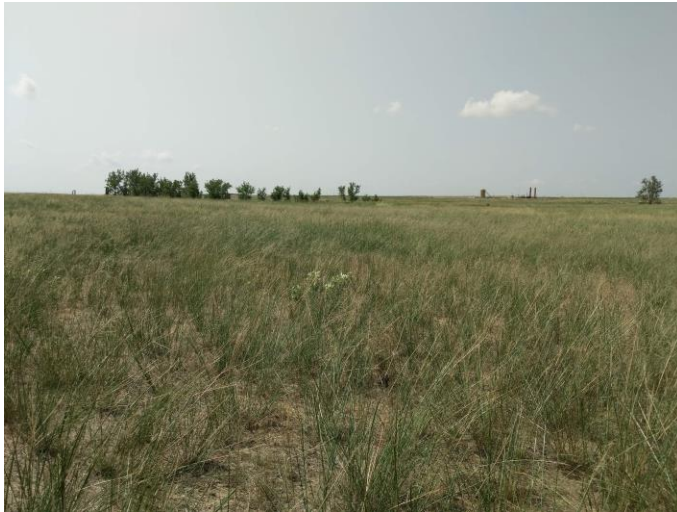
**Area 25**

Of particular note to Area 25, the area has seen significant progress in past years. It had been a parcel without successful vegetation growth and was reseeded in 2012 and interseeded in 2014. Sand dropseed was the visually dominant species in this parcel.

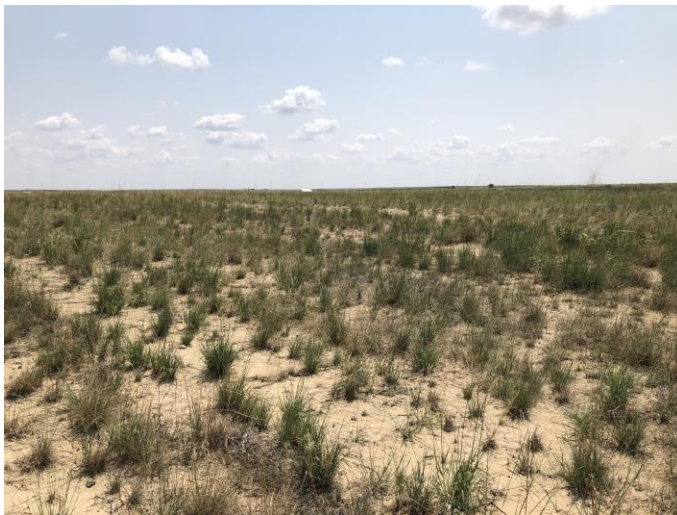
**Area 32**

The following areas were inspected by Binns, Zuber, and Kipp (Bay was observed for a short time but was left to do her work): 25, 32, 31, 23, 33, and 34 (in chronological order). In general, all areas have good to excellent cover with several desirable species of grasses. These include (but are not limited to) sand bluestem, little bluestem, prairie sandreed, Indian ricegrass, sideoats grama, blue grama, Western wheatgrass, switchgrass, and sand dropseed. The lack of perennial forbs was noted by Janet in most areas. Many plants have been impacted by the large number of grasshoppers at the mine.

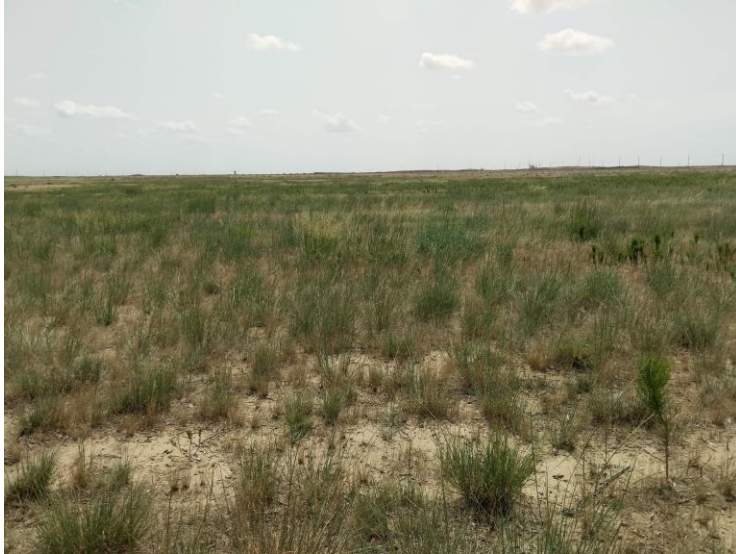
**Area 29**

In Area 29, the grasses are not as robust, but this area appears to have more forbs than many other areas.
