MINERALS PROGRAM INSPECTION REPORT
PHONE: (303) 866-3567

MINE NAME: Wonder Lode	MINE/PROSPECTING ID#: M-2018-047	MINERAL: Silver	COUNTY: San Miguel
INSPECTION TYPE: Multi Person Inspection	INSPECTOR(S): Lucas J. West, Wally Erickson	INSP. DATE: September 4, 2018	INSP. TIME: 11:30
OPERATOR: Dennis Mitchell	OPERATOR REPRESENTATIVE: Dennis Mitchell	TYPE OF OPERATION: NM - Not Mining	
REASON FOR INSPECTION: Citizen Complaint	BOND CALCULATION TYPE: None	BOND AMOUNT: No Bond Held	
DATE OF COMPLAINT: NA	POST INSP. CONTACTS: None	JOINT INSP. AGENCY: None	
WEATHER: Raining	INSPECTOR'S SIGNATURE:

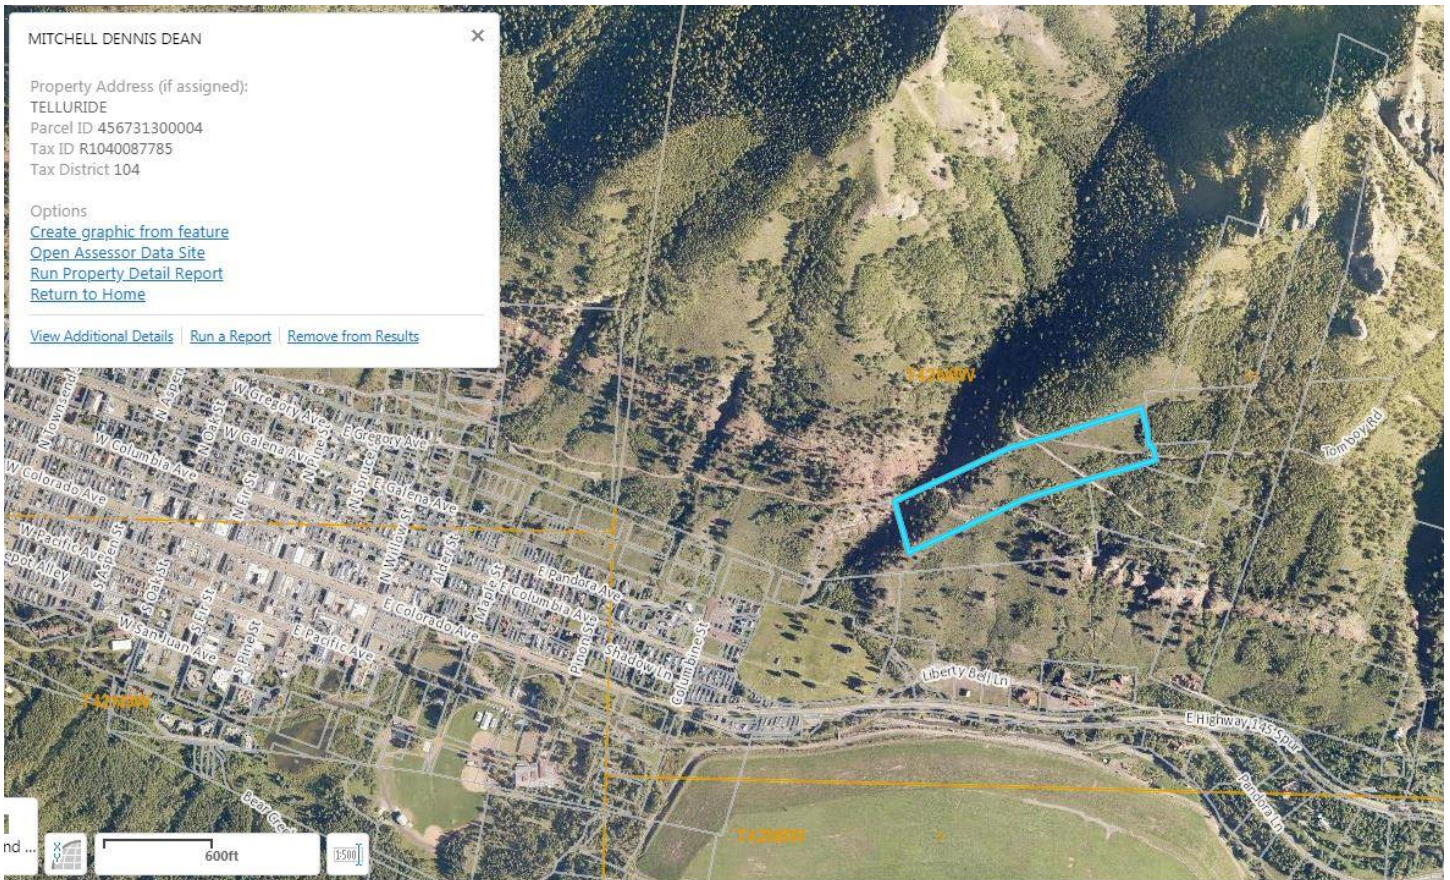
As shown in the aerial image, Photo One, the site is located within the boundary of the Wonder Lode patented mining claim, approximately one mile east-northeast of Telluride. Mitchell Dennis (Landowner) indicated he had re-opened an historic portal and extended the portal bench for the purposes of preparing a water storage pad. The portal is accessed by foot trail, the Owl Creek Trail, a popular hiking trail which passes through the private property. The goal of the Landowner is to store approximately 20 320 gallon capacity "IBC" water tanks for potable water and fire suppression water for use at his home site located on the claim. An example of the "IBC" storage tanks can be seen in Photo Two. According to San Miguel County no building permit has been issued.

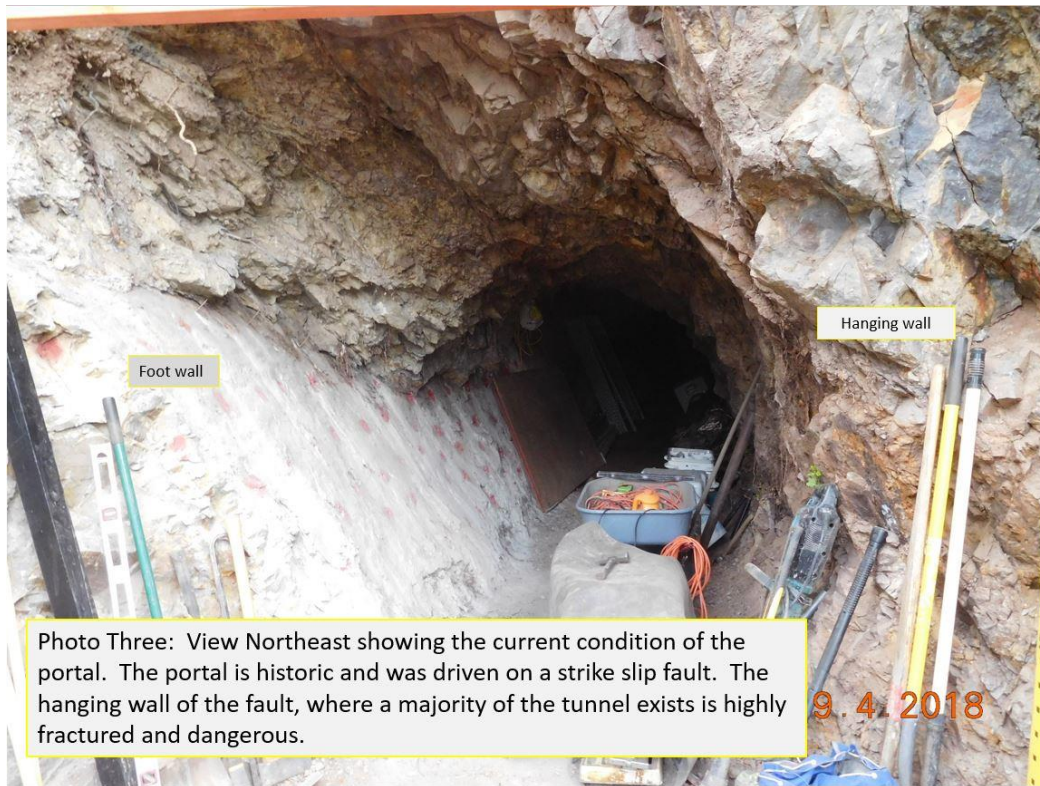
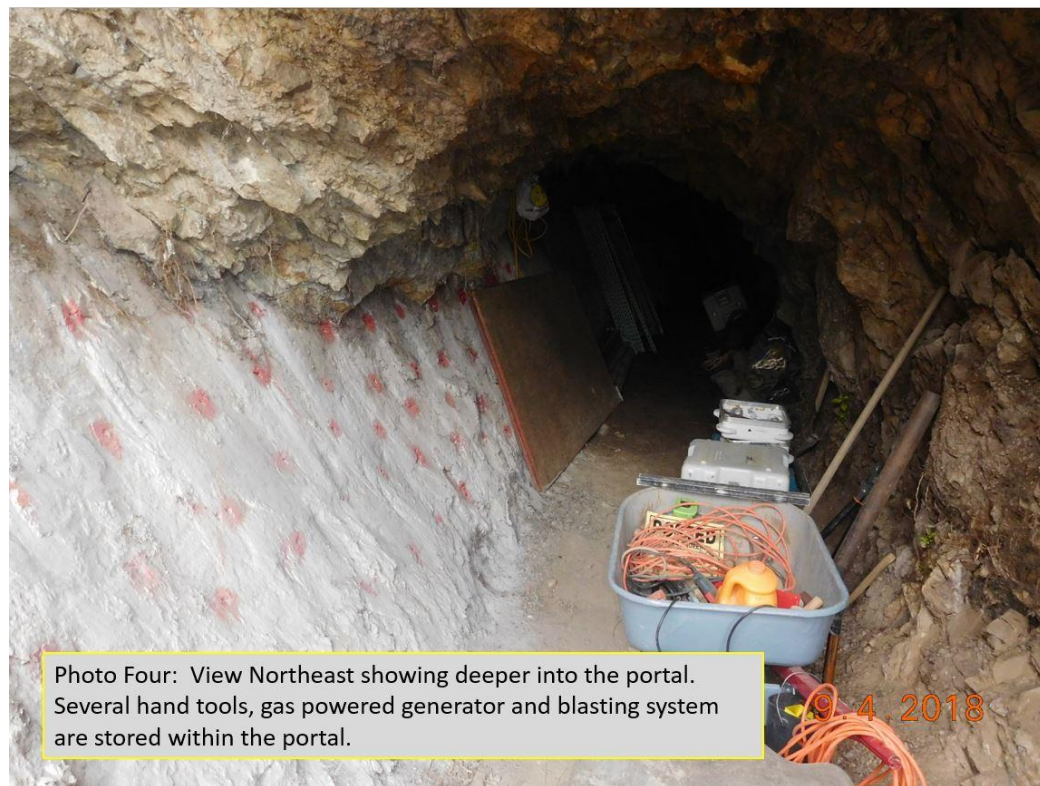
All surface disturbances were proximal to the portal and can be seen in Photos Three and Four. The historic portal had been re-opened with hand tools and limited blasting with the Sierra Blasting System. Excavated materials appeared to have remained on-site and used to level and extend the portal bench. Minor rock fall was evident on the steep slopes downgradient from the portal pad. The Landowner had attempted to control rock fall by installing a series of four fence segments as seen in Photos Six and Seven. The fence segments were constructed of metal grating secured with metal T-post. The improvised rock fall mitigation structure appeared to be potentially successful as evidenced by the absence of rock fall on Tomboy Road, a heavily traveled county road located immediately downslope from the portal. Given the steep topography at the portal, and proximity to Tomboy Road, rock fall is a public safety concern at this site.

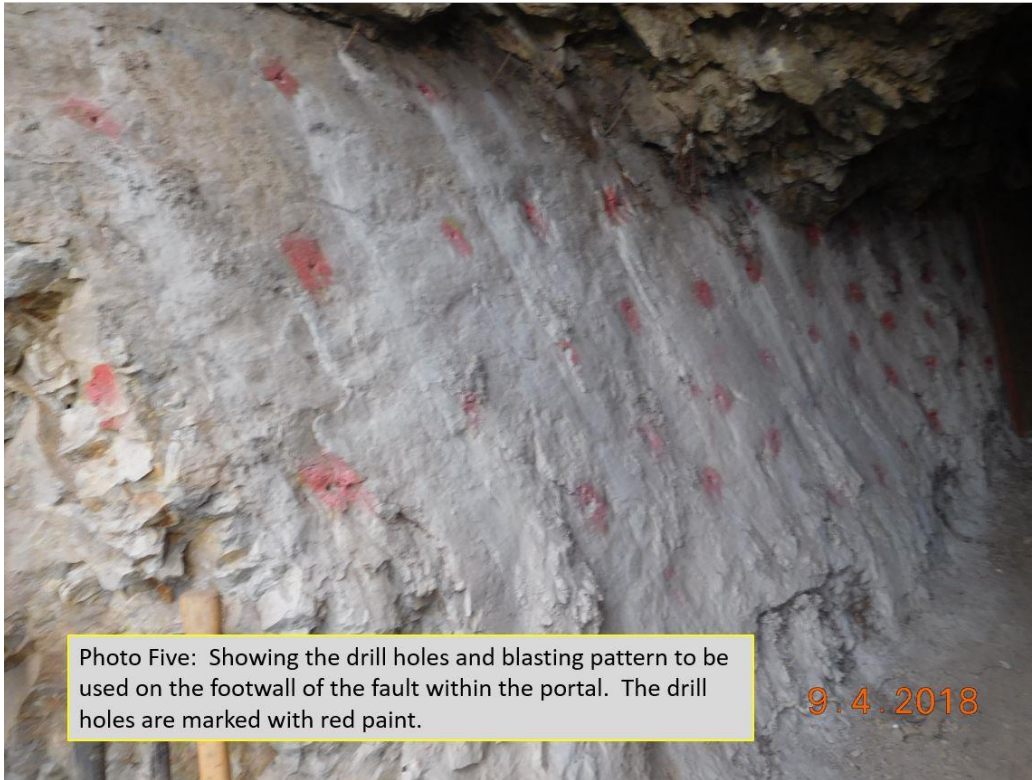
Photo Five: Showing the drill holes and blasting pattern to be used on the footwall of the fault within the portal. The drill holes are marked with red paint.

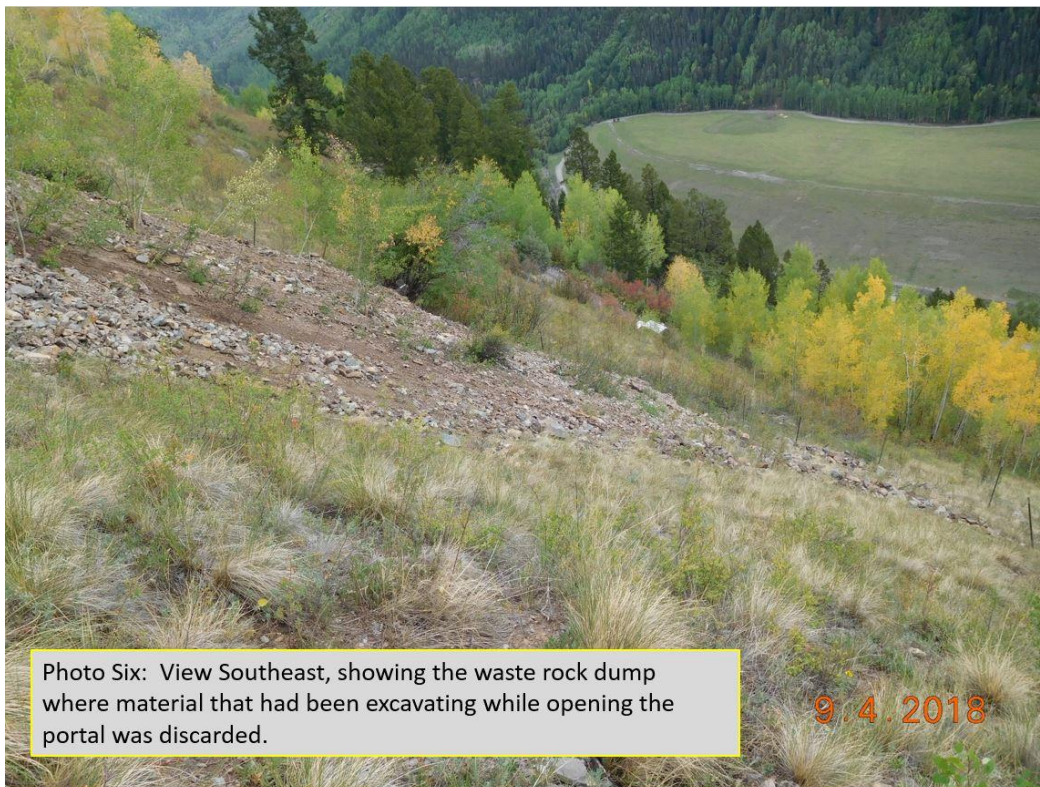
Photo Six: View Southeast, showing the waste rock dump where material that had been excavating while opening the portal was discarded.

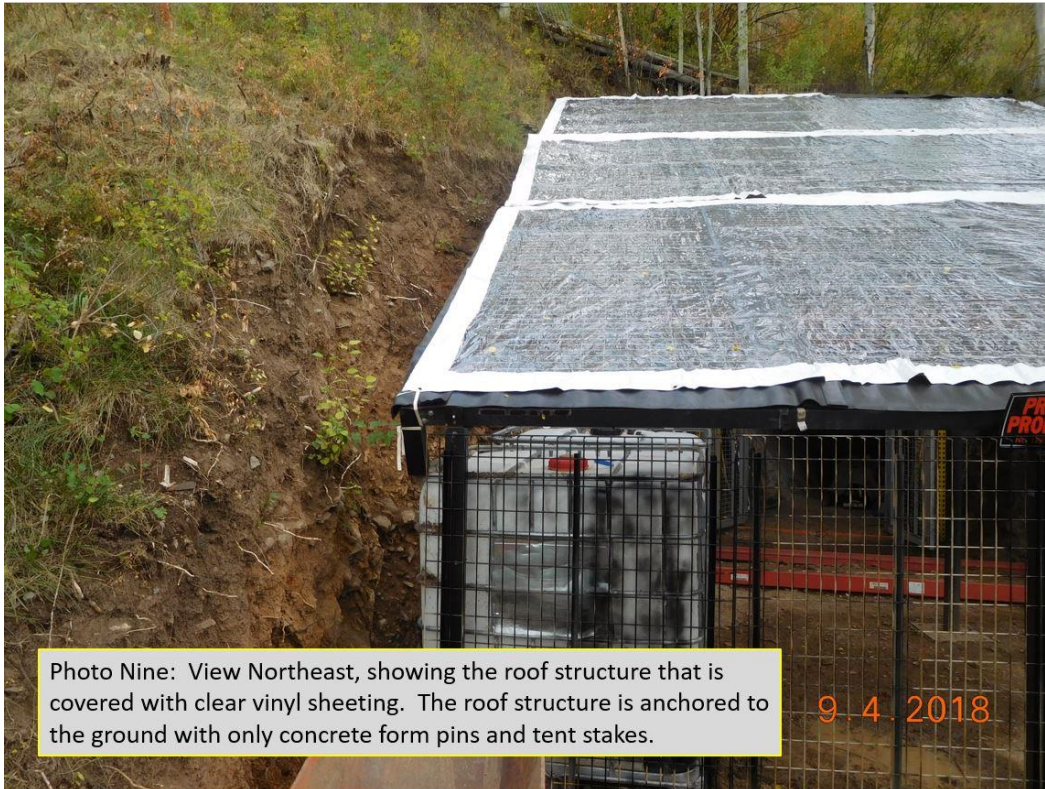
A roof structure has been constructed over the portal and portal pad. The roof structure constructed with steel grating, supported by aluminum framing, which was secured to the ground with concrete framing stakes (18 inches long by ¾ inch diameter) and military style tent stakes. The roof area, estimated at 20 feet wide and 30 feet long, was sheeted with clear plastic or vinyl fabric. The pallet shelving has a custom locking metal gate installed for security. The roof and internal structure, as well as locking gates can be seen in Photos Eight through Ten. The site possess no storm water controls or diversion structures of any kind. Evidence of settling, slumping or erosion was not observed. However given the unconsolidated soils at the portal, headward erosion to the upslope areas is a concern.

Photo Nine: View Northeast, showing the roof structure that is covered with clear vinyl sheeting. The roof structure is anchored to the ground with only concrete form pins and tent stakes.

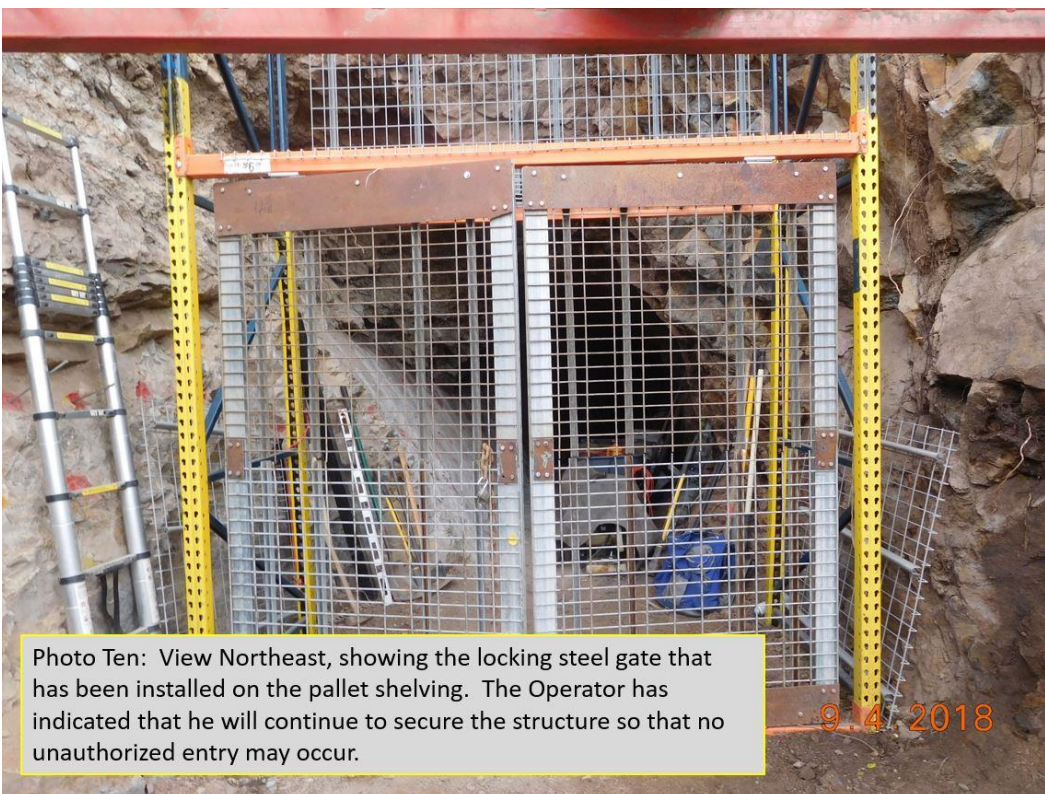
Photo Ten: View Northeast, showing the locking steel gate that has been installed on the pallet shelving. The Operator has indicated that he will continue to secure the structure so that no unauthorized entry may occur.
