TECHNICAL MEMORANDUM

Re: 1333.01.13
Henderson Mill Seepwater Detention Berm Road Raise
Hydrologic Design Basis

Henderson Mill
1 Dam Seepwater Detention Berm
Road Raise
Design Basis Photos

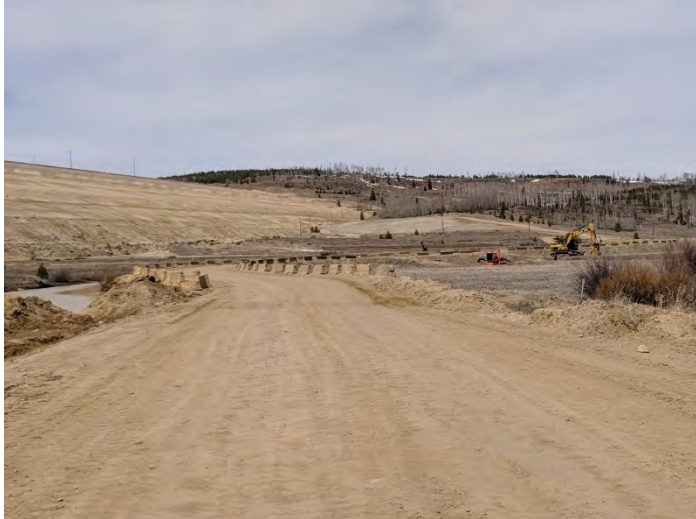
Photo 1. View of the seepwater detention berm from the south end, looking north. June 21, 2018

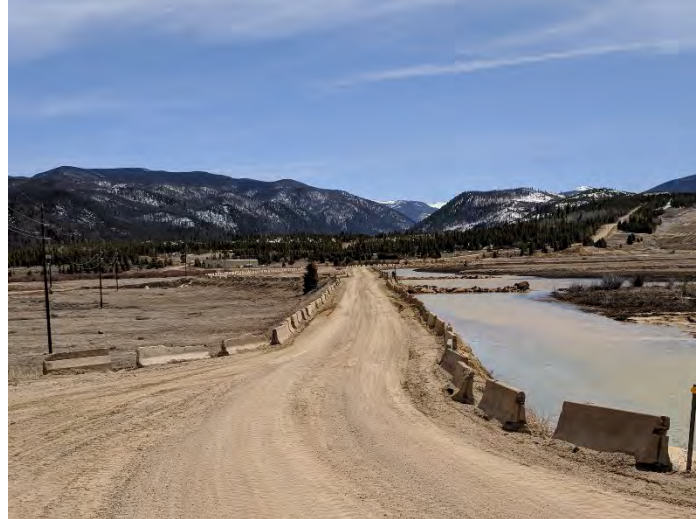
Photo 2. View of the seepwater detention berm from north end, looking south. June 21, 2018

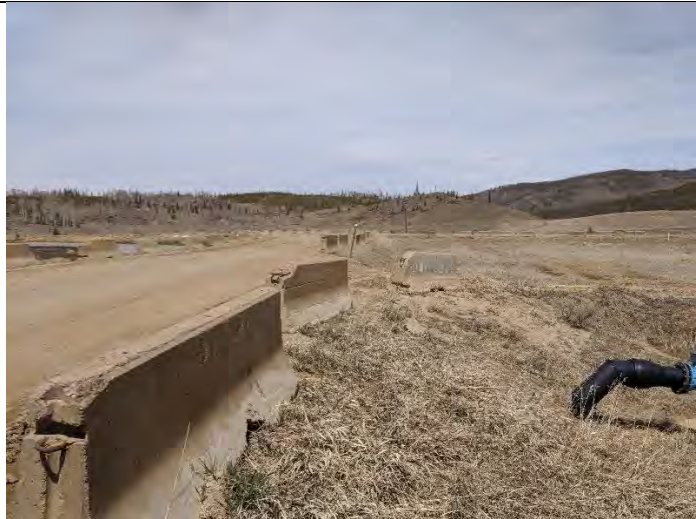
Photo 3. View of the seepwater detention berm and downstream slope at South feeder channel, looking north. June 21, 2018

The south feeder channel culvert was previously extended approximately 20 feet on the downstream end to include the intake piping to the Emergency Diesel Pump System (EDPS) adjacent to the culvert and thus does not require modification as a part of the raise. The location of the EDPS concrete pad and flow meter at the downstream toe of the existing Seep Road require the installation of two levels of a Mechanically Stabilized Earth (MSE) block walls on the berm side of the pad to prevent placement of fill on the system components. The wall will be constructed without modifications to the EDPS and to allow for ease of access to components for future maintenance and repair.

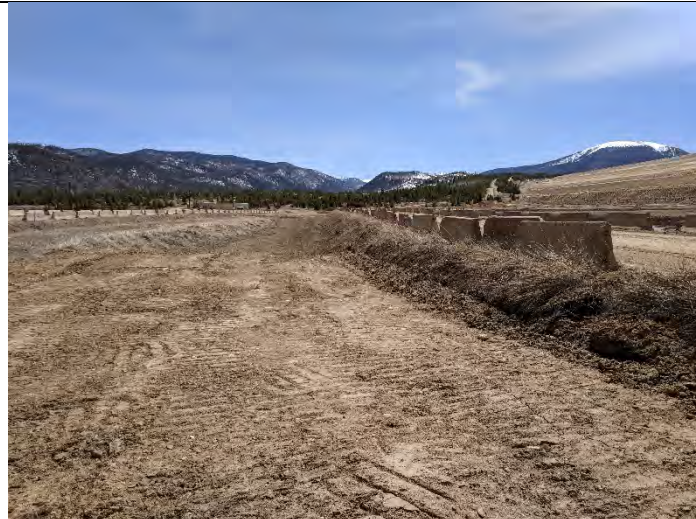
Photo 4. View of the seepwater detention berm and downstream slope at north feeder channel, looking south. June 21, 2018

There are two gate operated culverts under/through the Seep Road that feed the channels into the Ute Park Seepwater Pump Station (UPPS). The length of the north feeder channel culvert currently restricts the width of the roadway at the crossing to prevent inundation of the culvert outlet. This culvert will be extended approximately 25 feet on the downstream end in conjunction with the raise to prevent burial of the downstream end.

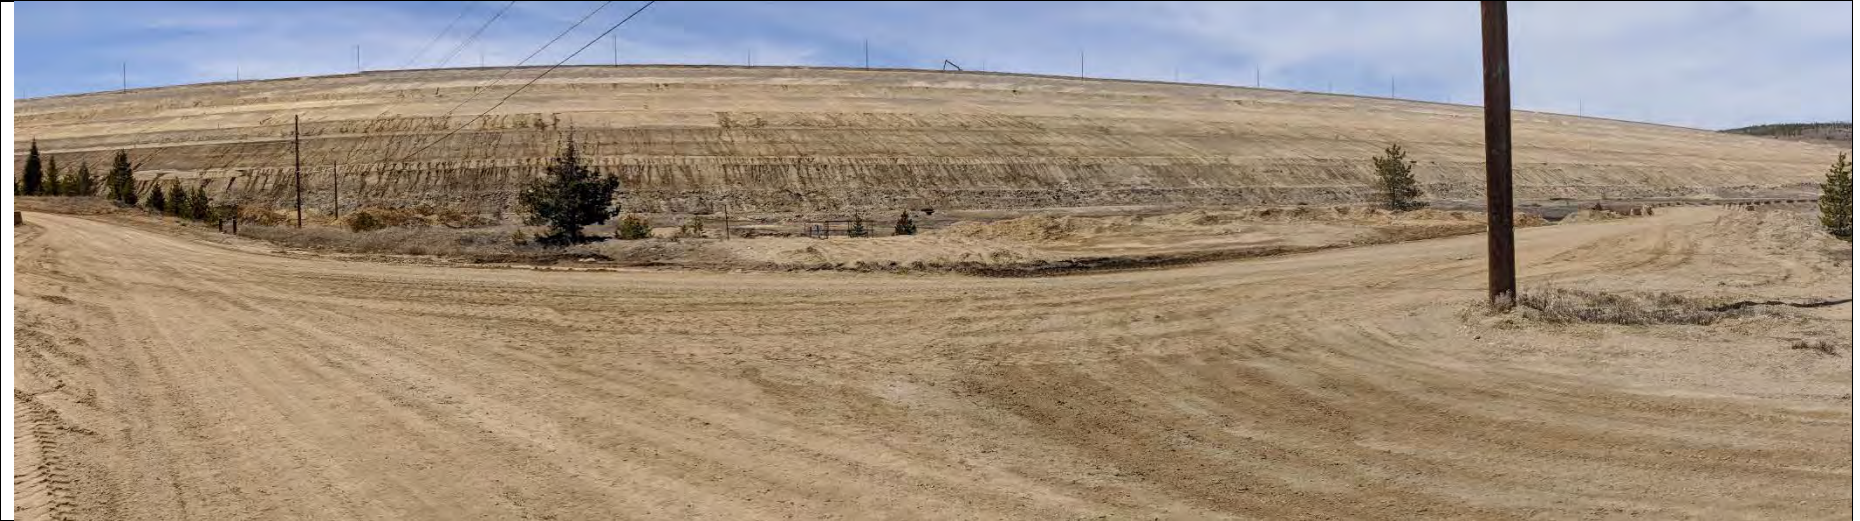
Photo 5. View of the roadside fill berm area beyond existing road at the south end (looking west). The 1 Dam right abutment road is on the left. The area where the raise will transition from the entire berm to roadside berm is to the right of the power pole. April 19, 2018

The raise is expected to consist of compacted soil placed on top of and on the downstream side of the existing Seep Road. The nominal side slope of the Seep Road raise is two horizontal feet for every one vertical foot. The average existing Seep Road width of 35 feet will be preserved or extended with the raise as needed for wider road sections. The raise will tie into the existing road at the north end of the SDA as the road climbs up the left abutment of 1 Dam. The raise will transition down to the existing seep road surface on the south end of the SDA. The transition will occur approximately 150 feet north of the intersection with the right abutment roadway of 1 Dam. At this location, there is an existing roadside berm that will be rebuilt to continue the impoundment up to the design elevation. The roadside berm is anticipated to extend approximately 250 feet and will tie into the edge of the right abutment road.

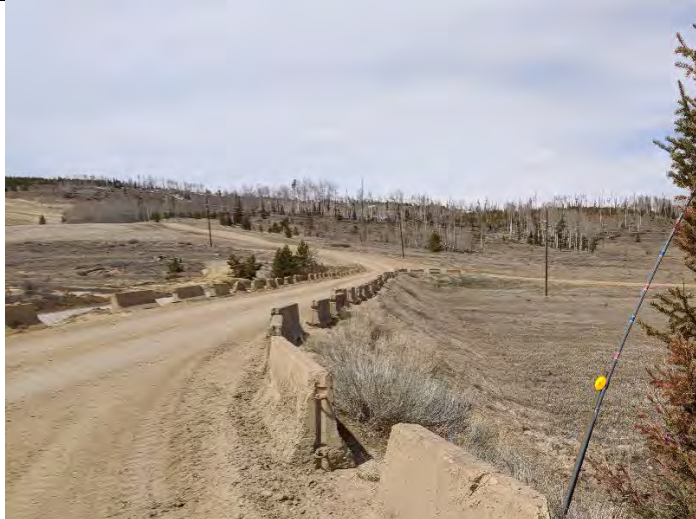
Photo 6. View of the seepwater detention berm and downstream slope at north feeder channel, looking north. April 19, 2018

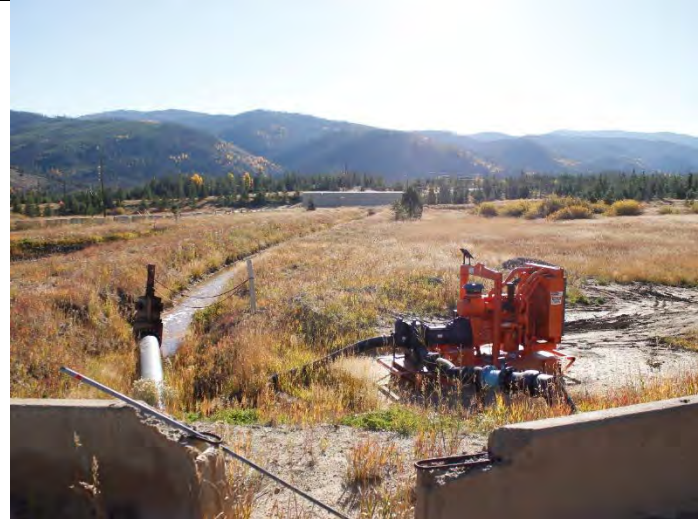
Photo 7. View of emergency diesel pump system from seepwater detention berm road. September 25, 2015

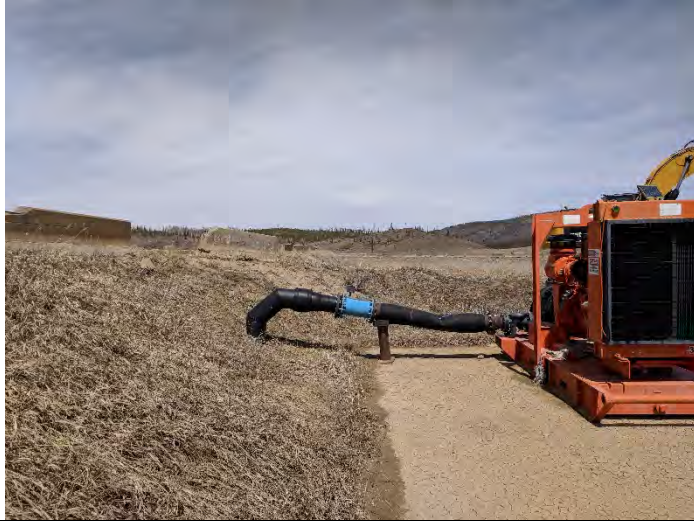
Photo 8. View of Emergency Diesel Pump System and downstream slope of berm, looking north. April 19, 2018

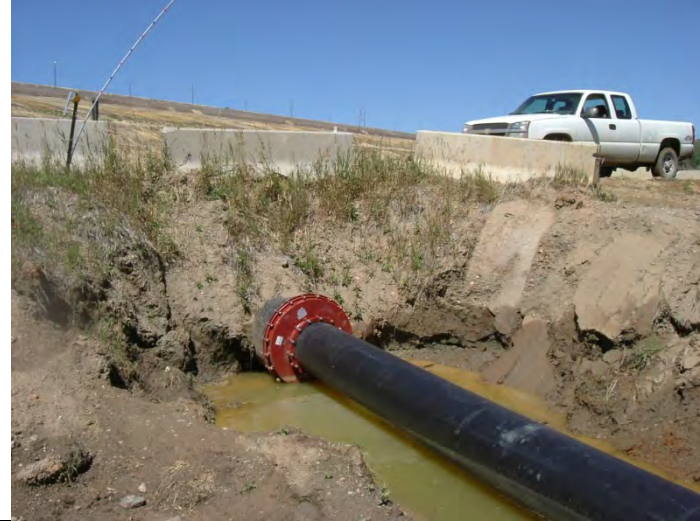
Photo 9. View of coupling for culvert extension downstream end of culvert during construction for diesel pump system intake. April 19, 2018

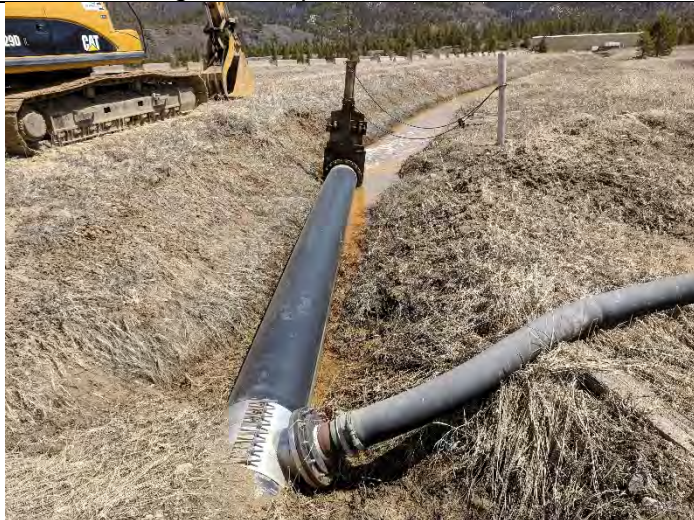
Photo 10. View of culvert extension downstream end of culvert and coupling for diesel pump at south feeder channel. April 19, 2018

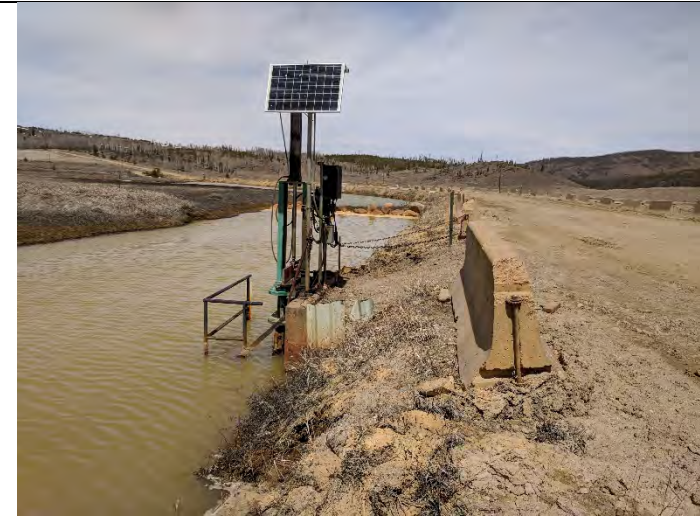
Photo 11. View of upstream gate for north feeder channel culvert from detention berm road, looking north. April 19, 2018

Henderson will also raise the gate operator electronics above the new high-water line that will be performed in conjunction with the road raise. New buried conduit for the gate communications cabling will be installed across the roadway by Henderson personnel at the same time as the Seep Road raise.

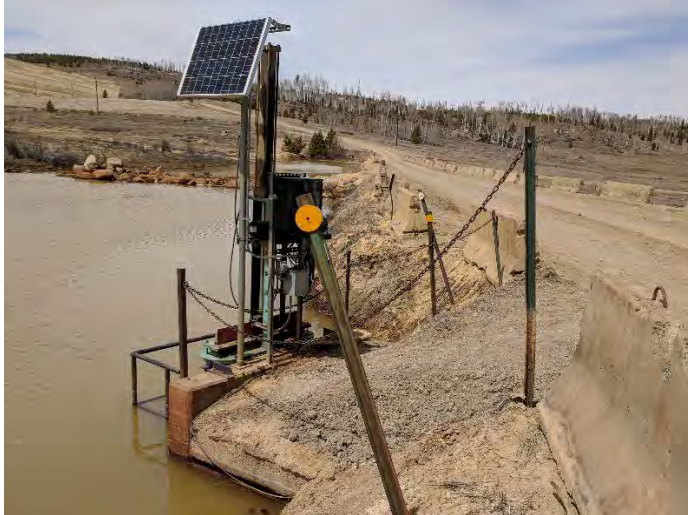
Photo 12. View of upstream gate for north feeder channel culvert from detention berm road, looking west. April 19, 2018

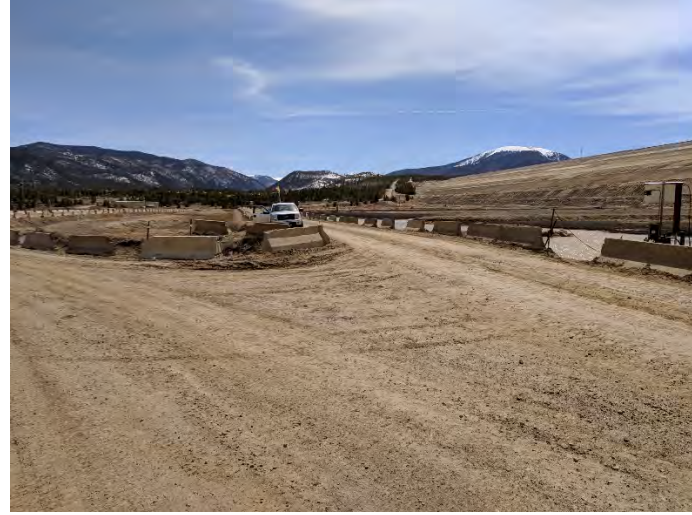
Photo 13. View of north feeder channel culvert crossing and road intersection, looking south. April 19, 2018

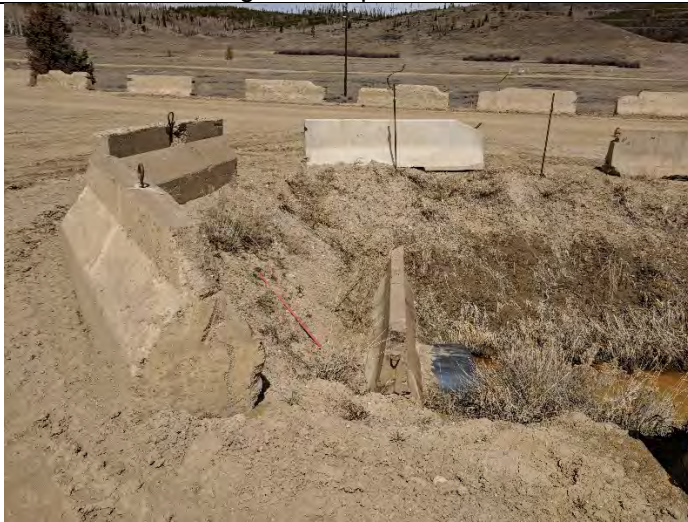
Photo 14. View of downstream end of north feeder channel culvert from detention berm road, looking northeast. April 19, 2018

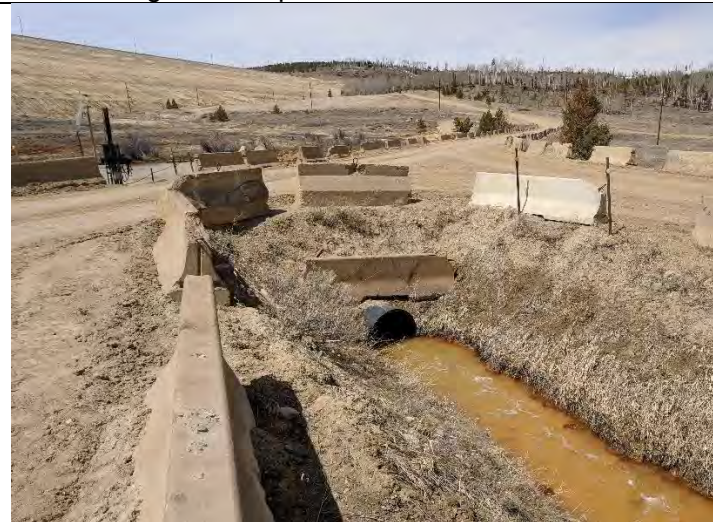
Photo 15. View of downstream end of north feeder channel culvert from detention berm road, looking west. April 19, 2018
