Minerals Exploration/Sampling/Testing Inspection

U.S. Department of the Interior Bureau of Land Management Royal Gorge Field Office

Operation Type: □ 3600 □ 3809 w/ occupa	ancy	⊠ 3809 w/o oo	ccupancy	
Date: 09/14/18 Time: 10:18 am Weather: Sunny	Operation Name: Dawson Mountain Operator: Zephyr Case Number: COC077472 CDRMS #: P2013002			
Operator(s): Mark Gravec, Will Felderhof & Loren Operation(General (s) are in compliance with documentation on file □ Yes □ No □ N/A (s) and disturbance on-site coincide with the sand access on file		
Other(s): Angela Belentoni		⊠ Yes	□ No	□ N/A
Inspection Purpose: ☐ Pre-Operations ☒ C	General	☐ Final	☐ Trespass	☐ Complaint
Inspection Items		Compliant	Non- Compliant	N/A

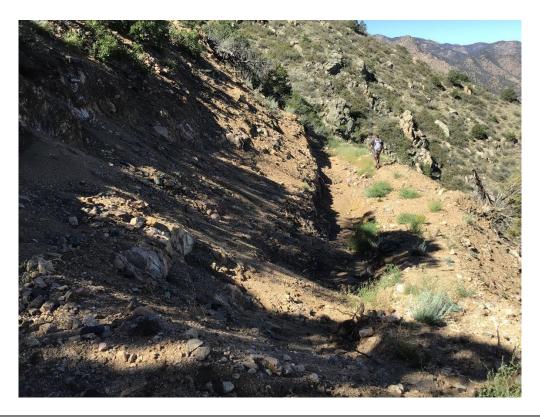
Image 3:

Comment: Trench 2 (lower trench)

- Sluffing along trench 1 (middle trench) where loose material has collected along on the western face and trench center.
- Operator plans to complete interim reclamation of trench 1 & 2 within the next month. Depending upon the fire assay and petrographic results, trench 3 (highest elevated trench) may remain open as an access road for future exploration and hauling.

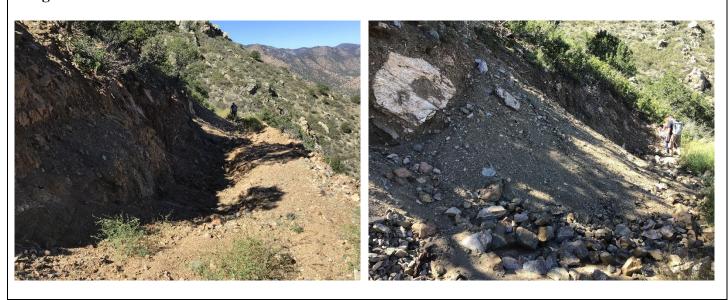
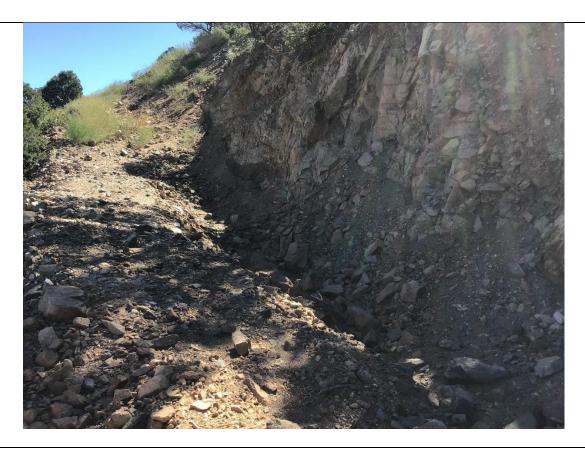
Image 4:

Comment: Trench 1 (middle trench) with sluffing along western face

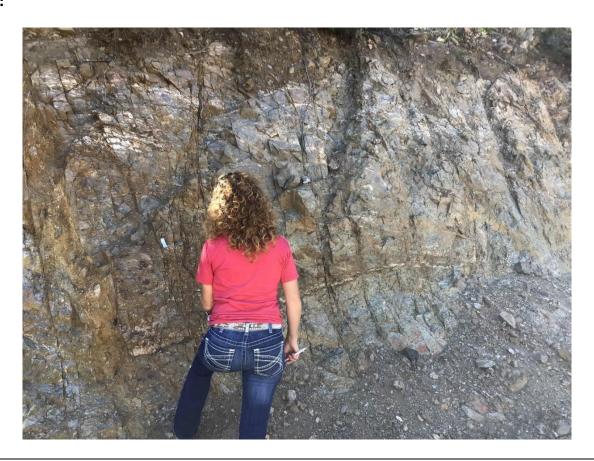
Image 5:

Comment: Trench 3 (highest trench)

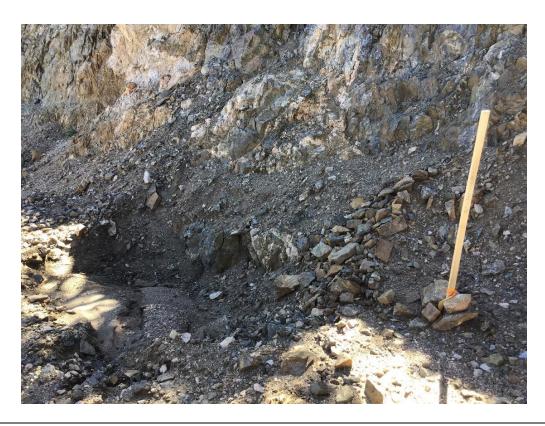
Image 6:

Comment: Drill hole (WP-18-18) located along the access road (Mod 3). 2 drill holes remain to be drilled at this site.

- 4 additional holes remain to be drilled. The operator plans to drill the remaining holes within the next couple of weeks.
 - o 2 holes are located NE of BLM lands & the other 2 holes along the access road/switch back to the BLM lands and trench excavation (ref. images below).

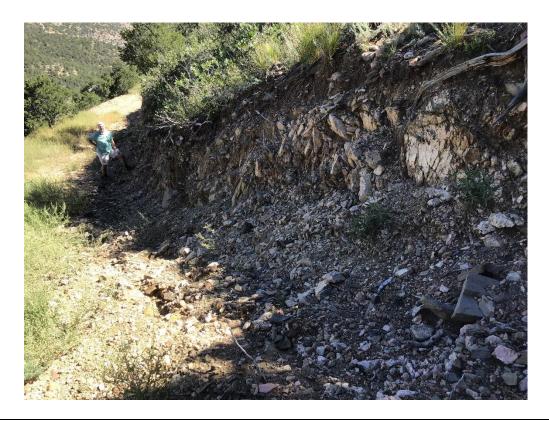
Image 7:

Comment: Trench 3 located along access road

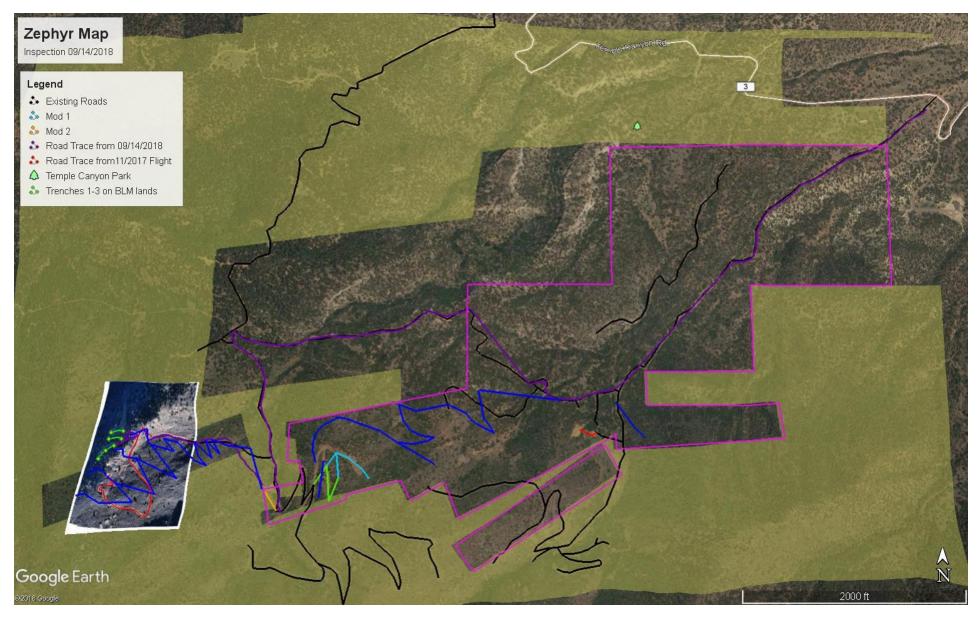
Image 8: Map of Zephyr operational boundary (pink), Mods 1-3 (light blue, orange & blue), road trace from 09/14/18 inspection (purple), road trace of 11/2017 flight (red) and BLM lands (yellow). Road realignment was traced from the 11/2017 flight.

- The 2016 Mod 3 road design was constructed differently on both the private and BLM lands due to the steep topography and geology. Multiple switch backs were excluded from the original road

design (ref images). The road realignment included 1 switchback to the north and 2 additional switch backs to the south and southwest (ref. images 8-10).

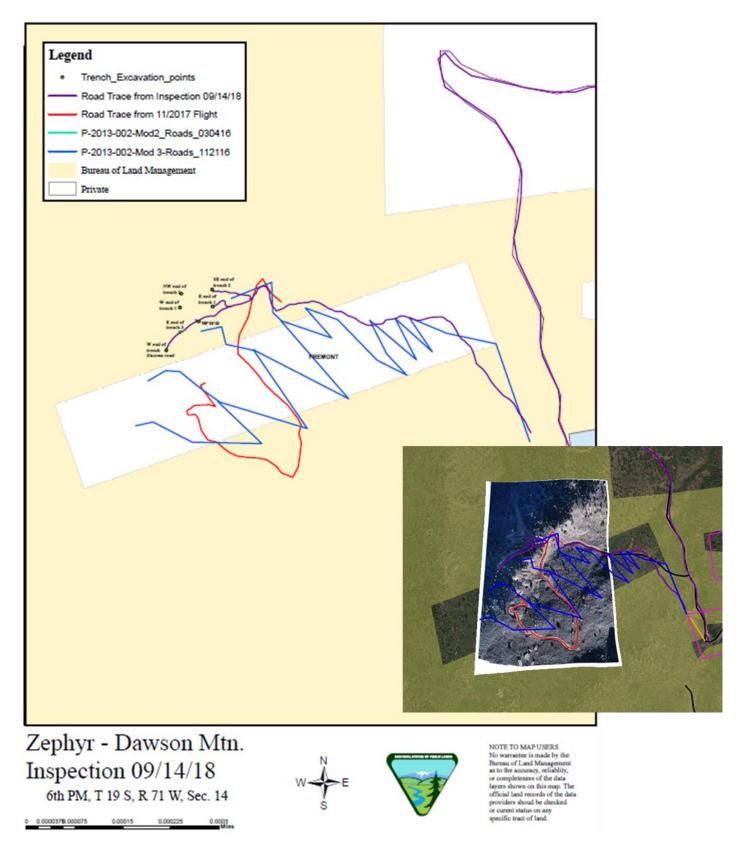
Image 9: Map of Zephyr Notice modifications (1-3) and the 11/2017 flight data of Mod-3 road realignment.

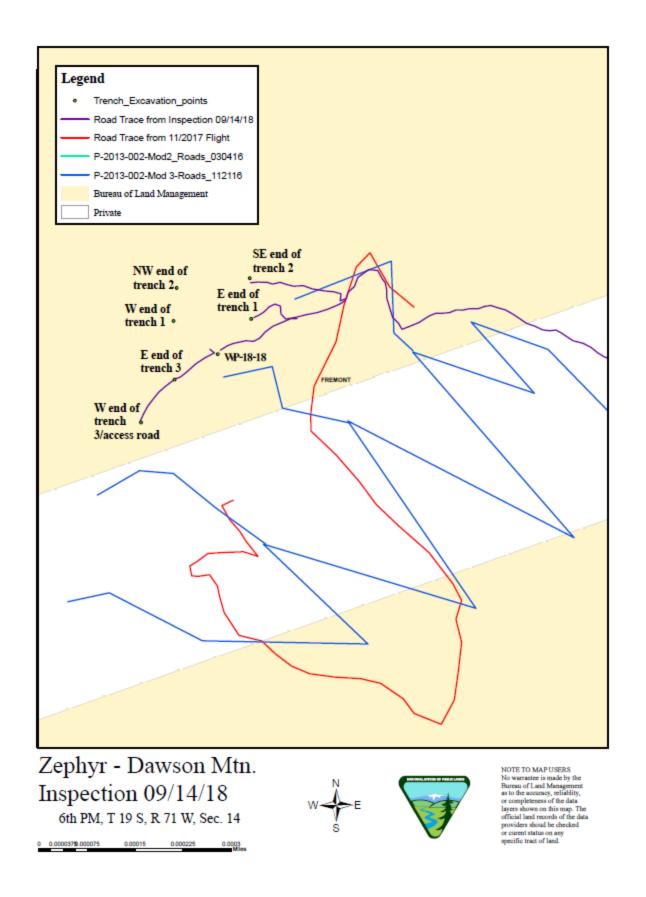
Image 10: Close-up of the Zephyr operations and the 09/14/18 inspection. The trench excavation has been traced from the east-west ends on BLM land. WP-18-18 is 1 of the 2 drill areas that still remains to be drilled under Mod-3.
