MINERALS PROGRAM INSPECTION REPORT
PHONE: (303) 866-3567

MINE NAME: Rock-N-Pine	MINE/PROSPECTING ID#: M-2003-074	MINERAL: Sand and gravel	COUNTY: Park
INSPECTION TYPE: Monitoring	INSPECTOR(S): Elliott R. Russell	INSP. DATE: September 5, 2018	INSP. TIME: 09:15
OPERATOR: Rock-N-Pine LLC	OPERATOR REPRESENTATIVE: Mark Balderson	TYPE OF OPERATION: 110c - Construction Limited Impact

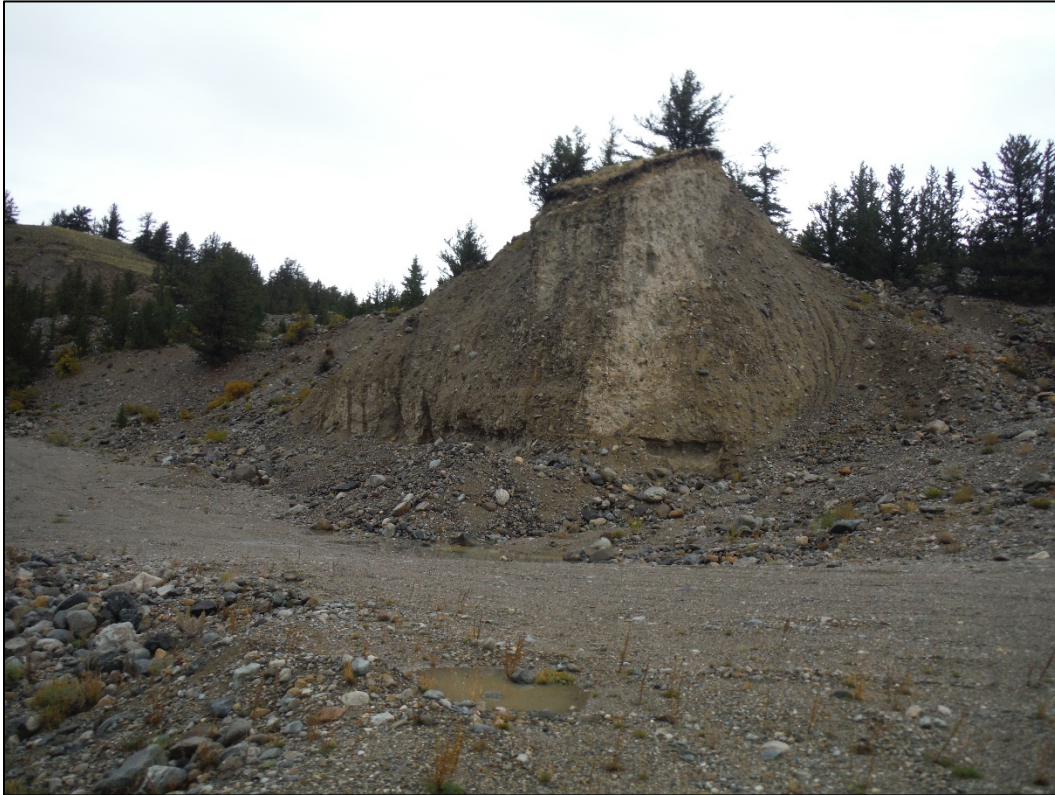
Using the photographs contained within the complaint, the Division observed the area of concern regarding the alleged off-site mining. This area is located just west of the western permit boundary for the site. The Division observed what appeared to look like small hand-tool dig pockets or erosional features near the base of a 30-foot highwall. Mr. Balderson stated this highwall is a remnant of the historical hydraulic mining activities which disturbed much of the north side of the river. Mr. Balderson believes these small dig features may have been created by "weekend hobby miners" who were likely running material through a small portable sluice box trying to recover gold. Mr. Balderson stated he was not aware of these disturbances nor did he create them. Mr. Balderson stated that there has not been any mining activity at the site for several years. The operation was approved for the first term of Temporary Cessation beginning on January 24, 2017, and will end on January 24, 2022. Temporary Cessation lets Operators enter into a non-active status which allows mining activities to temporarily cease for a five year period. Additionally, Mr. Balderson stated he currently cannot access his mine site even if he wanted to come out of Temporary Cessation as he currently has pending litigation against Mr. Sullivan for illegally blocking access to his mine site. Lastly, the Division observed no heavy equipment on site nor an operational processing plant. Based on the observations made, the Division found no conclusive evidence that mining was occurring outside of the permit boundary.

Photo 1. Area of alleged off-site disturbance; looking north.

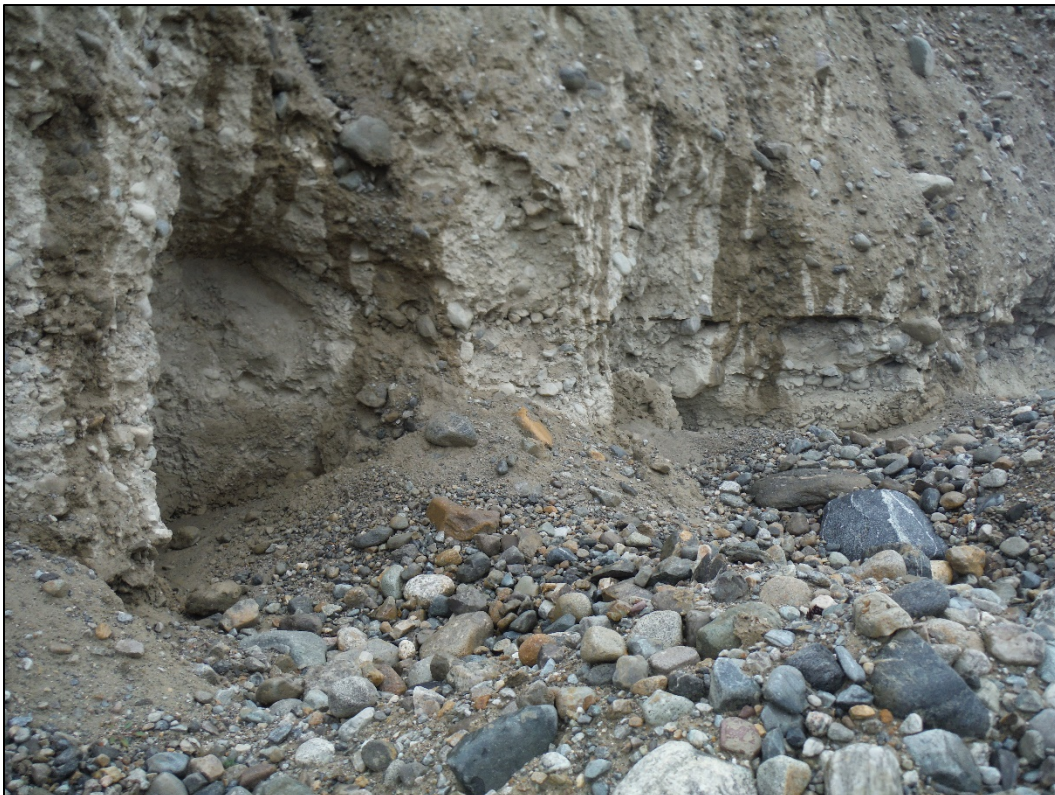
Photo 2. Close up of area of possible hand-diggings; looking east.

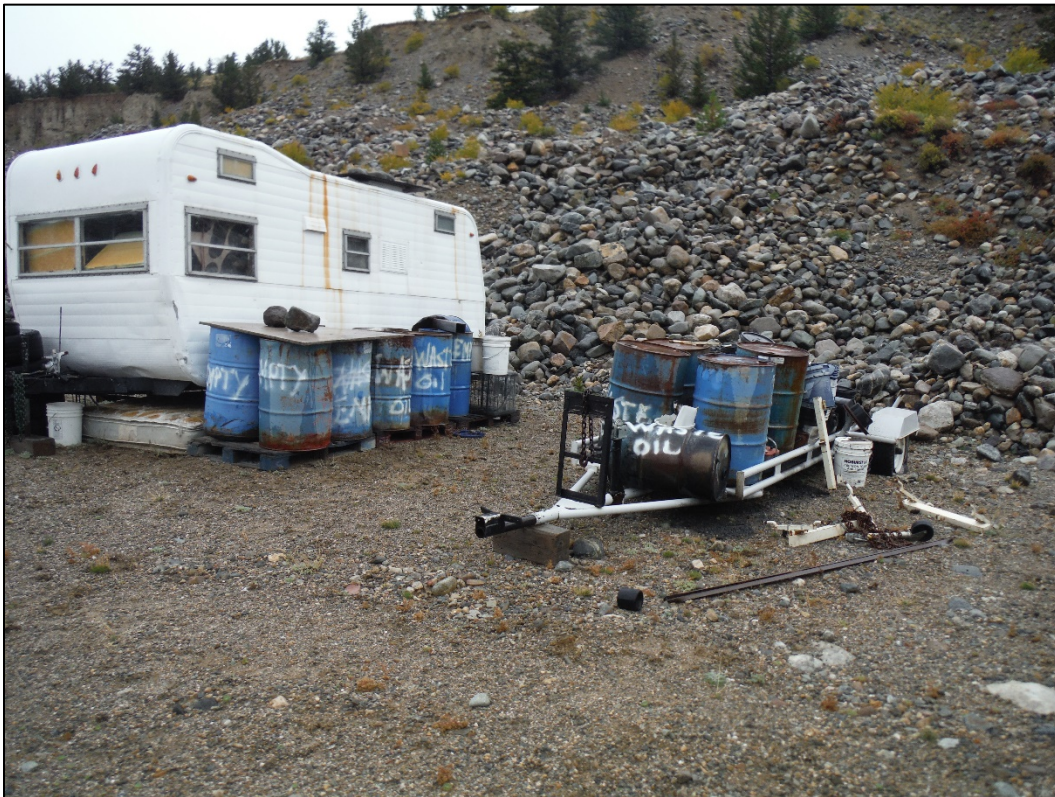
During the inspection, the Division observed the area being used to store used oil and empty 55-gallon oil drums and buckets. Previously, following the August 15, 2016 inspection, the Division required the Operator to consolidate various oil drums and buckets from across the mine site, store them upright and off the ground, and properly label the containers. The Operator completed this corrective action, however with time the trailer and pallets used to store these containers appears to not be adequate. The Division recommends the Operator remove any empty oil drum or bucket from the mine site and dispose of them properly or appropriately cover

Photo 3. Used oil and barrel storage area; looking north.

and/or move inside to protect them from the weather elements. The Division also recommends consolidating the used oil and lubricants on-site and addressing them similarly.

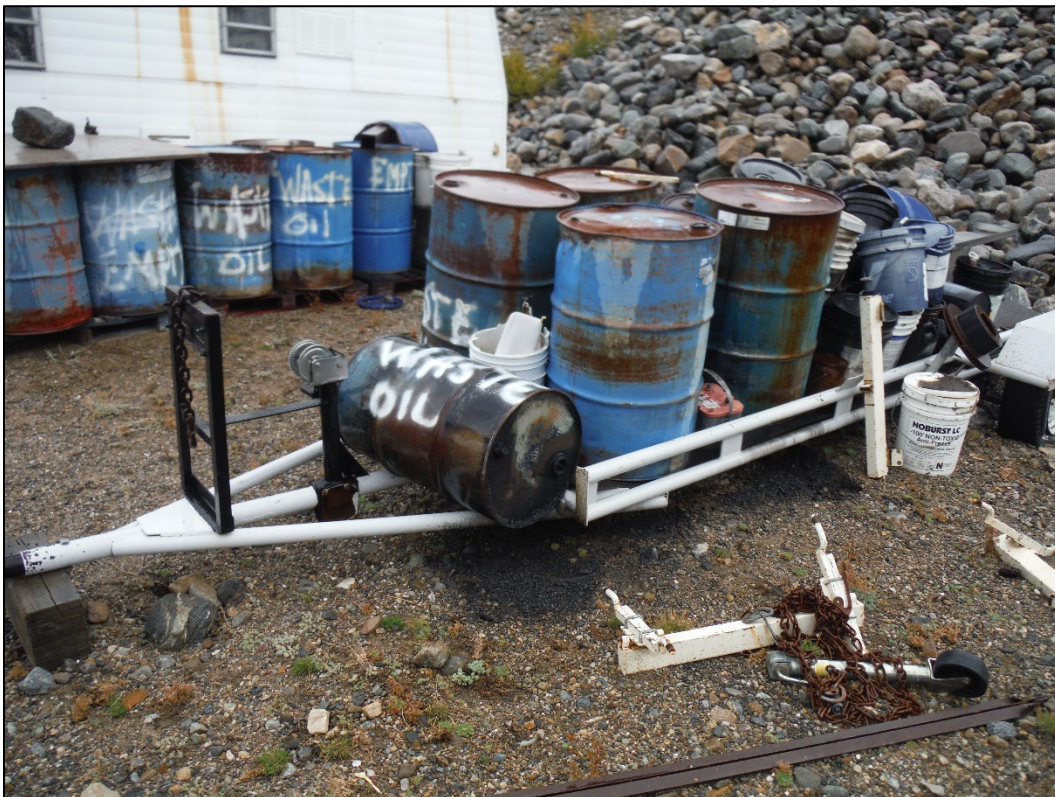
PROBLEM/POSSIBLE VIOLATION: Problem: A fuel/oil spill has occurred at the site which has impacted soils, surface water or groundwater.

The Division observed evidence of minor oil spills located in the used oil drum storage area. This has been cited as a compliance problem and will require corrective actions by the Operator; please see the second page of this report for additional information. Additionally, the Division observed a single 55-gallon oil drum located away from the used oil drum storage area which showed evidence of a small oil spill, less than 3 square feet in size. This has been included in the compliance problem discussed above.

Photo 4. Used oil and barrel storage area with small oil spill; looking north.

CORRECTIVE ACTIONS: The operator shall remediate the spill and submit a final report to the Division containing at least the following information:

- 1.) A description of how the spill was cleaned up containing at a minimum - the appropriate maps, volumes removed, sample locations, analytical data, and photo documentation.
- 2.) Evidence in the form of a receipt that the contaminated soil was disposed of by an approved method (such as sent to an approved landfill, land farming, recycling center, etc.).

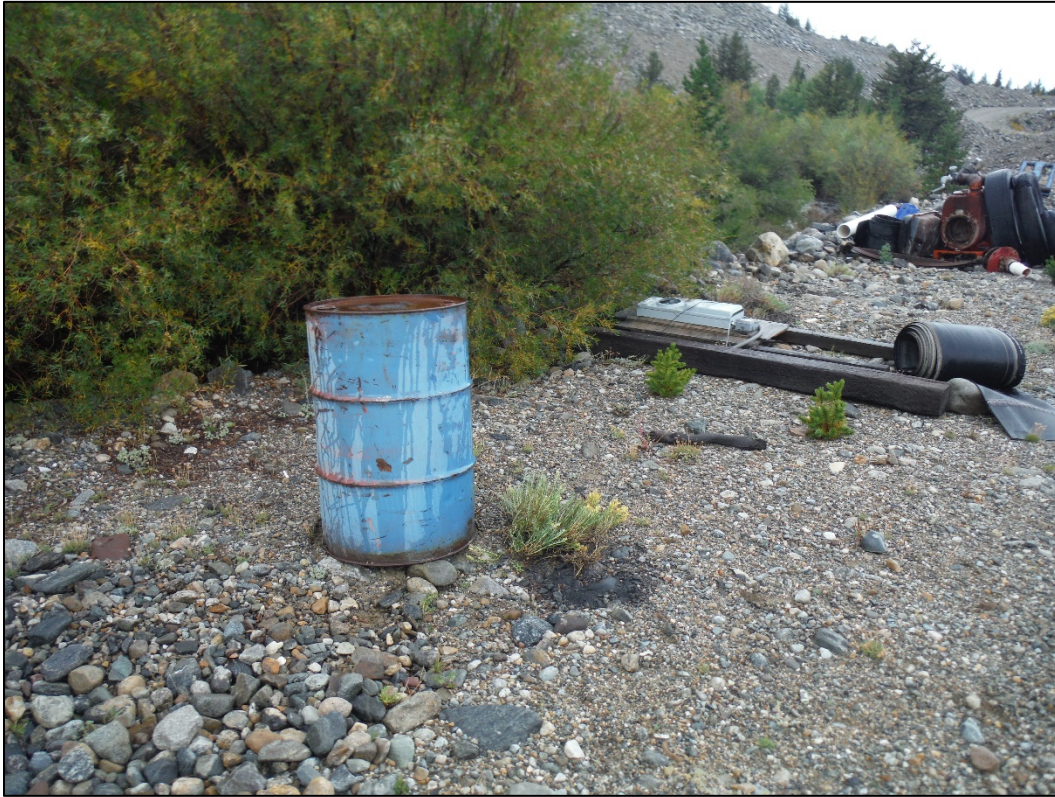
Photo 5. Single oil barrel with small oil spill; looking west.
