MINERALS PROGRAM INSPECTION REPORT**PHONE: (303) 866-3567**

MINE NAME: Dahlia North Resources Pit	MINE/PROSPECTING ID#: M-1994-093	MINERAL: Sand and gravel	COUNTY: Adams
INSPECTION TYPE: Surety Release Inspection	INSPECTOR(S): Jared L. Ebert	INSP. DATE: October 10, 2018	INSP. TIME: 09:00
OPERATOR: Aggregate Industries - WCR, Inc.	OPERATOR REPRESENTATIVE: Connie Davis and Joel Bolduc	TYPE OF OPERATION: 112c - Construction Regular Operation	
REASON FOR INSPECTION: Surety Related	BOND CALCULATION TYPE: Partial Bond	BOND AMOUNT: \$744,000.00	
DATE OF COMPLAINT: NA	POST INSP. CONTACTS: None	JOINT INSP. AGENCY: None	
WEATHER: Cloudy	INSPECTOR'S SIGNATURE:

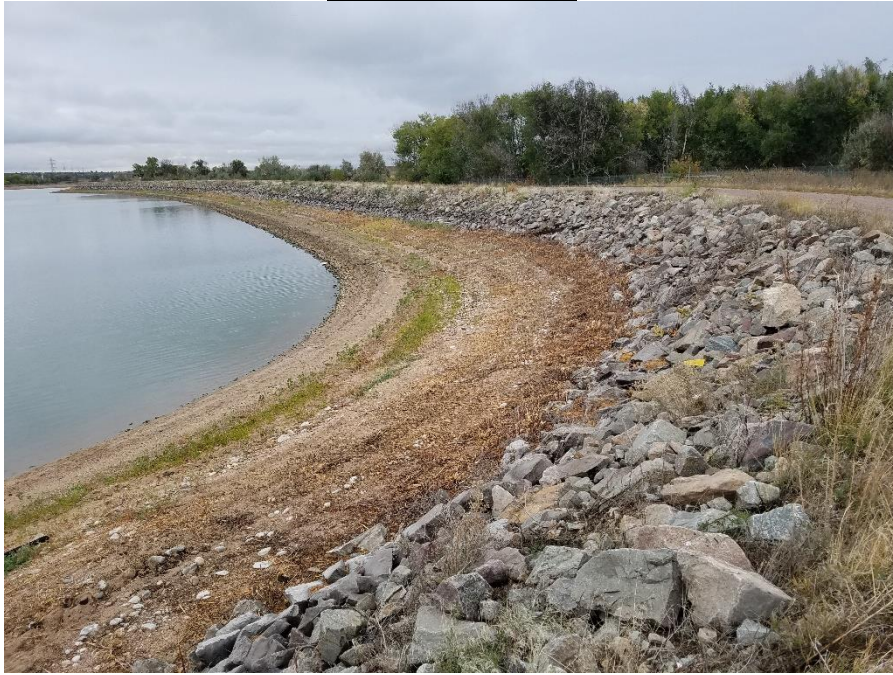
Figure 1. From the southeast corner of the reservoir looking north (Area 2A/2B) .

The area remaining within Area 2A/2B consists of the above water level slopes and surrounding affected land. Aside from the access road around the reservoir, the affected land has been revegetated with native grasses. The approved reclamation plan for this area includes a very specific tree and shrub planting plan. Also included was a requirement for AI to demonstrate to the Division that at least 50% of the planted trees and shrubs have survived. There does appear to have been some tree planting that has occurred around the site and based on the 2001 annual report some tree planting was documented. However details confirming the plantings of the required number and types of trees and shrubs could not be found. Also, AI did not make the survival demonstration in accordance with the approved reclamation plan. Given that a slurry wall encompasses the reservoir, trees and shrubs are often discouraged from growing in these areas as their root system can damage the slurry wall. Mr. Redman with the City of Thornton indicated they would prefer that trees and shrubs not be planted. Given this, AI will need to submit a Technical Revision to the reclamation plan removing the tree and shrub planting requirement. This Technical Revision would need to be submitted and approved by the Division before this area can be release from reclamation liability. Otherwise, the vegetation established around the reservoir is adequate.

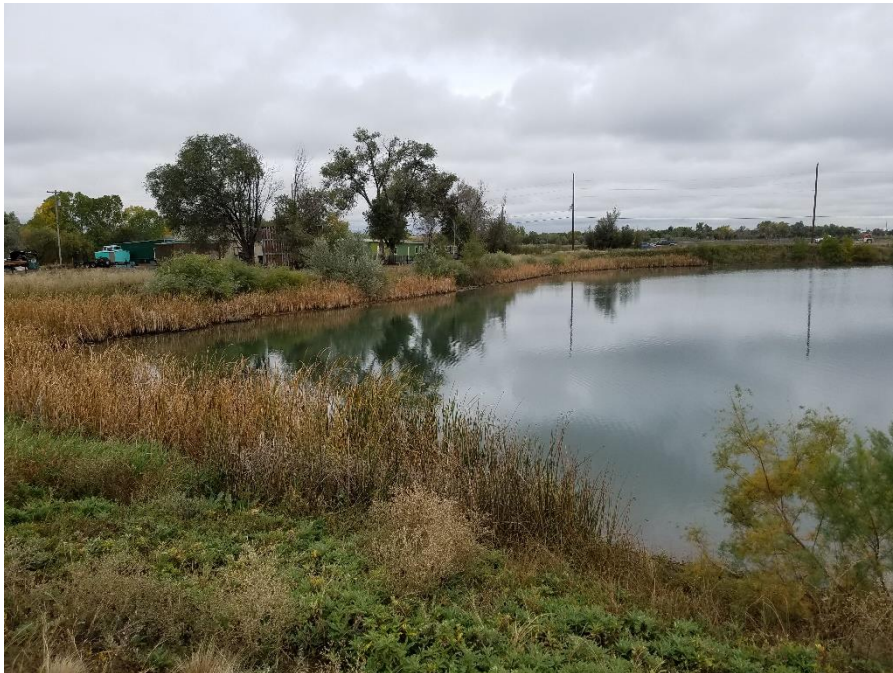
Figure 2. From the north end of the Area 1 pond looking southeast.

The Division finds that Area 1 has been reclaimed. This area was originally planned to be backfilled, instead the area consists of an open groundwater pond covered by an approved permanent plan of augmentation. The area appears stable and vegetated. Some noxious weeds were observed in the area such as knapweed,

Russian olive and Tamarisk. According to Mr. Redman, upon release, weed control will be undertaken by the City in accordance with their weed management standards for areas near water storage reservoirs. Given the condition of Area 1, the Division will approve this area for release.

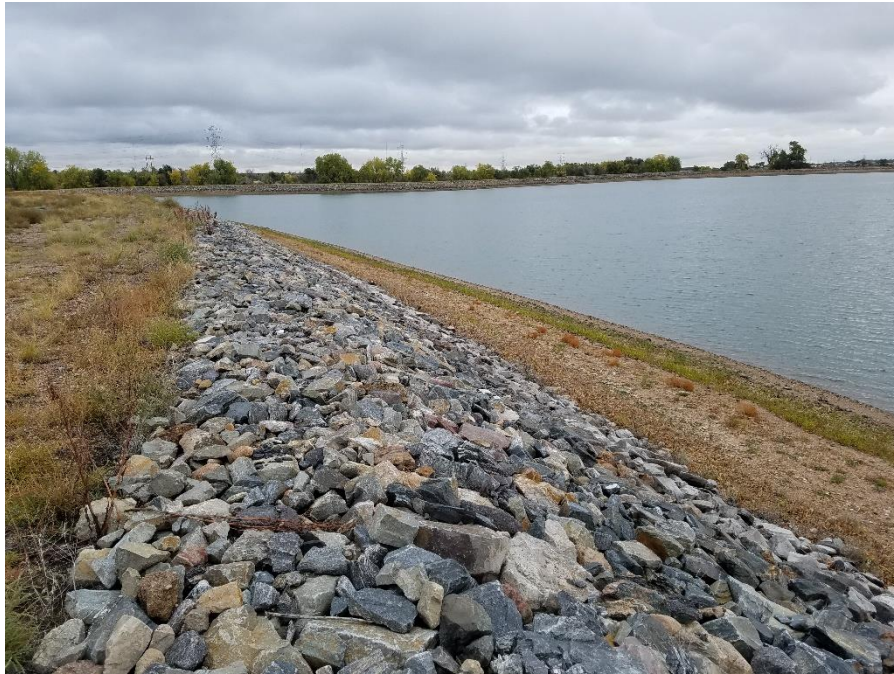
Figure 3. From the west side of the reservoir looking north.

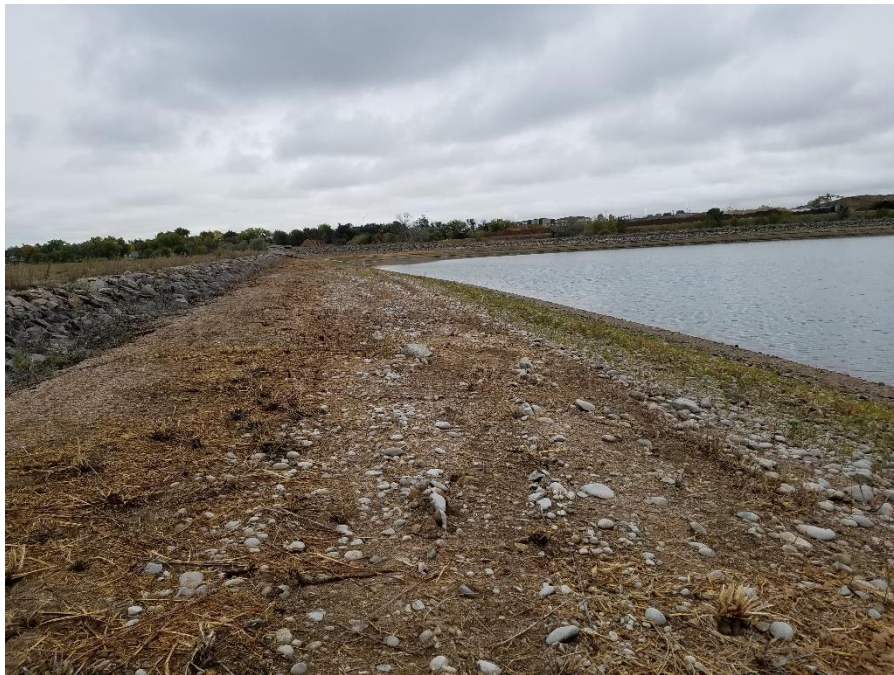
Figure 4. From the north side of the reservoir looking east.

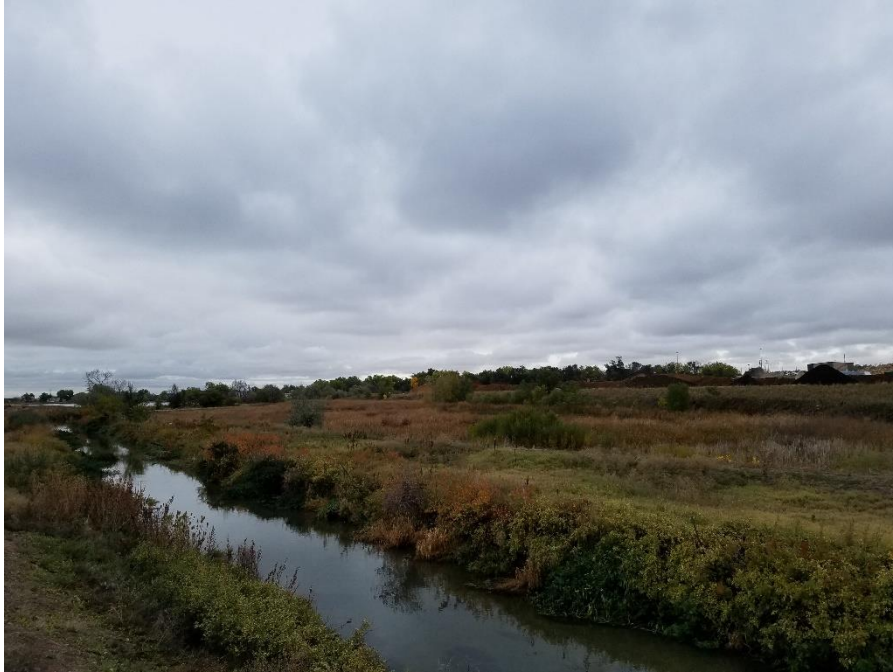
Figure 5. View of Area 2C from the west side of the Bull Seep ditch looking east.

The reclamation plan indicates that Area 2C was to be backfilled and used for urban development. As discussed above, this area has been partially backfilled and is being used for industrial uses. A small wetland area about 5.21 acres in size remains within this area. Permanent augmentation of the remaining exposed groundwater within this area will need to be addressed prior to the Division's release of this area.
