Sunday Mine – Permit No. M-1977-285

In reference to my letter on August 1, 2018, the surface waste rock pile was characterized at the Sunday Mine. This project was performed and completed on October 12, 2018. A XRF hand held unit was used. The concerned area consisted of 40 x 40 ft. blocks, taking five different samples in each of those blocks to get an average of the value of grade.

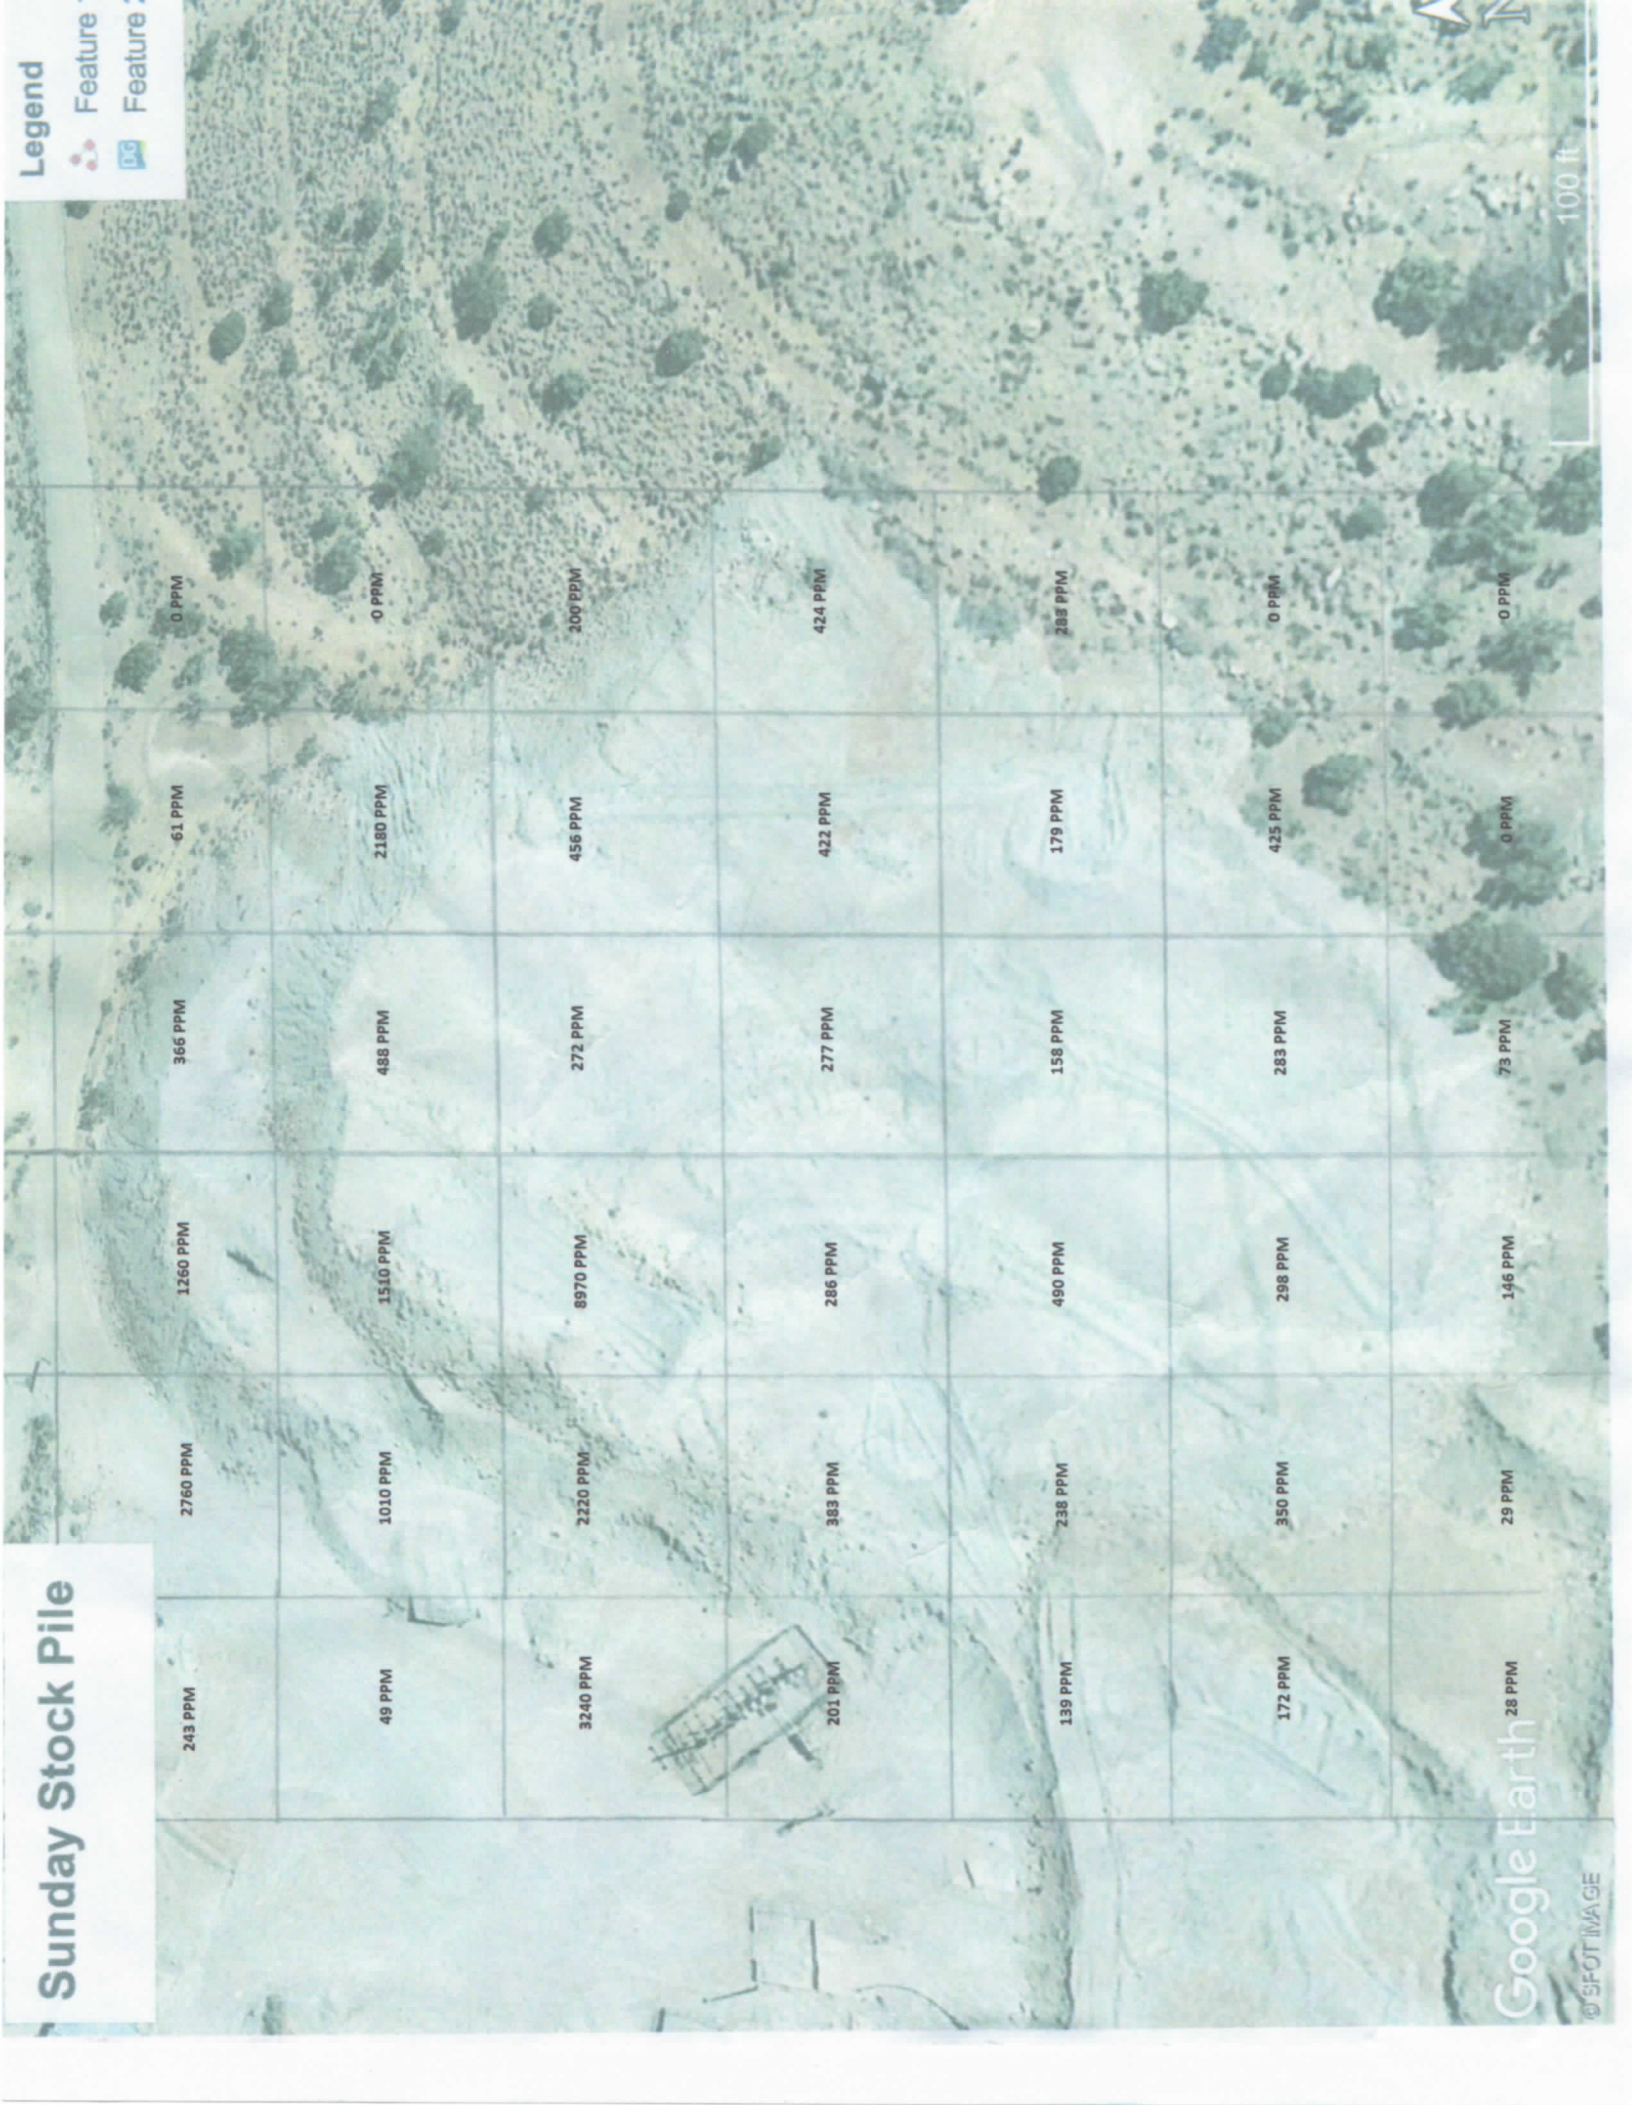
I have provided the average samples on the attached map. I believe the averages on the surface of the waste pile to be very low grade.
