## MINERALS PROGRAM INSPECTION REPORT

<b>MINE NAME:</b> Gray Pit	<b>MINE/PROSPECTING ID#:</b> M-1990-148	<b>MINERAL:</b> Gravel	<b>COUNTY:</b> Kiowa
<b>INSPECTION TYPE:</b> Monitoring	<b>INSPECTOR(S):</b> Amy Eschberger	<b>INSP. DATE:</b> October 10, 2018	<b>INSP. TIME:</b> 10:30
<b>OPERATOR:</b> Kiowa County	<b>OPERATOR REPRESENTATIVE:</b> Rick Spady	<b>TYPE OF OPERATION:</b> 110c - Construction Limited Impact	
<b>REASON FOR INSPECTION:</b> Normal I&E Program	<b>BOND CALCULATION TYPE:</b> None	<b>BOND AMOUNT:</b> \$0.00	
<b>DATE OF COMPLAINT:</b> NA	<b>POST INSP. CONTACTS:</b> None	<b>JOINT INSP. AGENCY:</b> None	
<b>WEATHER:</b> Cloudy	<b>INSPECTOR'S SIGNATURE:</b>

## **OBSERVATIONS**

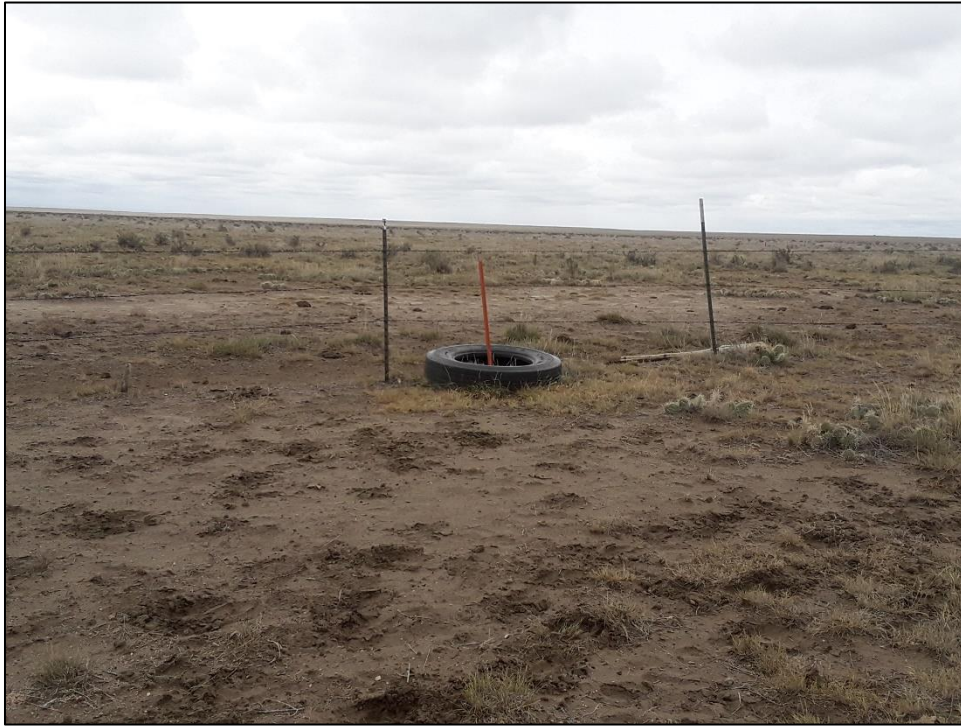
**Photo 1.** View of T-post and tire marking southwestern corner of permit boundary. This boundary corner aligns with the existing property fence.

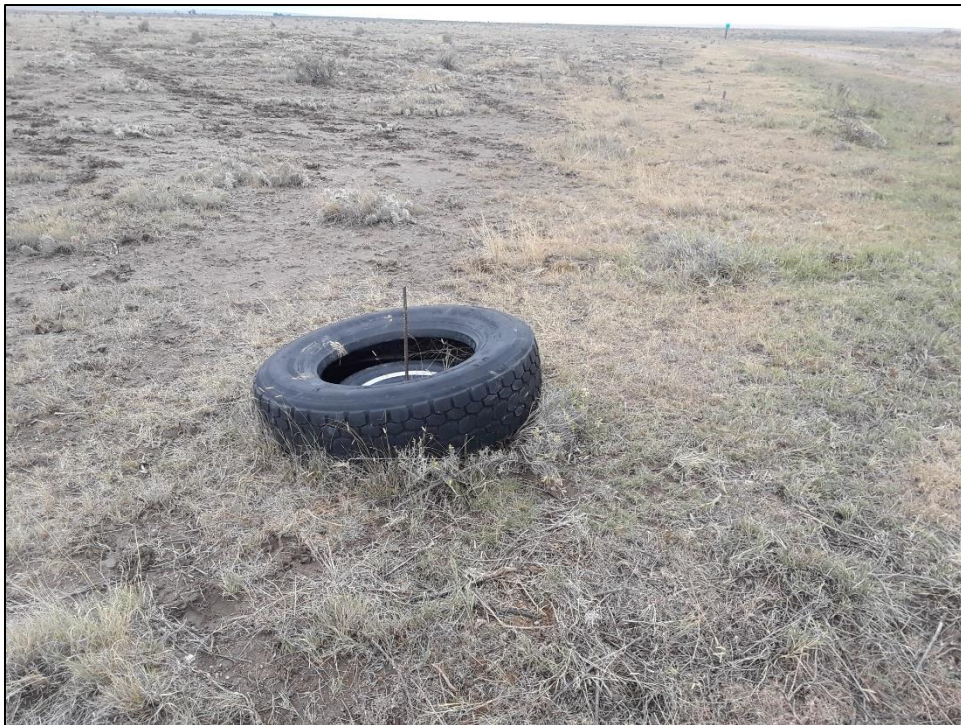
**Photo 2.** View of T-post and tire marking western edge of permit boundary.

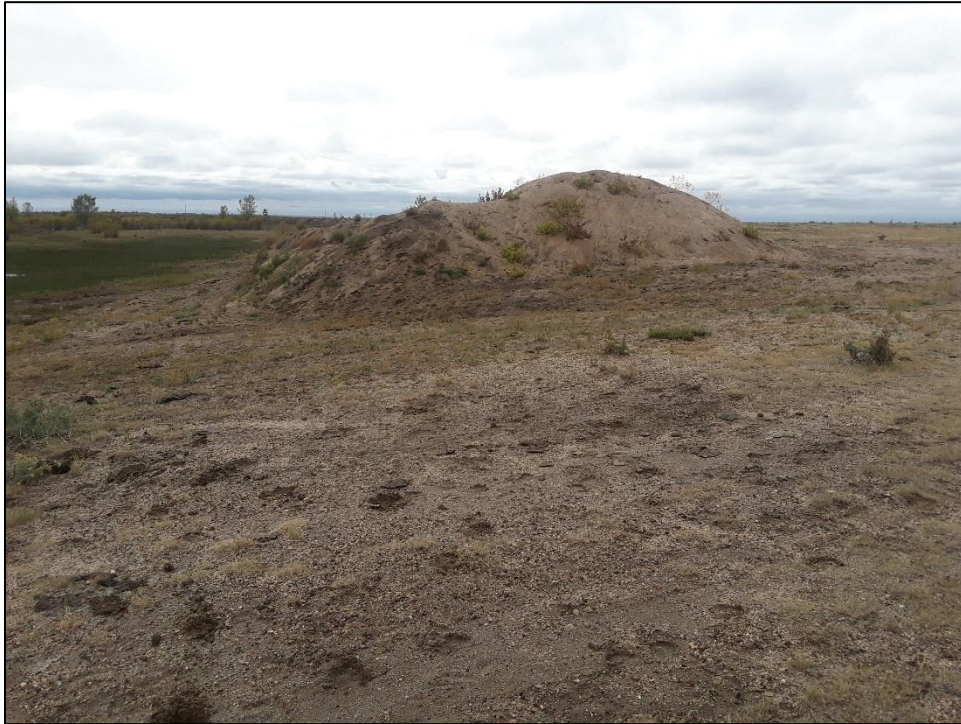
**Photo 3.** View of small material stockpile present on western creek bank.

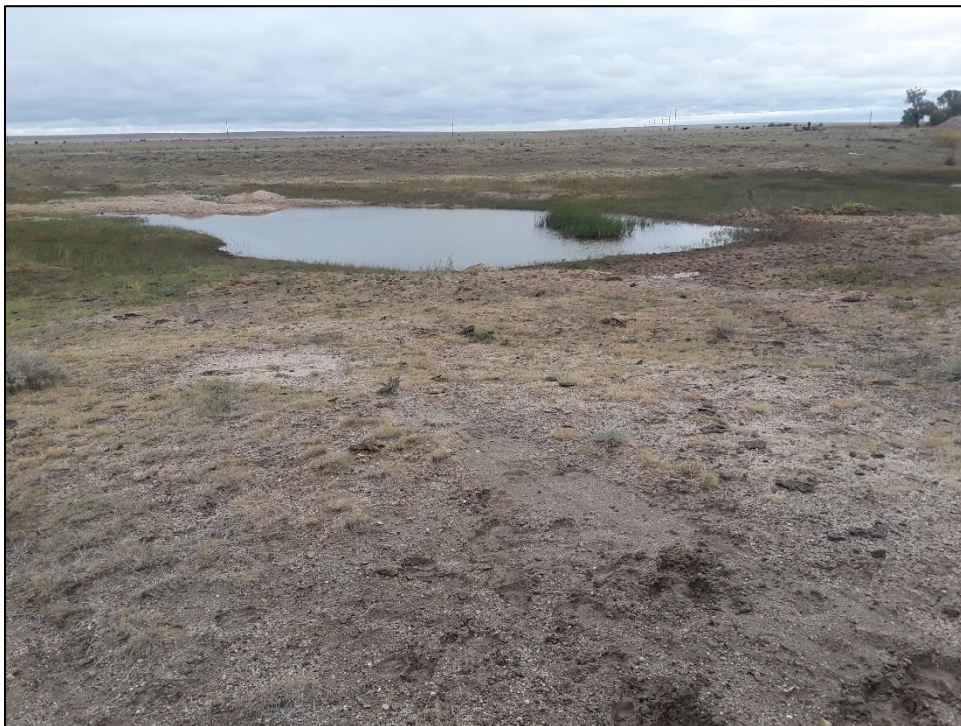
**Photo 4.** View of work basin dug into creek bed to catch sediment when creek flows. This basin was holding water due to a recent storm event.

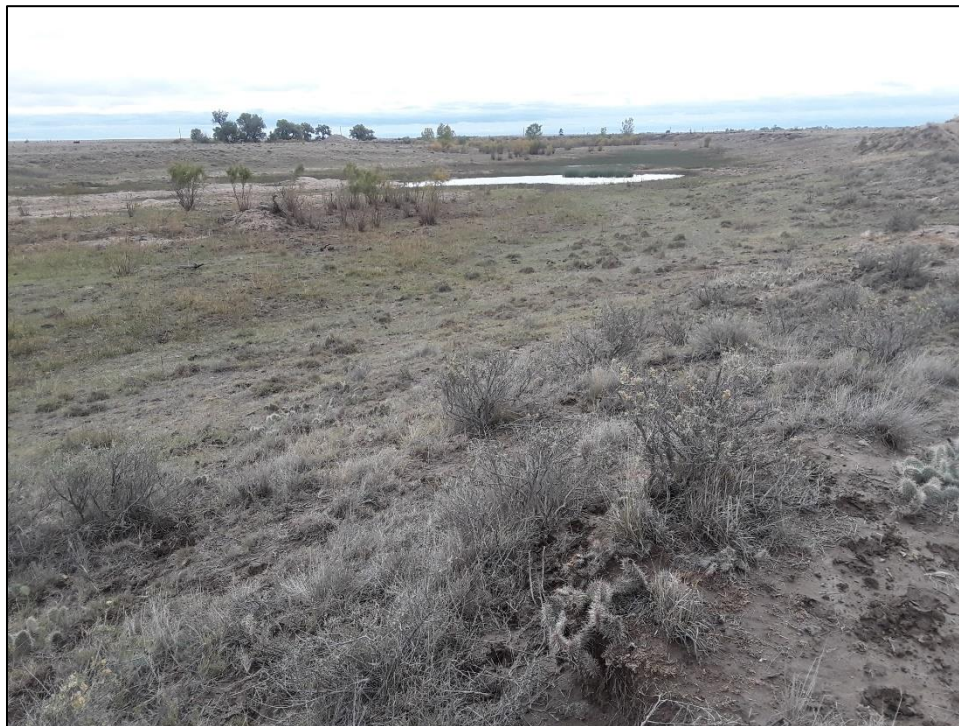
**Photo 5.** View looking south across section of creek within permit area. Note creek bank stable with vegetative cover.

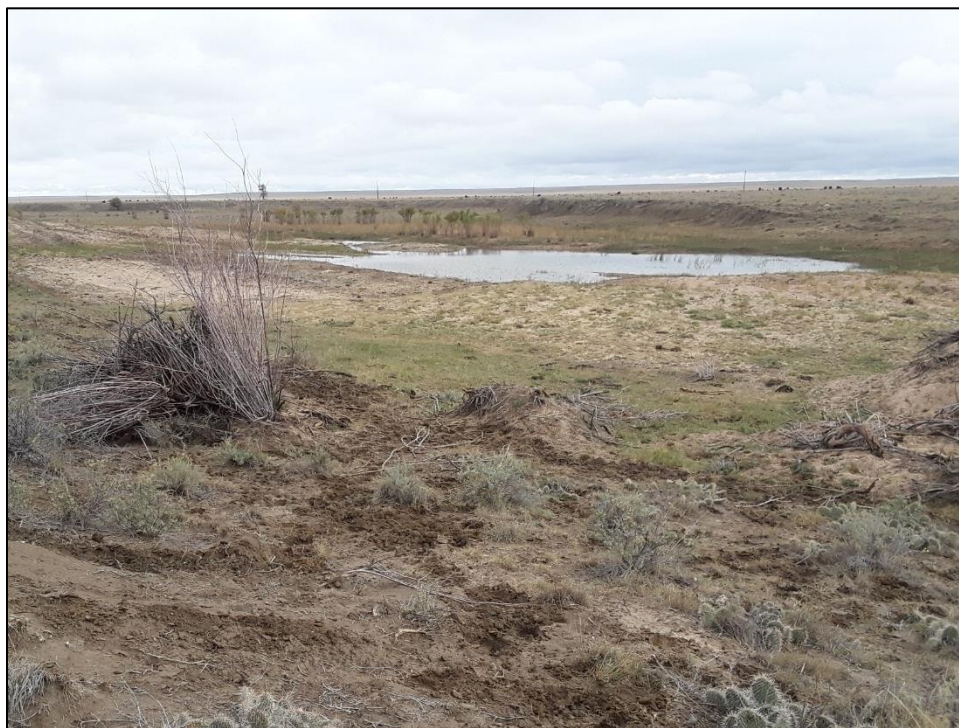
**Photo 6.** View of work basin dug into creek bed to catch sediment when creek flows. This basin was holding water due to a recent storm event.

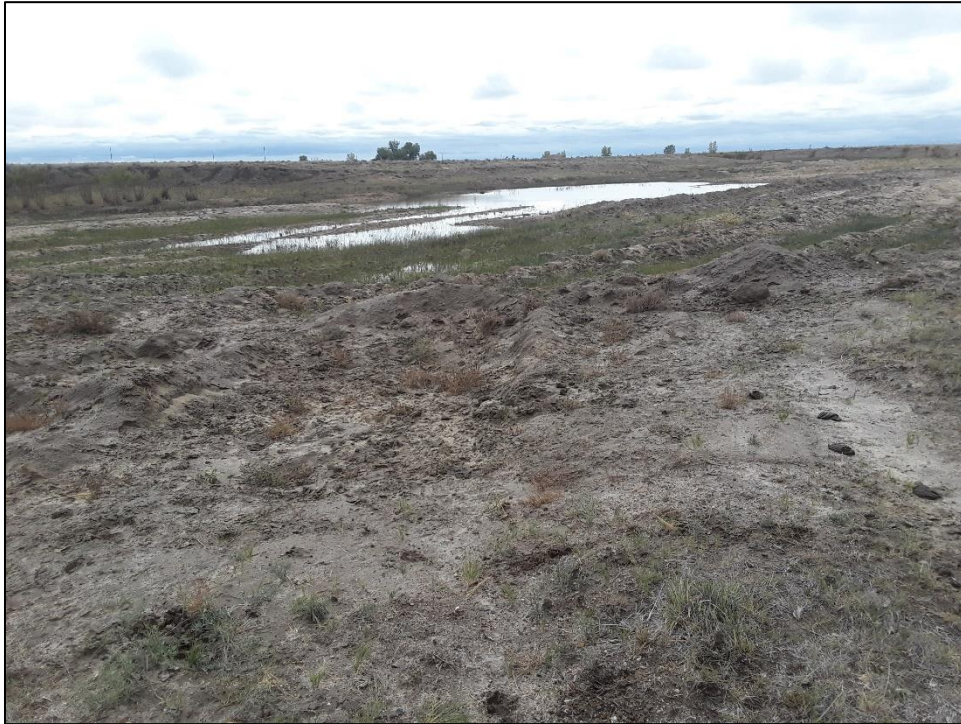
**Photo 7.** View looking south across northern edge of work basin shown in Photo 6.

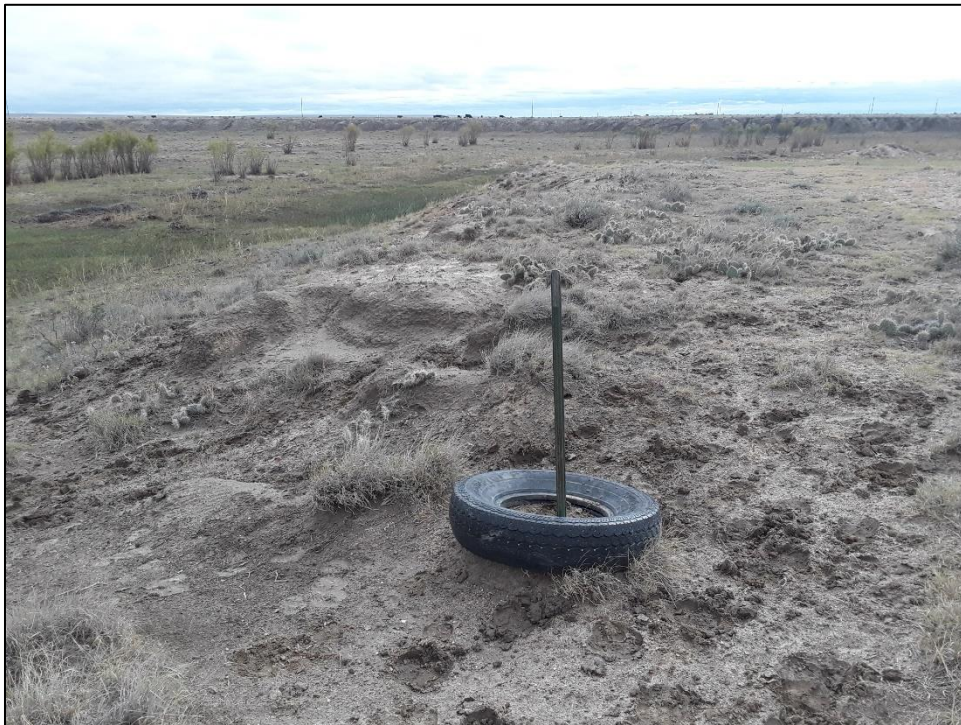
**Photo 8.** View of T-post and tire marking northwestern corner of permit boundary on western creek bank.
