MINERALS PROGRAM INSPECTION REPORT**PHONE: (303) 866-3567**

MINE NAME: Heintzelman Project (Pit 116)	MINE/PROSPECTING ID#: M-2009-018	MINERAL: Sand and gravel	COUNTY: Weld
INSPECTION TYPE: Monitoring	INSPECTOR(S): Peter S. Hays	INSP. DATE: November 1, 2018	INSP. TIME: 10:00
OPERATOR: Varra Companies, Inc.	OPERATOR REPRESENTATIVE:	TYPE OF OPERATION: 112c - Construction Regular Operation	
REASON FOR INSPECTION: Normal I&E Program	BOND CALCULATION TYPE: IT.Bondcalculationtype.CD.Desc	BOND AMOUNT: \$239,266.00	
DATE OF COMPLAINT: NA	POST INSP. CONTACTS: None	JOINT INSP. AGENCY: None	
WEATHER: Clear	INSPECTOR'S SIGNATURE:

Heintzelman Project

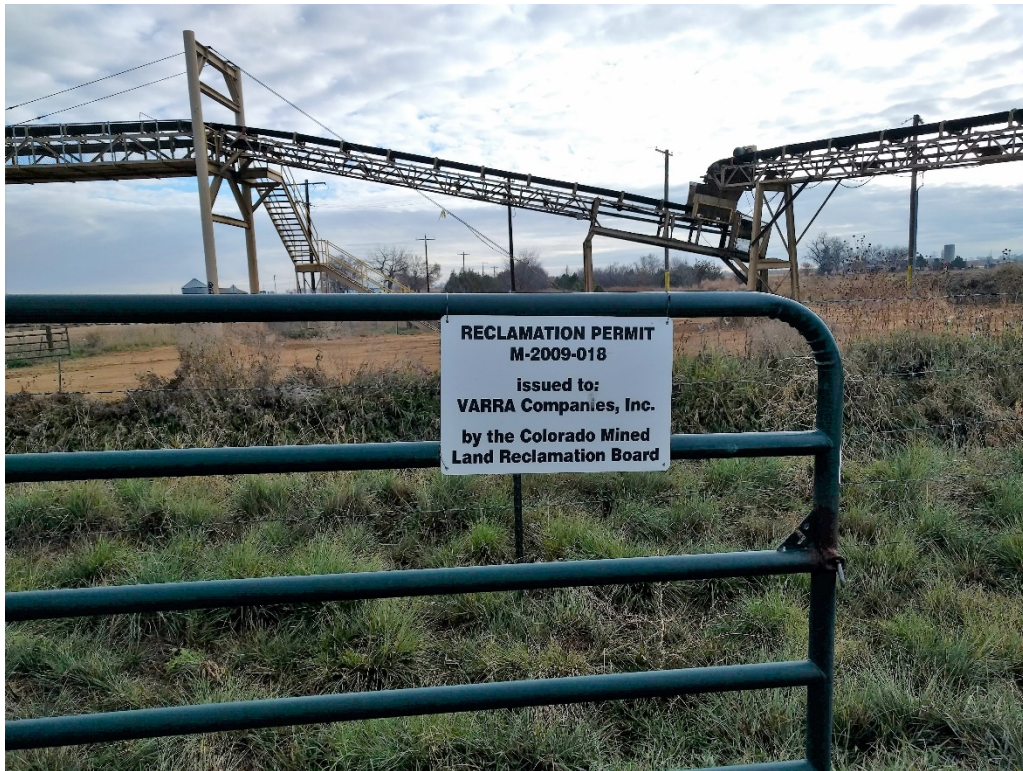
The entrance sign and boundary markers were observed as required by Rule 3.1.12. The site is fenced on all sides and is delineated by WCR 17 to the west, WCR 26 to the south and WCR 28 to the north.

Heintzelman mine sign

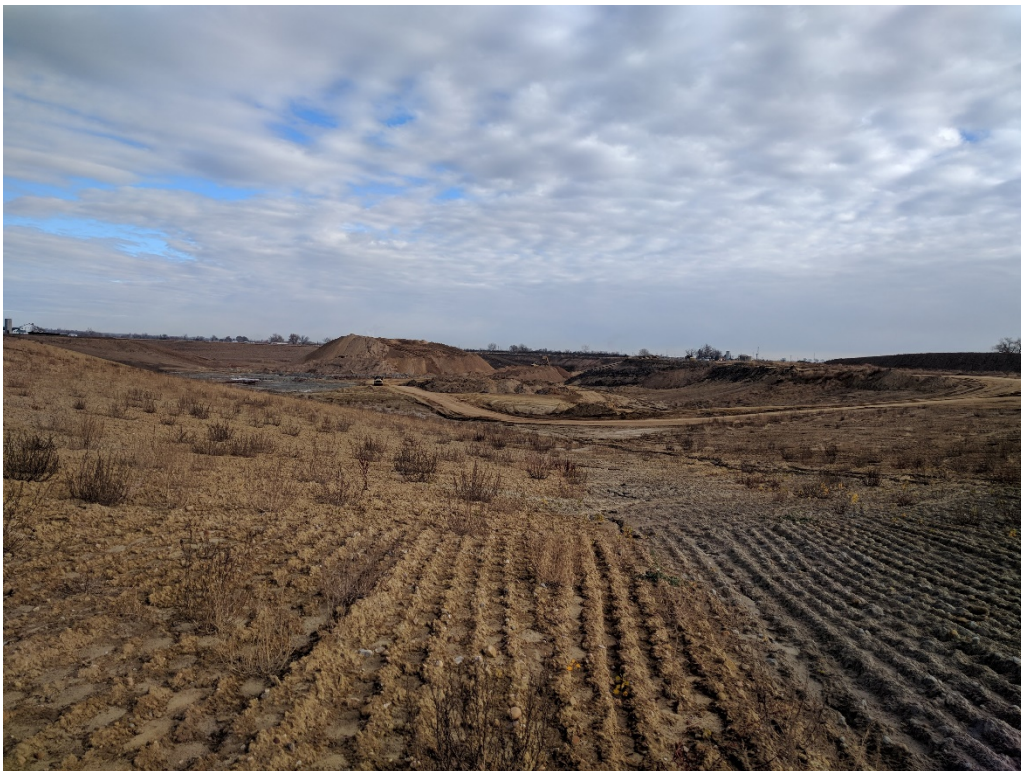
The mining excavation in the tract was estimated at 80% complete by the Division. The north, west and a portions of the east pit highwalls were backfilled and sealed with a clay liner. Topsoil has not been replaced on the regraded slopes. Annual weeds were observed on the north, east and portions of the west slopes. The regraded slopes were stable and no erosion features were observed during the inspection. Mining excavation was occurring in the southeast corner of the tract. Material stockpiled on the pit floor of the tract was being conveyed to the Kurtz Project for processing. The pit was being dewatered from the tract to the seep ditch adjacent to the east permit boundary.

View of Tract A from the southwest corner looking northeast

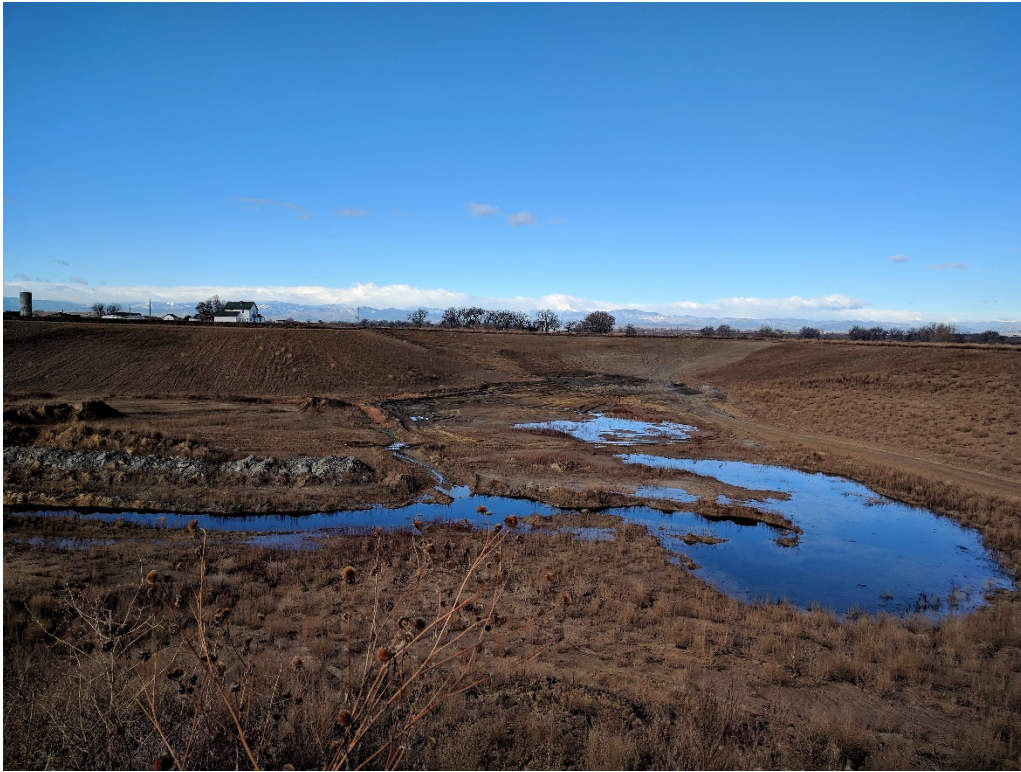
View of Tract A from the northeast corner looking west

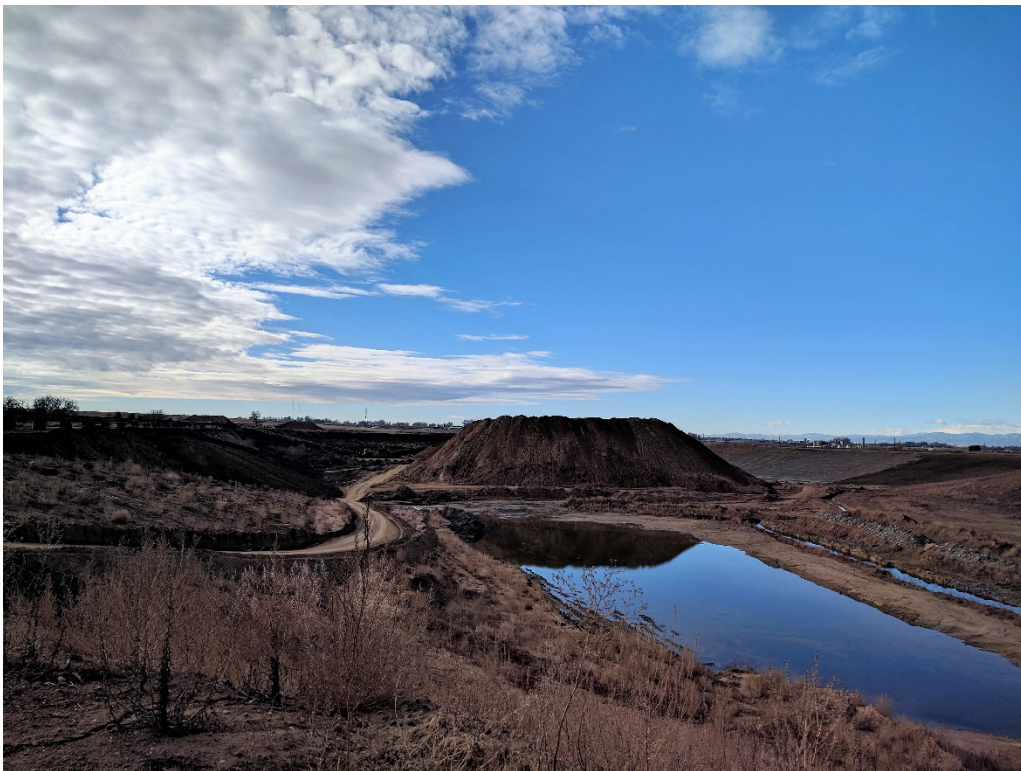
View of Tract A from the northeast corner looking south

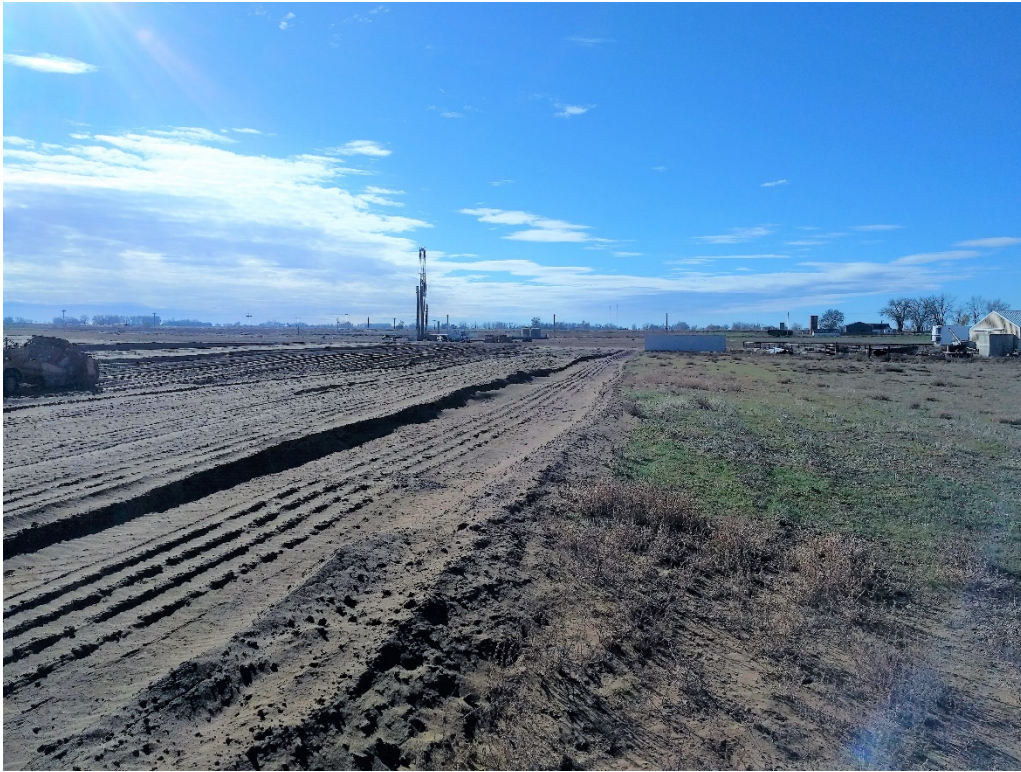
The eastern half of the tract was stripped of topsoil and overburden and was being excavated by a scraper to provide backfill material for Tract B. The Operator does not intend to mine gravel from the tract. The perimeter slopes of the tract are planned to be mined at the final 3H:1V slopes. The Operator estimates 15 to 20 feet of sand will be removed from the tract. The excavation will not intercept groundwater. The final excavation will create a shallow dry basin. The Division will require the Operator to revise the approved Mining and Reclamation Plans for the tract with the submittal of a technical revision or as part of a future permit amendment for the site.

View of sand excavation in Tract C

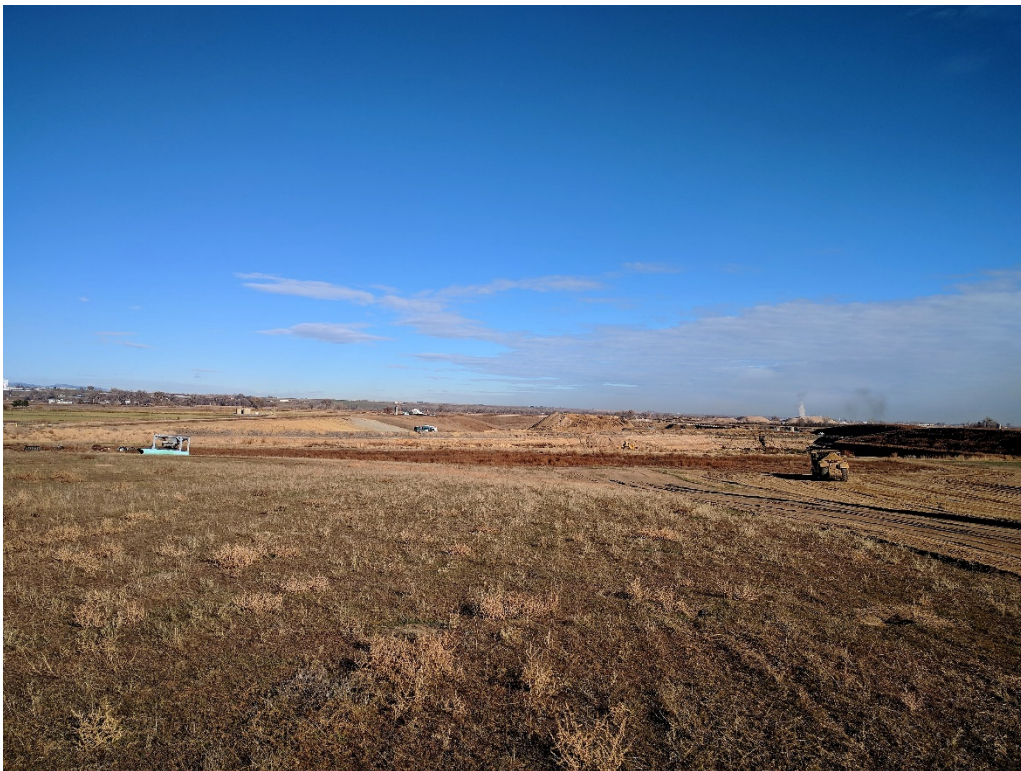
View of site from Tract C looking north

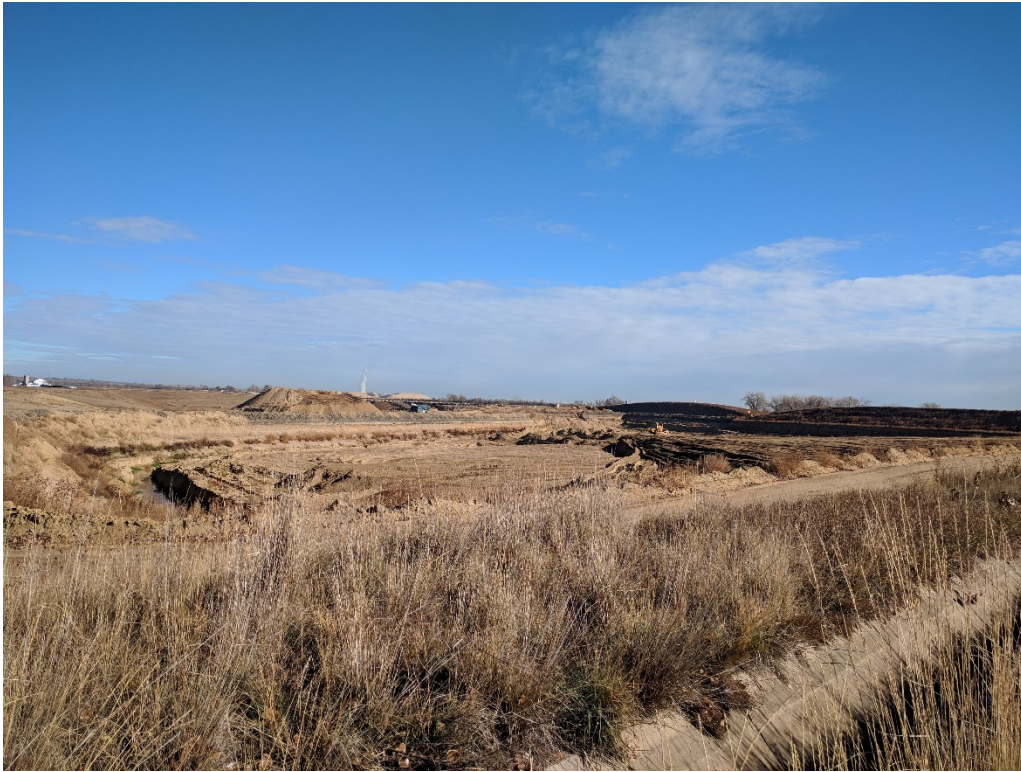
The mining excavation in the tract is complete. The pit depth was estimated at 30 feet with 1H:1V perimeter highwall slopes. The Operator has elected to backfill the tract with sand from Tract C to eliminate long-term groundwater exposure. The backfilling operation was progressing from south to north with a scraper. The Division will require the Operator to revise the approved Mining and Reclamation Plans to backfill the tract with the submittal of a technical revision or as part of a future permit amendment for the site.

View of Tract B from the southwest corner looking northeast

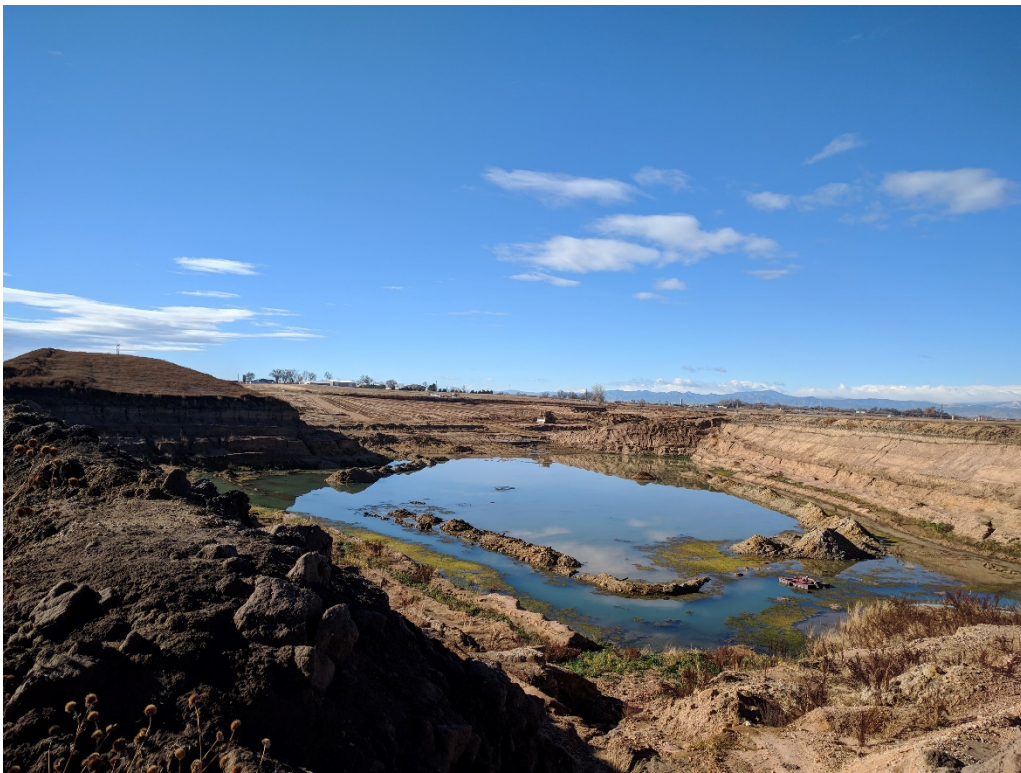
View of Tract B from the northeast corner looking southwest

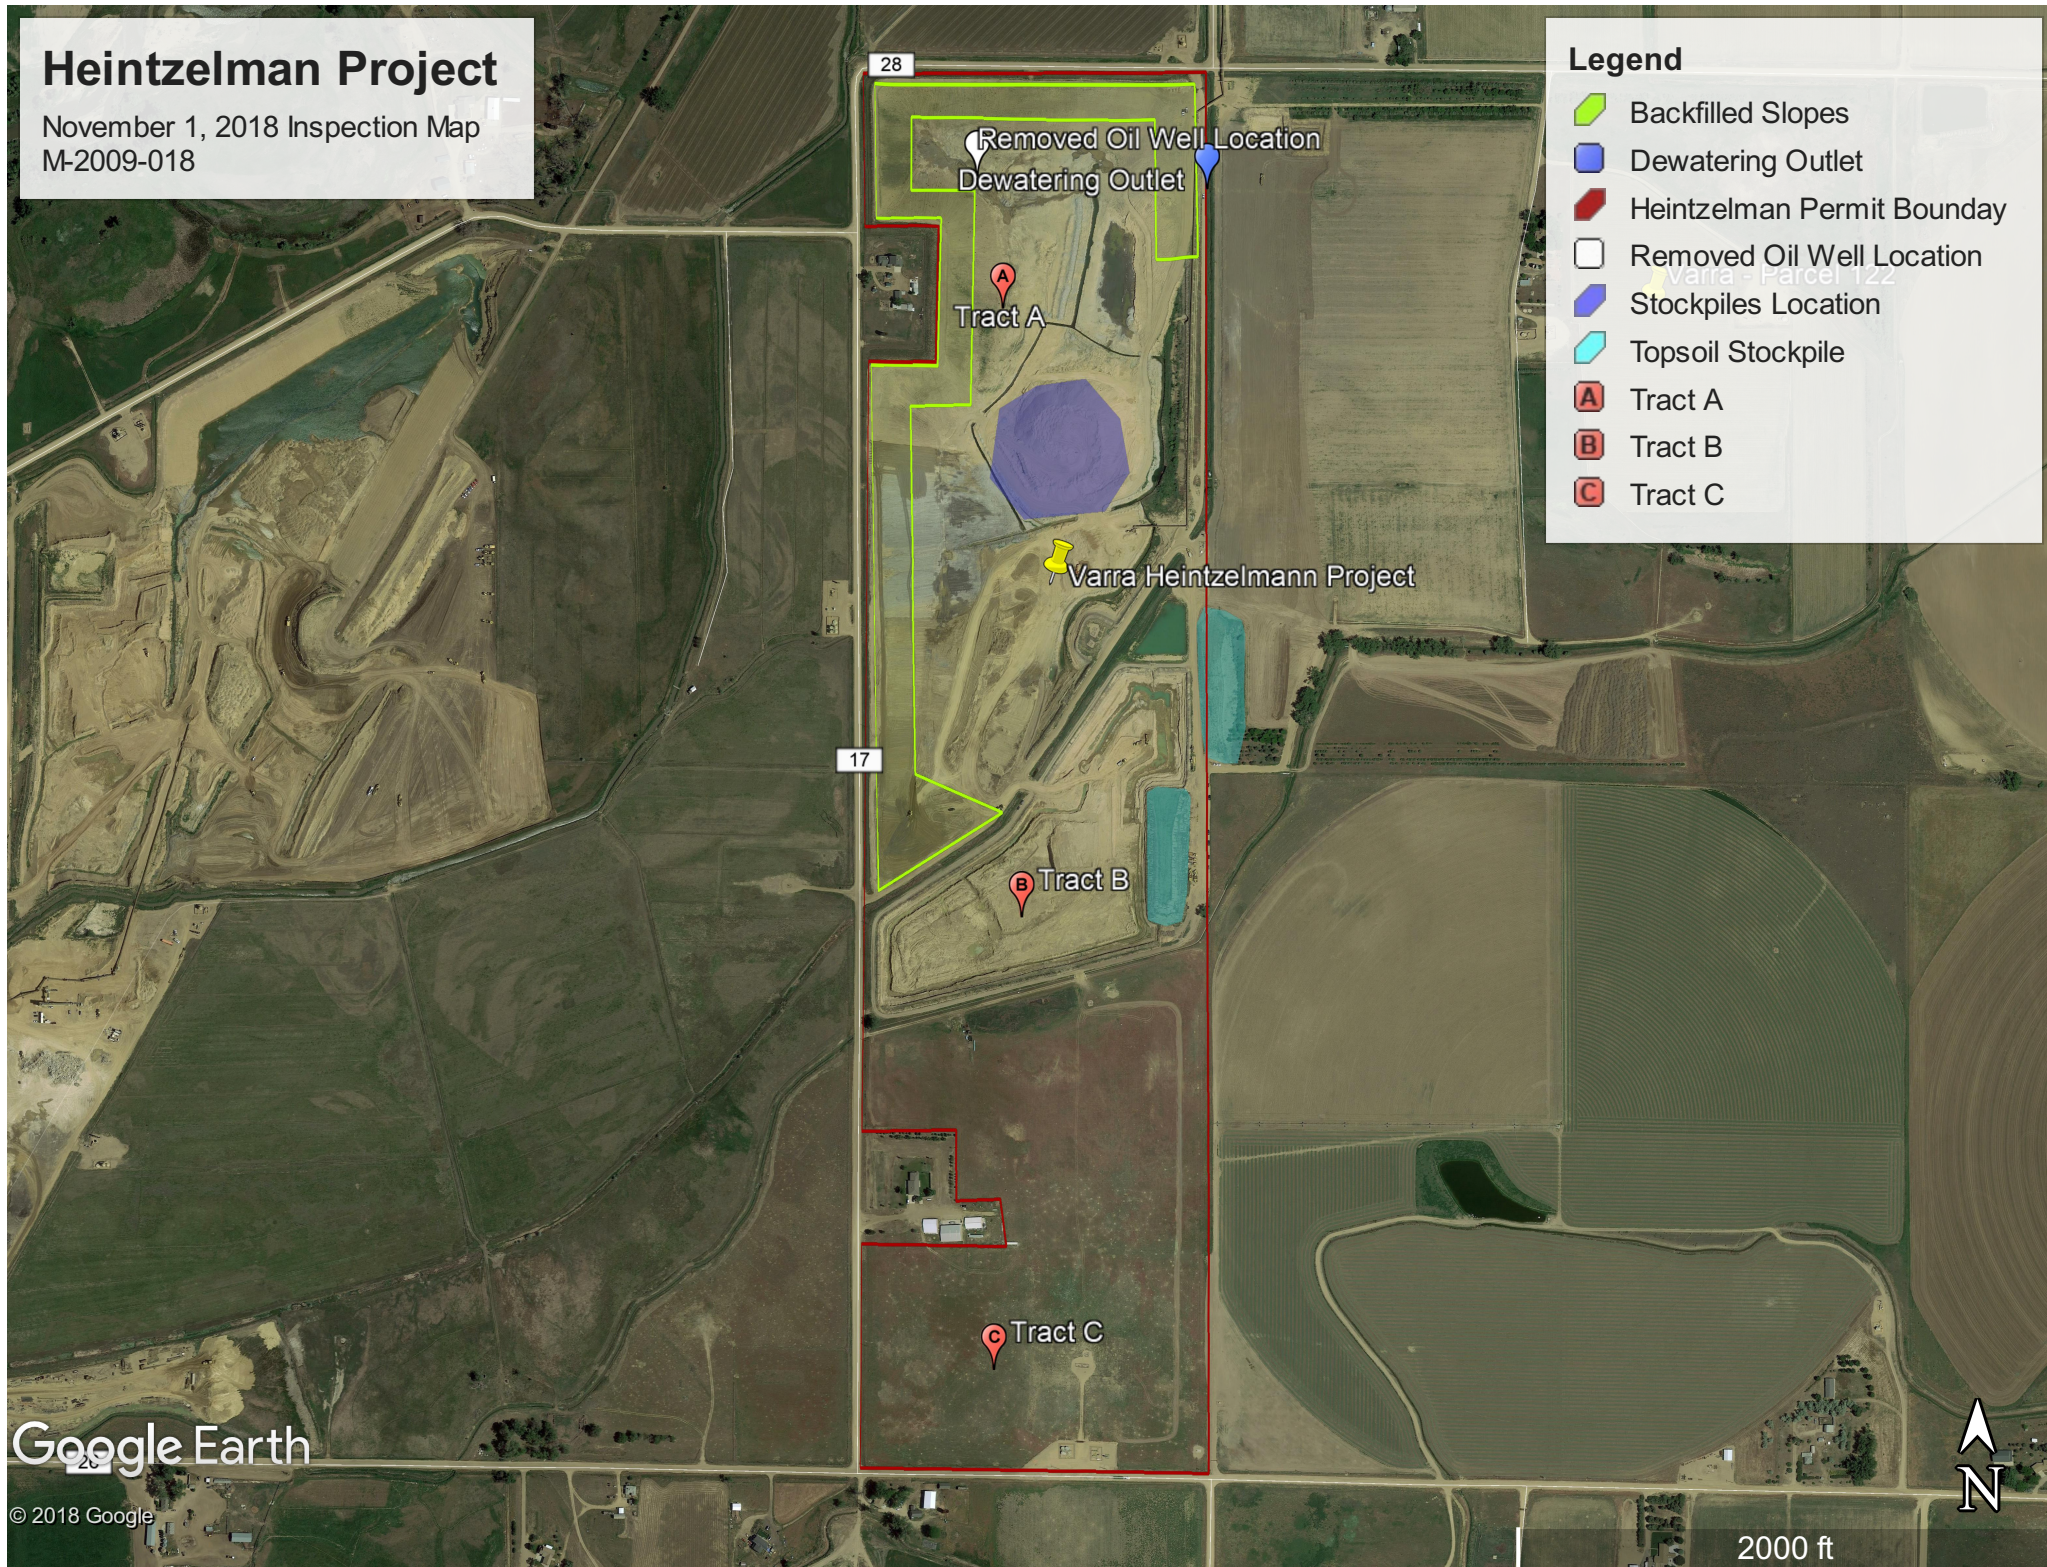
November 1, 2018 Inspection Map
M-2009-018

Photographs taken during the inspection and an inspection map created by the Division based on the inspection observations are attached.
