MINERALS PROGRAM INSPECTION REPORT

MINE NAME: Gentz Gravel Pit	MINE/PROSPECTING ID#: M-1983-116	MINERAL: Sand and gravel	COUNTY: Prowers
INSPECTION TYPE: Monitoring	INSPECTOR(S): Amy Eschberger	INSP. DATE: October 10, 2018	INSP. TIME: 14:30
OPERATOR: Kiowa County	OPERATOR REPRESENTATIVE: Jack Howard	TYPE OF OPERATION: 110c - Construction Limited Impact	
REASON FOR INSPECTION: Normal I&E Program	BOND CALCULATION TYPE: None	BOND AMOUNT: \$0.00	
DATE OF COMPLAINT: NA	POST INSP. CONTACTS: None	JOINT INSP. AGENCY: None	
WEATHER: Cloudy	INSPECTOR'S SIGNATURE:

This was a normal monitoring inspection of the Gentz Gravel Pit (Permit No. M-1983-116) conducted by Amy Eschberger of the Division of Reclamation, Mining and Safety (Division). Mr. Jack Howard represented the operator during the inspection. The site is located approximately 12 miles north of Lamar in Prowers County. Access to the site is from the north off Co Rd Vv 3/10. **Photos 1-10** taken during the inspection are included with this report.

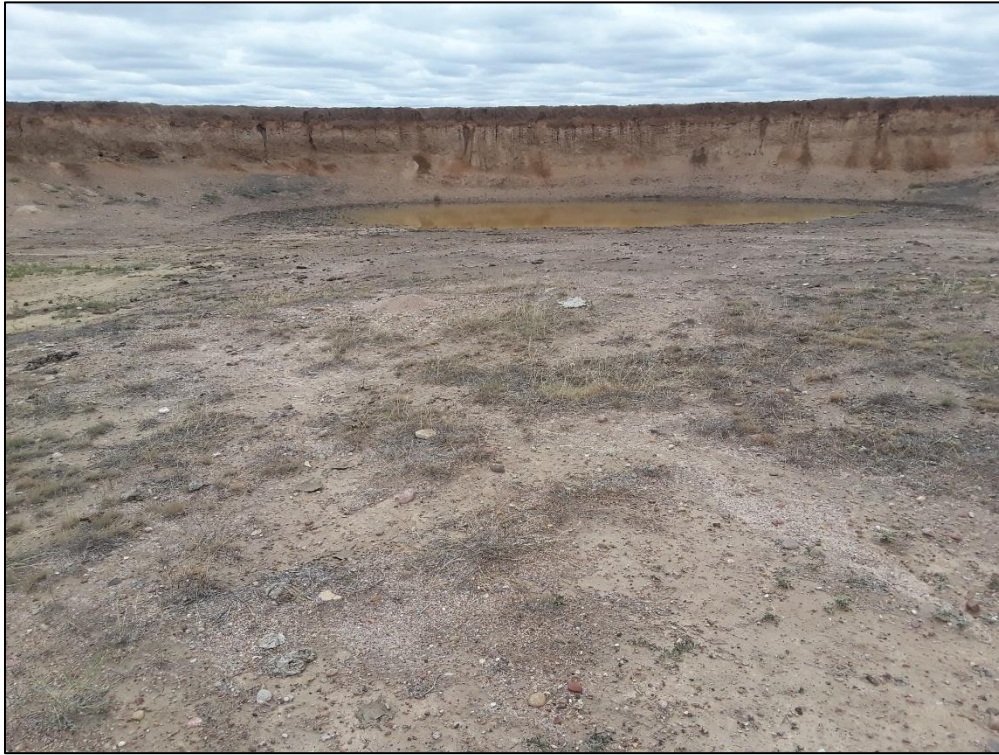
Photo 1. View looking south across pit. Pit highwall is approximately 15 feet in height with near vertical slopes.

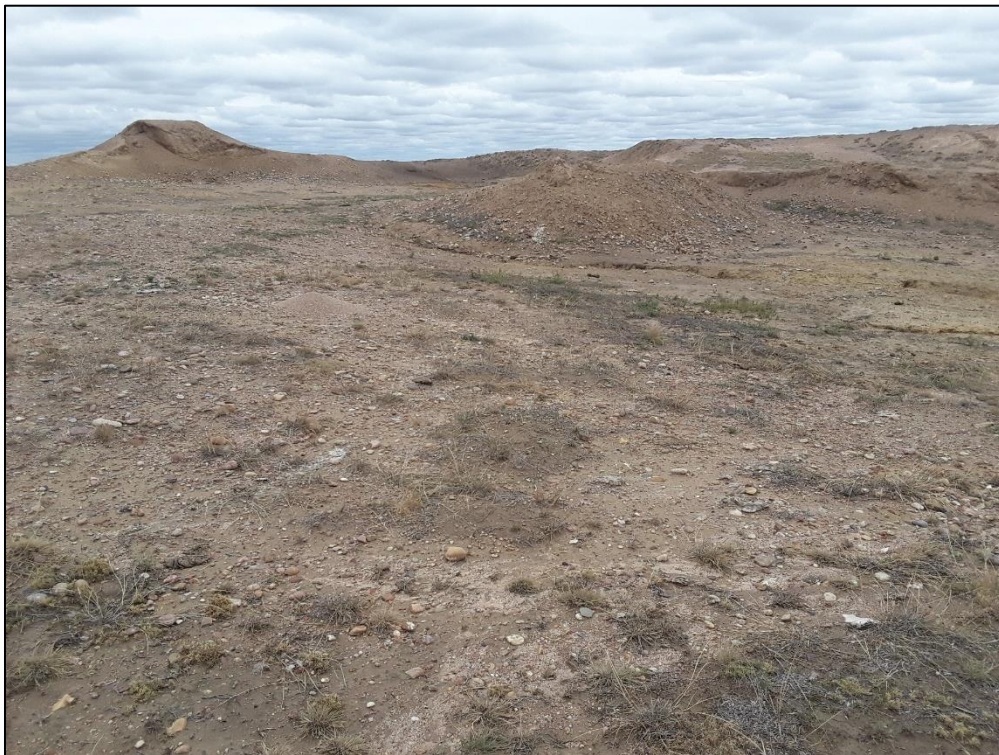
Photo 2. View looking east from pit floor, showing topsoil stockpile (at left) and small material stockpile (at right) stored at eastern edge of pit.

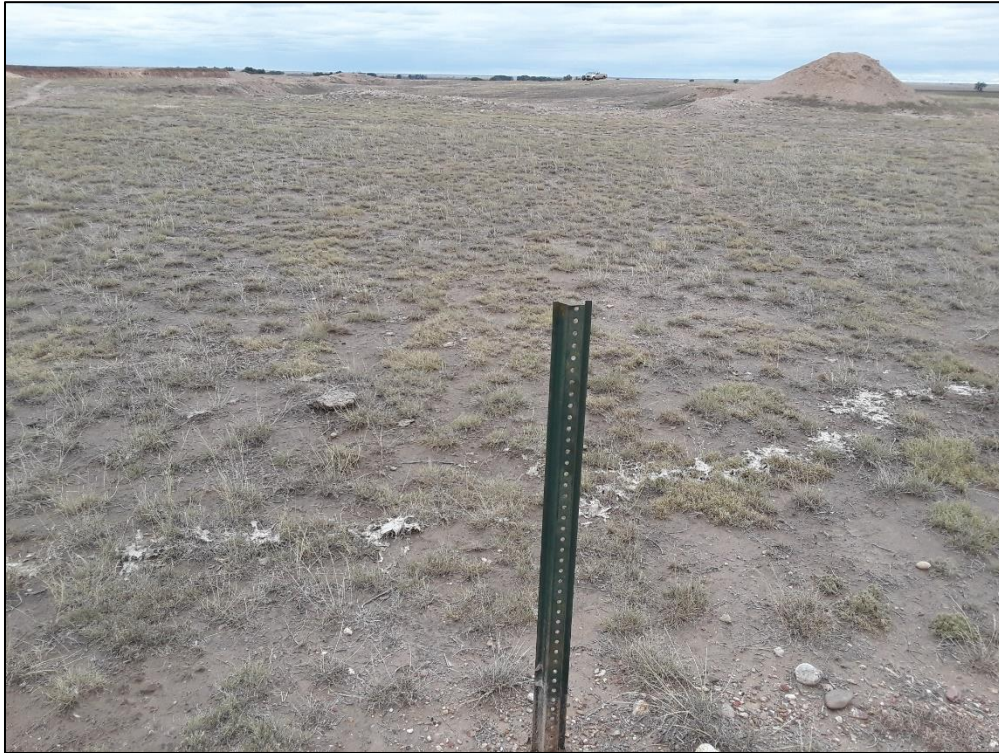
Photo 3. View looking northwest, showing T-post marking southeastern permit boundary.

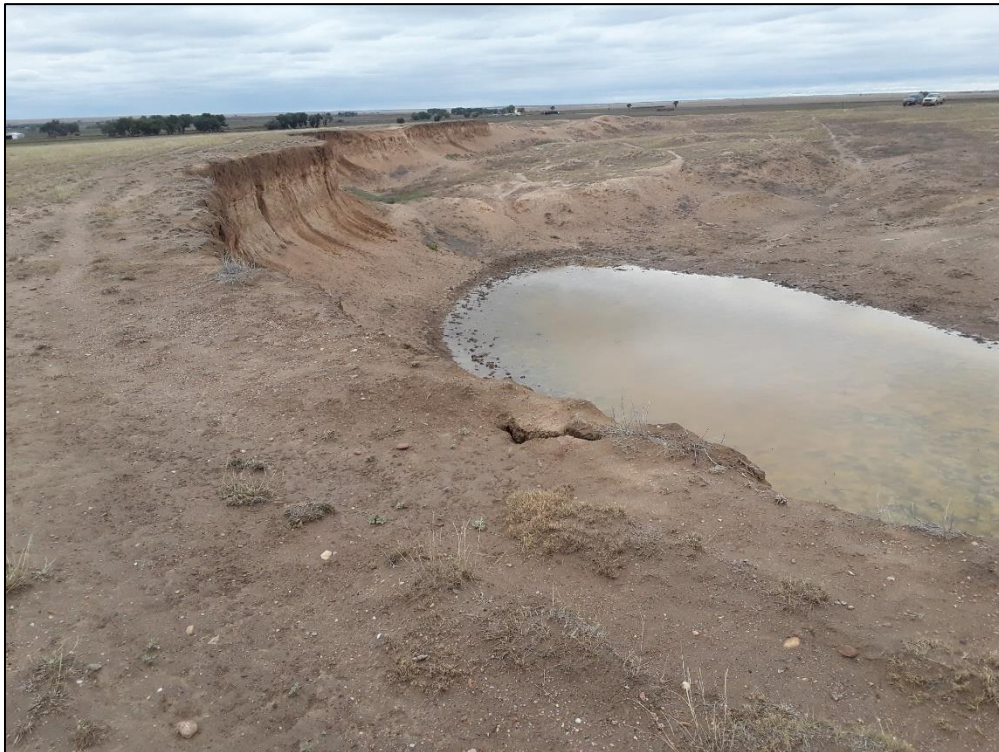
Photo 4. View looking west from southern edge of pit, showing western portion of highwall. Pit highwall is approximately 15 feet in height with near vertical slopes. Note ponded water in pit during inspection due to recent storm event.

The pit floor and the depressions created at the western edge of the pit were holding some water during the inspection due to a recent storm event. Mr. Howard indicated the landowner would like the operation to leave a few small depressions for reclamation to be utilized as cattle ponds. However, the approved reclamation plan for the site does not include this use. If the operator wishes to change the reclamation plan to leave cattle ponds, this can be done through submittal of a Technical Revision (see enclosed form). The revision should also include a revised reclamation plan map showing the approximate location of any ponds to remain.

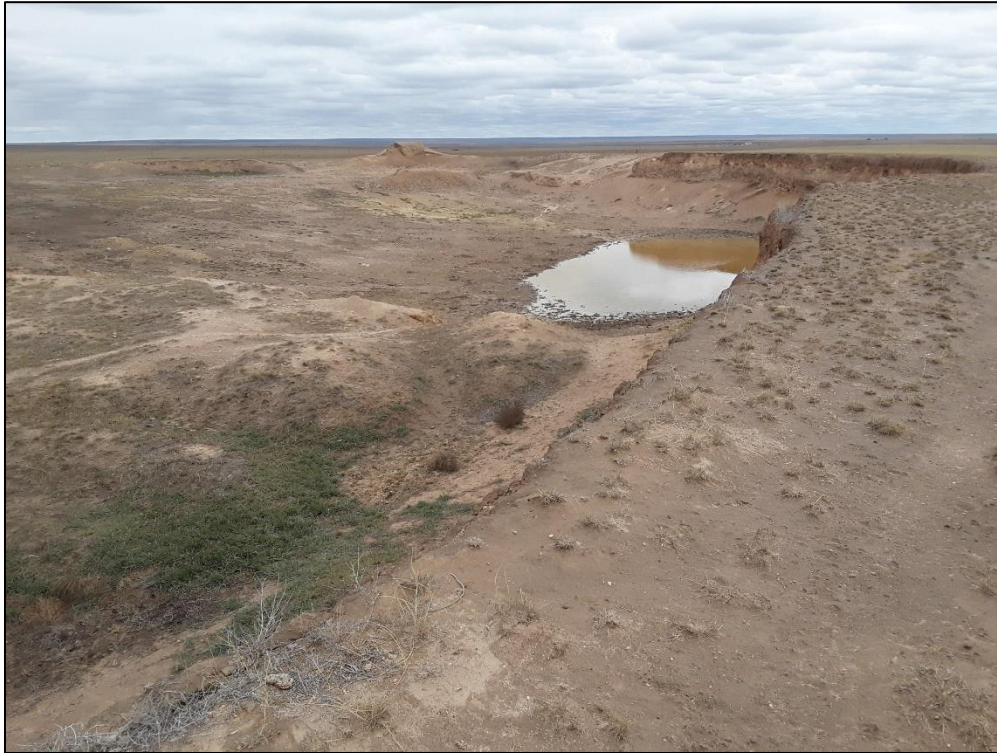
Photo 5. View looking east across pit from top of highwall. Pit highwall is approximately 15 feet in height with near vertical slopes. Note ponded water in pit during inspection due to recent storm event.

Mr. Howard informed the Division the material at the site is hard to use as road base. Therefore, the operator is considering closing operations at this site and beginning final reclamation. The Division estimates reclamation of the site in its current condition would require grading the highwall to 3H:1V via the cut and fill method, grading other disturbed areas to blend with the surrounding topography, replacing topsoil across disturbed areas, and revegetating disturbed areas for rangeland use. Much of the site already has 3H:1V or flatter slopes and good grass cover, so the operator would only need to seed areas that were re-disturbed during reclamation and any areas that currently have minimal to no grass cover.

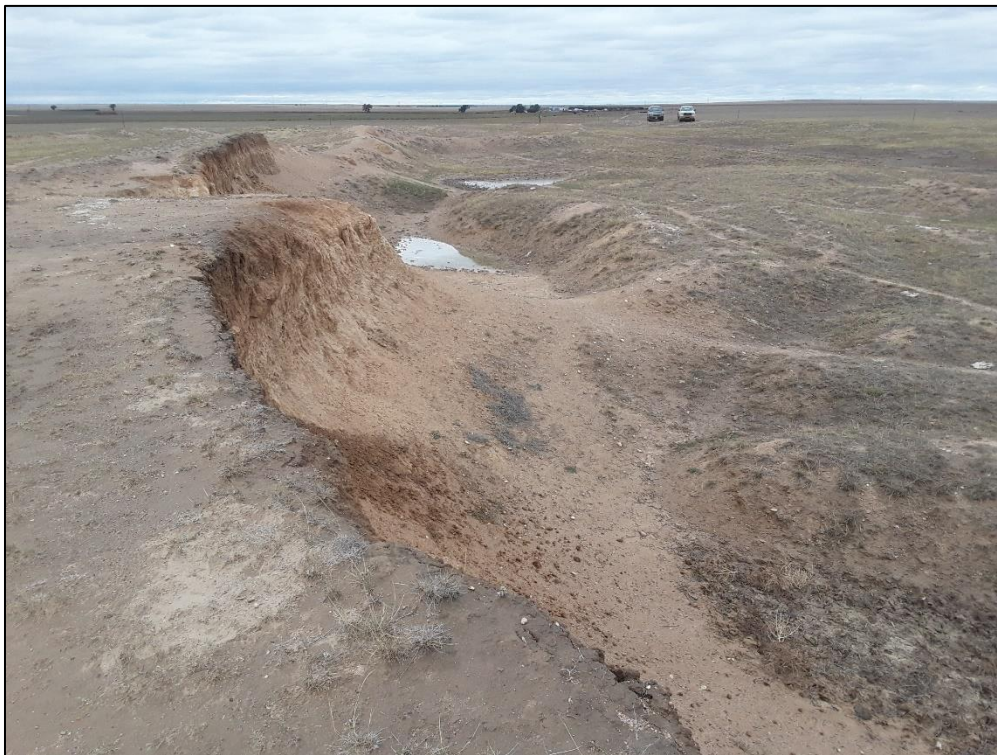
Photo 6. View looking west from top of highwall, showing far western edge of highwall. Pit highwall is approximately 15 feet in height with near vertical slopes.

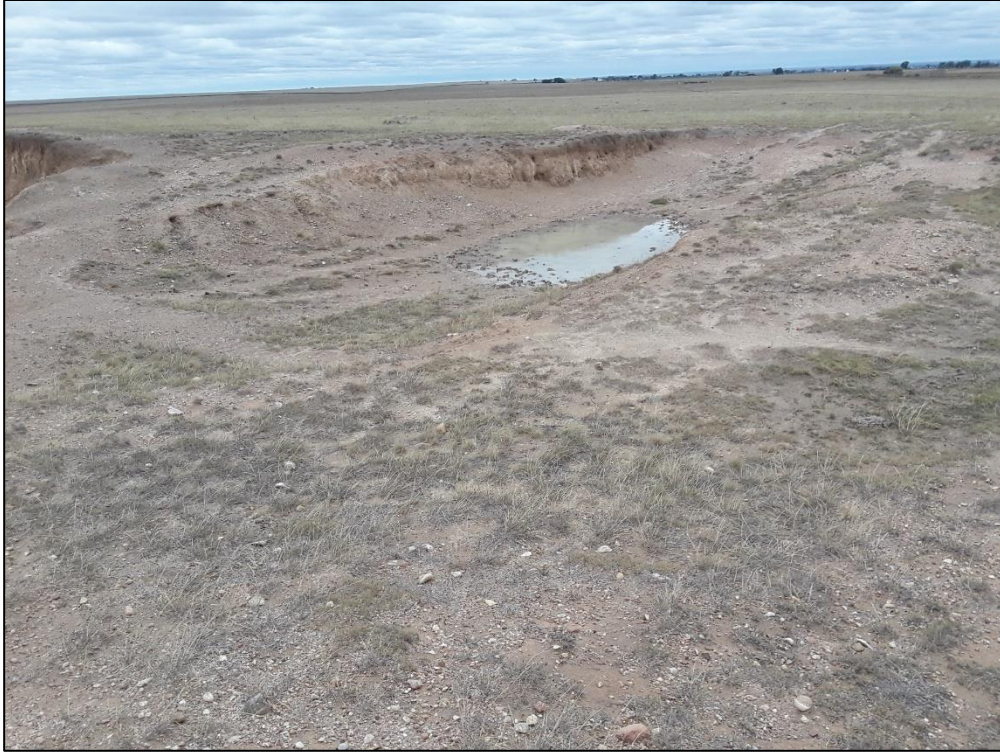
Photo 7. View looking south, showing small excavated depression located at western edge of pit.

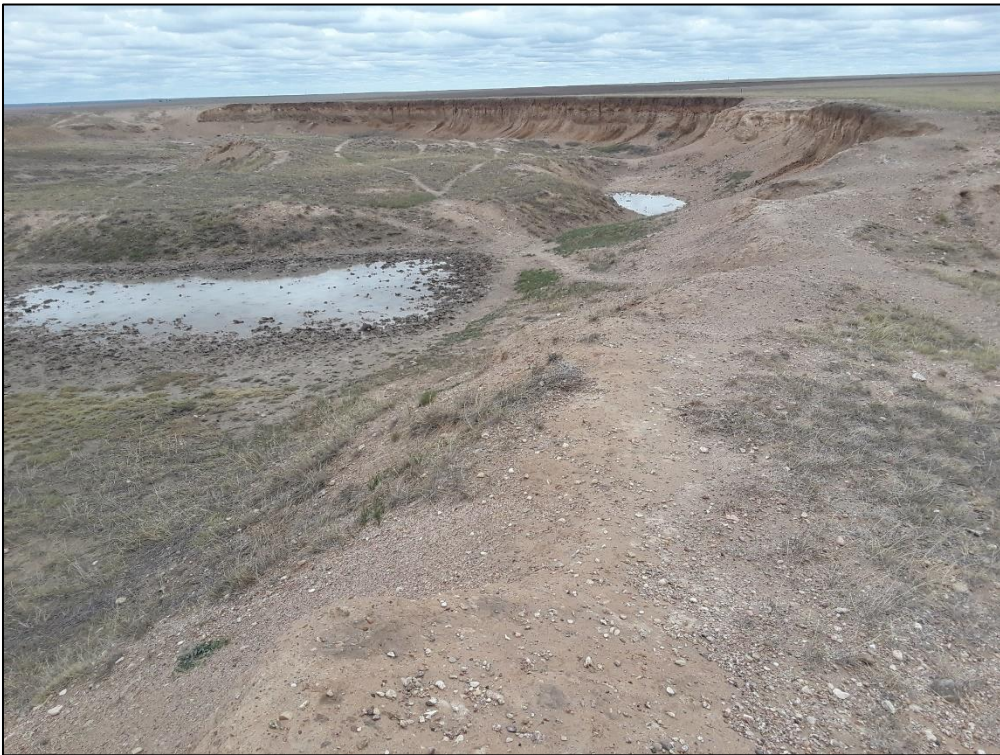
Photo 8. View looking southeast across pit from western edge of pit. Note ponded water in pit during inspection due to recent storm event.

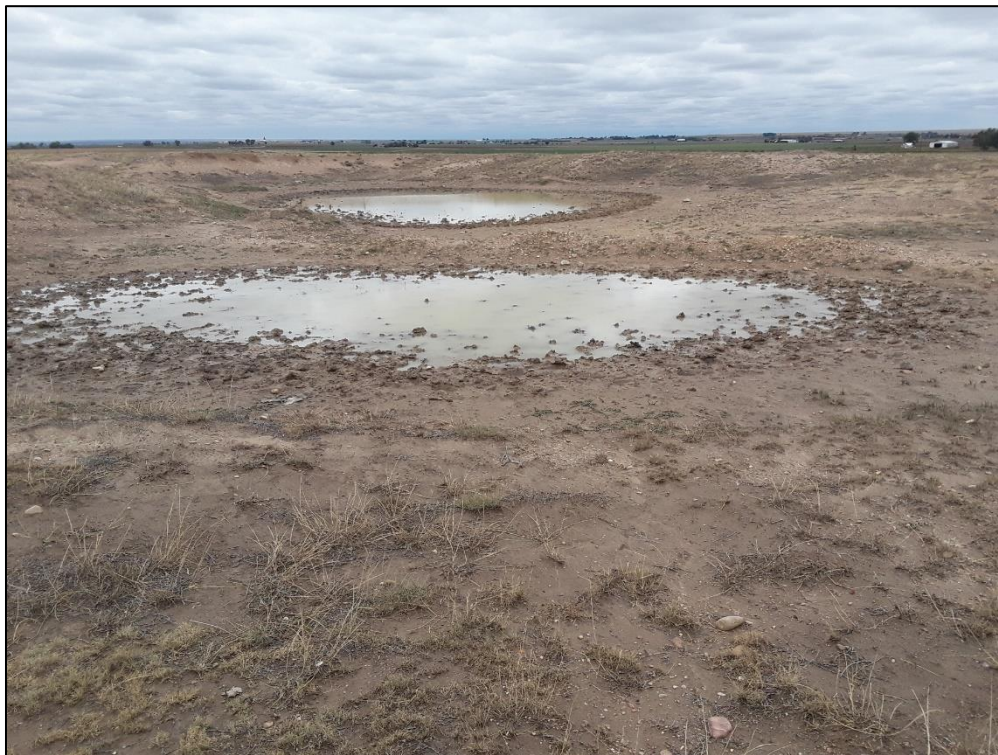
Photo 9. View looking southwest across two small excavated depressions located at western edge of pit. Note ponded water during inspection due to recent storm event.

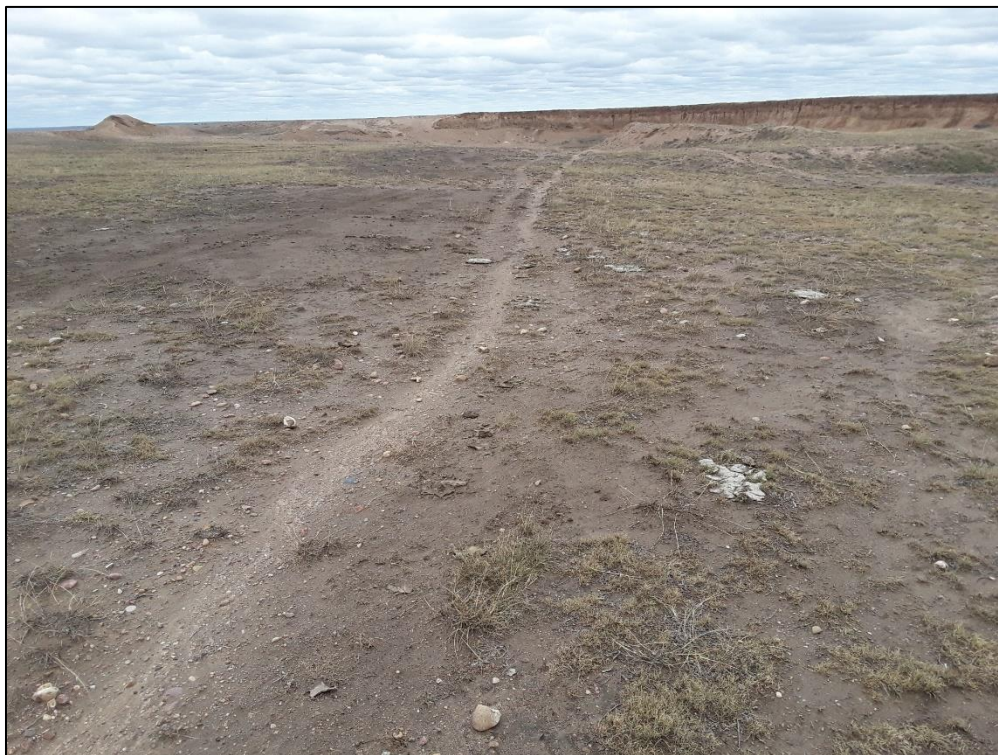
Photo 10. View looking southeast toward pit from main access road.

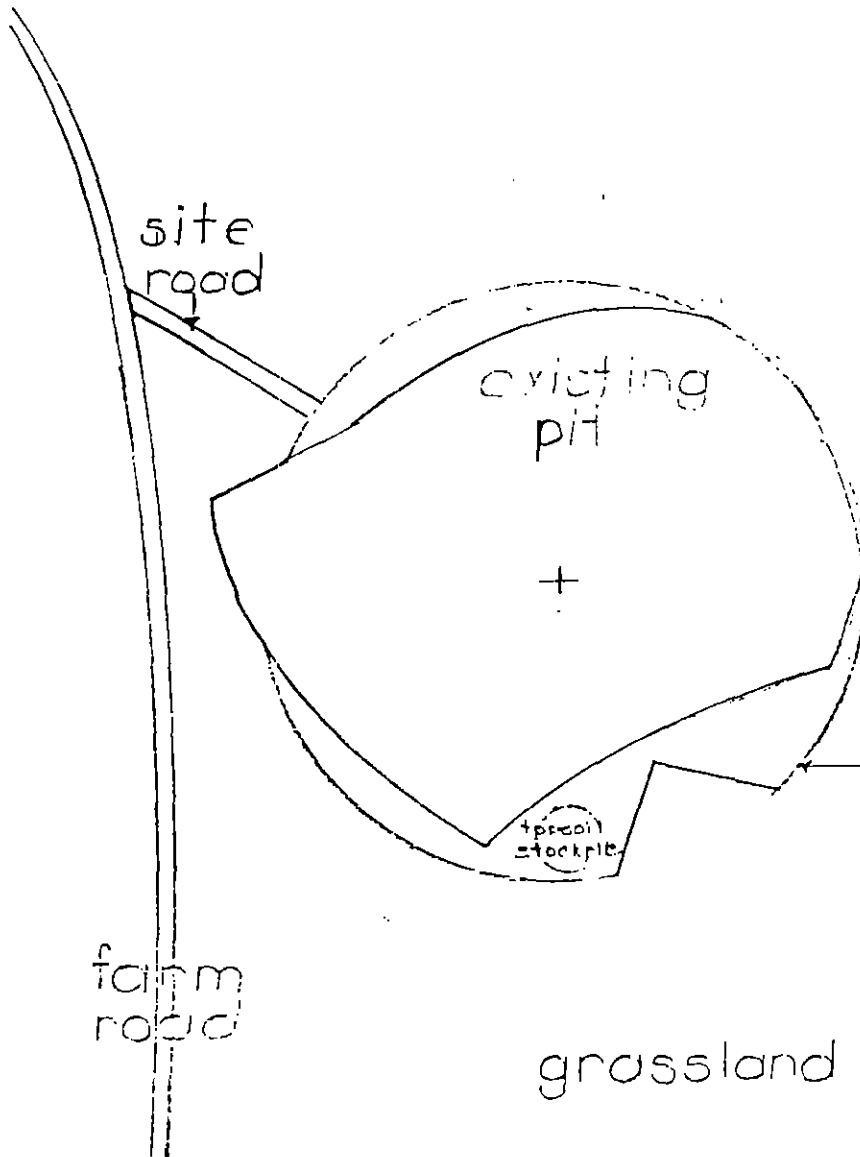
EXHIBIT C - PART 3
first replacement

located in the Northeast Quarter of
Section 9 of Township 21S Range 46W

existing
pit

Permit Area

trap
stockpile

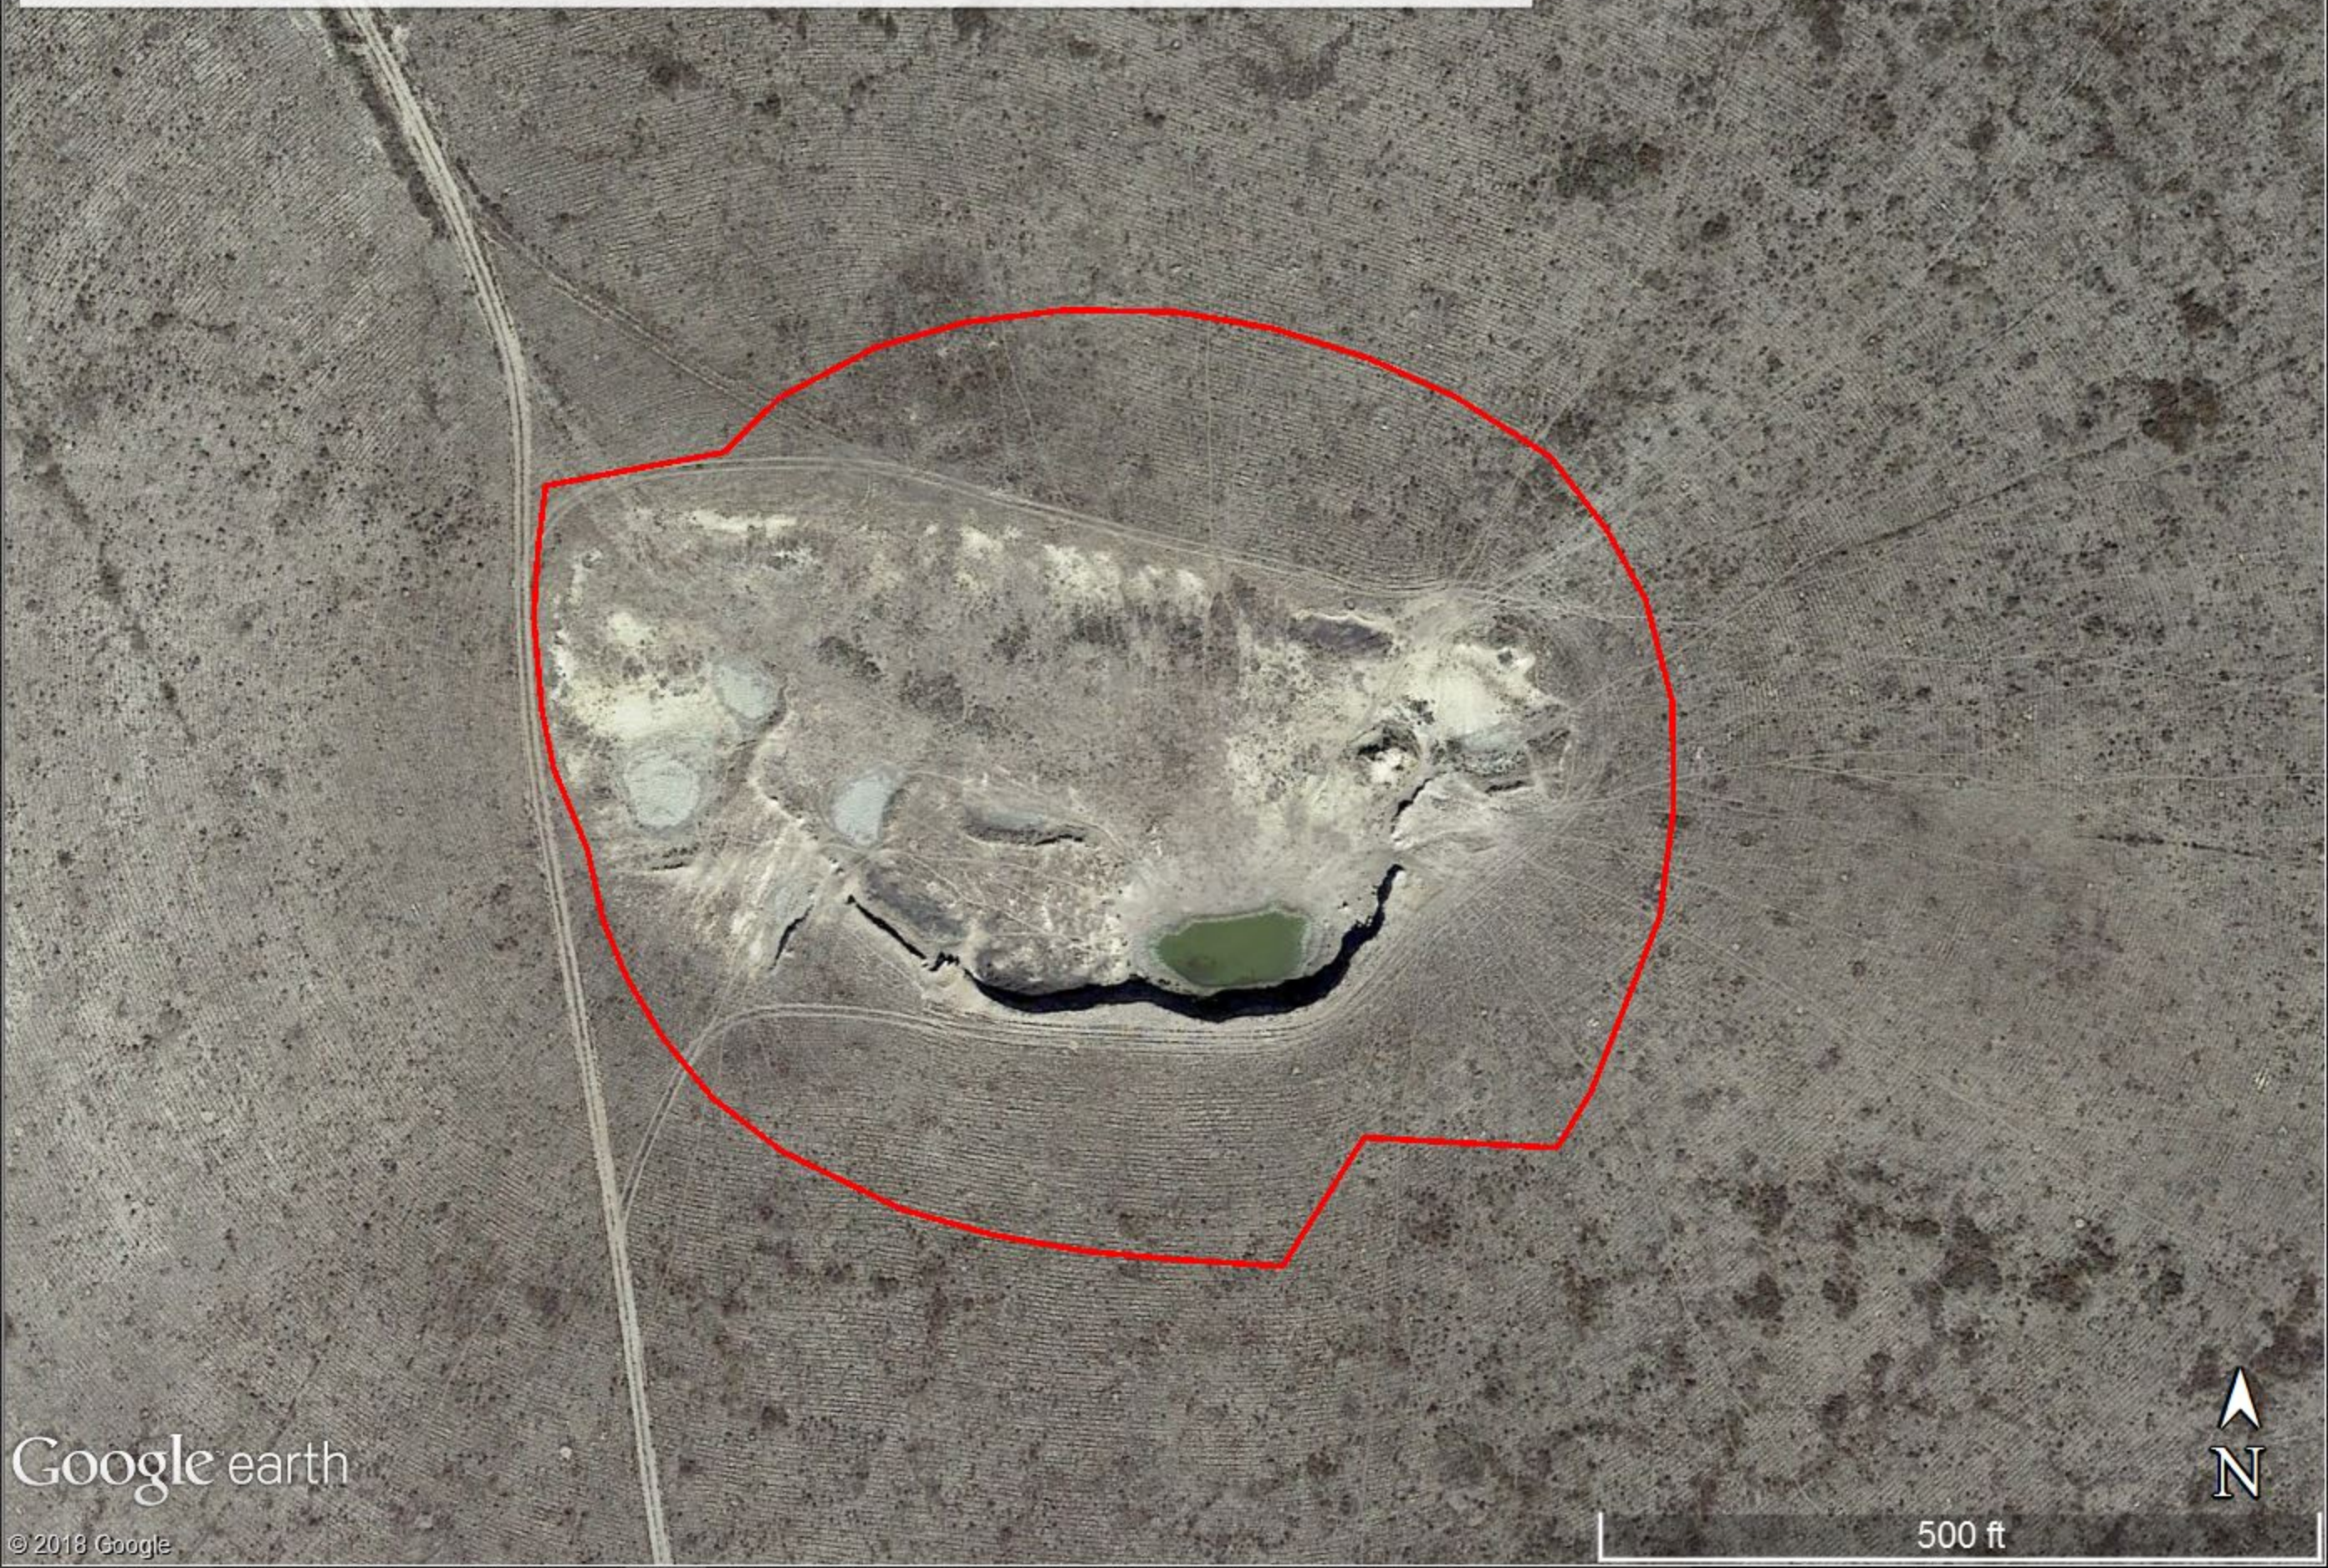
M1983-116 / Gentz Gravel pit / Kiowa County (110c)

Red Outline = 9.2 acres = Approved Permit Area (location approximated based on mining plan map)
(Image data from 10/11/2015)
