Re: Permit No. M-1980-244; Cripple Creek & Victor Gold Mining Company (CC&V); Cresson Project; – Addendum to VLF2 Liner Inspection TR#100

VLF2 Liner Investigation

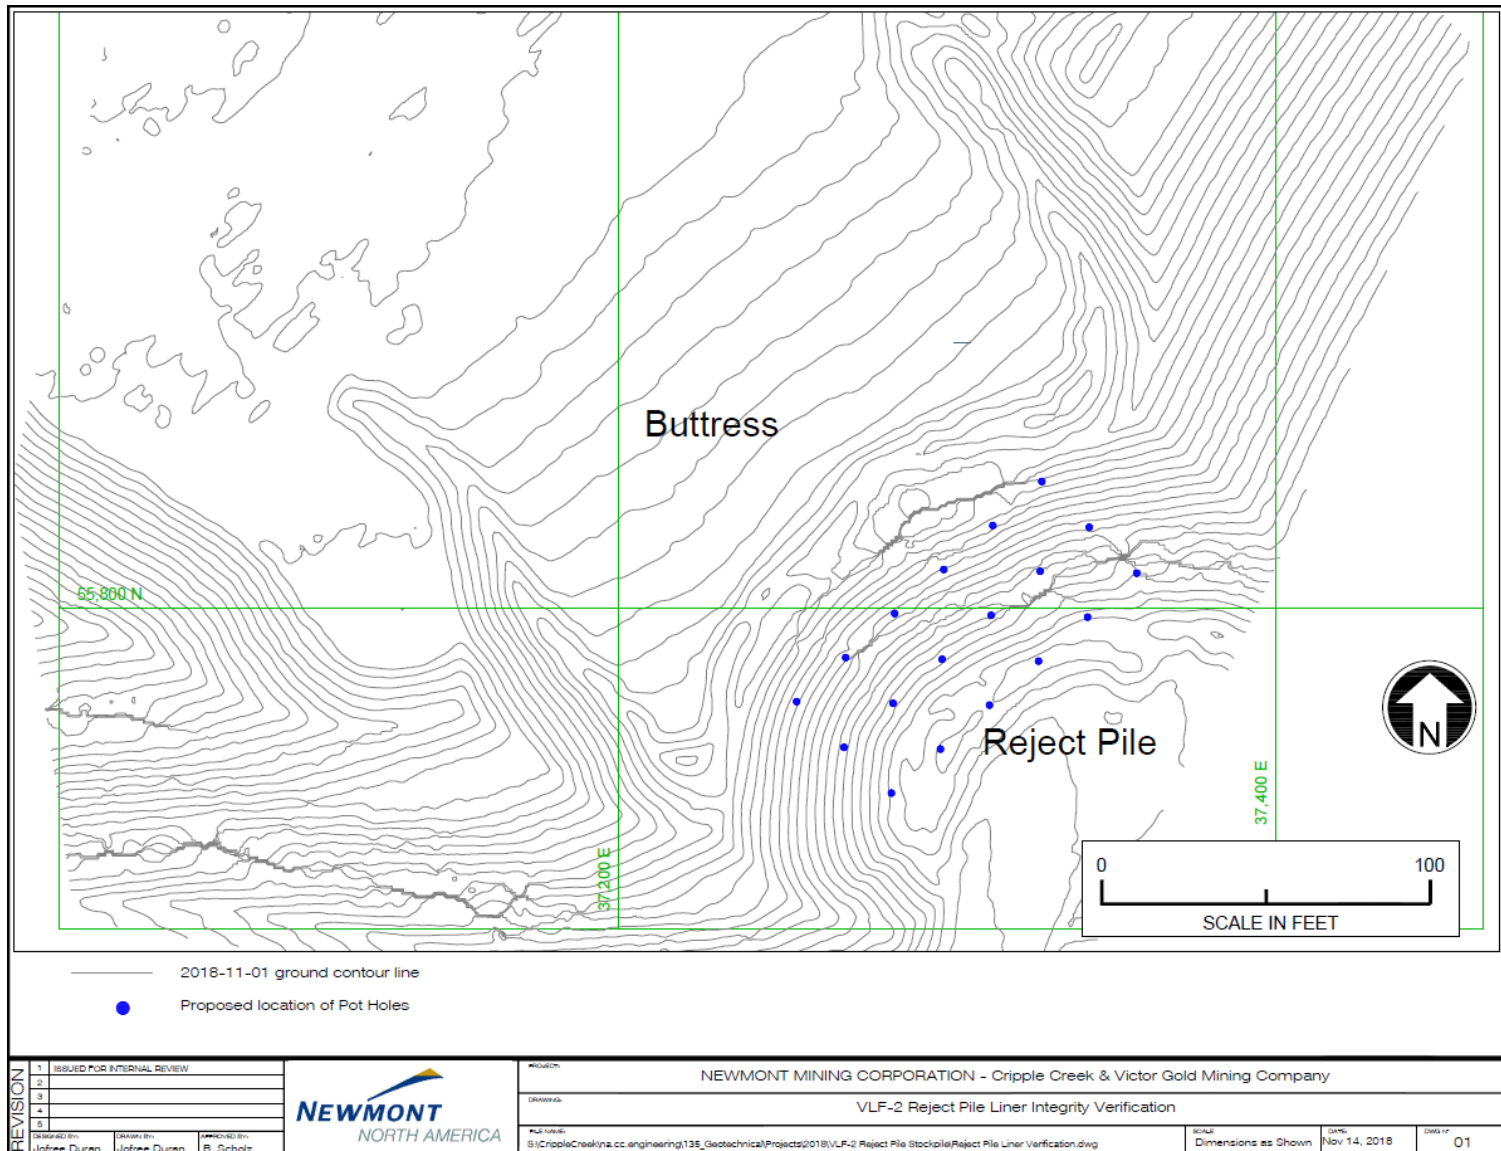
Figure 1 Potholing Investigation

- The test pits will be spaced 20' ft apart (horizontally). The location and spacing of the test pits, shown on Figure 1, may be altered based on field conditions.
- Once the test pitting is completed, NewFields' Certifying Engineer and CC&V personnel will examine the area. If required, additional test pits will be dug to examine the geomembrane.
- NewFields will document the backfilling of drain cover material over the exposed geomembrane liner after the inspection is complete.
- Upon completion of the work, a certified report will be developed detailing all the work completed.
