Re: Permit No. M-1980-244; Cripple Creek & Victor Gold Mining Company (CC&V);
Cresson Project; – Addendum to VLF2 Liner Inspection TR#100 PAR Response

Figure 1 Potholing Investigation

| DRAWING: | VLF-2 Reject Pile Liner Integrity Verification - Revision 1 | | |

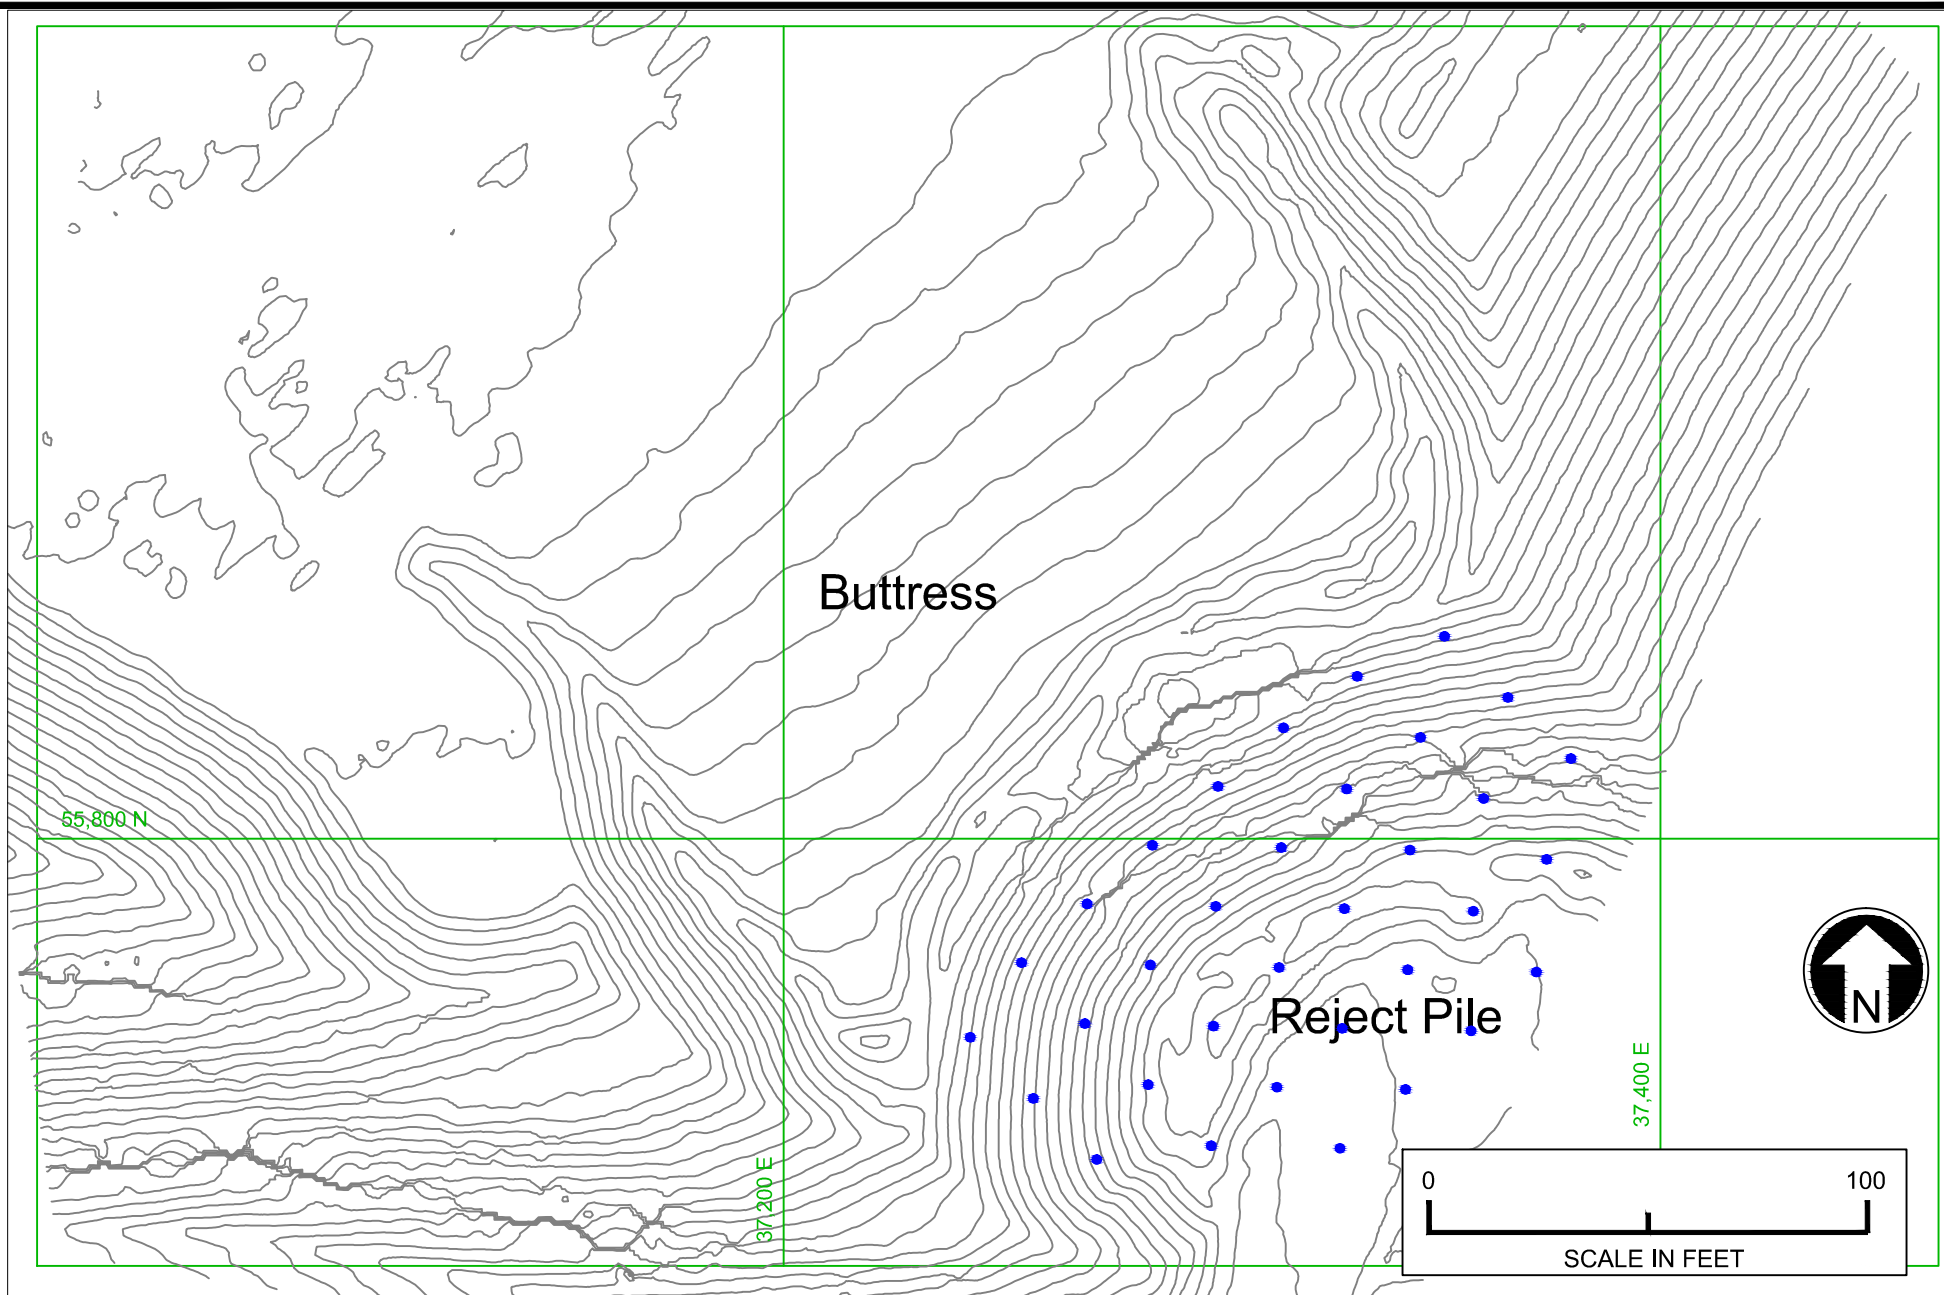
The Division has only one comment of the proposed investigation plan: the proposed pothole investigation plan grid appears to avoid the top (crest) and the flanks of the Reject Pile (please see the red outline in the image included below). The Division is concerned about potential rotational movement that may have been initiated as equipment was beginning to push down the reject material, but may have been subsequently covered up while pushing additional reject material down slope. Please expand the pot-holing investigation to include the crest and flanks (northeast and west sides) of the Reject Pile.

CC&V agrees to expand the potholing locations in the areas identified by DRMS. Figure 1 has been updated to display the proposed potholing locations.
