# MINERALS PROGRAM INSPECTION REPORT PHONE: (303) 866-3567

MINE NAME:		MINE/PROSPECTING ID#:	MINERAL:	COUNTY:
Crowley Cnty Grav 2		M-1982-126	Sand and gravel	Crowley
INSPECTION TYPE:		INSPECTOR(S):	INSP. DATE:	INSP. TIME:
Monitoring		Patrick Lennberg and Michael Cunningham	December 20, 2018	12:30
OPERATOR:		OPERATOR REPRESENTATIVE:	TYPE OF OPERATION:	
Crowley County		David Ragsdale and Greg Sprosty	112c - Construction Regular Operation	
REASON FOR INSPECTION: Normal I&E Program		BOND CALCULATION TYPE: None	BOND AMOUNT: \$0.00	
DATE OF COMPLAINT: NA		POST INSP. CONTACTS: None	JOINT INSP. AGENCY: None	
WEATHER: Clear	INSPECTOR'S SIGNATURE:  SIGNATURE DATE: December 28, 2018		Е:

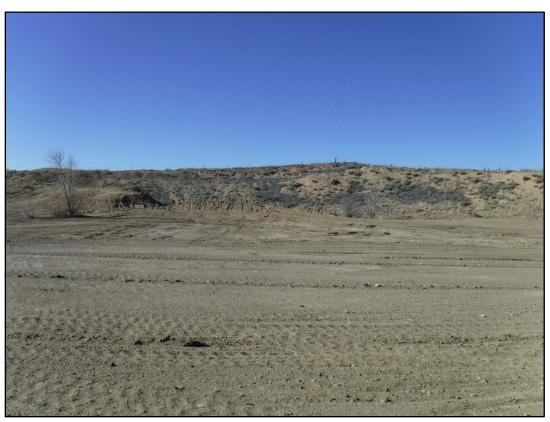
**Photo 3:** Beginning of reclamation on the west side of pit.

The county is no longer mining material from the pit and verbally informed the Division that reclamation of the site has commenced. Pursuant to Rule 3.1.3, the county will have five years from the date of this inspection to complete final reclamation.

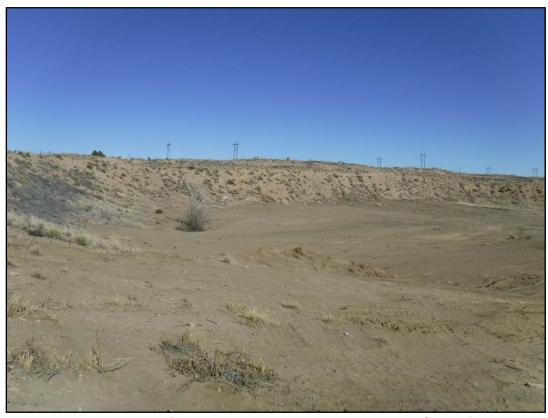
**Photo 4:** North side of pit with steep slopes that require grading and/or backfilling.

The post mining land use for the property is rangeland and slopes will be graded to 3H:1V or flatter. The remaining stockpiles will be graded to help achieve the required slope configuration. Some material from the cleaning out of culverts is being stockpiled on site to amend the topsoil that will be spread at the site. Topsoil is to be applied at a depth of five to six inches with crimped mulch. A copy of the Reclamation Plan Map is being included for reference.

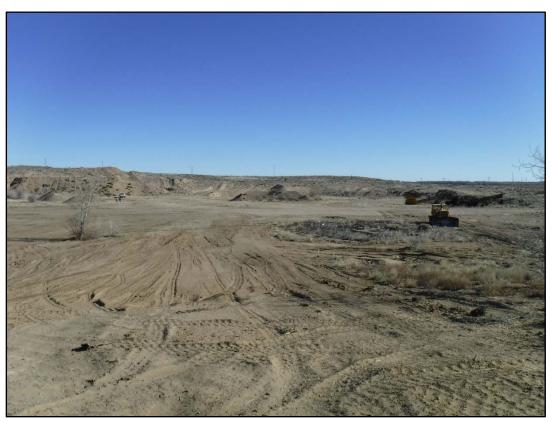
**Photo 5:** Looking east across the pit note various stockpiles of material both gravel and topsoil.

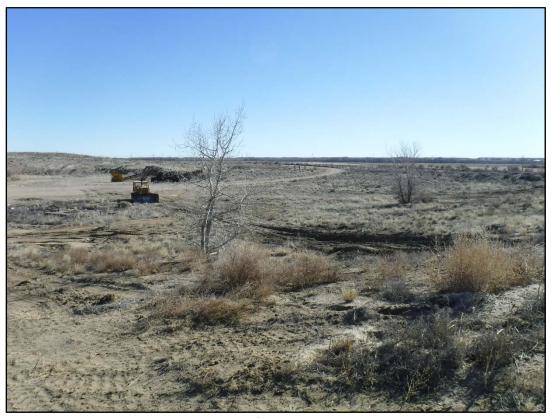
Photo 6: Looking at the south end of the pit where the haul road enters the pit.
