COLORADO DIVISION OF MINERALS AND GEOLOGY
MINERALS PROGRAM INSPECTION REPORT
PHONE: (303) 866-3567

MINE NAME: Mid-Continent Limestone Quarry OPERATOR: Mid-Continent Resources, Inc.
COUNTY: Gardfield MINERAL: Limestone TYPE OF OPERATION: 1/2 Quarry
INSPECTOR(S): Gregg R Squire - Gregg Robinson
MINE ID # OR PROSPECTING ID #: 62-1482-121
INSPECTION DATE: 1-15-96 DATE OF COMPLAINT: _____
INSPECTOR'S INITIALS: GKS TIME OF DAY (MILITARY): 1330
INSPECTION TYPE CODE^(a): MI POST INSP. CONTACTS^(a): BL
JOINT INSP. AGENCY CODE^(a): BL REASON FOR INSP. CODE^(a): IE
WEATHER CODE^(a): CL OP. REP. PRESENT: Diane Delaney - Mid-Continent; Mike Savage Consultant

OBSERVATIONS

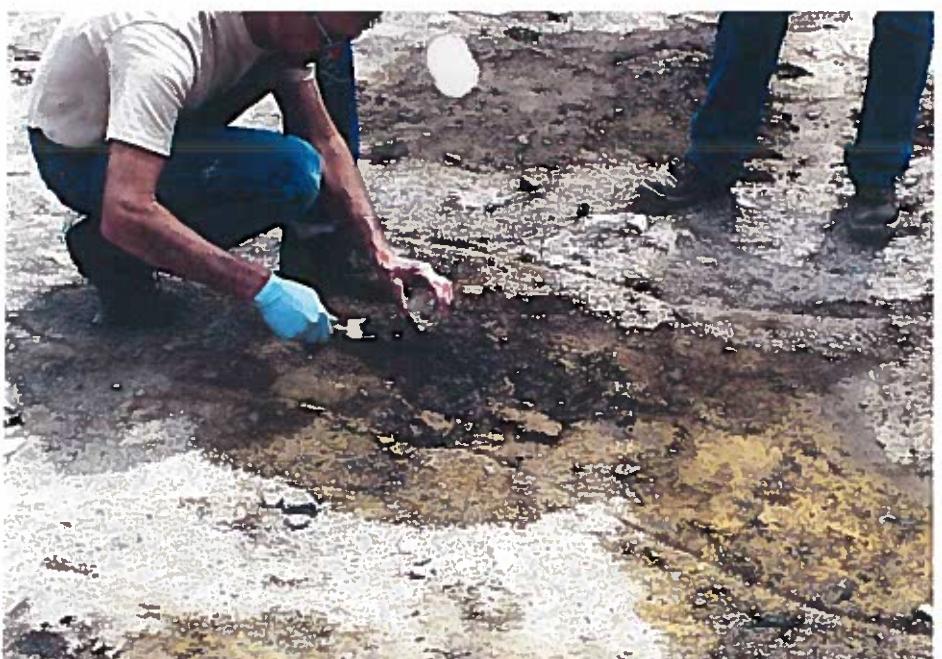
Sample
5/2/96

There were several 55 gallon drums of lubricants and a bucket of what appeared to be grease or hydraulic fluid on the site. There were also several patches of spilled fluids on the ground.

<u>Possible impact to surface water system Rule 3.1.6(1)</u>
 <u>of the Construction Materials Rules and Section</u>
 <u>34-325-116(4)(h) of the Construction Materials Act</u>
 <u>Remove containers and clean up spills - Demonstrate</u>
 <u>to the Division that these materials were properly</u>
 <u>disposed of.</u></p> | <p><u>05/31/96</u></p> <p>PB or PV <u>P B</u></p> <p>TOPIC(S) <u>H B</u></p> <p>-----</p> |

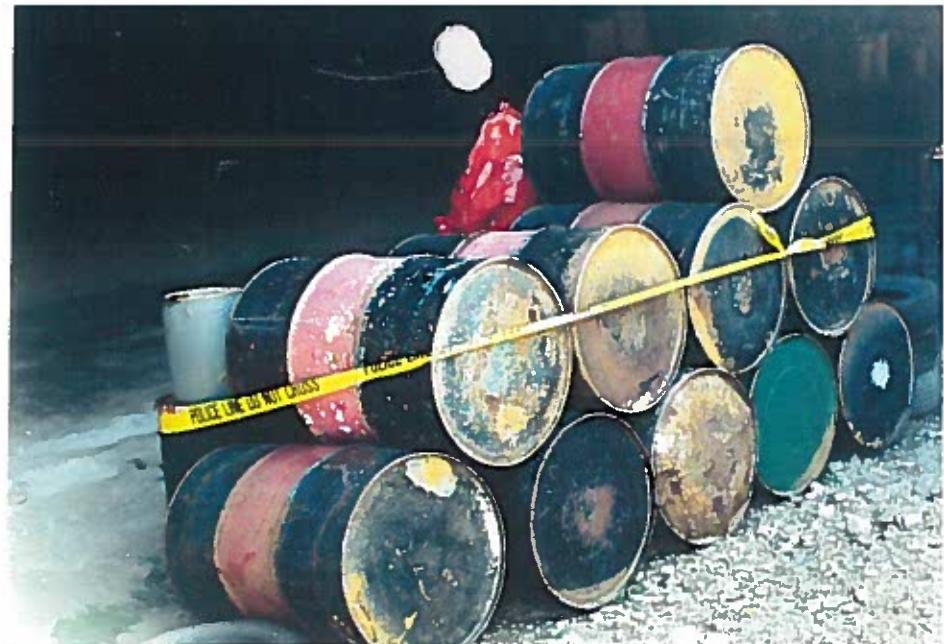
Drums from Quarry

Upon returning to the DMG office ^{after the inspection} the Division inspector was notified by the BLM that the barrels had been removed from the site before they were sampled by the BLM and placed in a facility in Carbondale, and that the BLM had impounded them.

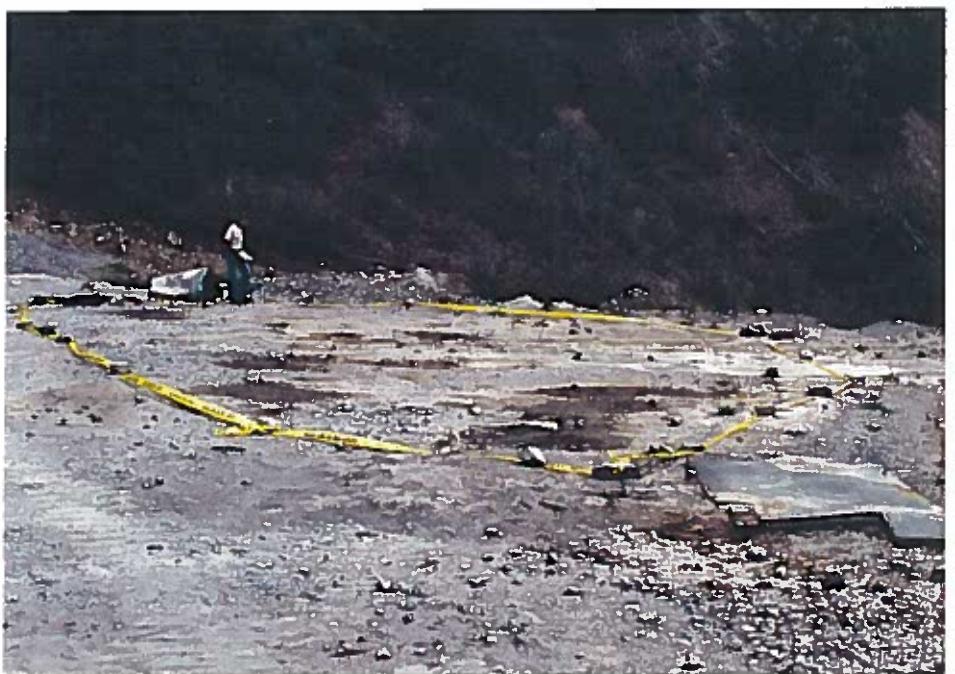
**Area of Localized
Surface Stains**
