COLORADO
Division of Reclamation,
Mining and Safety
Department of Natural Resources

Permit Number: C-1981-028 Mine Name: Keenesburg Strip Mine Operator: Coors Energy Company Operator Address: Mr. Danny Kipp P.O Box 467 Golden , CO 80402	County: Weld Operation Type: Surface Permit Status: Active Ownership: Private
	Operator Representative Present: Danny Kipp
Operator Representative Signature: (Field Issuance Only)

Inspection Start Date: January 25, 2019 Inspection Start Time: 08:15 Inspection End Date: January 25, 2019 Inspection End Time: 09:40		Inspection Type: Coal Partial Inspection Inspection Reason: Normal I&E Program Weather: Clear	
Joint Inspection Agency: None		Joint Inspection Contacts: 	
Post Inspection Agency: None		Post Inspection Contacts: 	
Inspector(s): Robert D. Zuber, P.E.	Inspector's Signature:

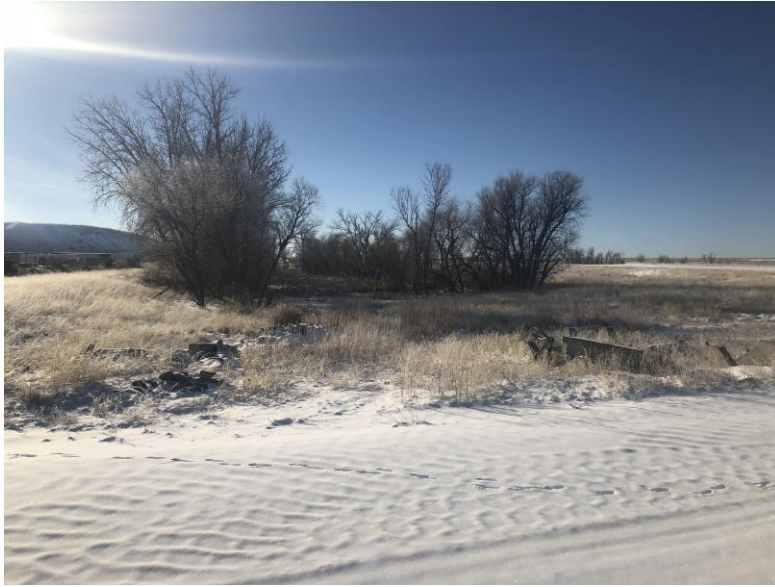
Water/snow/ice levels in Sediment Pond 2 and the Dugout Pond were not near the spillways. Neither pond was discharging during the inspection. No problems were observed with the two ponds.

Dugout Pond

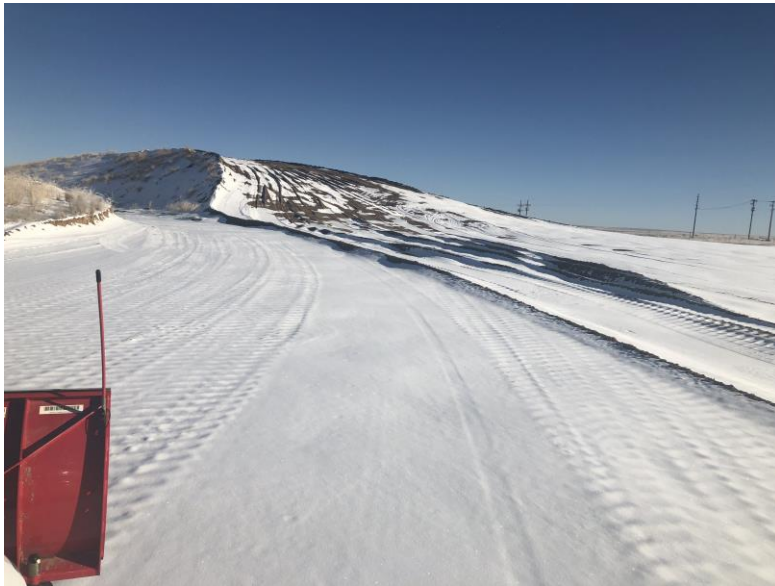
Recent disturbance was seen at the south end of Topsand Pile A-1. Per Danny Kipp this has been moved to the roads south and east of Area 25. These roads appeared to have received topsand recently, although the snow on

Topsand Pile A-1

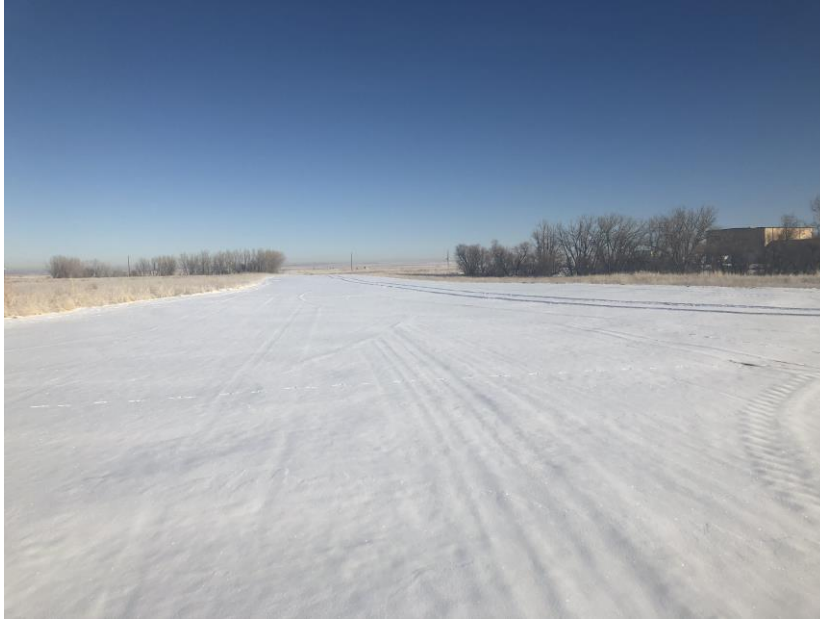
the ground precluded a thorough observation of this area.

Road between Area 25 (left) and Area 2 (right)

Topsand has been laid down here (no topsand in foreground)

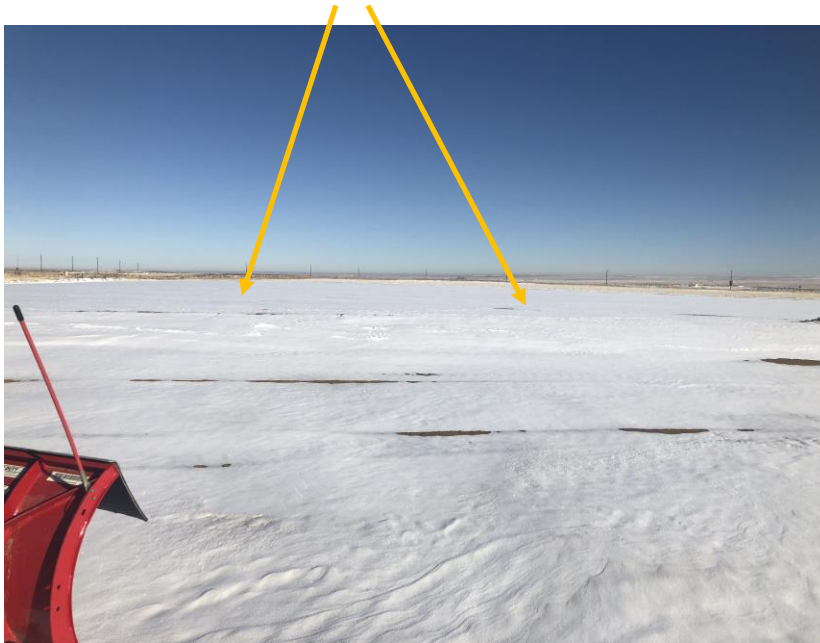
Per Danny, some topsand has been spread over 50 percent or more of the remaining area of B Pit, although the entire depth has not yet been spread. He still needs to spread the B horizon of topsand over much of the former pit area.

Looking north at north end of B Pit

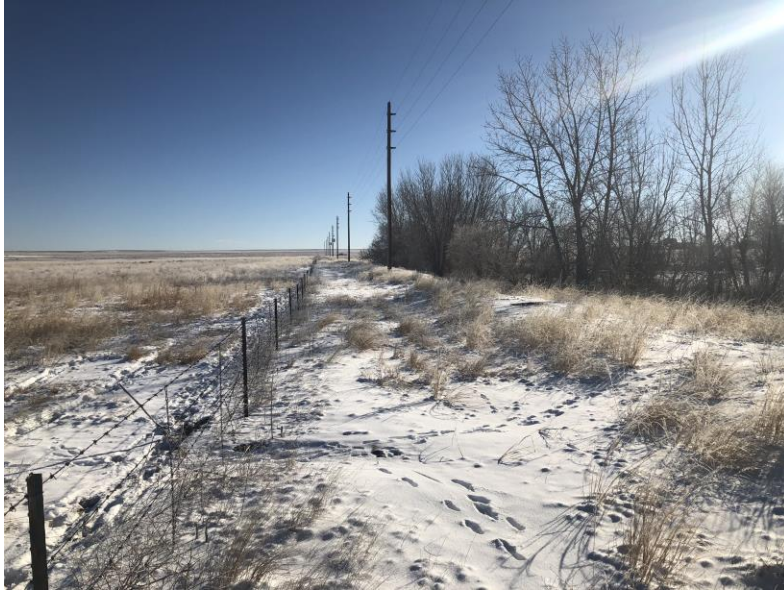
Permit boundary north of Sediment Pond 2

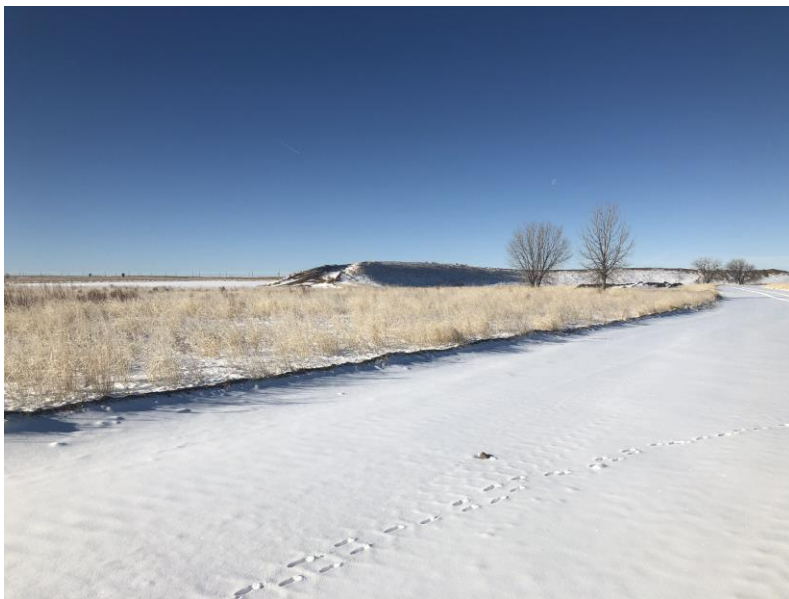
Topsand Pile A-3 was observed from all sides. No significant erosion problems were seen.

Topsand Pile A-3
