MINERALS PROGRAM INSPECTION REPORT
PHONE: (303) 866-3567

MINE NAME: Sprague Red Lyons	MINE/PROSPECTING ID#: M-1981-057	MINERAL: Sandstone (silica, stone, quartzite)	COUNTY: Boulder
INSPECTION TYPE: Monitoring	INSPECTOR(S): Amy Eschberger	INSP. DATE: July 11, 2018	INSP. TIME: 10:00
OPERATOR: Arkins Park Stone Corporation	OPERATOR REPRESENTATIVE: Dewey Chandler, David Sprague, John E. Holliday	TYPE OF OPERATION: 112c - Construction Regular Operation

REASON FOR INSPECTION: Citizen Complaint	BOND CALCULATION TYPE: None	BOND AMOUNT: \$47,050.00
DATE OF COMPLAINT: July 3, 2018	POST INSP. CONTACTS: None	JOINT INSP. AGENCY: None
WEATHER: Clear	INSPECTOR'S SIGNATURE:

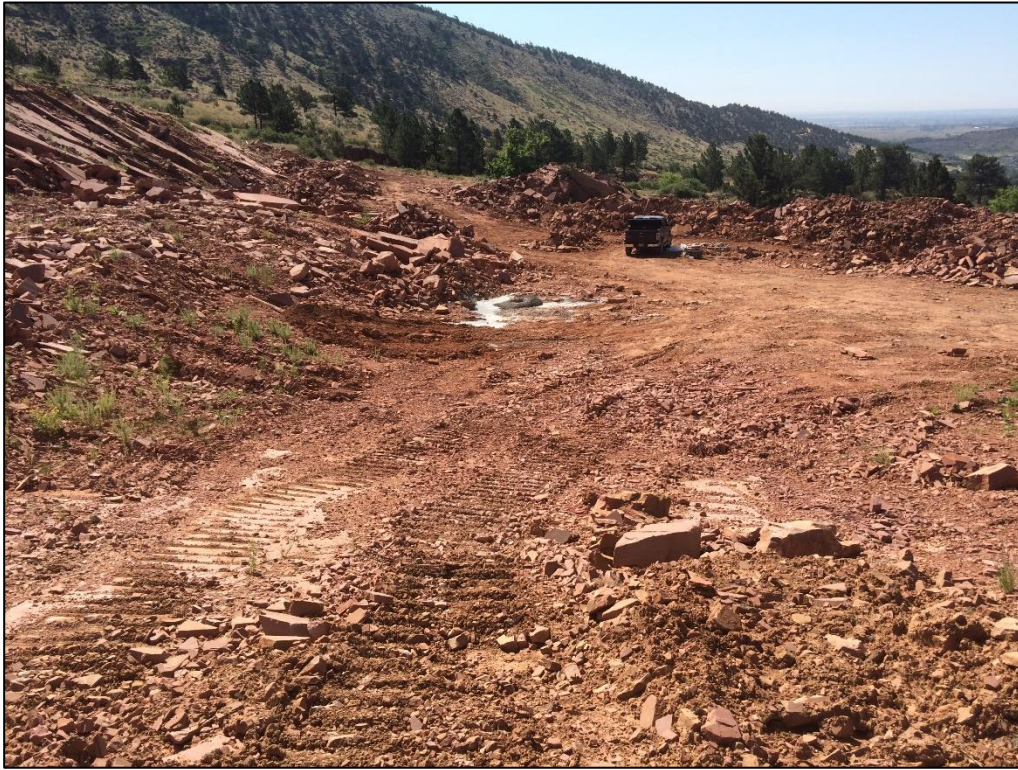
Photo 1. View looking southeast across Quarry 3, showing piles of loose stone present on pit floor during last inspection have been removed.

The Division first inspected Quarry 3, located at the southern end of the permit area. Mining of this quarry ceased many years ago. The loose stones that were stockpiled on this pit floor during the Division's last inspection (on July 11, 2017) had been removed (**Photo 1**). Some of the excess rock was used to backfill a portion of the northeastern highwall with slope gradients near 3H:1V. Some smaller waste rock piles remain scattered around the edges of the pit. The operator indicated any remaining material will be used to build the pad site for the new residence being constructed on the floor of this pit. The Division observed a few workers present during the inspection constructing a concrete foundation near the center of the pit floor (**Photo 2**).

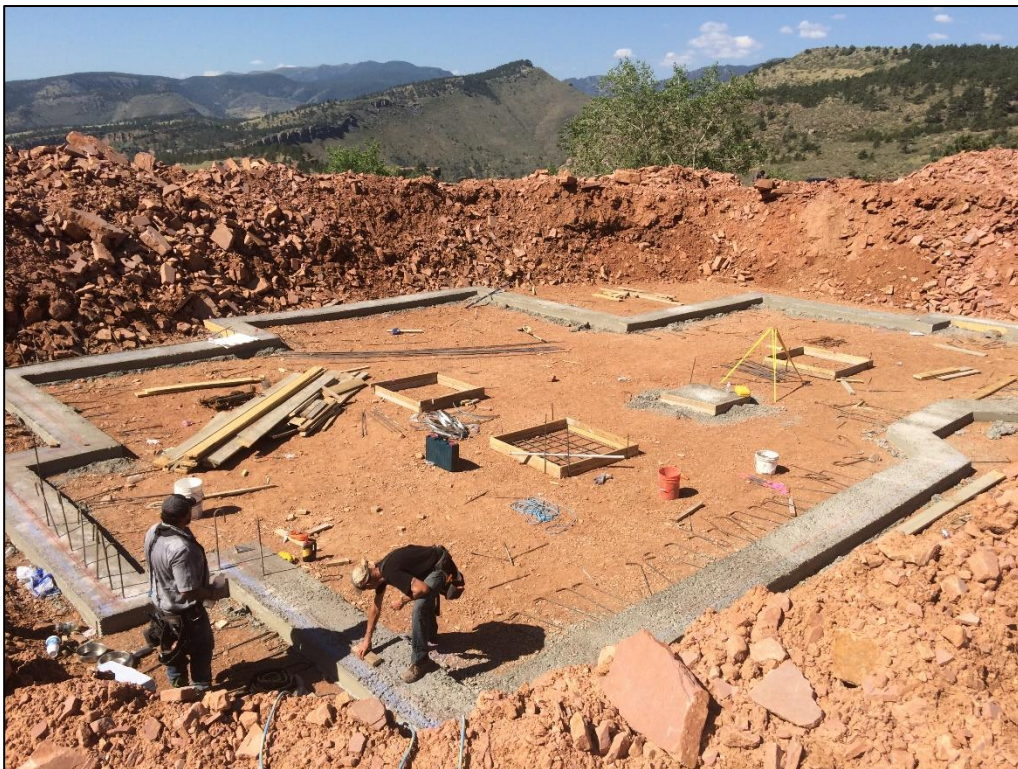
Photo 2. View of Quarry 3 pit floor where concrete foundation is being constructed for new residence.

Boulder County issued a residence permit for the site in May of 2018. Therefore, the operator appears to be in compliance with the county with regard to construction of the new residence. This activity is also in compliance with the approved mine permit, which allows for residential use of the reclaimed lands.

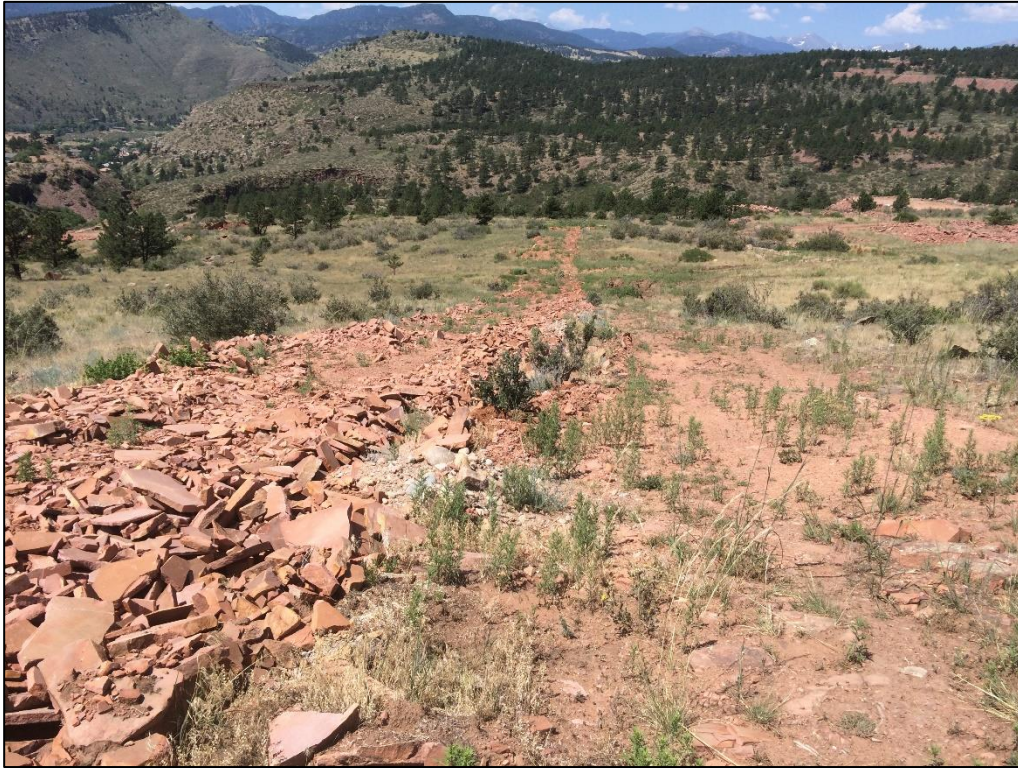
Photo 3. View looking southwest between Quarries 2 and 3, showing (backfilled) underground powerline installed in support of new residence being constructed in Quarry 3.

The new landowner has begun installing infrastructure to support the residence. A buried power line was installed across the property between Quarries 2 and 3 (**Photo 3**), tying into an existing power line pole located adjacent to the road at the eastern edge of the property. According to the operator, there was an agreement made with the new landowner to keep all mining activities north of this buried power line. The operator should be advised that for any new permanent, man-made structures constructed within 200 feet of the affected land, the operator must provide notarized structure agreements with the structure owner that the operator will provide compensation for any damage to the structure, pursuant to Rule 6.4.19 (sample structure agreement attached). Where such structure is a utility, the operator may supply a notarized letter, on utility letterhead, from the landowner(s) of the utility that the mining and reclamation activities, as proposed, will have "no negative effect" on their utility.

Additionally, the mining plan map will need to be updated to show any new structures located within 200 feet of the affected land, including any new roads, buildings, water wells and lines, septic lines, or power and communication lines. The revised map should also show any setbacks from these structures the mining operation will maintain. These revisions to the mining plan map can be done through submittal of a Technical Revision (form enclosed).

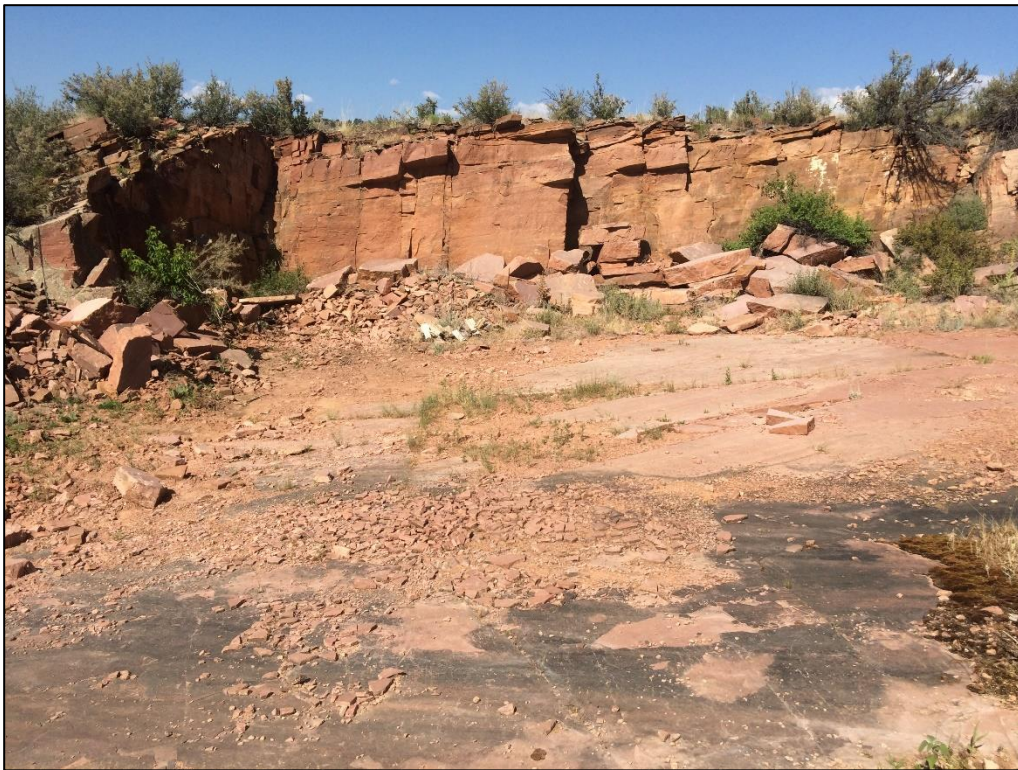
Photo 4. View of L-shaped highwall section that remains at northwestern edge of Quarry 3, approximately 10-12 feet in height with near vertical slopes.

The Division also discussed with the operator the small L-shaped section of highwall that remains at the northwestern edge of Quarry 3 (**Photo 4**). This highwall is approximately 10-12 feet in height with near vertical slopes. The Division estimates this highwall section to be approximately 70-80 feet in total length. The approved reclamation plan would require the mined wall be backfilled with overburden/waste rock, graded to 3H:1V, then retopsoiled and seeded. Alternatively, the reclamation plan allows for the placement of large stones on portions of steeper highwalls to form steps that can be retopsoiled and seeded. The operator indicated the new landowner has expressed a desire to keep the small highwall section as-is for use as an amphitheater near his residence. If this is the case, the operator will need to submit a Technical Revision to revise the reclamation plan and map to describe and show the location of the amphitheater that will remain. Additionally, the operator will need to provide a notarized letter from the landowner confirming his desire to use the small highwall section as an amphitheater. Once the Division has approved a Technical Revision to revise the reclamation plan and map for Quarry 3, the operator could submit an Acreage Reduction request (form enclosed) to release Quarry 3 from the permit area, as it meets the approved beneficial use.

- 1) Demonstration of the operator's legal right of entry to the site to conduct mining and reclamation from the new landowner. This may be a copy of access lease, deed, abstract of title, or a current tax receipt. A signed statement by the landowner and acknowledged by a Notary Public stating that the operator has legal right to enter and mine the affected lands is also acceptable.
- 2) A Technical Revision to revise the mining plan map and reclamation plan map for the site to include:
 - Leaving the small portion of highwall in Quarry 3 with steeper slopes than 3H:1V so it can be used as an amphitheater by the landowner.

- A notarized letter from the landowner confirming his desire to leave the portion of highwall as-is for use as an amphitheater.
- Location(s) and name of structure owner(s) for any new structures located within 200 feet of the affected lands (e.g., buildings, underground and above ground utilities).
- Notarized structure agreements for any new structures located within 200 feet of the affected lands not owned by the operator.

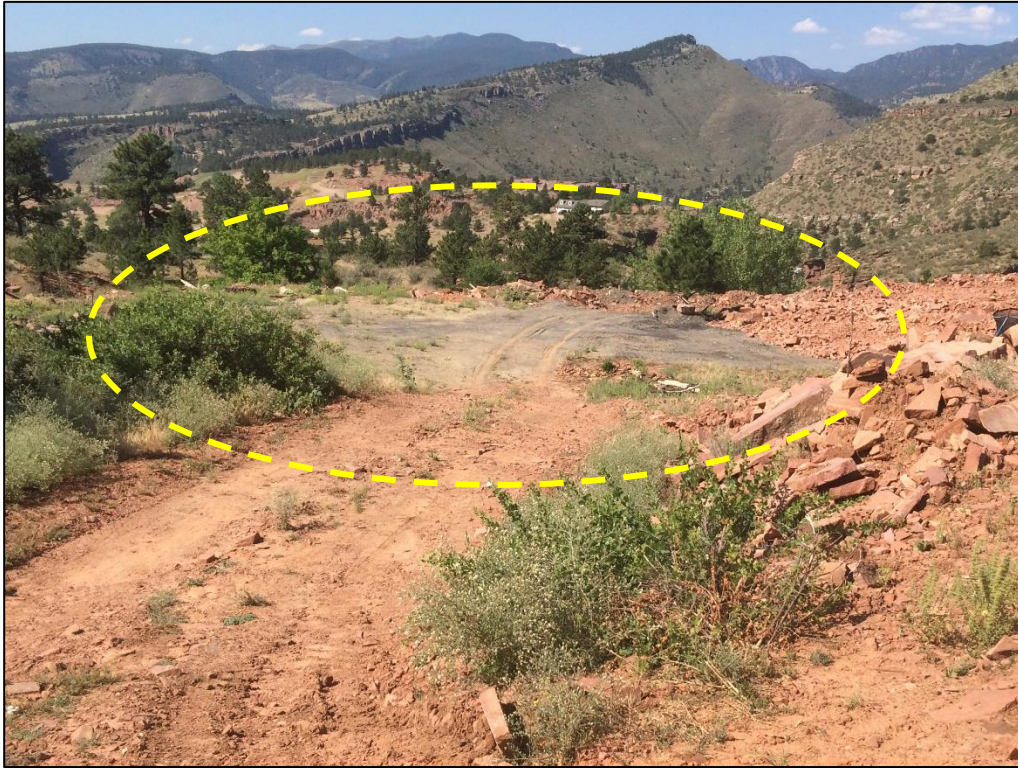
Photo 5. View looking southwest, showing area south of Quarry 3 where a large amount of crushed shale material was stored during last inspection (circled).

It should be noted, the operator has removed the crushed shale material that was stockpiled at the southern edge of Quarry 3 during the last inspection (**Photo 5**). The operator had indicated the material could be used as a growth medium. The Division cited a problem in the last inspection report, requiring the operator to revise the reclamation plan to include more information on the material and its use in reclamation of affected lands. However, since the material has been removed from the site, the Division considers this problem to be abated.

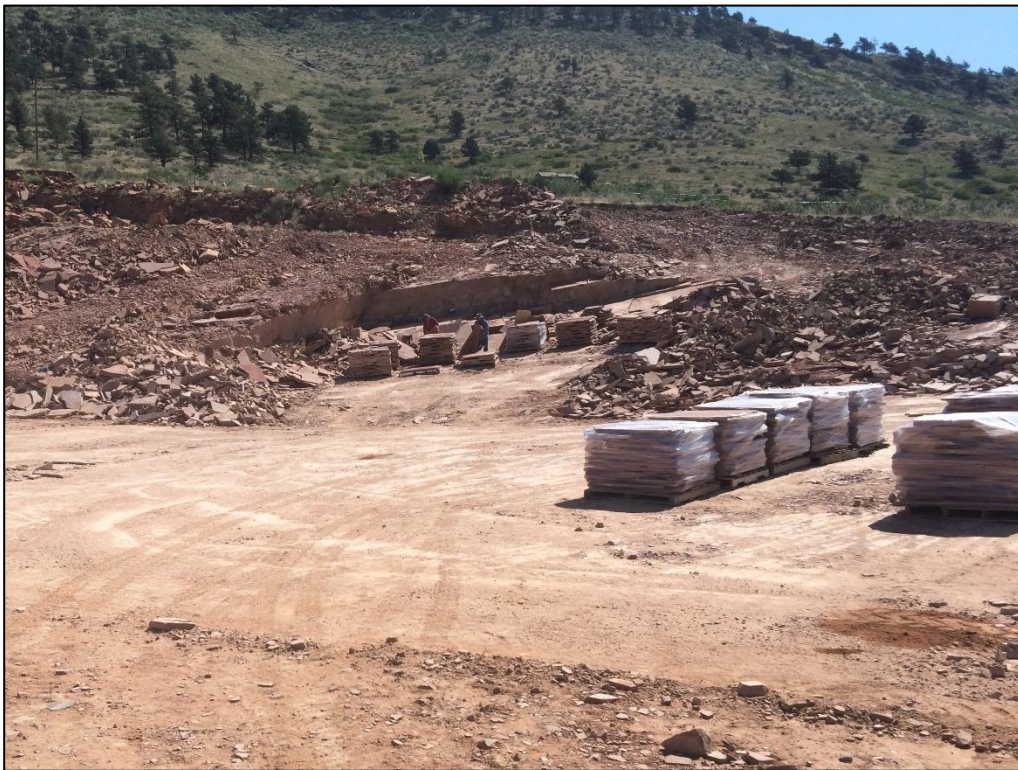
Photo 6. View looking east, showing active working face along eastern edge of Quarry 1.

The Division next inspected Quarries 1 and 2, which are connected. This area was active during the inspection. A few men were on site splitting and stacking stone near the active working face along the eastern edge of Quarry 1 (**Photo 6**). The Division observed the amount of disturbance in this area to be very similar to what was observed during the last inspection a year ago. Given the nature of the operation's method of mining (with hand tools and a small loader), the operation proceeds at a fairly slow pace which limits overall disturbance. The operation reclaims portions of the affected land as it moves to other areas. A portion of the northwestern pit wall of Quarry 1 has been backfilled, retopsoiled, and seeded. This backfilled area has some grass cover and early growth pine trees (**Photo 7**). A portion of the eastern edge of Quarry 2 had been backfilled with waste rock since the last inspection.

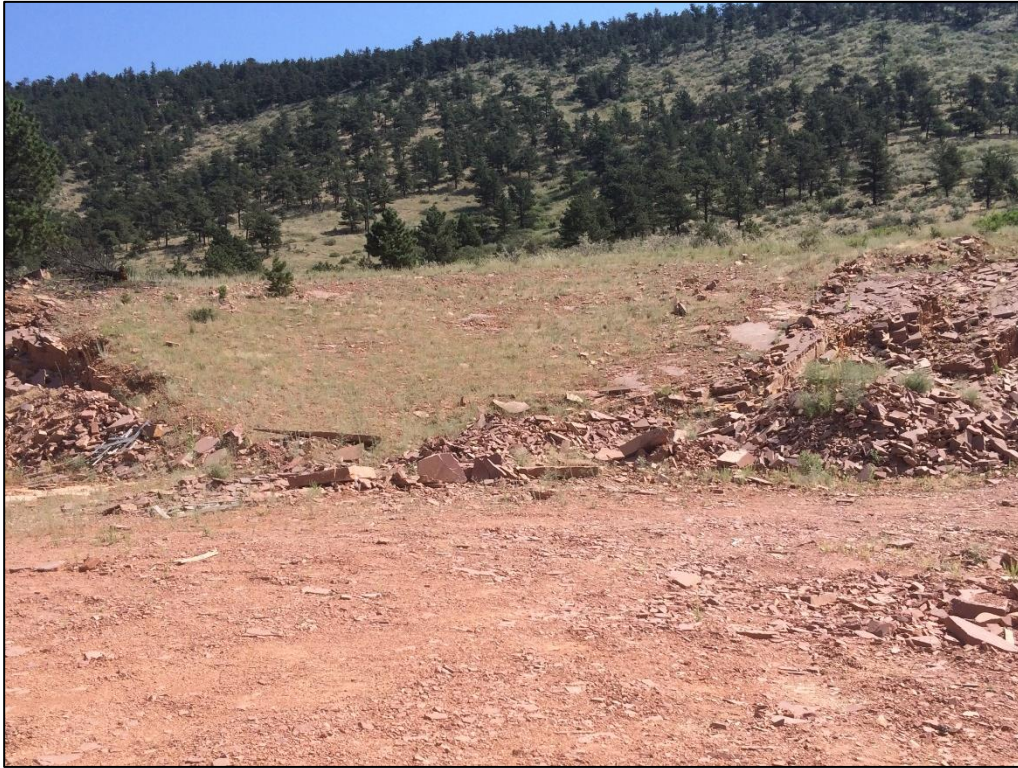
Photo 7. View looking north, showing portion of northern pit wall of Quarry 1 that was backfilled with waste rock, retopsoiled, and seeded. This area has some grass cover and a few early growth pine trees.

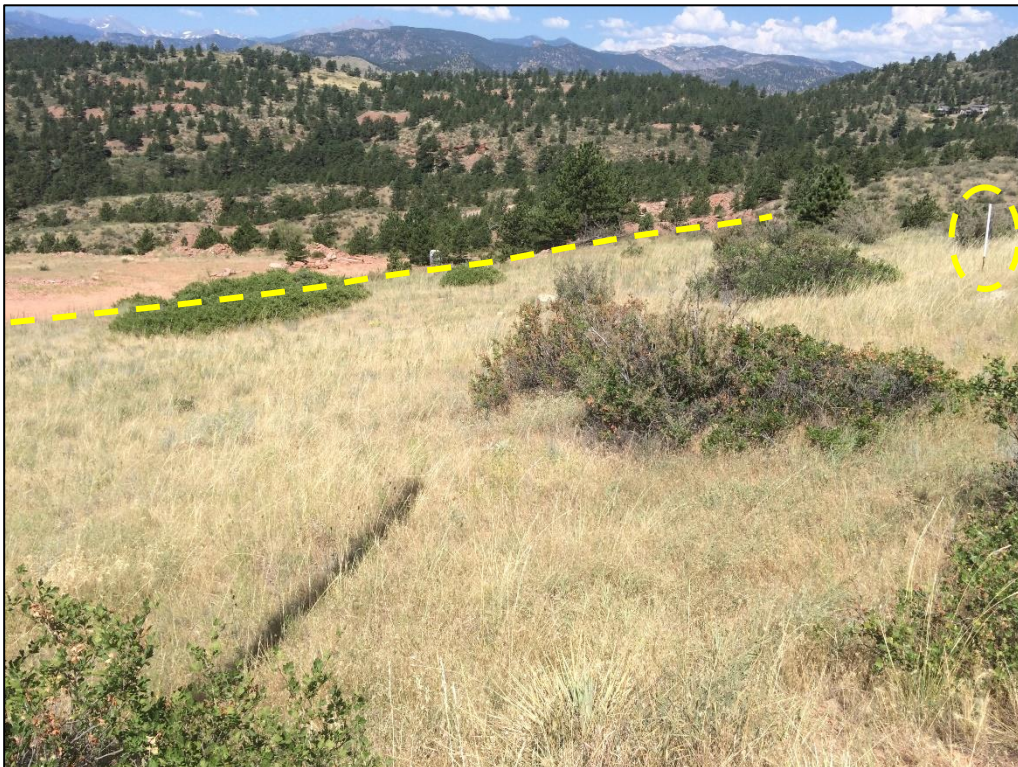
Photo 8. View looking west across undisturbed land between Quarry 1 and northeastern permit boundary. Post delineating northeastern permit boundary circled, and approximate edge of Quarry 1 disturbance indicated with dashed line.

The Division walked around the outside perimeter of Quarries 1 and 2, where the complaint indicated the operation may have disturbed land outside the approved permit boundary. The Division observed no offsite disturbances in these areas (**Photo 8**). The corners of the permit boundary are clearly delineated by white PVC posts (**Photo 9**). The northern and eastern edges of Quarry 1 are very close to the permit boundary, but have not extended beyond the marked boundary. The eastern edge of Quarry 1 ranges from approximately 50 to 100 feet from the eastern permit boundary. The operator has completed mining the northern edge of Quarry 1, and no new disturbances were observed in that portion of the quarry. The historic rubble piles located in the drainage north of Quarry 1 did not appear to have been disturbed (**Photo 10**), as they had the same configuration and vegetative cover (mainly shrubs) observed during the last inspection. The operator acknowledged the current active pit is very close to the eastern permit boundary, and they will not extend the pit much further in that direction. At this stage, the operation still has enough sandstone to mine in Quarry 1 by going deeper.

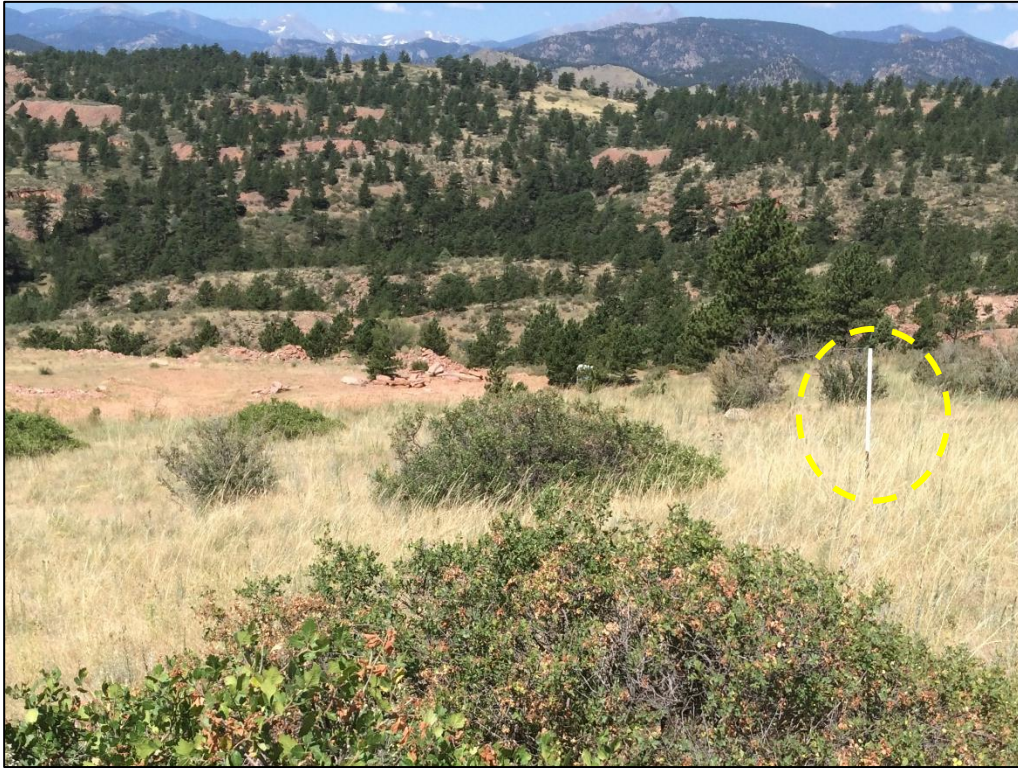
Photo 9. View looking west across undisturbed land between Quarry 1 and northeastern permit boundary, showing white PVC pipe delineating permit boundary (circled).

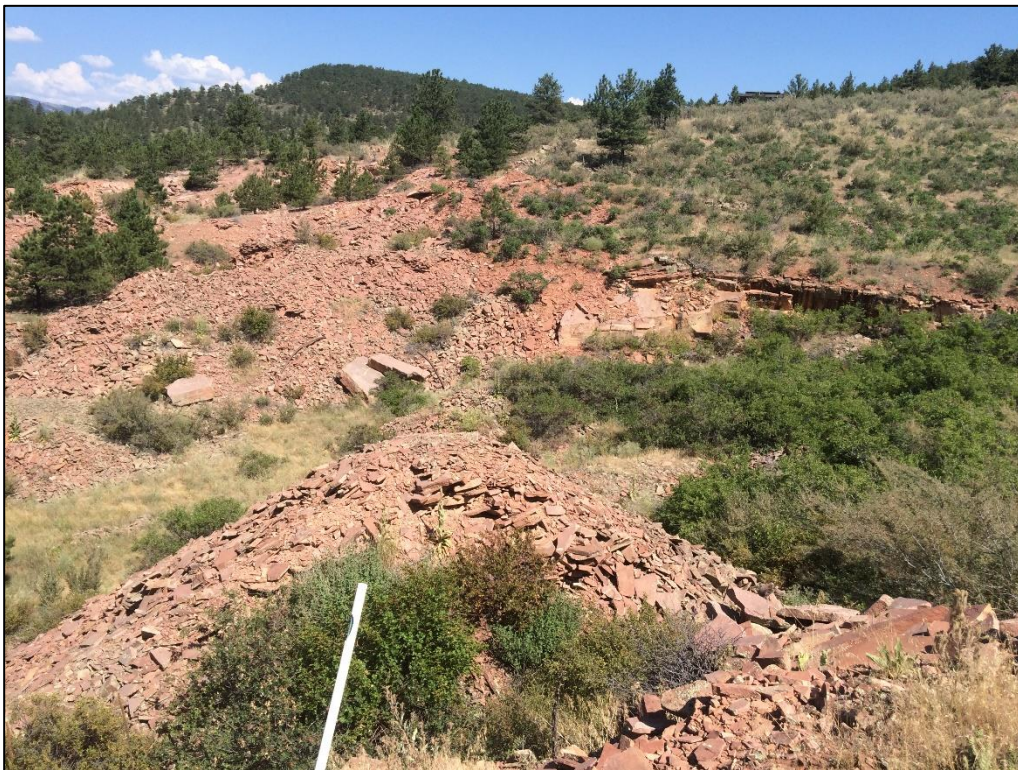
Photo 10. View looking northwest from Quarry 1, showing historic rubble piles located in drainage. These piles appeared to be undisturbed, as they had the same configuration and vegetative cover as observed during the last inspection.

The Division observed the areas west of Steamboat Valley Road where quarry rubble had been pushed off the side of the road into the canyon during the 1990's. The operation is not authorized to redisturb these piles. The Division observed no evidence the operator has continued to dump on these piles, as they had the same configuration and vegetative cover observed during the last inspection (mainly shrubs with some grasses).
