MINERALS PROGRAM INSPECTION REPORT
PHONE: (303) 866-3567

MINE NAME: Sprague Red Lyons	MINE/PROSPECTING ID#: M-1981-057	MINERAL: Sandstone (silica, stone, quartzite)	COUNTY: Boulder
INSPECTION TYPE: Surety Release Inspection	INSPECTOR(S): Amy Eschberger	INSP. DATE: February 21, 2019	INSP. TIME: 10:00
OPERATOR: Arkins Park Stone Corporation	OPERATOR REPRESENTATIVE: Shari Swenson, John Holliday	TYPE OF OPERATION: 112c - Construction Regular Operation

M1981-057 / Sprague Red Lyons / Arkins Park Stone Corporation

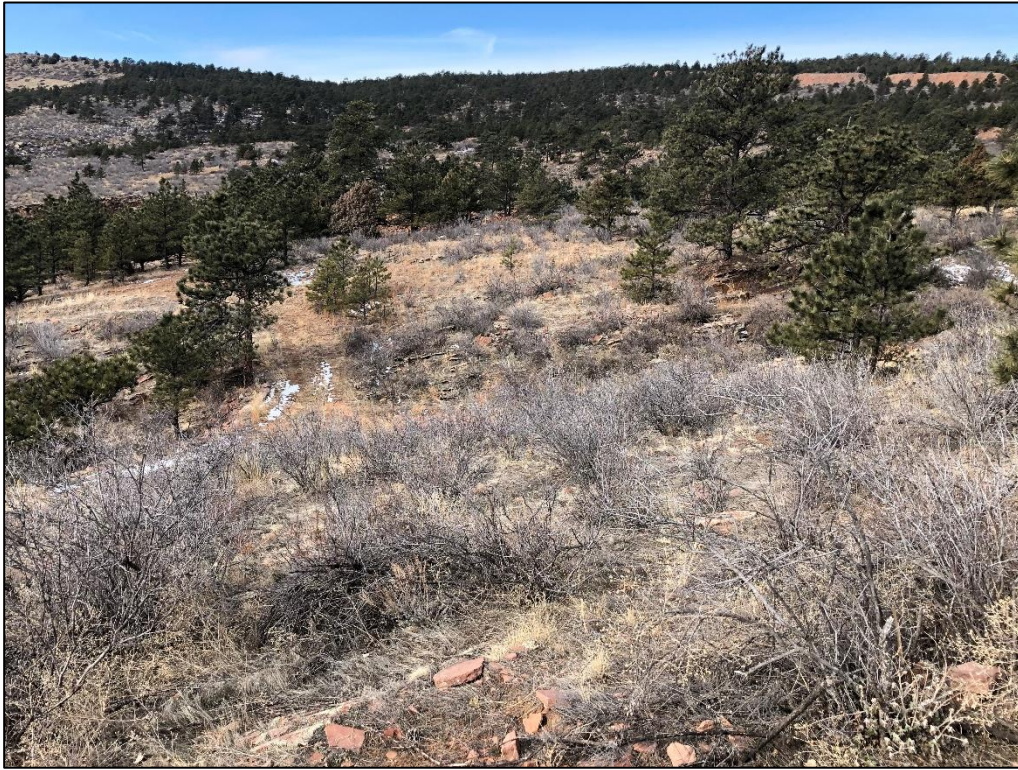
Photo 1. View looking west across southwestern portion of permit area proposed for release in AR-1. This area was not disturbed by the operation.

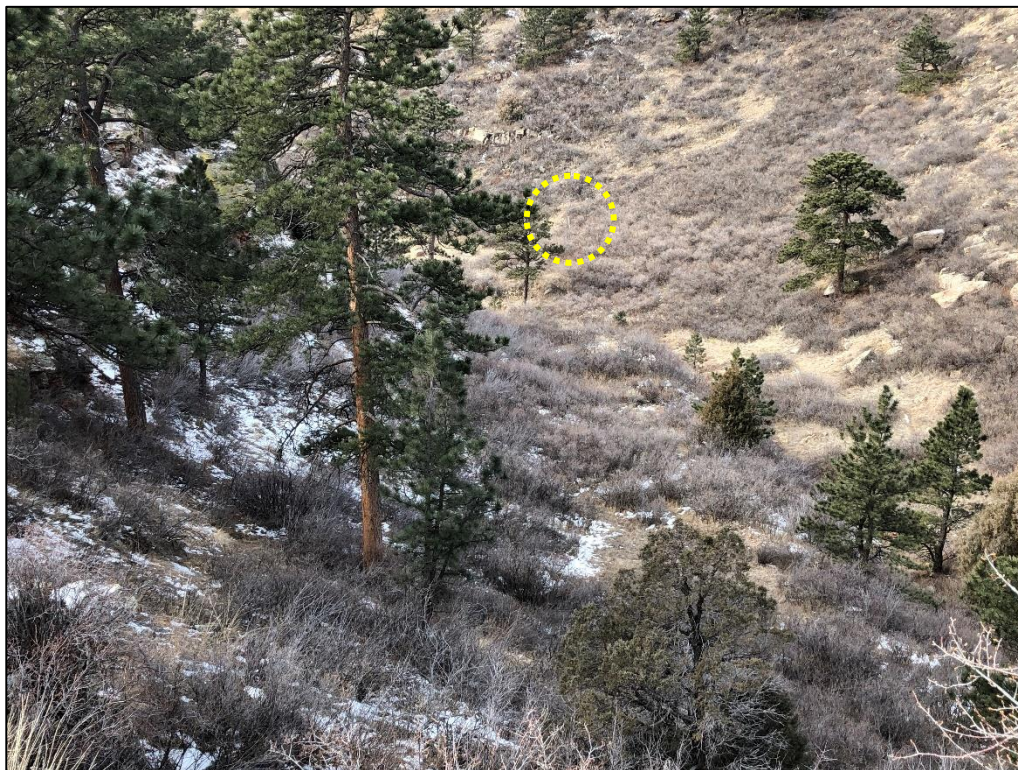
Photo 2. View looking south down drainage located at western edge of portion of permit area proposed for release in AR-1. Post marking existing southwestern boundary corner (circled) needs to be relocated to new southwestern boundary corner.

The Division inspected the entire 16 acre area proposed for release in AR-1. The portion of this area located west of Steamboat Valley Road is forested land undisturbed by this operation. A few small historic rubble piles exist in this area. The Division observed the post marking the southwestern corner of the existing permit boundary (at the bottom of the canyon), but was unable to find a marker for the proposed new southwestern corner. The operator will need to relocate the post approximately 200 feet northward to mark the new southwestern boundary corner.

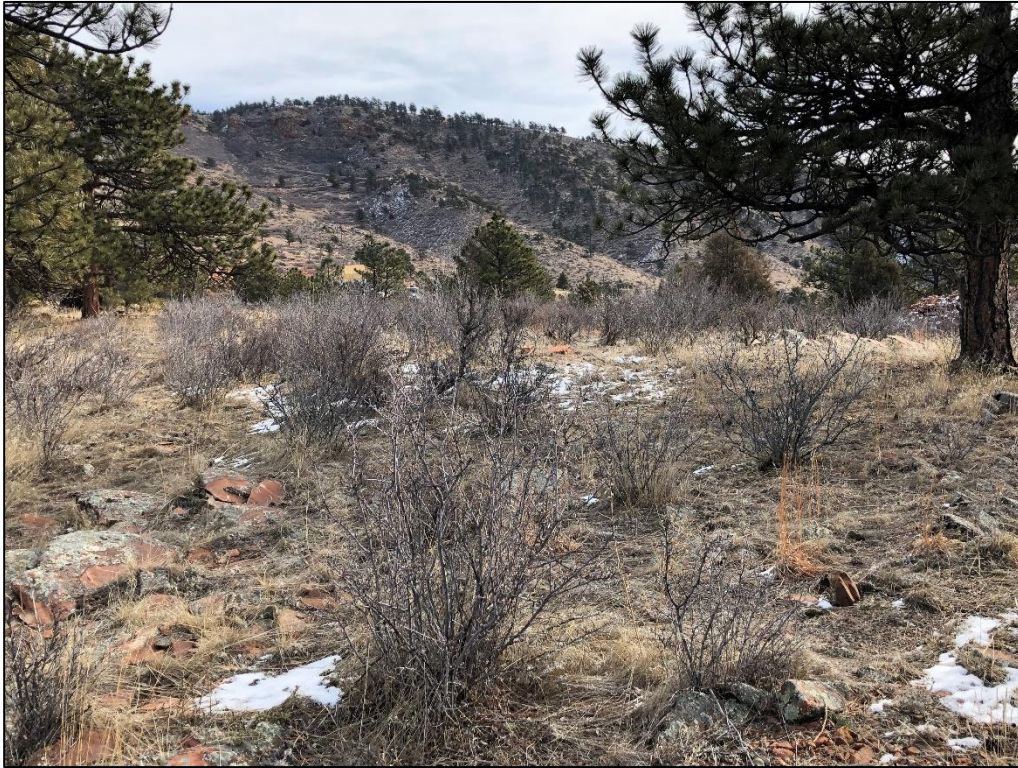
Photo 3. View looking east across southwestern portion of permit area proposed for release in AR-1. This area was not disturbed by the operation.

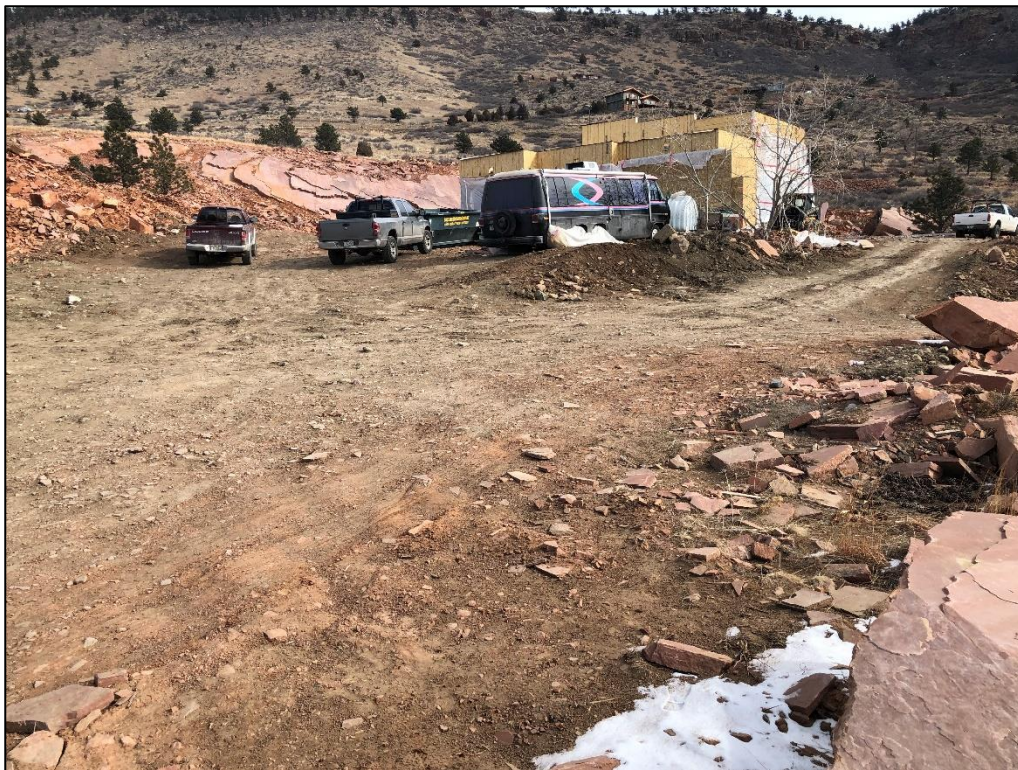
Photo 4. View looking east across Quarry 3 from its access road off Steamboat Valley Road. This quarry is proposed for release in AR-1. A residence is under construction in this quarry, in accordance with the approved post-mining land use.

The Division inspected the Quarry 3 area, where a few workers were present constructing the residential building on the pit floor. Boulder County issued a residence permit for the site in May of 2018. Therefore, the operation appears to be in compliance with the county with regard to construction of the new residence. This activity is also in compliance with the approved mine permit, which allows for residential use of the reclaimed lands. In accordance with TR-1, the small L-shaped section of highwall (10-12 feet in height) located at the northwestern edge of the pit will be utilized by the new landowner as a natural amphitheater. The exposed sandstone along the eastern pit edge will remain as-is, dipping toward the pit with slope gradients ranging from 2H:1V to 3H:1V. The large product and waste rock that had been stockpiled on the pit floor were removed in 2017/2018. A small portion of waste rock was left for the landowner to use in constructing the pad site for the new residence. Native grasses and pine trees have volunteered into the quarry area. However, the area will not be revegetated by the operator, per TR-1. The Quarry 3 area appears to be reclaimed in accordance with its approved post-mining land use. Historic rubble piles are present at the southern and eastern edges of Quarry 3. These piles were not re-disturbed by the operation and therefore, do not require reclamation.

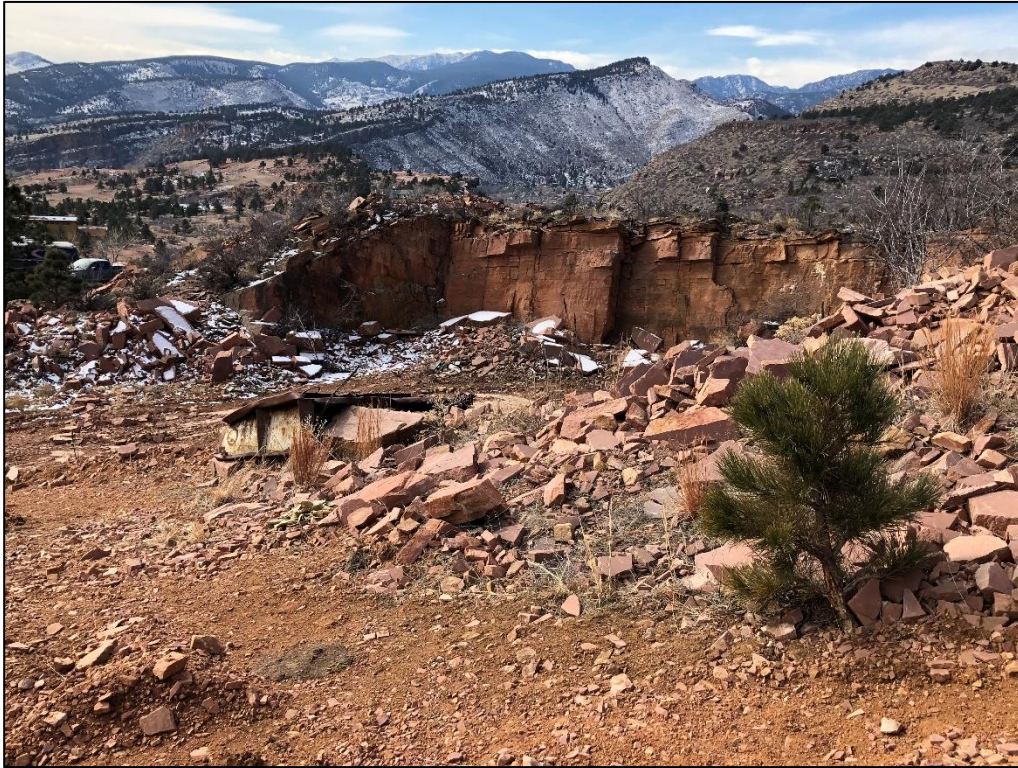
Photo 5. View of small L-shaped section of steep highwall to remain at northwestern edge of Quarry 3 for use by the new landowner as a natural amphitheater.

The reclamation plan for Quarry 3 was revised with Technical Revision No. 1 (TR-1; approved on November 30, 2018) to allow the quarry to remain as-is for residential use, including leaving a small section of steep highwall as a natural amphitheater. The Division was provided with a notarized letter from the new landowner on October 5, 2018 agreeing with these changes to the reclamation plan for Quarry 3. This letter also provides the operator legal access to the affected lands for mining and reclamation. The AR-1 submittal included an executed structure agreement for the new structures constructed on site which are owned by the new landowner (residential home, well, underground utilities). These structures are shown on the site map provided with AR-1. By submitting an updated legal right of entry and structure agreements for the new landowner and his structures, the operator has complied with the Division's recommendations outlined in the inspection report sent on August 3, 2018.

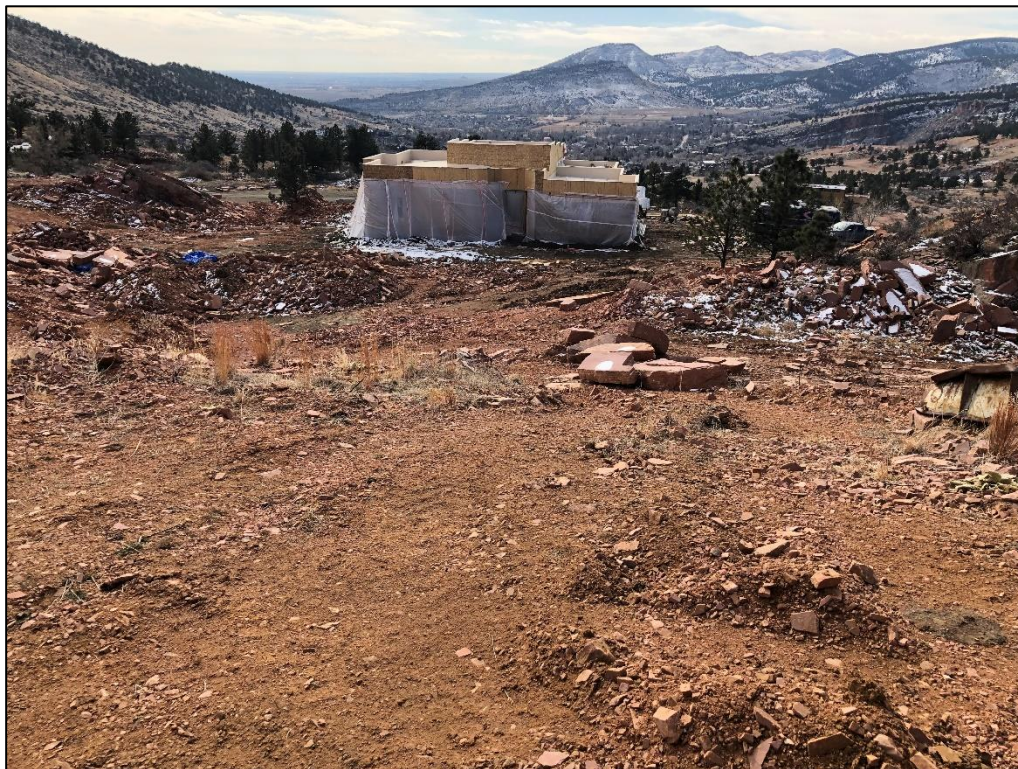
Photo 6. View looking southeast across Quarry 3 proposed for release in AR-1, showing residence under construction on pit floor.

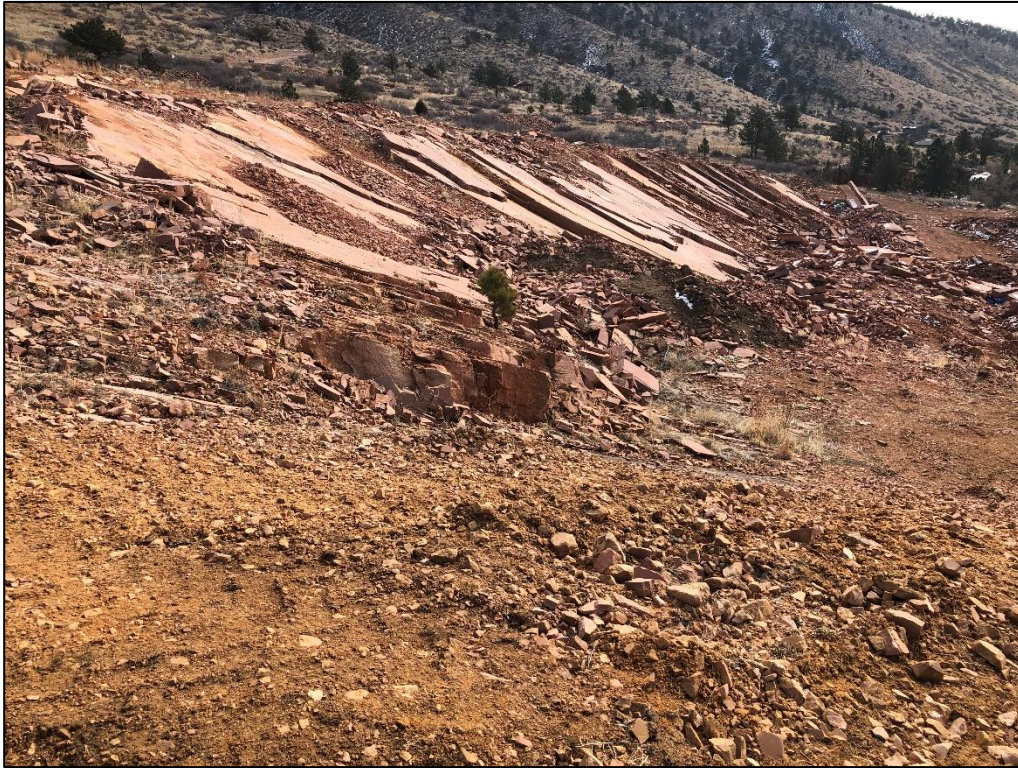
Photo 7. View looking south across eastern pit wall of Quarry 3 to remain as-is for reclamation, with slope gradients of 2H:1V to 3H:1V.

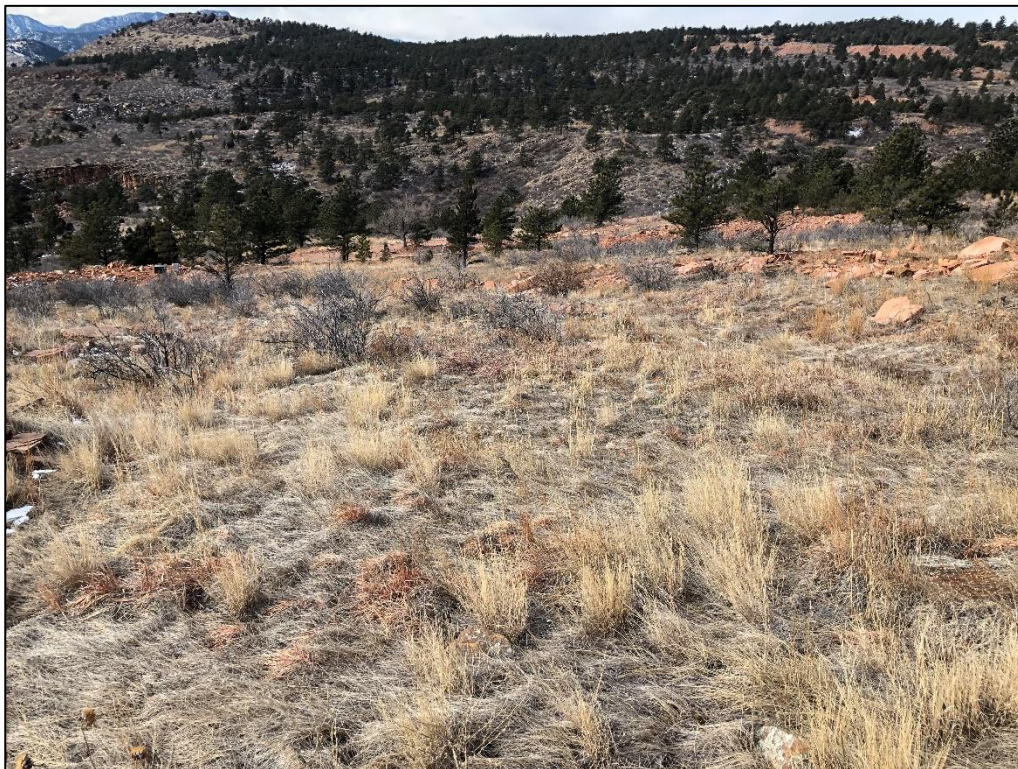
Photo 8. View looking southwest across portion of permit area between Quarries 2 and 3 proposed for release in AR-1. This area appears to be undisturbed by the operation.

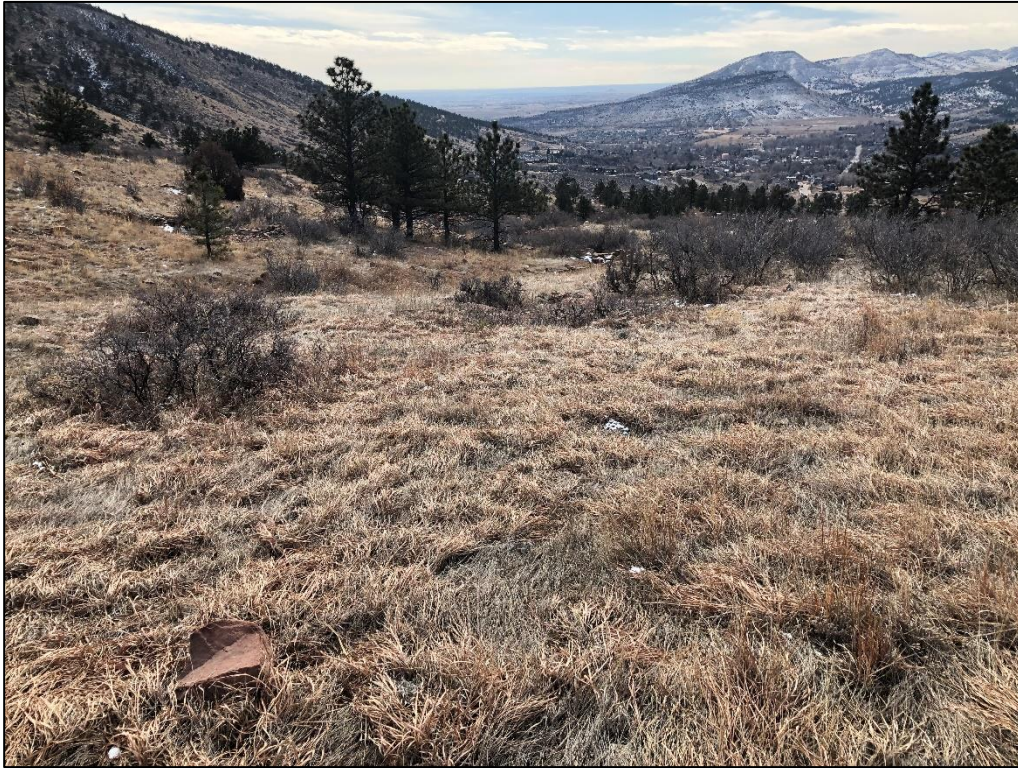
Photo 9. View looking southeast across portion of permit area located east of Quarry 3 proposed for release in AR-1. This area appears to be undisturbed by the operation.

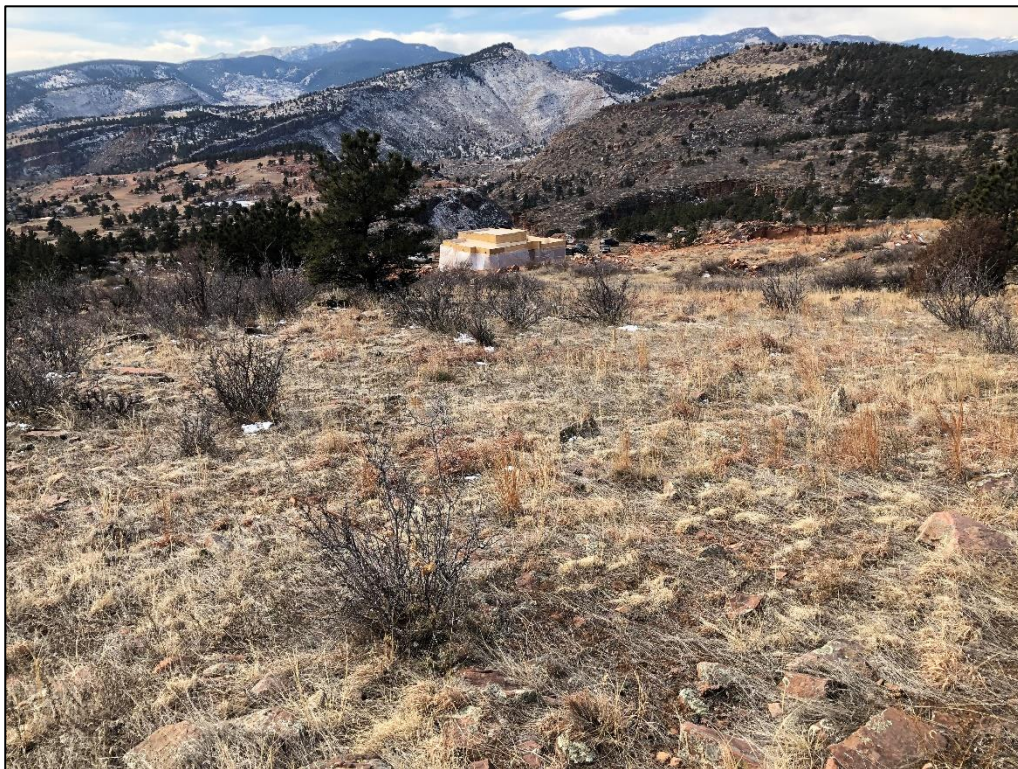
Photo 10. View looking west (toward Quarry 3) across southeastern portion of permit area proposed for release in AR-1. This area appears to be undisturbed by the operation.

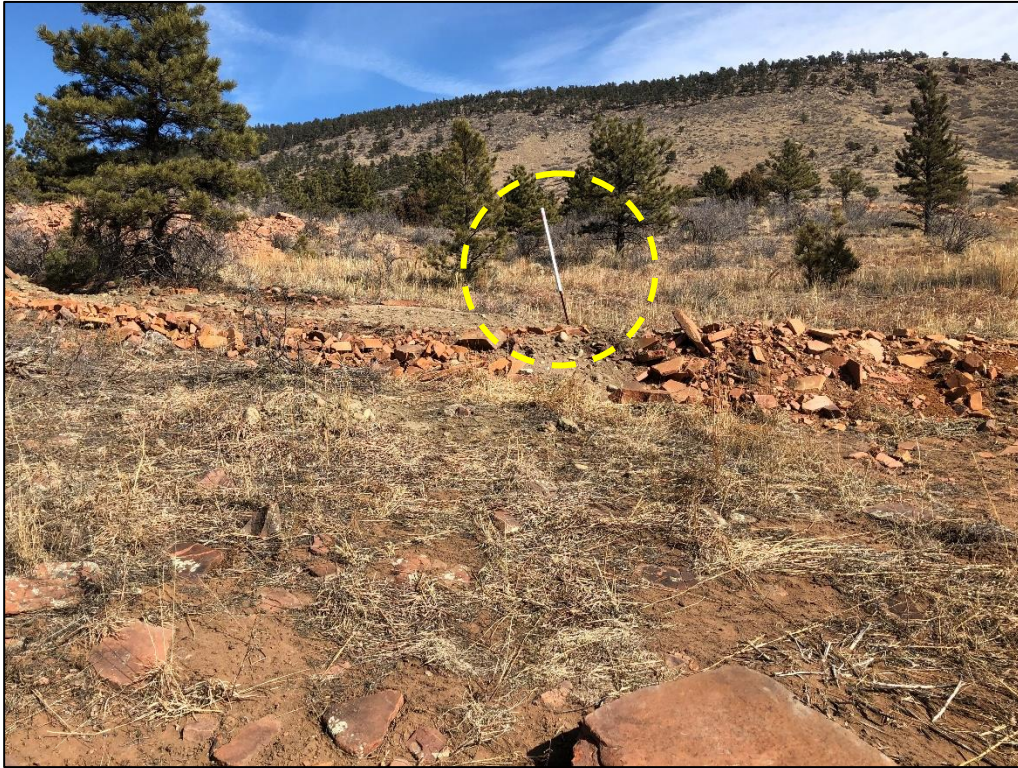
Photo 11. View looking northeast showing post (circled) marking new boundary corner located south of Quarry 2.

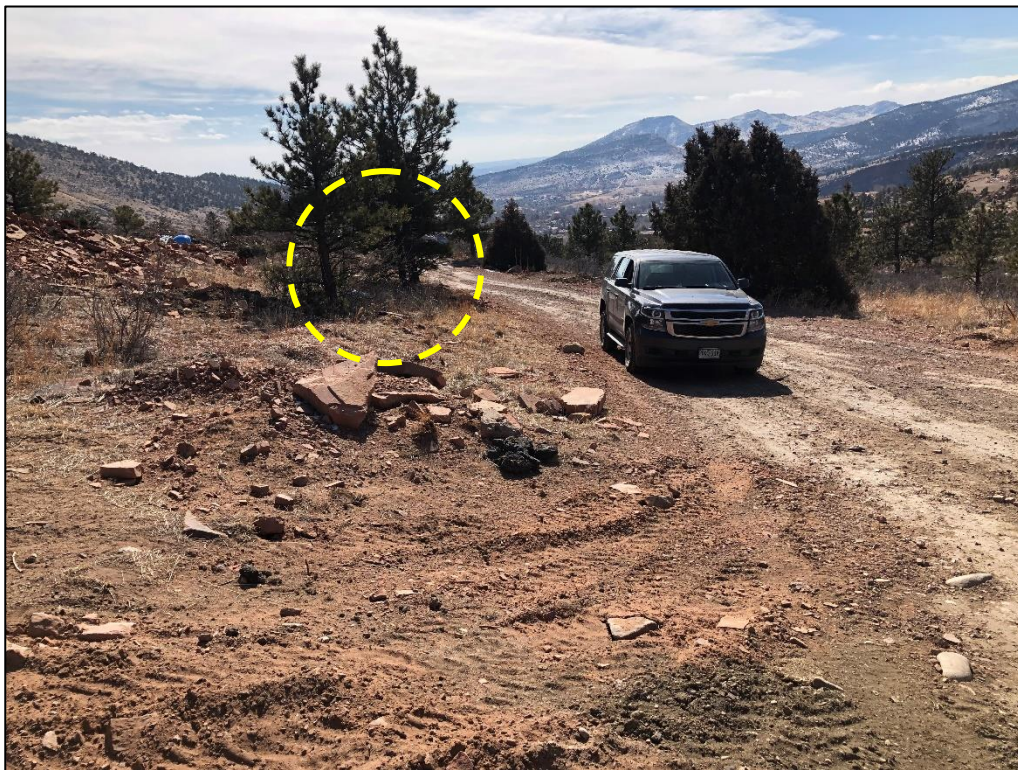
Photo 12. View looking southeast showing approximate location (circled) where marker needs to be placed to delineate new boundary corner located northwest of Quarry 3, adjacent to Steamboat Valley Road.

The Division inspected the lands located east of Quarry 3 proposed for release in AR-1. These lands were not disturbed by the operation, and they are well-vegetated with native grasses, shrubs, and some pine trees. The Division observed the marker at the southeastern corner of the existing permit boundary (near an existing power pole), but was unable to find a marker for the proposed new southeastern corner. The operator will need to relocate the marker approximately 600 feet northward to delineate the new southeastern boundary corner. There are two additional corners in the proposed new permit boundary, located between Quarries 2 and 3, near Steamboat Valley Road. The boundary corner closest to Quarry 2 was marked. However, the operator will need to mark the boundary corner closest to Quarry 3, adjacent to the road.

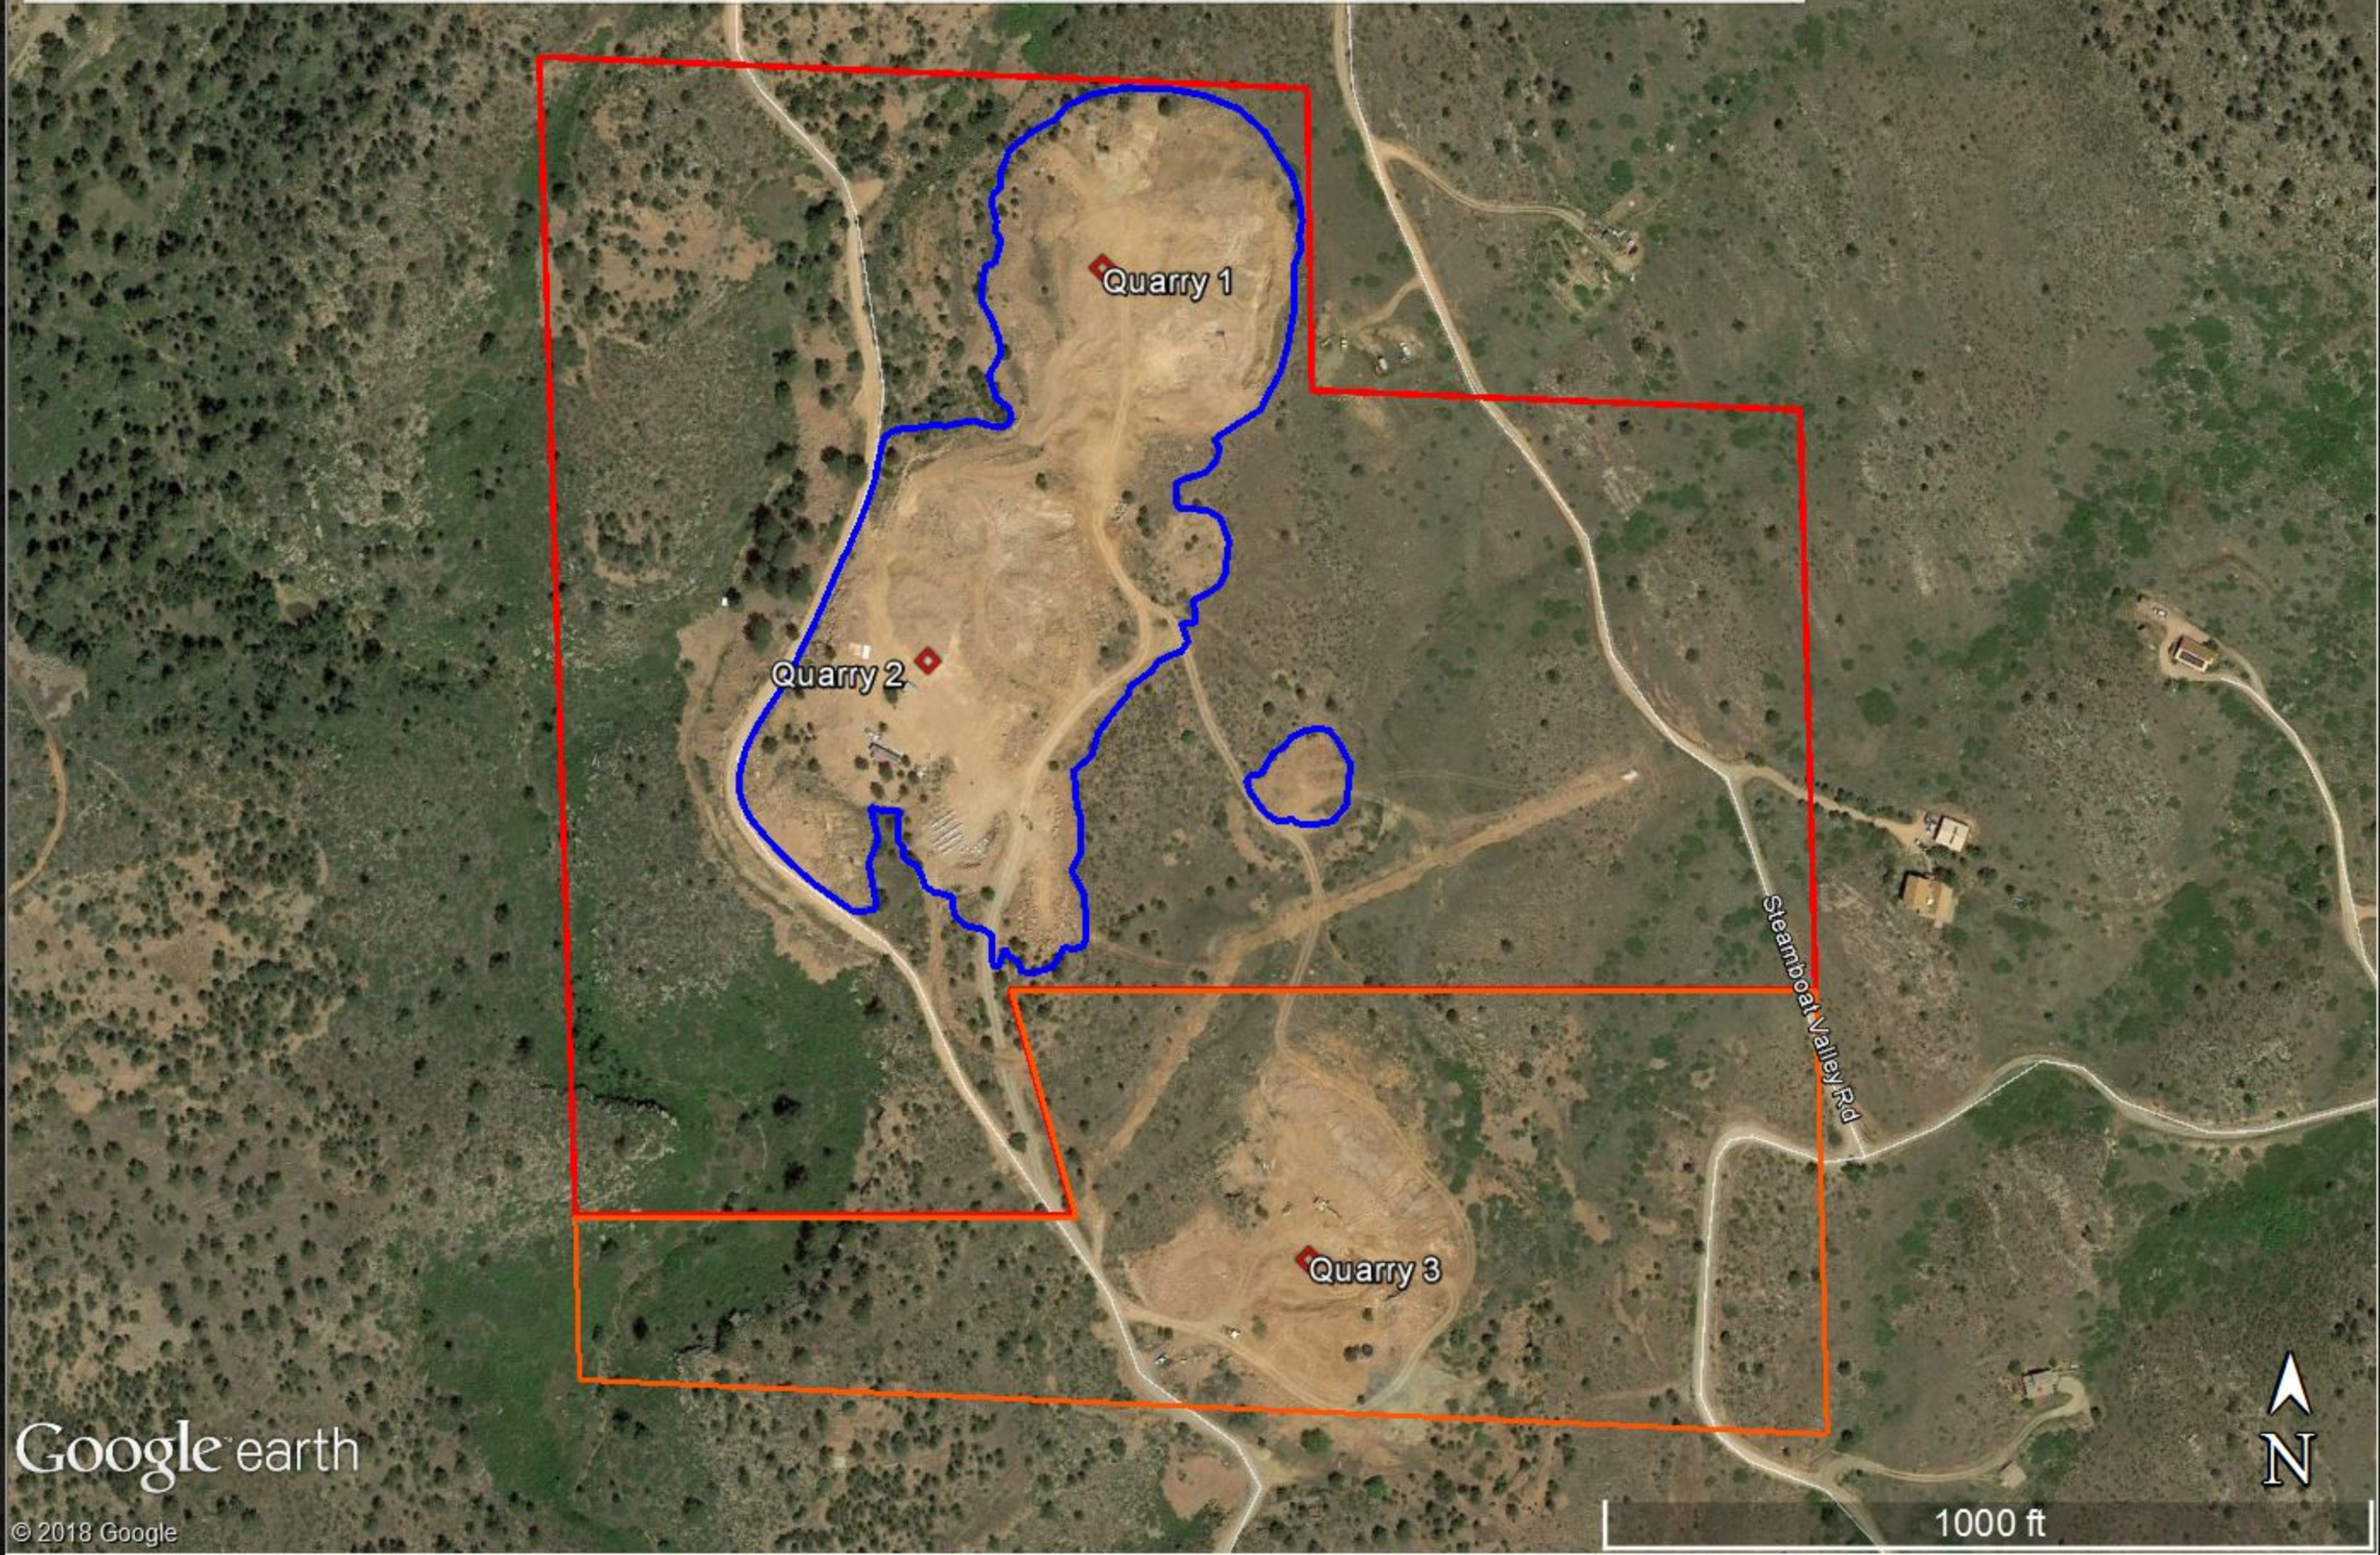
Red outline = 42.16 acres = New permit area (after AR-1 approval)

Orange outline = 16 acres = Area released in AR-1

(Image data from 5/31/2018)
