MINERALS PROGRAM INSPECTION REPORT**PHONE: (303) 866-3567**

MINE NAME: Korinek #1 Pit	MINE/PROSPECTING ID#: M-1979-131	MINERAL: Sand and gravel	COUNTY: Crowley
INSPECTION TYPE: Monitoring	INSPECTOR(S): Patrick Lennberg	INSP. DATE: February 20, 2019	INSP. TIME: 09:40
OPERATOR: JH Sand & Gravel, LLC	OPERATOR REPRESENTATIVE: Jim McCuistion	TYPE OF OPERATION: 112c - Construction Regular Operation

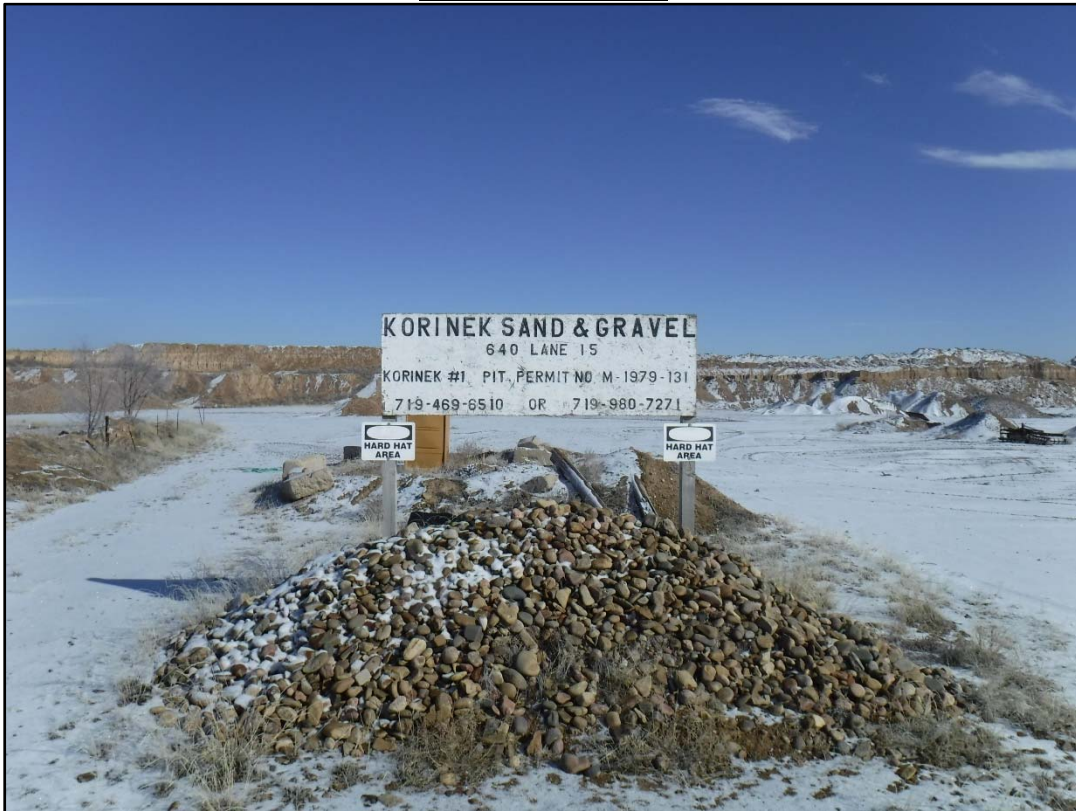
The site was not active at the time of inspection, but there were several product stockpiles onsite. A mine sign was observed as required by Rule 3.1.12 but the sign should be updated to reflect current ownership and contact numbers. Boundary markers were also observed during the inspection consisting of metal tee-posts and 4"x4" wooden stakes.

Photo 1: Mine sign

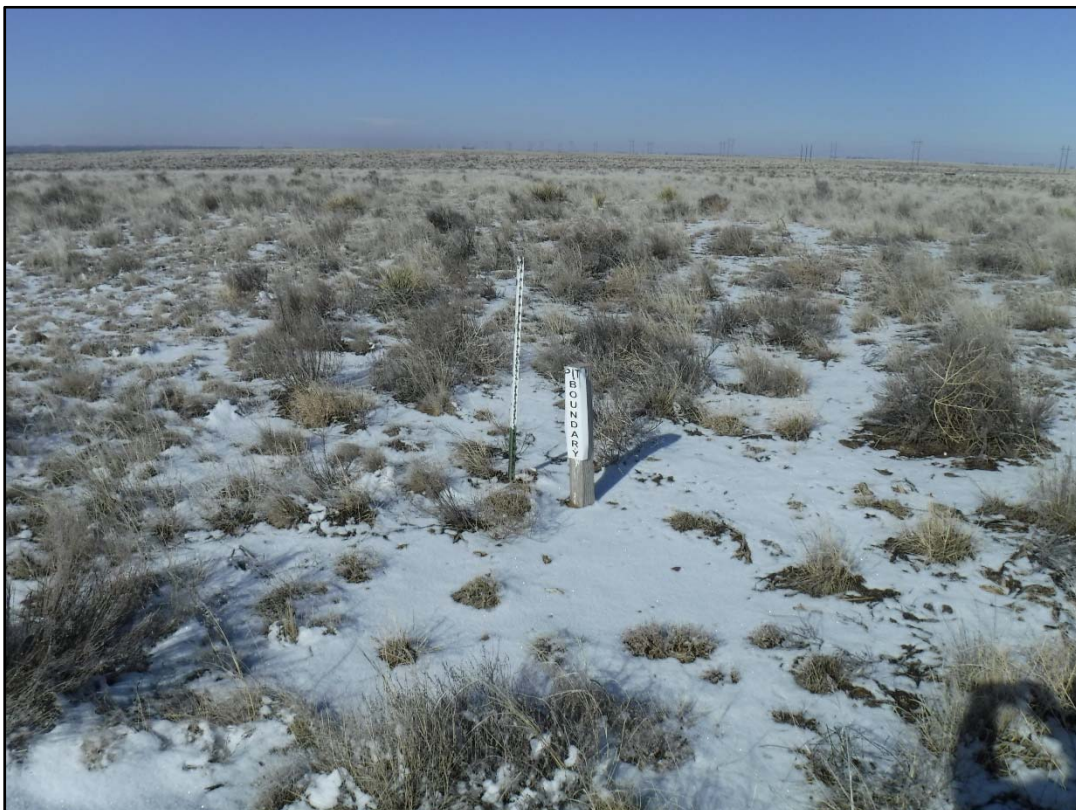
Photo 2: Typical permit boundary marker

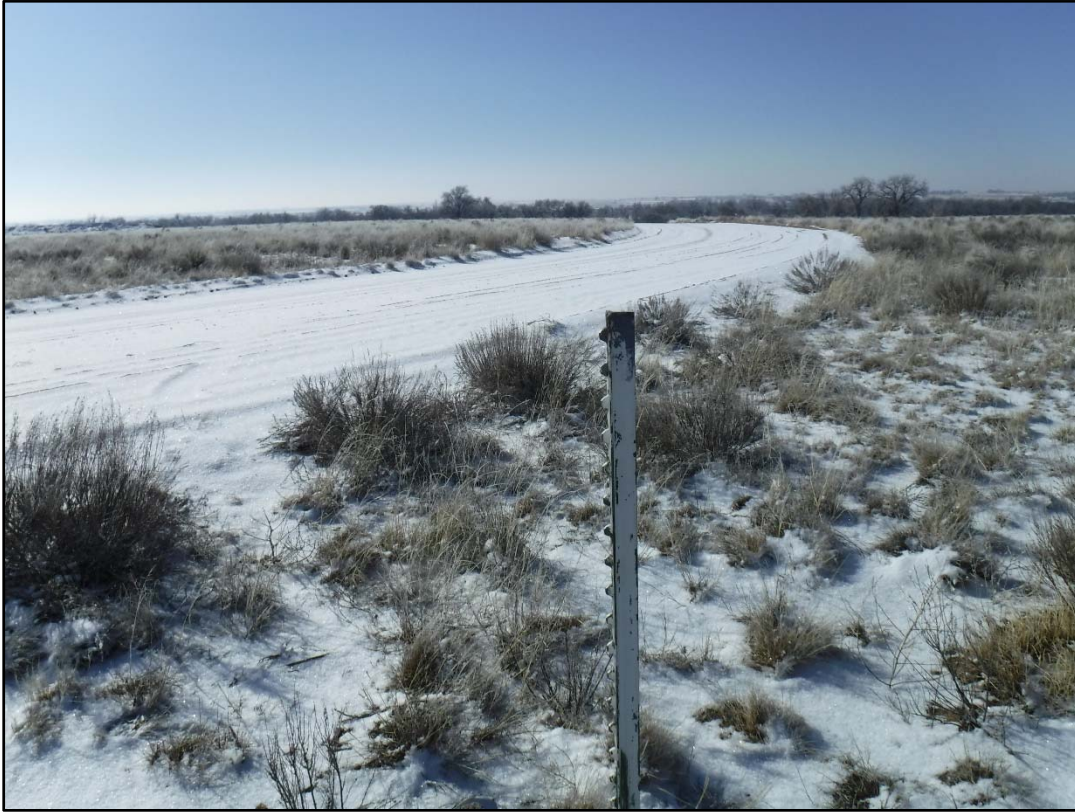
A portion of County Lane 15, which initially ran southwest through the middle of the site, separating the pre-law gravel pit to the east and the active mining area to the west, was relocated by the County between early 2013 and late 2014. This road only serves as access to the Korinek property located south of the permit area. In the approved Mining Plan, the Operator stated that this road would need to be diverted around the mine, and would remain after reclamation. However, its final location is not shown on the approved maps. Approximately 2,000 feet of the road now runs along the northwestern and western edges of the permit boundary. It appears that the far northwestern corner of the permit boundary overlaps this road. The Operator provided a structure agreement with the County for this road in the approved Succession of Operators application. The realignment of the county lane is not reflected in the Division's files and is being cited as a problem in this report. The Operator will need to submit a Technical Revision, with associated \$216 fee by May 4, 2019, to update the Mining Plan Map and Reclamation Plan Map to show the final configuration of this road, including any setbacks the mining operation will need to maintain.

Photo 3: County Lane on the inside of permit marker in the northwest portion of the site

INSPECTION TOPIC: Gen. Compliance With Mine Plan**PROBLEM:** The current mine plan needs to be updated and clarified pursuant to C.R.S. 34-32.5-112 (3). The Operator needs to update the Mining Plan Map and Reclamation Plan Map to show the final configuration of the county lane.**CORRECTIVE ACTIONS:** The operator shall submit a Technical Revision, with the required \$216 revision fee, to update the Mining Plan Map and Reclamation Plan Map to show the final configuration of the county lane, including any setbacks the mining operation will need to maintain to reflect existing and proposed activities by the corrective action date.**CORRECTIVE ACTION DUE DATE:** 5/04/19

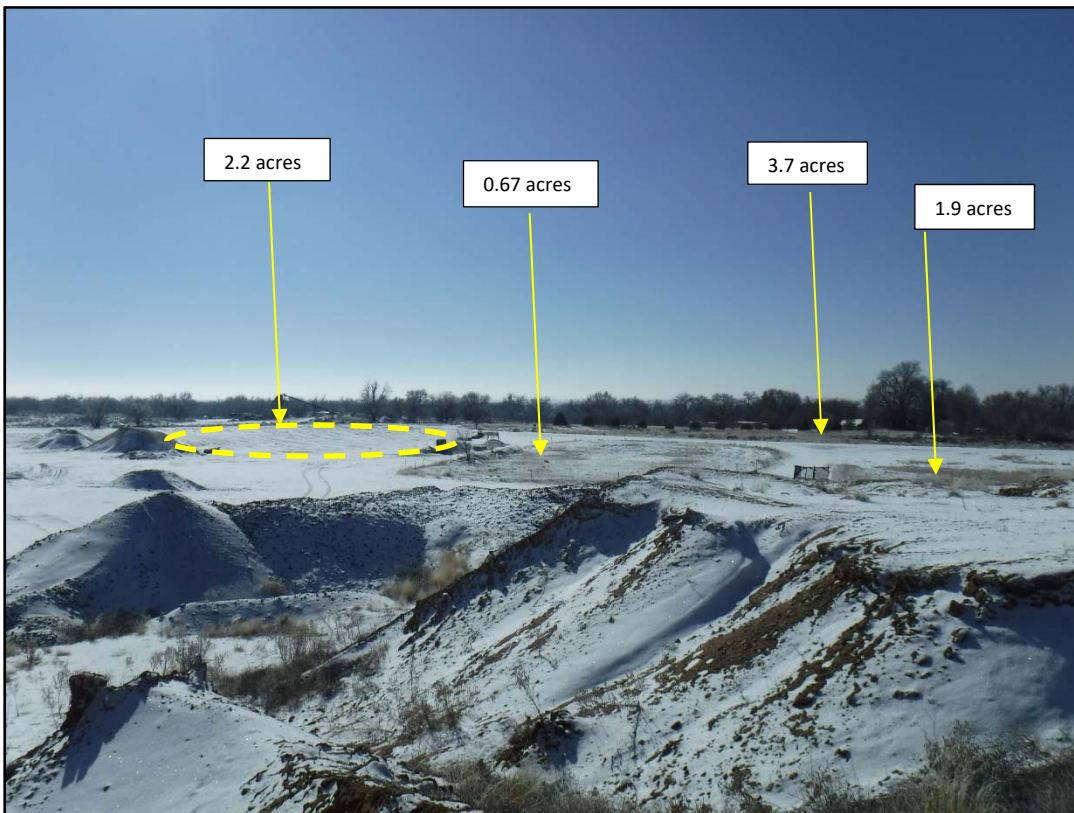
The Division estimates that the mining operation has currently disturbed approximately 8.6 acres, not including the 8.8 acres that are in various stages of reclamation (see enclosed Google Earth image of site). Of the 8.8 acres in reclamation it is estimated that up to 6.3 acres may be suitable for release. There is a section of reclaimed land that encompasses a historic fish farm structure. Gerald indicated that this area was never supposed to be included into the permit area but during the conversion from a 110 to 112 it was included. This area has been in reclamation since the conversion. The new Operator is encouraged to seek release for reclaimed lands that may be released from the permit area. This is a phased mining operation that is currently in Phase 1, with smaller portions of Phases 2, 3 and 4 also being mined. The maximum allowed disturbed

Photo 4: Four areas in various stages of reclamation, the three lots to the right may be suitable for release

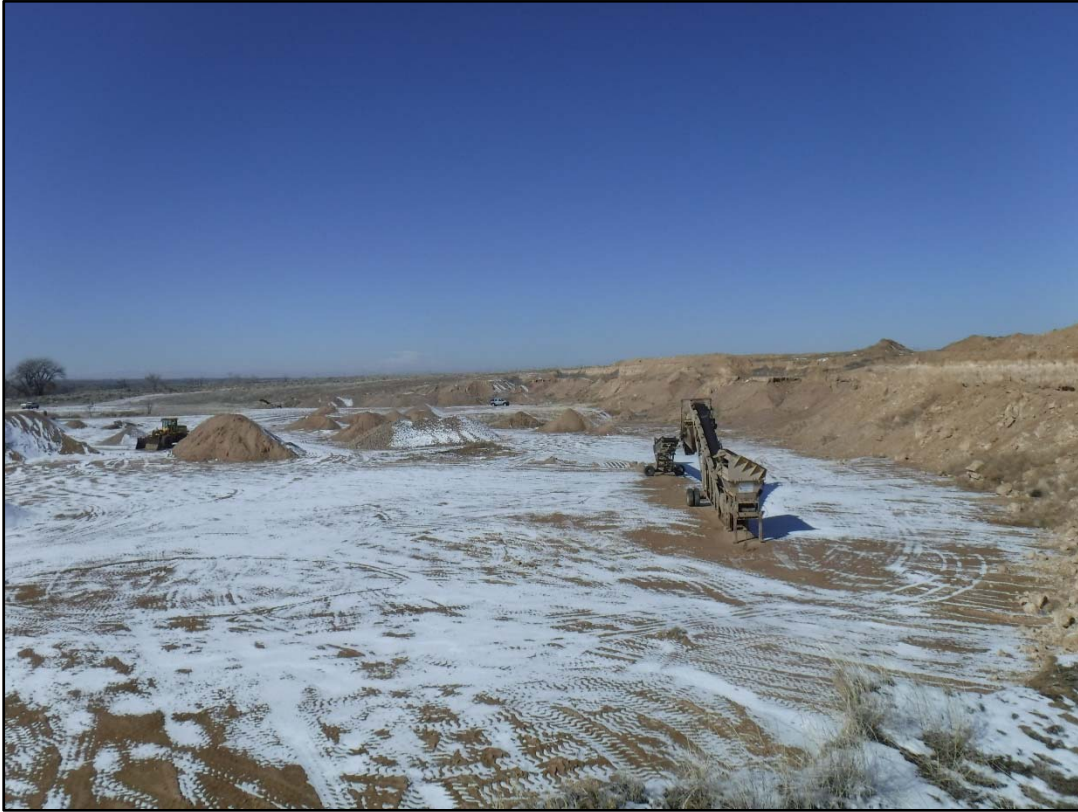
Photo 5: Looking west across the pit area

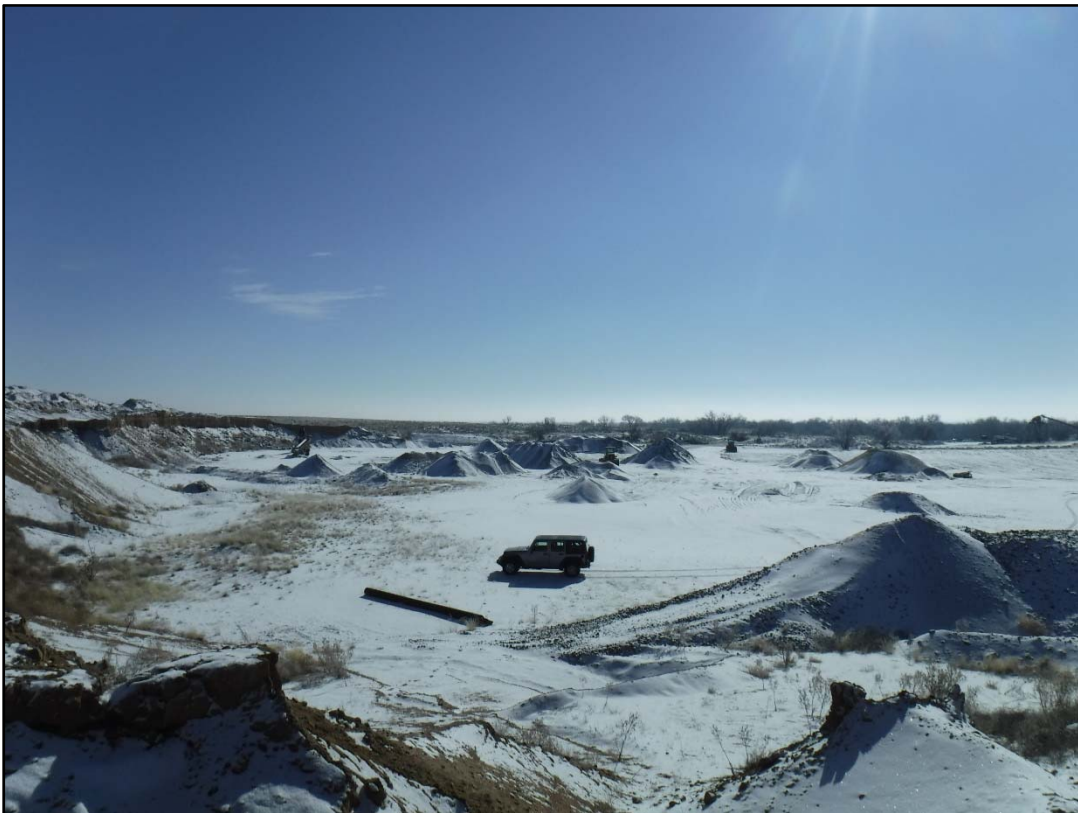
Photo 6: Looking east across the pit area

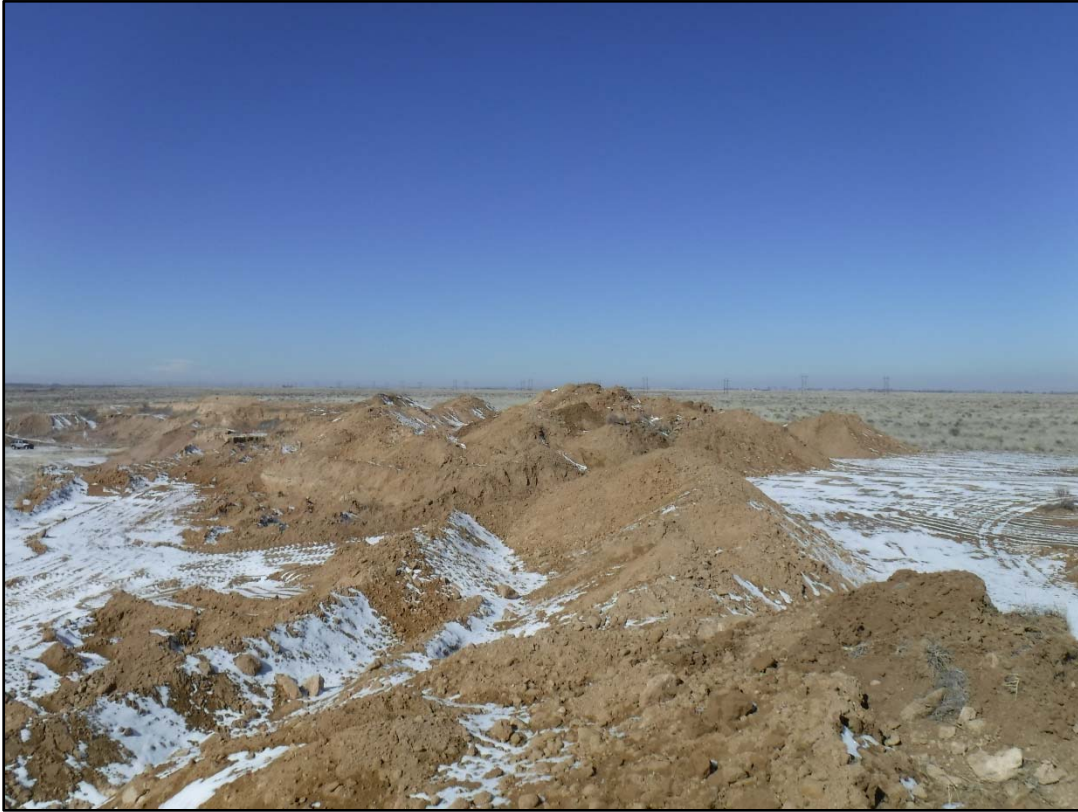
There appears to be an adequate amount of topsoil stockpiled in berms along the top of the highwall. These stockpiles appeared to be stable. In addition, there is a stockpile of approximately 1,600 CY of topsoil present in the pre-law gravel pit area. According to Mr. Korinek, this stockpile was left here by the County during reconstruction of County Lane 15, and it can be used for reclamation of this site.

Photo 7: Topsoil stockpiles at the top of the highwall area

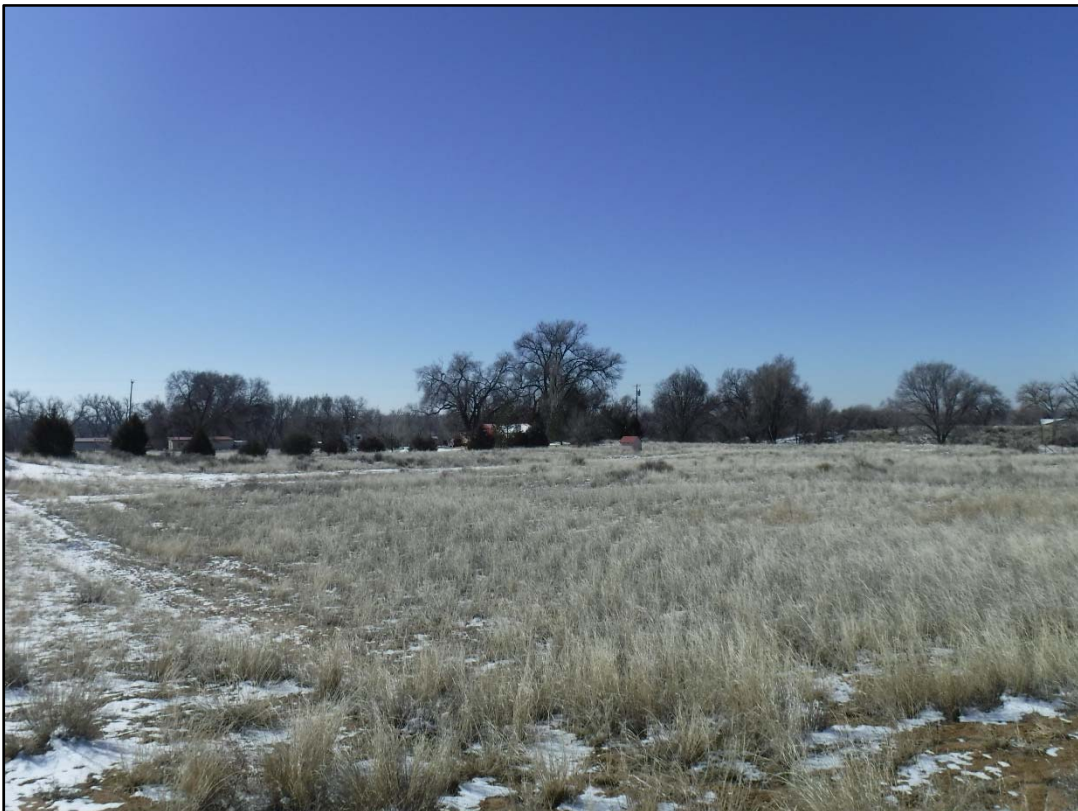
Photo 8: State of reclamation in the former fish farm area, 3.7 acres

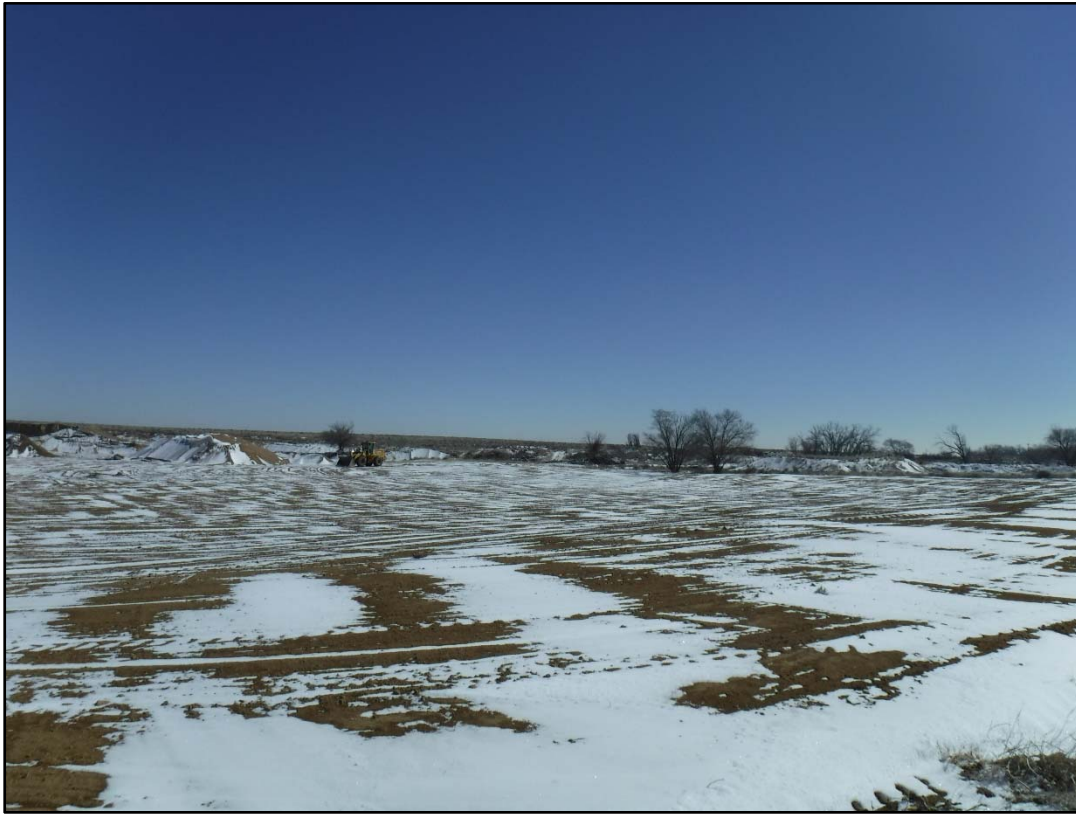
Photo 9: Area that is being prepped for reclamation, 2.2 acres
