# Debetz Pit Schedule - M-1977-283

# Memorandum

Division of Reclamation Mining and Safety (DRMS)
Kurt Carlson, Regional Park Manager LeC
Completion of Required Corrective Action Items - Debetz Pit
Permit number M-1977-283
03/21/2019

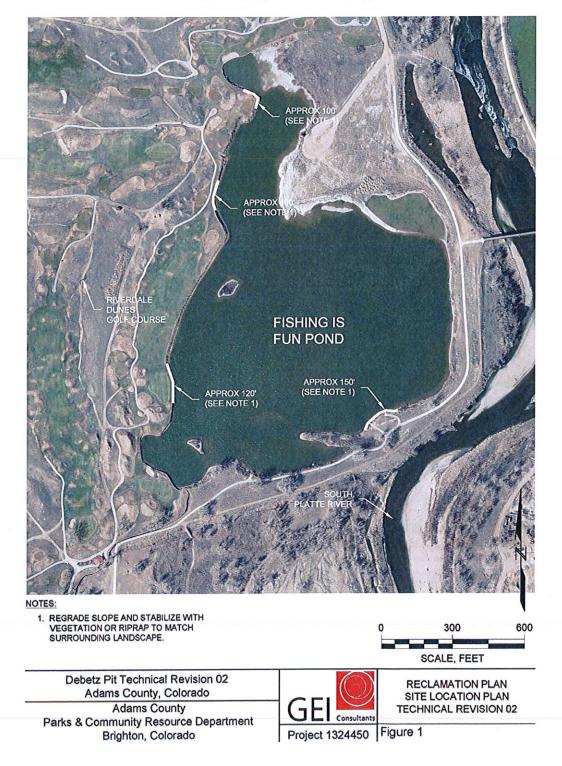
## Figure 1 (Approved TR02 Map)

As required by DRMS, this memo will verify through photo documentation, that Adams County (Operator) has completed all DRMS required shoreline erosion stabilization that was present at the December 20, 2017 inspection. The areas required to be repaired and previously approved by the DRMS through TR02 have all been properly reconstructed and stabilized to prevent further erosion damage.

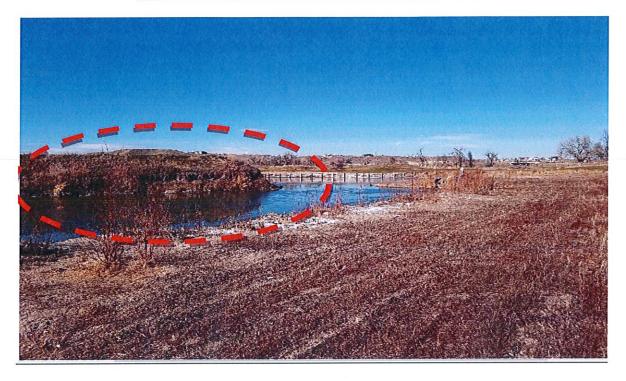
Photo 1 – Before photo taken on 12/20/2017 showing northernmost area on the TR02 Map

The following photo documentation in this report shows how the shoreline destabilization that was observed on December 20, 2017 along the western pond slopes was repaired and stabilized in order to prevent future erosion damages. Due to recent weather events soil conditions are too muddy to complete the seeding. However, we hope to have the seeding completed by next week or early April. Seeding will be completed on the northernmost area and the areas where soils and materials were stockpiled. The rip rap areas shouldn't require any seeding as the contractor was very careful not to disturb adjacent areas while placing rip-rap.

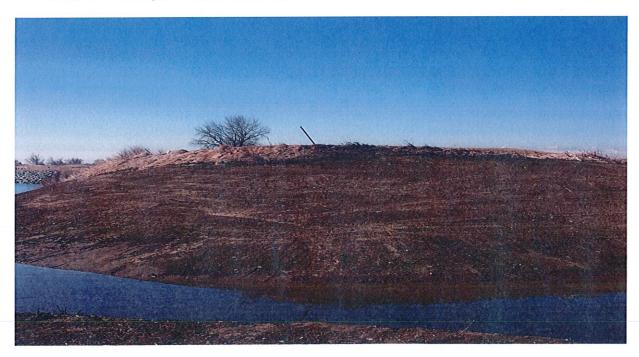
Photo 2 – Photo of final grade of embankment at northernmost area on TR02 Map Area (pre-seeding) Note: This area to be seeded and coconut erosion matting installed as weather/soil conditions allow.

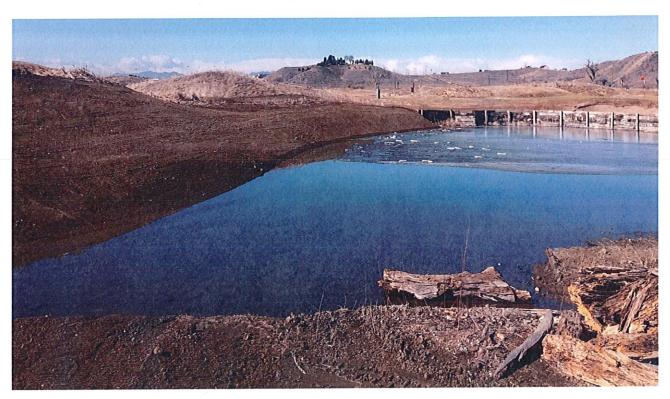
Photo 3 – Photo of final grade of embankment at northernmost area on TR02 Map Area (pre seeding) Note: This area to be seeded and mulch /coconut matting installed as weather/soil conditions allow

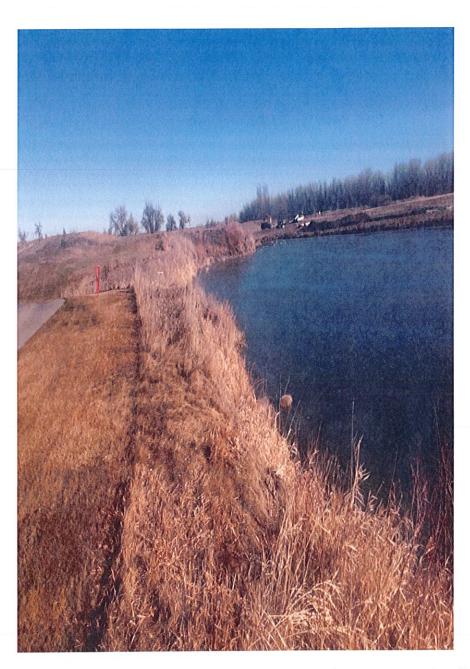
Photo 4 showing western pond bank (central area on TR02 Map) prior to rip rap installation Looking North

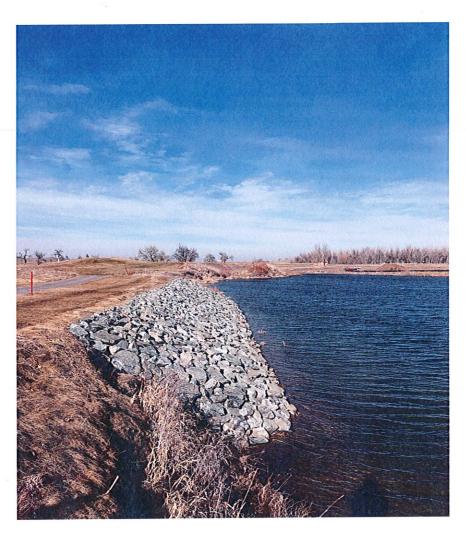
Photo 5 showing western pond bank (central area on TR02 Map) after rip rap installation

Looking north

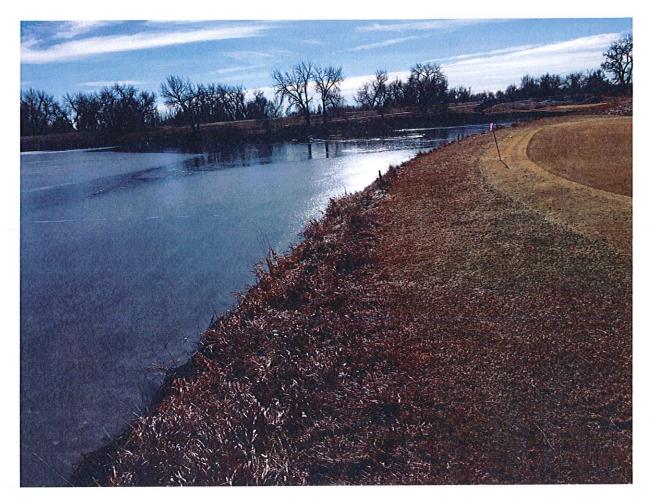
Photo 6 – Photo showing western pond bank (Southernmost area on TR02 Map) prior to rip rap (adjacent to green).

Looking South

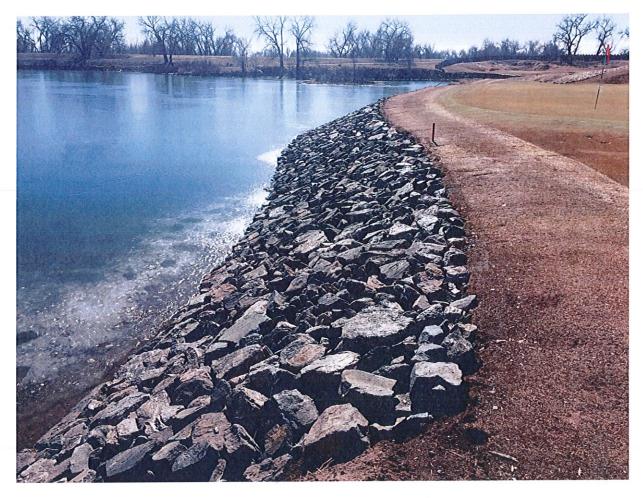
Photo 7 Photo showing western pond bank (Southernmost area - TR02 Map) rip rap adjacent to green Looking South

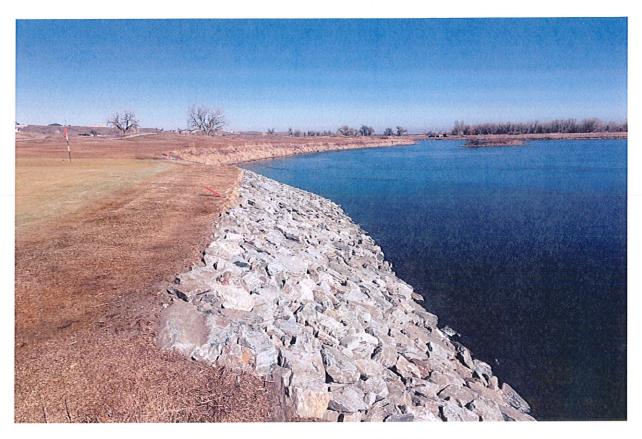
Photo 8 showing western pond bank (Southernmost area on TR02 Map) after rip rap adjacent to green Looking North
