**COLORADO**Division of Reclamation,
Mining and Safety

MINERALS PROGRAM INSPECTION REPORT**PHONE: (303) 866-3567**

MINE NAME: Monogram Mines	MINE/PROSPECTING ID#: M-1978-222-UG	MINERAL: Uranium and Vanadium	COUNTY: Montrose
INSPECTION TYPE: Monitoring	INSPECTOR(S): Dustin M. Czaplá	INSP. DATE: April 17, 2019	INSP. TIME: 11:00
OPERATOR: Nuvemco, LLC	OPERATOR REPRESENTATIVE: Craig Howell	TYPE OF OPERATION: 112d-1 - Designated Mining Operation

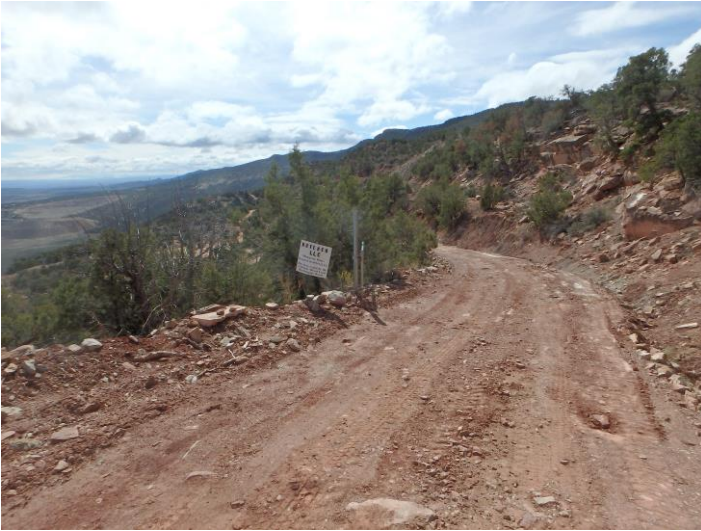
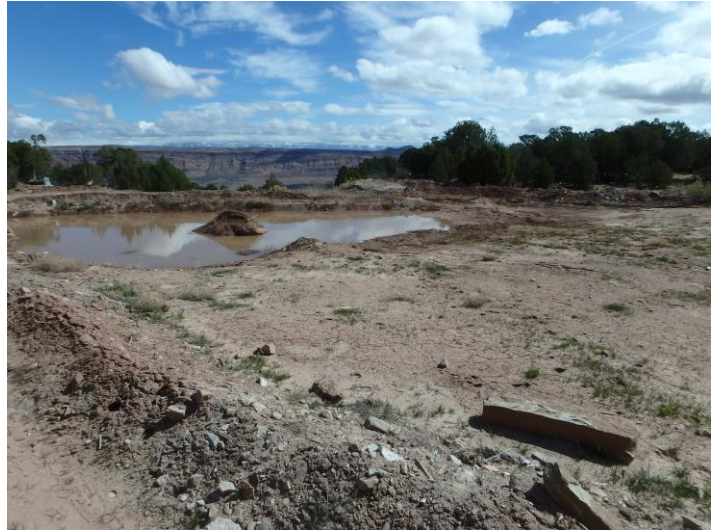
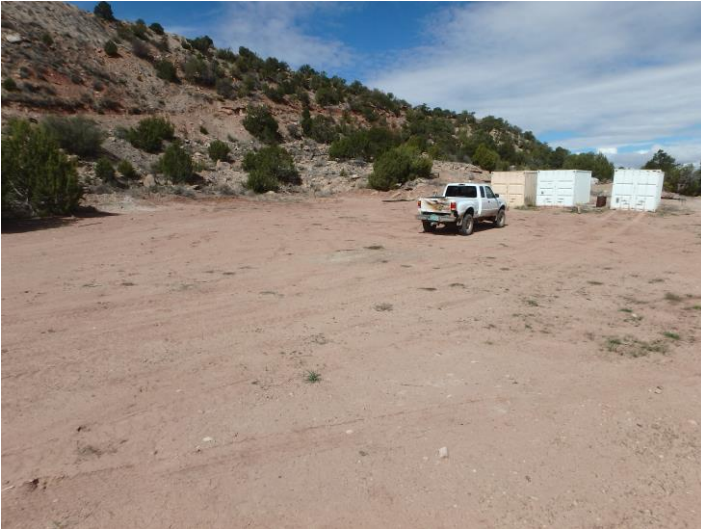
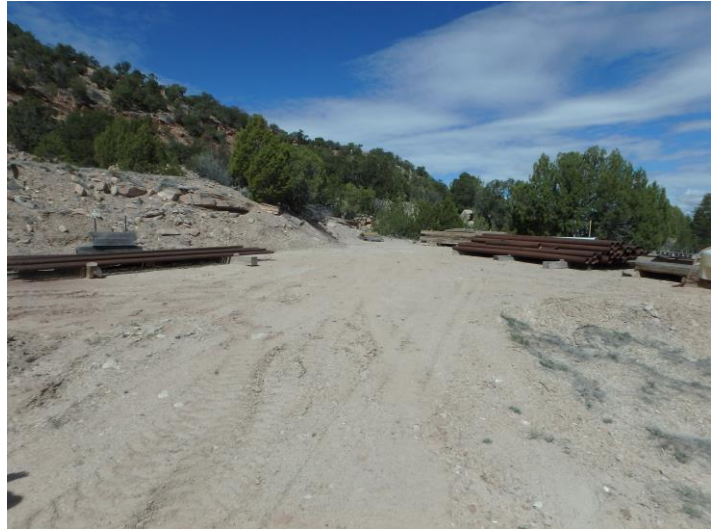
PHOTOGRAPHS

The Environmental Protection Plan was approved in 2009. Construction of environmental protection facilities has not yet commenced. Since the Division's last inspection, activity at the site has consisted of site maintenance, improvements to stormwater controls, underground exploration and sampling activities. Several of the old underground portals have been located and reopened. Once reopened, secure gates are installed.

Site stormwater controls direct water around the staging area to the location of the approved retention basin. The retention basin has not been constructed yet. An earthen berm has been constructed at the north end of the staging area to retain stormwater until the approved stormwater controls are constructed. Sediment is regularly cleaned out of the retention and added to the berms. The temporary stormwater controls appear effective.
