**COLORADO**Division of Reclamation,
Mining and Safety

MINERALS PROGRAM INSPECTION REPORT**PHONE: (303) 866-3567**

MINE NAME: Last Chance #3 & #4	MINE/PROSPECTING ID#: M-2008-012	MINERAL: Uranium and Vanadium	COUNTY: Montrose
INSPECTION TYPE: Monitoring	INSPECTOR(S): Dustin M. Czapla	INSP. DATE: April 17, 2019	INSP. TIME: 11:30
OPERATOR: Nuvemco, LLC	OPERATOR REPRESENTATIVE: Craig Howell	TYPE OF OPERATION: 112d-1 - Designated Mining Operation

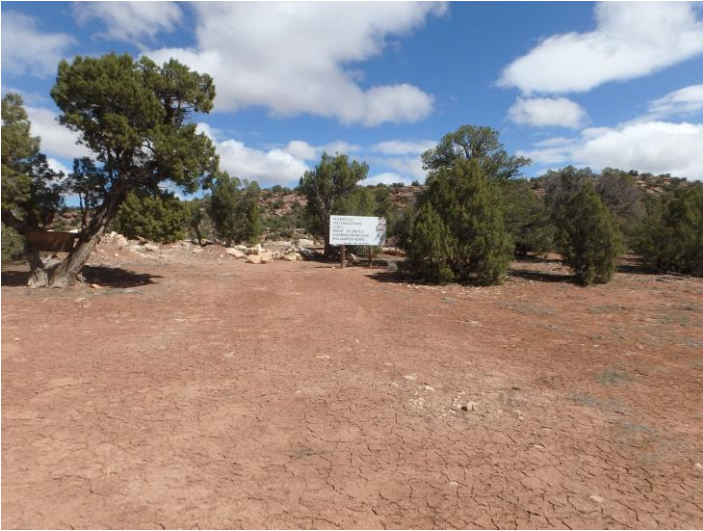
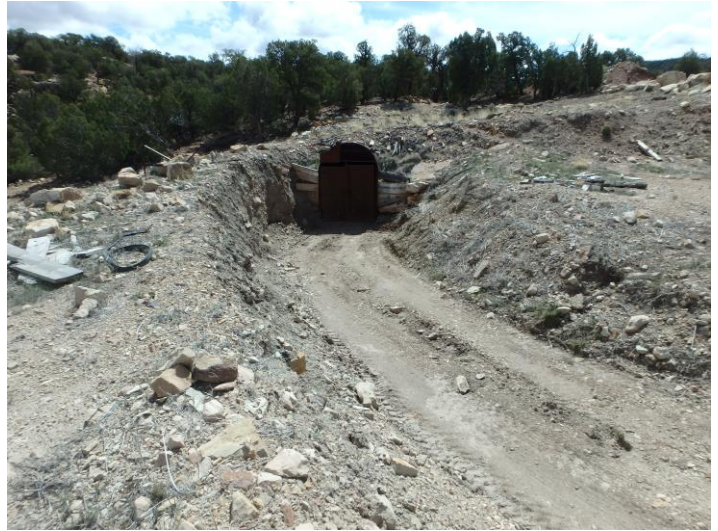
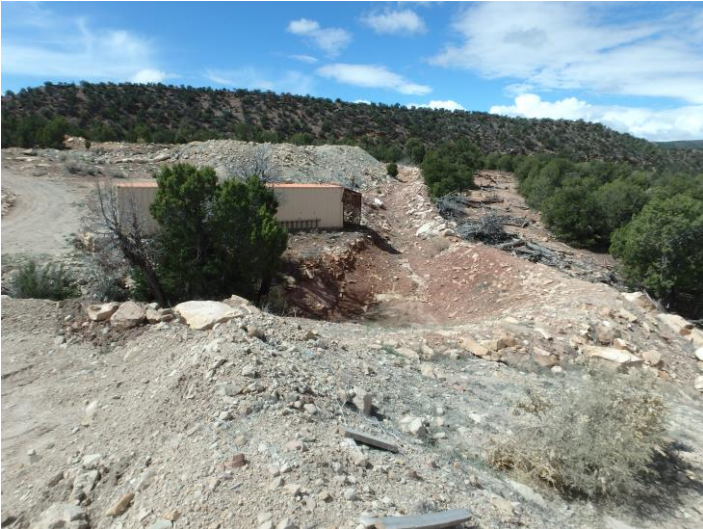
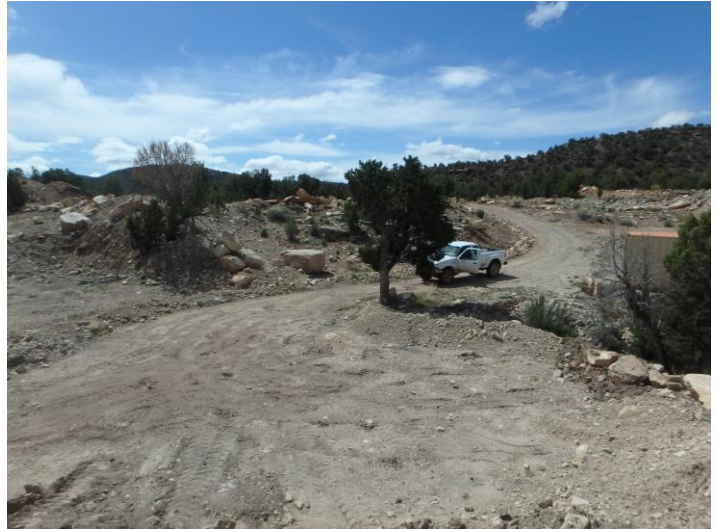
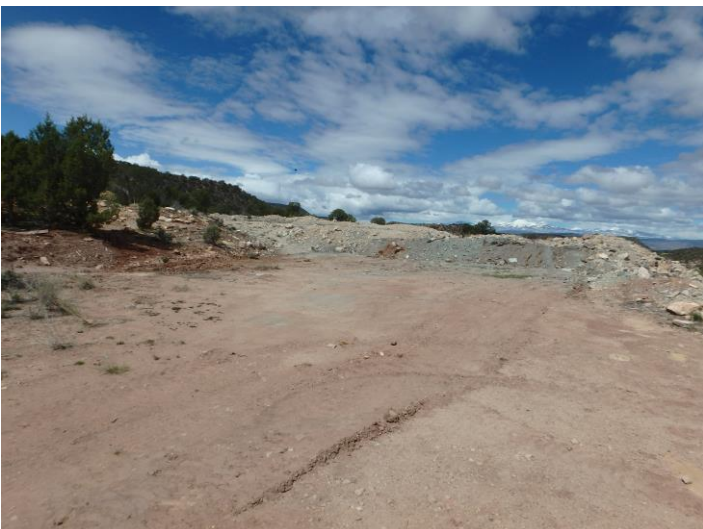
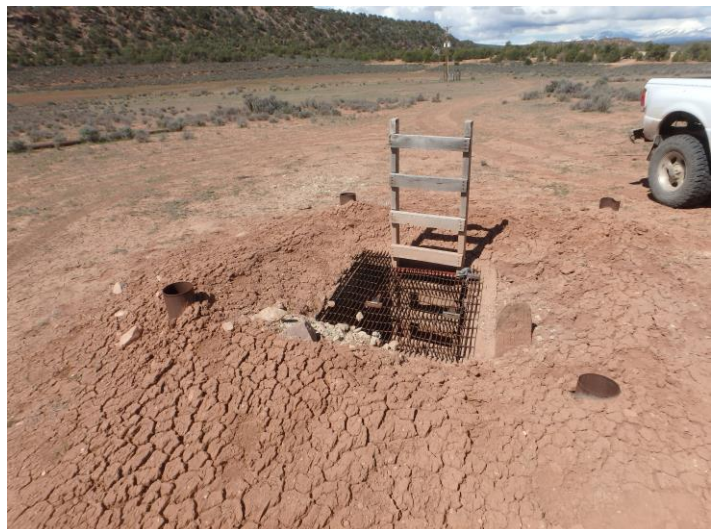
PHOTOGRAPHS

This inspection was conducted as part of the Division of Reclamation, Mining and Safety's (Division) normal monitoring program. Craig Howell, representing the Operator, was present during this inspection. Photographs are included with this report in order to illustrate some of the conditions observed.

The constructed stormwater controls appear effective. No erosion or sedimentation issues were noted.

The topsoil stockpile northwest of Pond 2 is in place and appears stable and protected from disturbance.

The mine portal is secured with a locked gate. Ventholes are secured with locking grates.
