COLORADO
Division of Reclamation,
Mining and Safety
Department of Natural Resources

Permit Number: C-1981-028 Mine Name: Keenesburg Strip Mine Operator: Coors Energy Company Operator Address: Mr. Danny Kipp 1801 California Street Suite 4600 Denver, CO 80202	County: Weld Operation Type: Surface Permit Status: Active Ownership: Private
	Operator Representative Present: Danny Kipp
Operator Representative Signature: (Field Issuance Only)

Inspection Start Date: May 22, 2019 Inspection Start Time: 07:45 Inspection End Date: May 22, 2019 Inspection End Time: 10:00		Inspection Type: Coal Complete Inspection Inspection Reason: Normal I&E Program Weather: Cloudy	
Joint Inspection Agency: None		Joint Inspection Contacts: 	
Post Inspection Agency: None		Post Inspection Contacts: 	
Inspector(s): Robert D. Zuber, P.E.	Inspector's Signature:

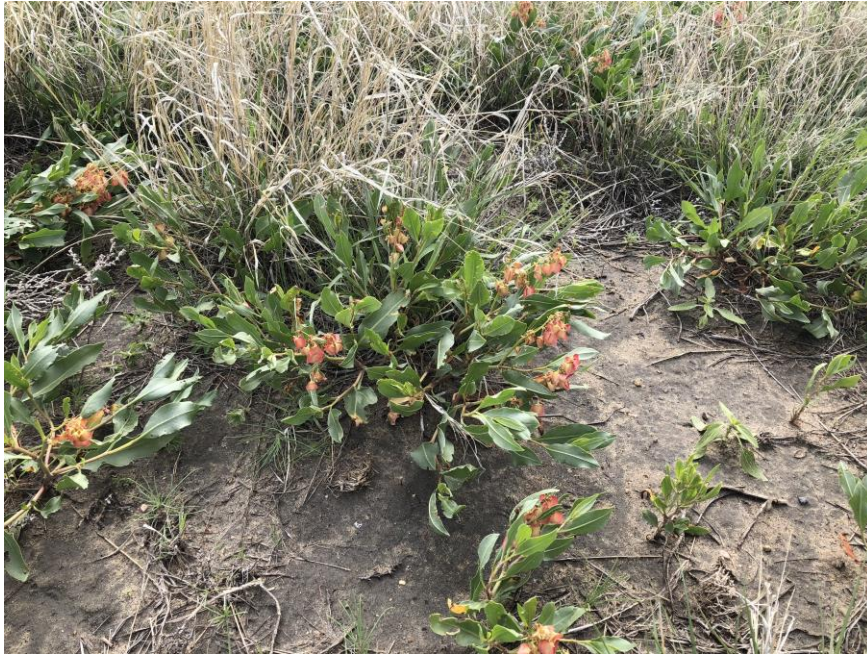
An unknown plant was seen east of the Dugout Pond (see photo below). The Division will try to identify the species.

Unidentified plant between Dugout Pond and facilities area

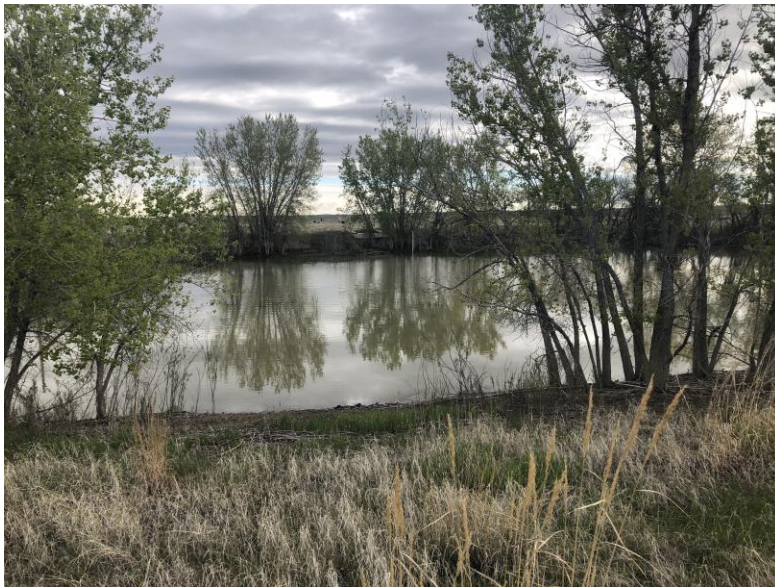
Sediment Pond 2

Water was observed in the two ponds, but levels in both ponds were several feet below the spillways, and neither pond was discharging during the inspection. Nor were there signs that they had discharged recently. No problems were observed with the two ponds.

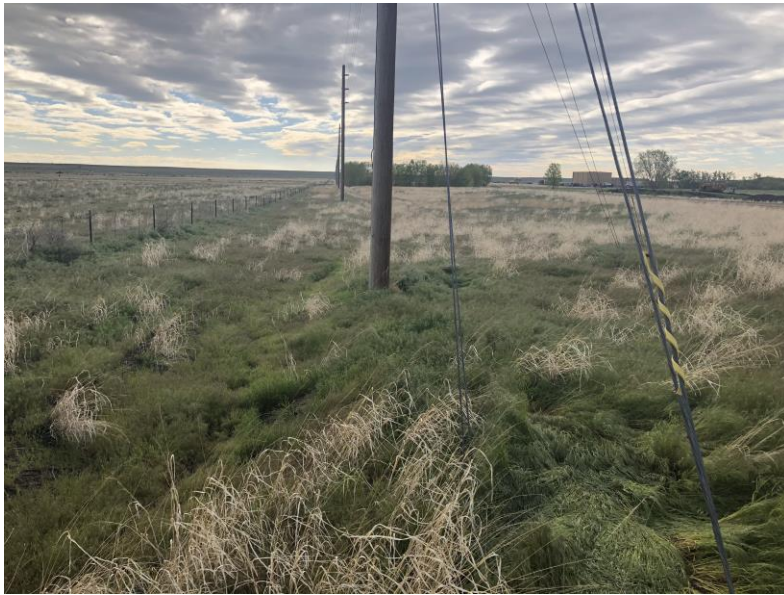
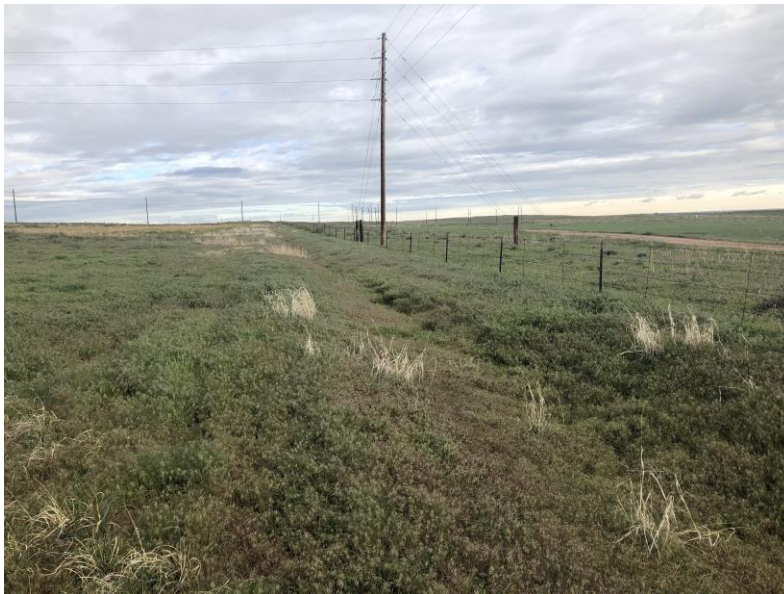
The ditch along the north perimeter was found to be in good shape.

West Perimeter Ditch, looking east with Sediment Pond 2 in background (under trees)

West Perimeter Ditch, looking west toward northwest corner of site

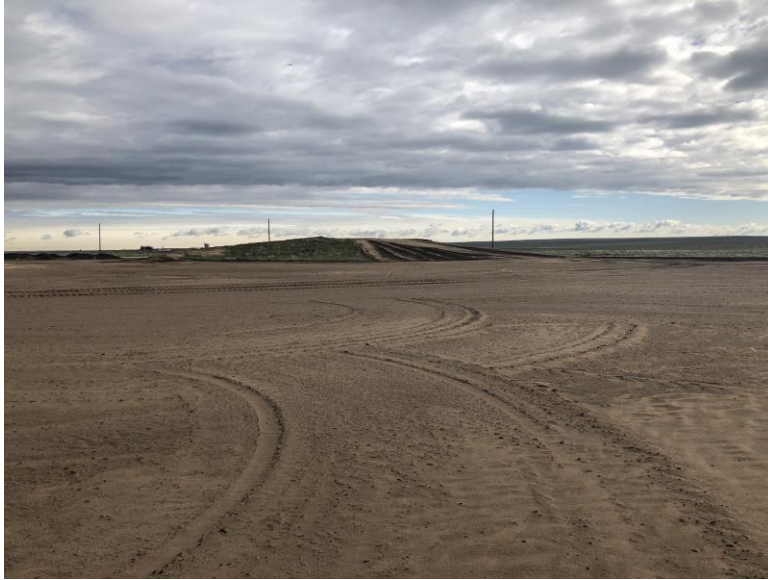
No significant erosion problems were seen at any of the topsand piles. Both of the topsand piles north of the long term spoil area are dwindling in size. The one to the northwest in particular (B horizon) is now very small compared to early in the year.

Remainder of B Horizon topsand in pile north of spoil area

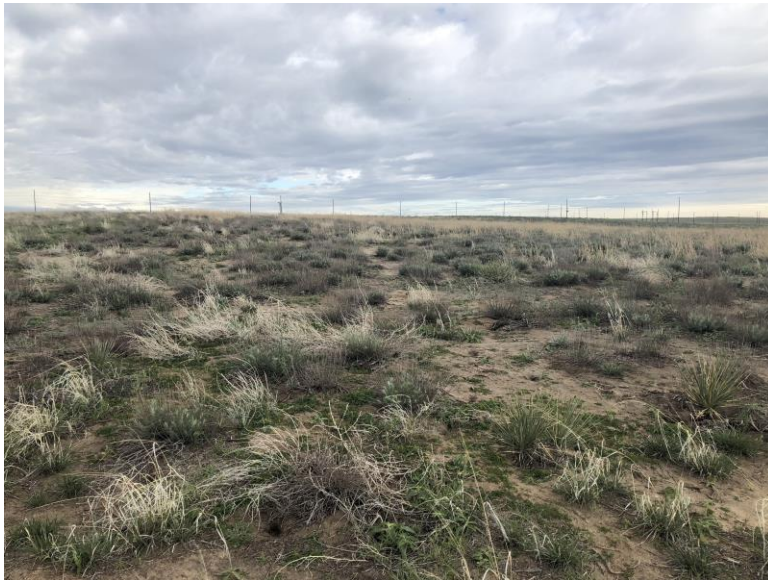
The undisturbed area north of B Pit and along the western permit boundary was inspected, and it appeared that there has been no disturbance in this area.

Undisturbed area north of B Pit

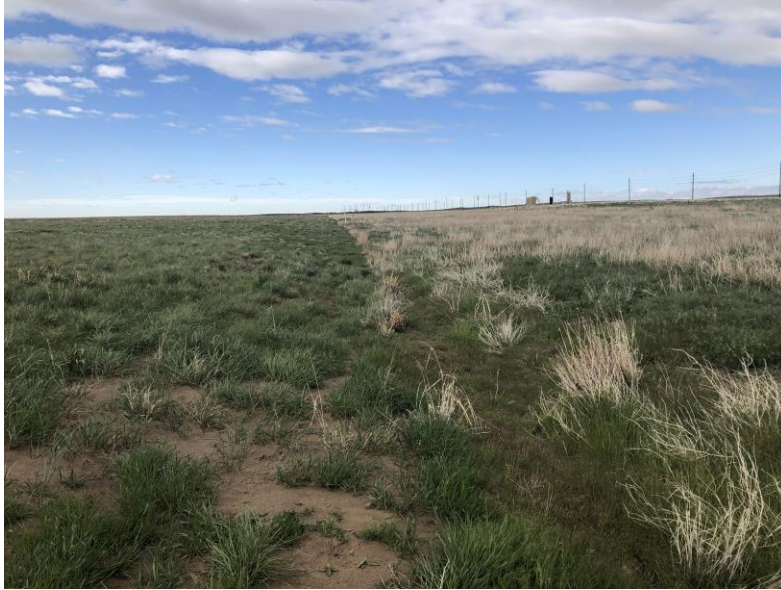
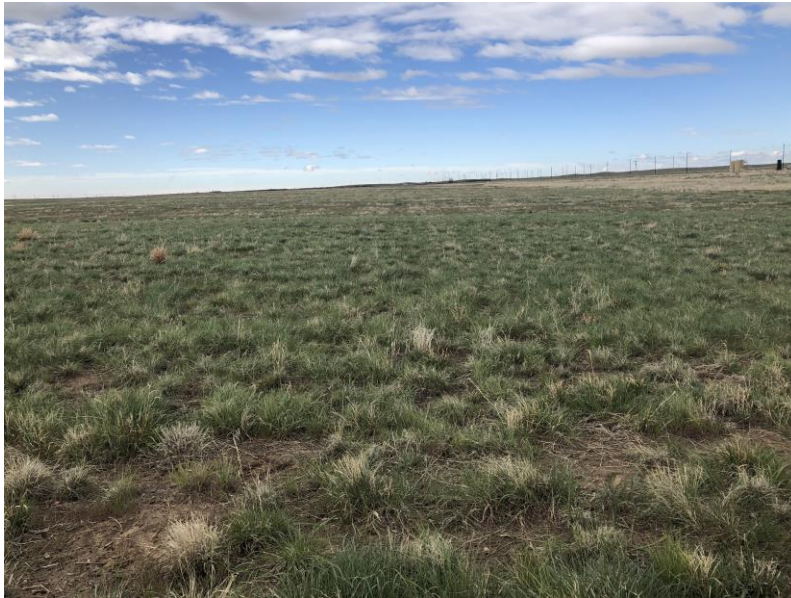
No problems were seen with any reclamation parcels. The particular areas that were inspected closely (by driving through them in a utility task vehicle) are 30, 31, and 32. The vegetation cover looks very good. Significant cheat grass (*Bromus tectorum*) was seen around the site, but the Division has accepted that this is an ongoing problem on-site and all around the site, and CEC has made a very good effort over the years to control this undesirable grass. Furthermore, the Division has no reason to believe that CEC will not continue to make a concerted effort at controlling cheat grass.

Looking south at Area 32 (on left) and undisturbed area (on right)

Looking south at Areas 32 (foreground) and 31

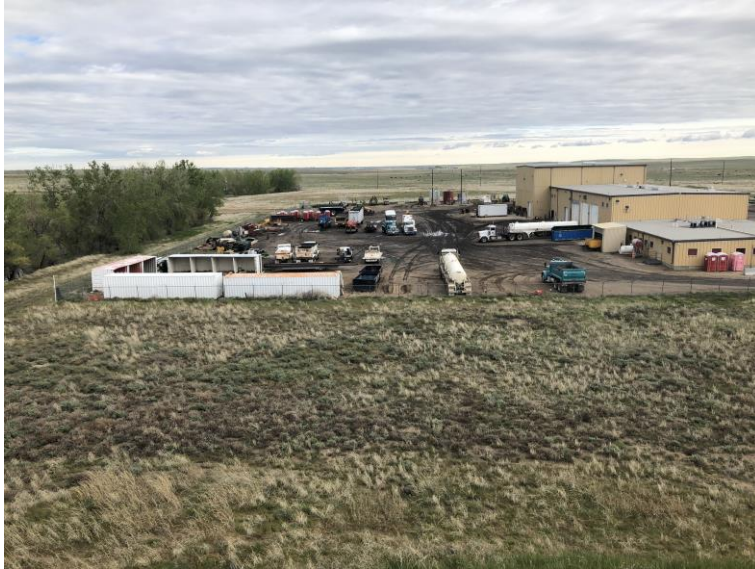
Facilities area

No problems were seen at the facilities area.
