**MINERALS PROGRAM INSPECTION REPORT**  
**PHONE: (303) 866-3567**

| <b>MINE NAME:</b><br>Bates Pit | <b>MINE/PROSPECTING ID#:</b><br>M-1977-387 | <b>MINERAL:</b><br>Sand and gravel | <b>COUNTY:</b><br>Prowers |
| <b>INSPECTION TYPE:</b><br>Monitoring | <b>INSPECTOR(S):</b><br>Amy Eschberger | <b>INSP. DATE:</b><br>March 26, 2019 | <b>INSP. TIME:</b><br>12:15 |
| <b>OPERATOR:</b><br>Prowers County | <b>OPERATOR REPRESENTATIVE:</b><br>Mark Dorenkamp | <b>TYPE OF OPERATION:</b><br>112c - Construction Regular Operation | |

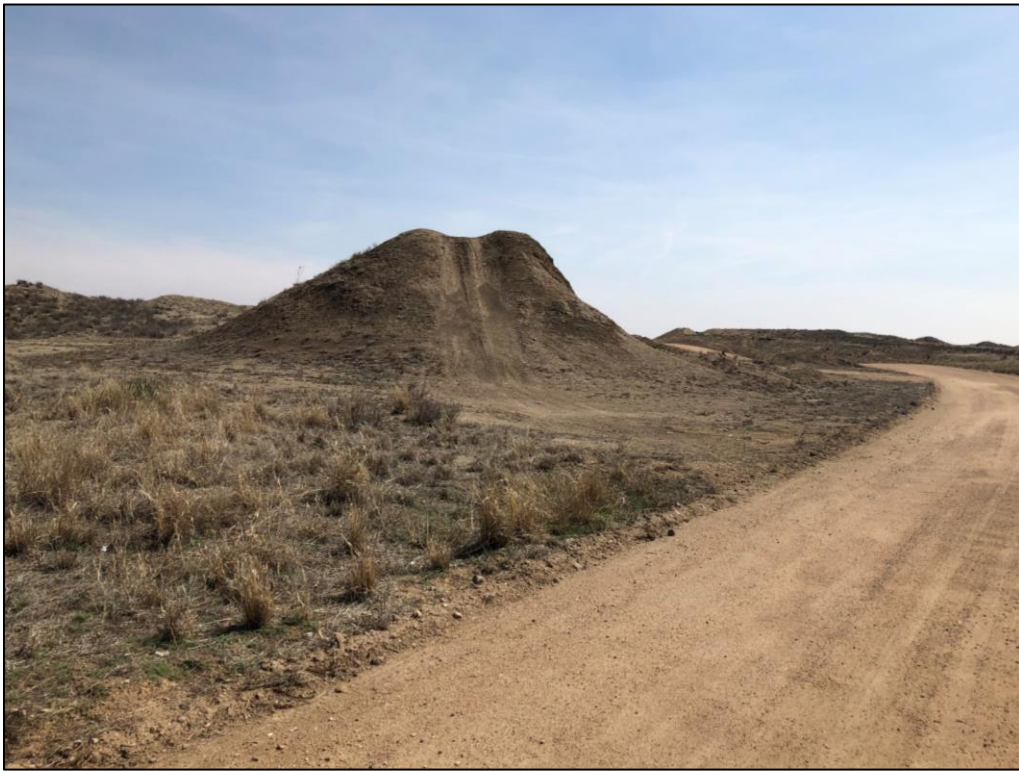
**Photo 1.** View looking east at topsoil stockpile stored adjacent to access road in western portion of permit area.

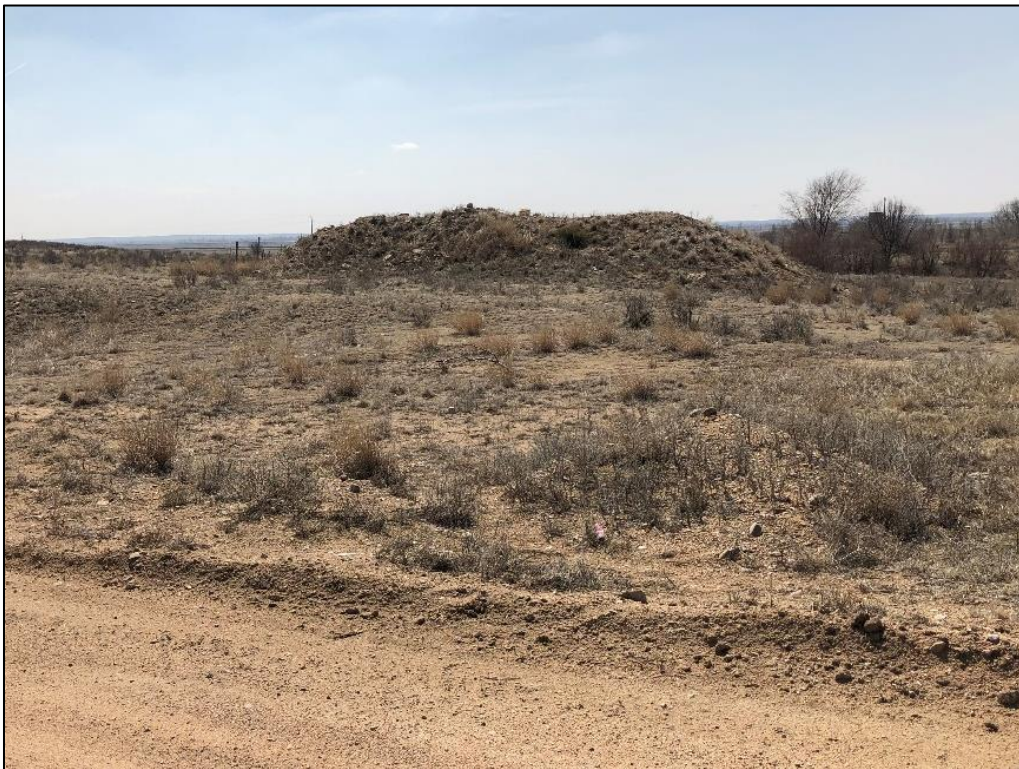
**Photo 2.** View looking south at topsoil stockpile stored south of access road in western portion of permit area.

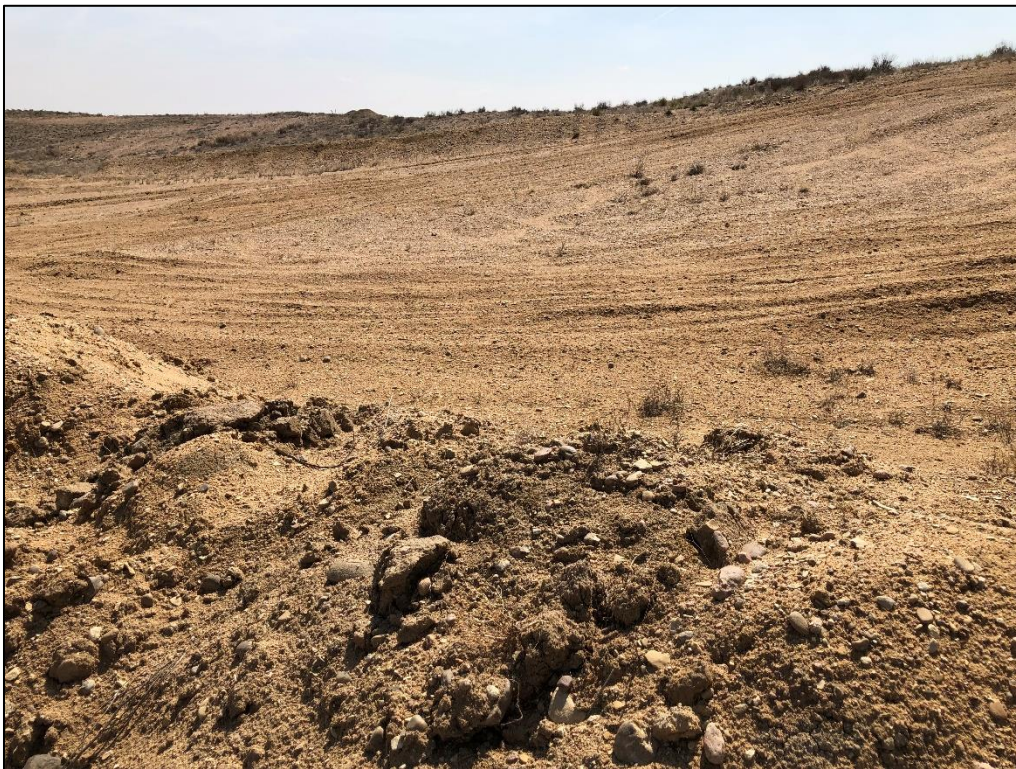
**Photo 3.** View looking south across portion of southern pit wall which has been graded to 3H:1V or flatter but not yet retopsoiled and revegetated.

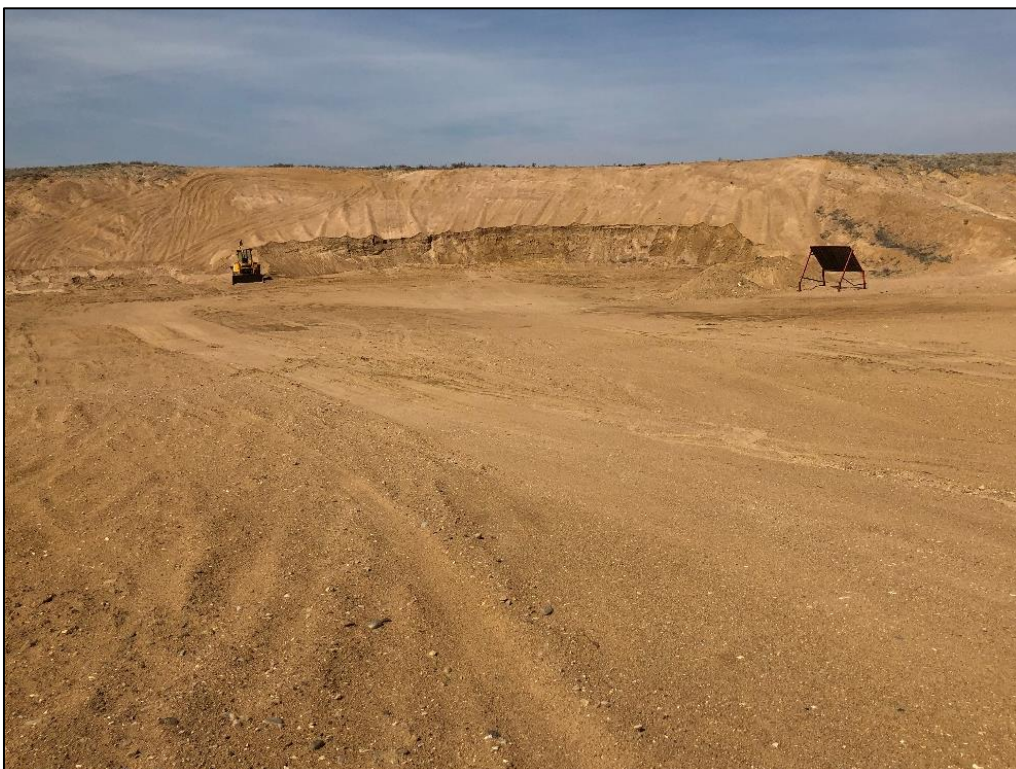
**Photo 4.** View looking northwest at active mining face along northwestern edge of pit, approximately 12-15 feet in height with near vertical to 1H:1V slopes.

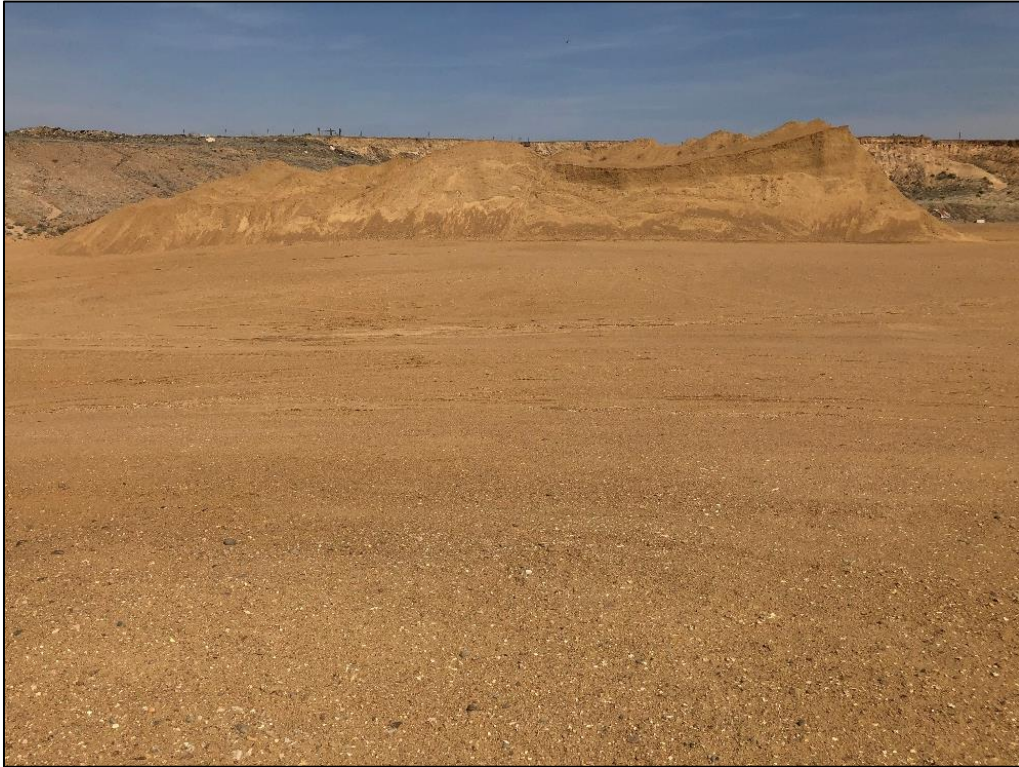
**Photo 5.** View looking east at large sand stockpile stored on pit floor.

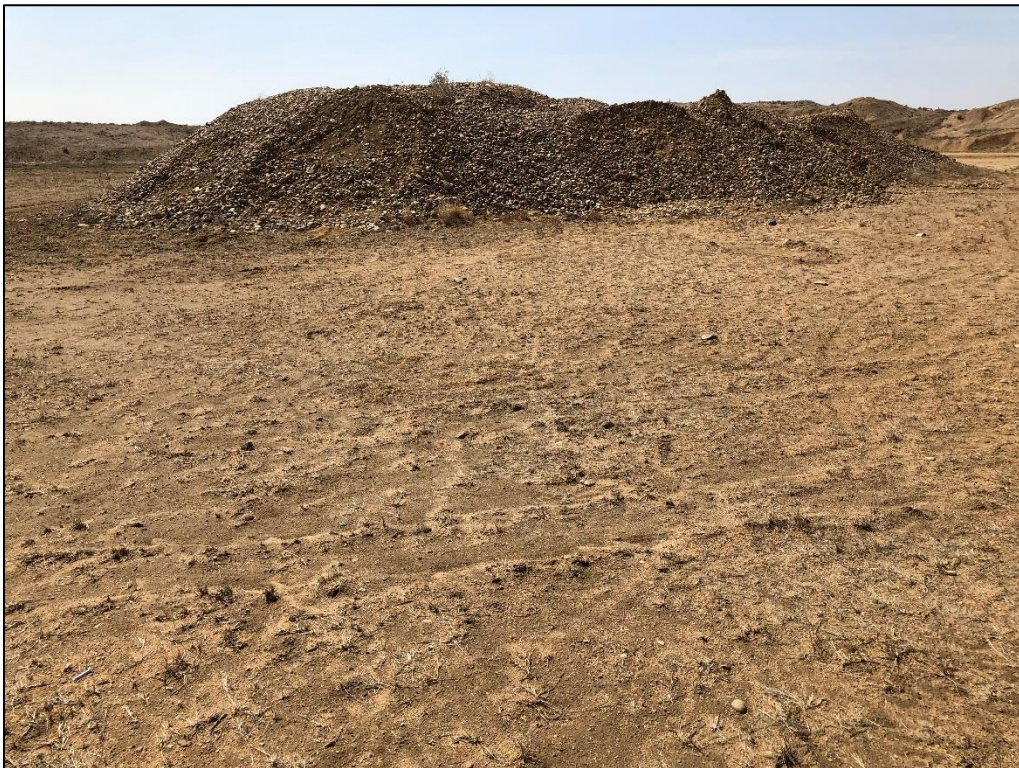
**Photo 6.** View looking north at rock stockpile stored on pit floor.

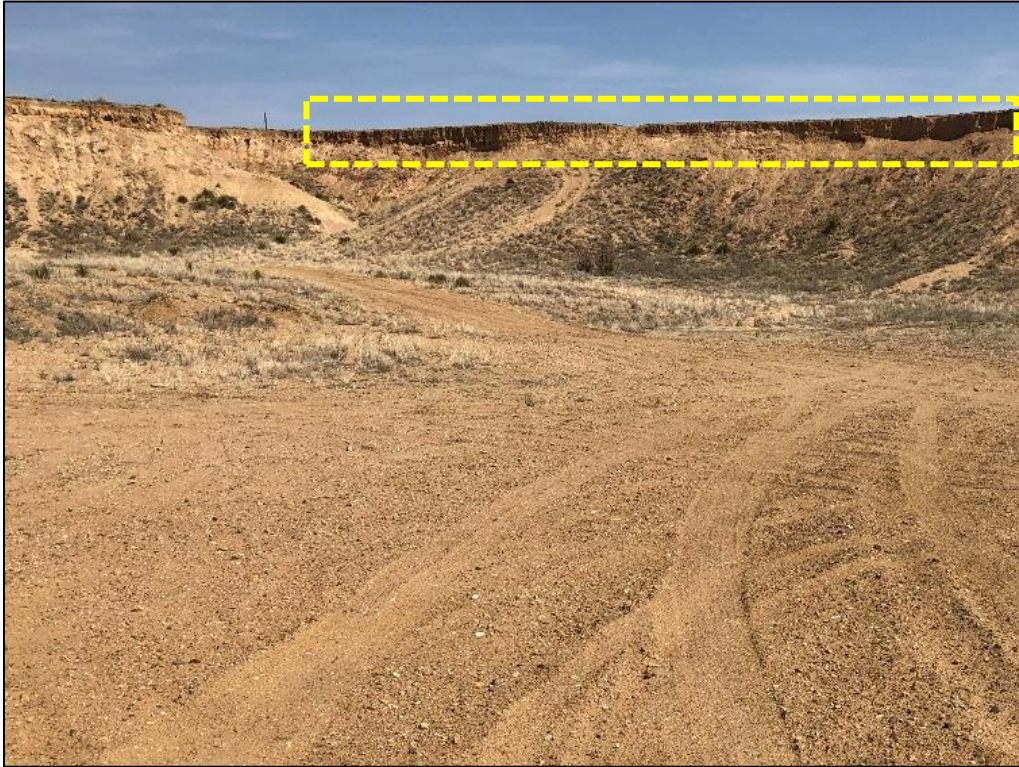
The northeastern pit wall is approximately 25-30 feet in height. The top 5-8 feet of the northeastern pit wall has near vertical slopes, while the bottom of this wall has 1H:1V to 2H:1V slopes. Grasses and shrubs are volunteering across much of the base of the northeastern pit wall. The top edges of the northeastern pit wall appear to be very close to the permit boundary, which would make it difficult for the operator to cut and fill the pit wall to the approved reclamation slope of 3H:1V without creating offsite damage (disturbance outside the approved permit boundary). Therefore, to reclaim the site in accordance with the approved plan, the operator will need to either find a way to backfill the steeper portions of the pit wall, or submit an Amendment application to increase the permit area to allow enough room to cut and fill this portion of the pit wall. One benefit of submitting an Amendment application is there are no limits to the amount of acreage that could be added – which may be beneficial to the operator considering the current permit area is nearly mined out.

**Photo 7.** View looking northeast at northeastern pit wall, approximately 25-30 feet in height. The top 5-8 feet of this wall (indicated) has near vertical slopes, while the bottom portion has 1H:1V to 2H:1V slopes.

Another option would be to submit a Technical Revision (see enclosed form) to revise the approved reclamation plan just for the northeastern pit wall. This revised plan might include changing the reclamation slope gradient to 2H:1V for this portion of the pit wall, which is the current slope gradient for much of its base. To get the steeper top 5-8 feet graded from near vertical to 2H:1V, the operation could potentially cut and fill this portion of the pit wall without disturbing land outside the existing permit boundary. The Technical Revision would need to explain how changing the reclamation slope for the northeastern pit wall from 3H:1V to 2H:1V would provide for a stable configuration of the reclaimed area consistent with the approved post-mining land use of rangeland. The Technical Revision would also need to include a revised reclamation plan map. Several sand and gravel stockpiles were stored on the pit floor, including one large sand stockpile near the center of the pit. Topsoil stockpiles were stored at the northern edge of the pit and in the western portion of the permit area. These stockpiles appeared to be stable with good grass cover.

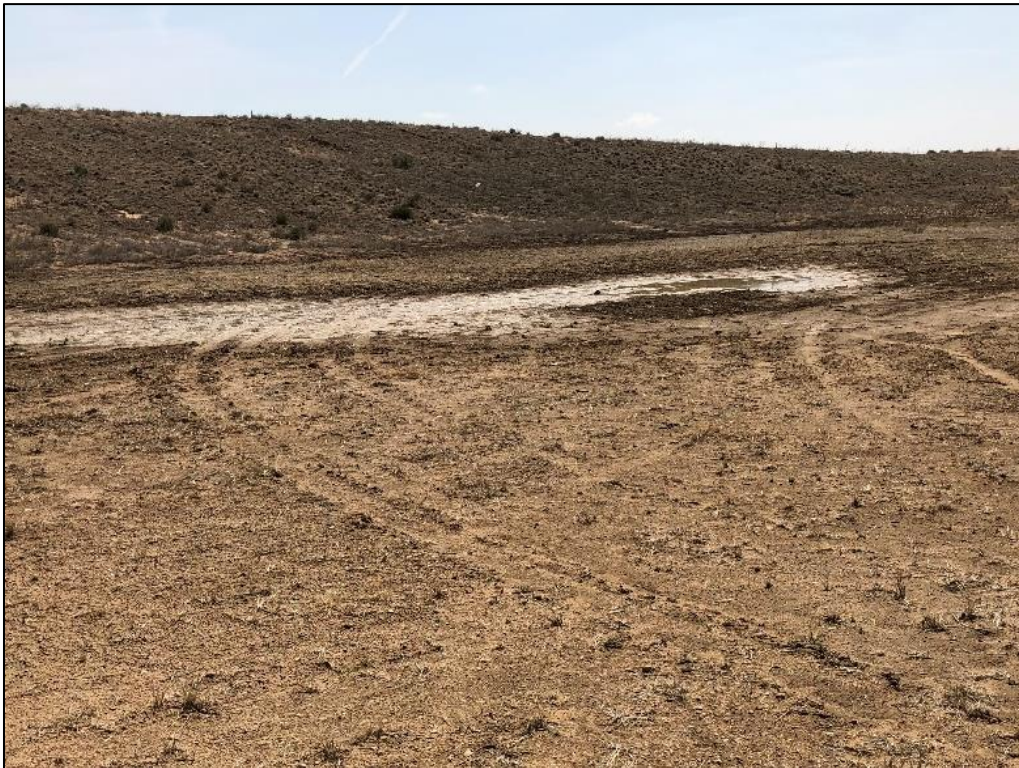
**Photo 8.** View looking east at eastern pit wall which has been graded to 3H:1V, retopsoiled, and revegetated.

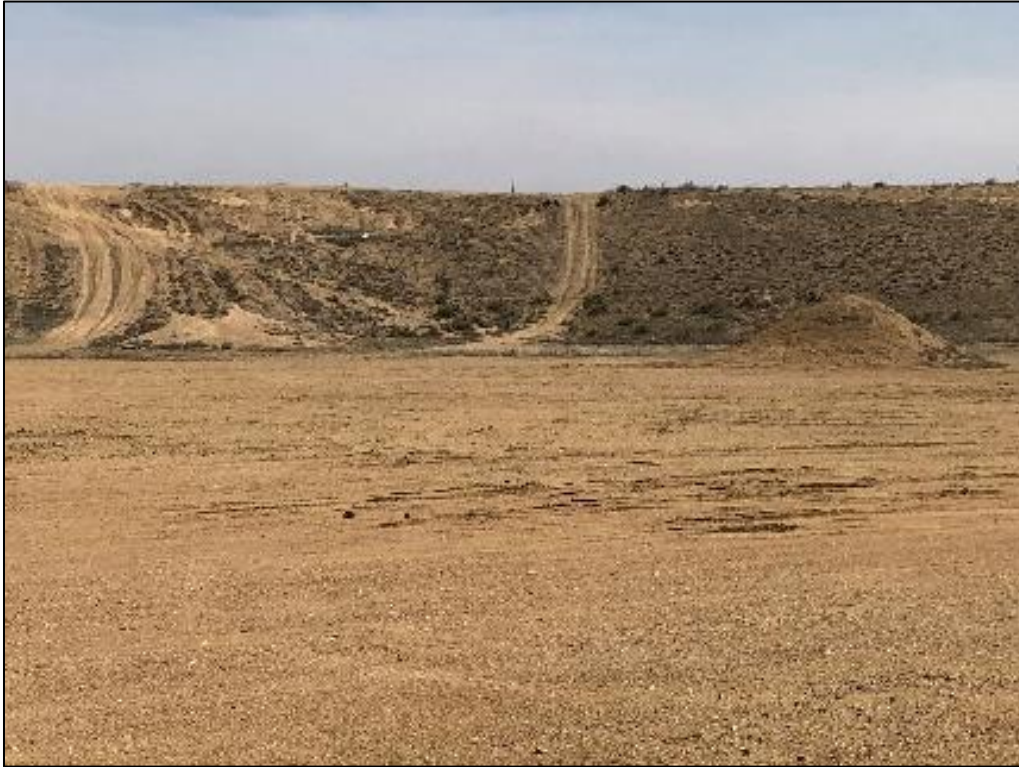
At the time of the inspection, the weather was clear and sunny, and the ground was mostly dry. A permit sign was posted at the main site entrance off of Co Rd 31. The permit boundary corners were delineated with large metal posts painted yellow. The site was not active during the inspection. The operation was approved for intermittent status in 2014 to operate for less than 180 days per year. The active mining face is located at the northwestern edge of the pit, daylighting to the southeast. The active pit wall is approximately 12-15 feet in height with near vertical to 1H:1V slopes. The eastern pit wall is approximately 20-25 feet in height, and has been graded to 3H:1V or flatter. The majority of the eastern pit wall has been retopsoiled and revegetated. However, there are a few areas where tracks have been left on the slopes by fourwheelers. These areas may need to be reseeded for reclamation.

**Photo 9.** View looking northeast at portion of reclaimed eastern pit wall which has been redisturbed by fourwheelers.

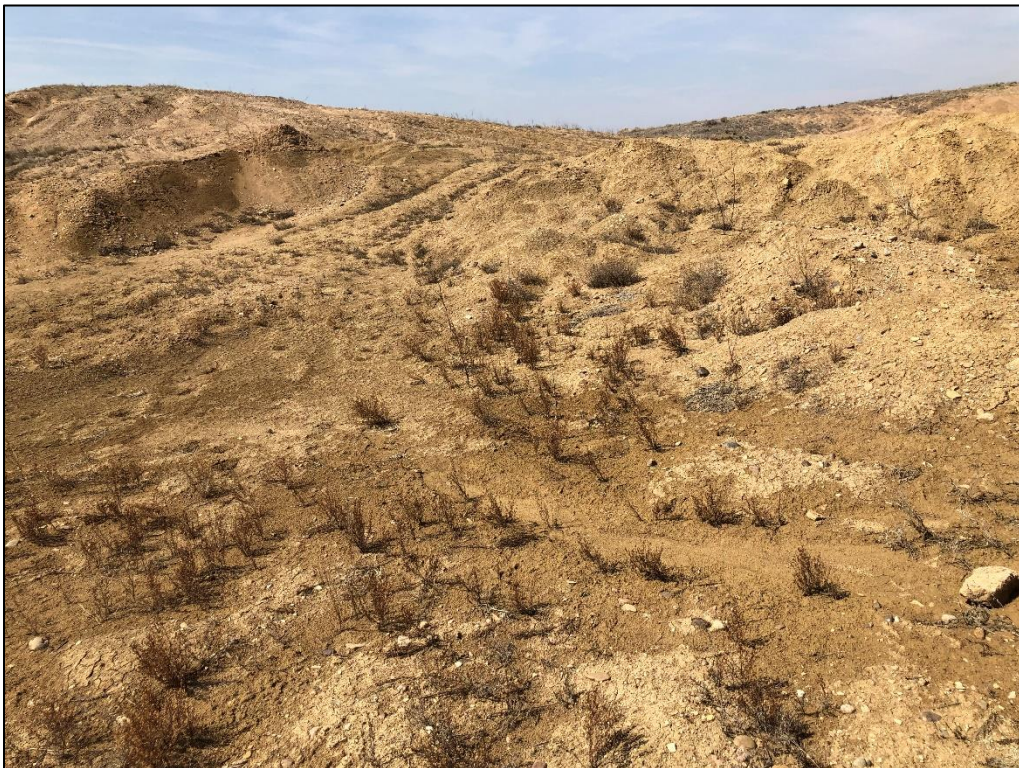
**Photo 10.** View looking southwest across western edge of pit. The western pit wall will need to be graded to 5H:1V for reclamation according to the approved plan.

The approved post-mining land use for the site is rangeland. The reclamation plan includes grading northern, eastern, and southern pit slopes to 3H:1V, and grading western pit slopes to 5H:1V. The taller northern pit slopes will have 1-3 inches of topsoil replaced, while the rest of the site will have 4-6 inches of topsoil replaced. The operation will incorporate 6,000 pounds of manure per acre into the topsoil. Discing and drill-seeding will occur perpendicular to pit slopes to provide furrows for water retention and erosion control. The disturbed land will be revegetated with a rangeland grass and legume mixture including Blue grama, Buffalograss, Sideoats grama, Sand dropseed, Three-awn, and Sainfoin. All haul roads on site will be reclaimed except for the northernmost access road off Co Rd 31.
